Asbestos Survey for

Hall & Woodhouse Ltd

The Snowdrop
Lyoth Lane
Lindfield
Haywards Heath
West Sussex
RH16 2QE

Project Number: AS08032 - Snowdrop

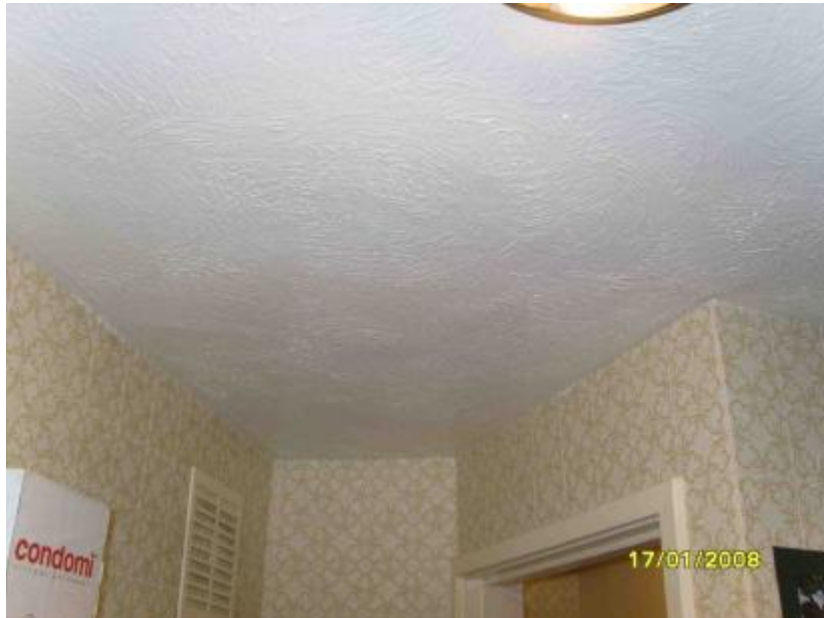
Location ID:	<input type="text" value="9632"/>	Survey Type:	<input type="text" value="T 2"/>
Location Ref:	<input type="text" value="1"/>	Product Type:	<input type="text" value="NADIS"/>
Product:	<input type="text" value="Textured coating"/>	Damage:	<input type="text" value="NADIS"/>
Area:	<input type="text" value="Not Applicable"/>	Treatment:	<input type="text" value="NADIS"/>
Floor:	<input type="text" value="Ground floor"/>	Asbestos Type:	<input type="text" value="NADIS"/>
Room:	<input type="text" value="WC - mens"/>	Identification:	<input type="text" value="Identified"/>
Surveyor Name:	<input type="text" value="J D Chilvers"/>	Quantity:	<input type="text"/>

Material Risk Score	<input type="text" value="0"/>
Material Risk Band:	<input type="text" value="NADIS"/>
Priority Risk Score:	<input type="text" value="N/A"/>

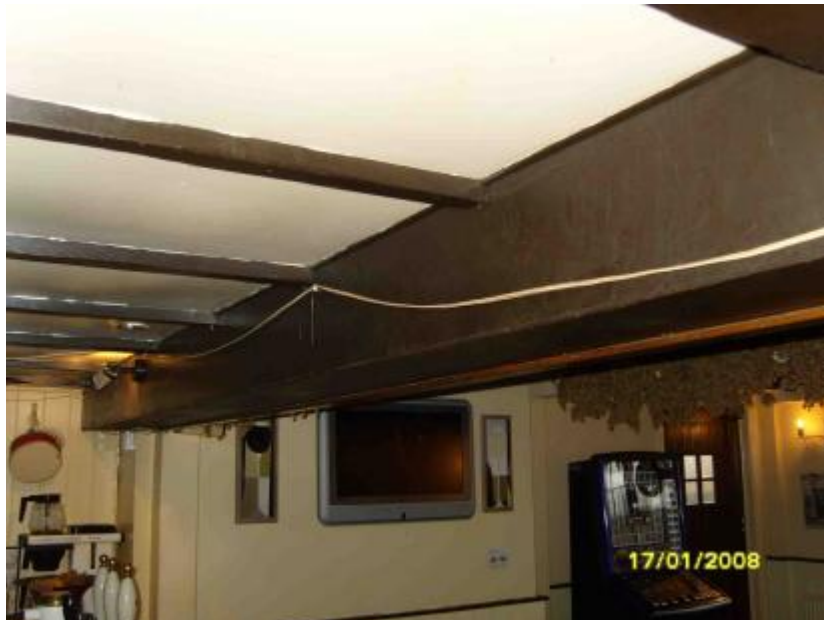
Location ID:	9633	Survey Type:	T 2
Location Ref:	2	Product Type:	Asbestos Insulating Board
Product:	Beam cladding	Damage:	No visible damage
Area:	Not Applicable	Treatment:	AIB painted or encapsulated
Floor:	Ground floor	Asbestos Type:	Amosite
Room:	Bar area	Identification:	Presumed
Surveyor Name:	J D Chilvers	Quantity:	
Drawing Ref:	2	Accessibility:	Medium Accessibility
Asbestos ?	Yes		
Date:	17 January 2008		
Next Inspection:	18 July 2008		
		Material Risk Score:	5
		Material Risk Band:	Low Risk
		Priority Risk Score:	5
Action:	Apply Warning Labels

Material Comments:	All structural beams are presumed to have ACMs underneath external surfaces.
--------------------	--

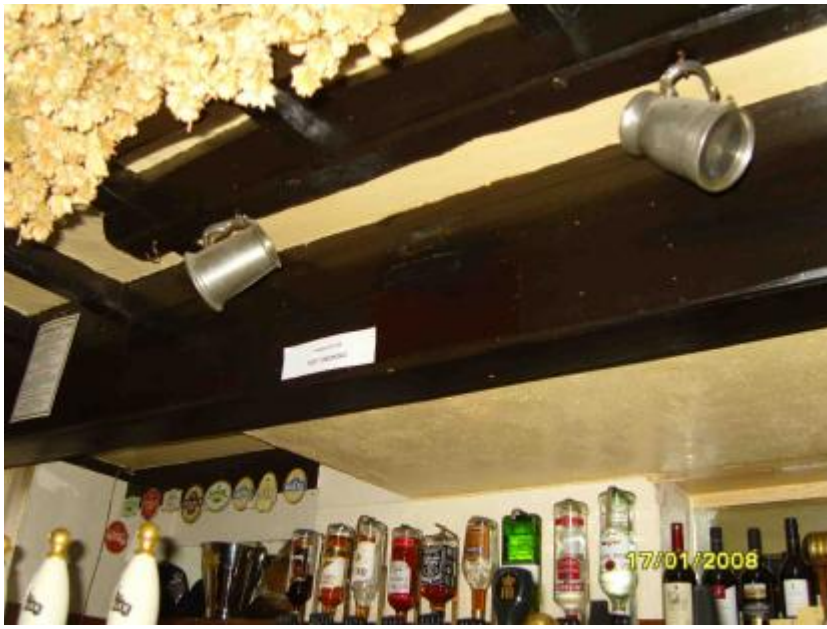
Location ID:	<input style="width: 95%;" type="text" value="9634"/>	Survey Type:	<input style="width: 95%;" type="text" value="T 2"/>						
Location Ref:	<input style="width: 95%;" type="text" value="3"/>	Product Type:	<input style="width: 95%;" type="text" value="Asbestos Insulating Board"/>						
Product:	<input style="width: 95%;" type="text" value="Beam cladding"/>	Damage:	<input style="width: 95%;" type="text" value="No visible damage"/>						
Area:	<input style="width: 95%;" type="text" value="Not Applicable"/>	Treatment:	<input style="width: 95%;" type="text" value="AIB painted or encapsulated"/>						
Floor:	<input style="width: 95%;" type="text" value="Ground floor"/>	Asbestos Type:	<input style="width: 95%;" type="text" value="Amosite"/>						
Room:	<input style="width: 95%;" type="text" value="Bar area"/>	Identification:	<input style="width: 95%;" type="text" value="Presumed"/>						
Surveyor Name:	<input style="width: 95%;" type="text" value="J D Chilvers"/>	Quantity:	<input style="width: 95%;" type="text" value=""/>						
Drawing Ref:	<input style="width: 95%;" type="text" value="3"/>	Accessibility:	<input style="width: 95%;" type="text" value="Medium Accessibility"/>						
Asbestos ?	<input style="width: 95%;" type="text" value="Yes"/>

Material Risk Score	<input style="width: 20%;" type="text" value="5"/>	Material Risk Band:	<input style="width: 20%;" type="text" value="Low Risk"/>	Priority Risk Score:	<input style="width: 20%;" type="text" value="5"/>
Material Risk Score	<input style="width: 20%;" type="text" value="5"/>								
Material Risk Band:	<input style="width: 20%;" type="text" value="Low Risk"/>								
Priority Risk Score:	<input style="width: 20%;" type="text" value="5"/>								
Date:	<input style="width: 95%;" type="text" value="17 January 2008"/>								
Next Inspection:	<input style="width: 95%;" type="text" value="18 July 2008"/>								
Action:	Apply Warning Labels

Material Comments:	All structural beams are presumed to have ACMs underneath external surfaces.
---------------------------	--

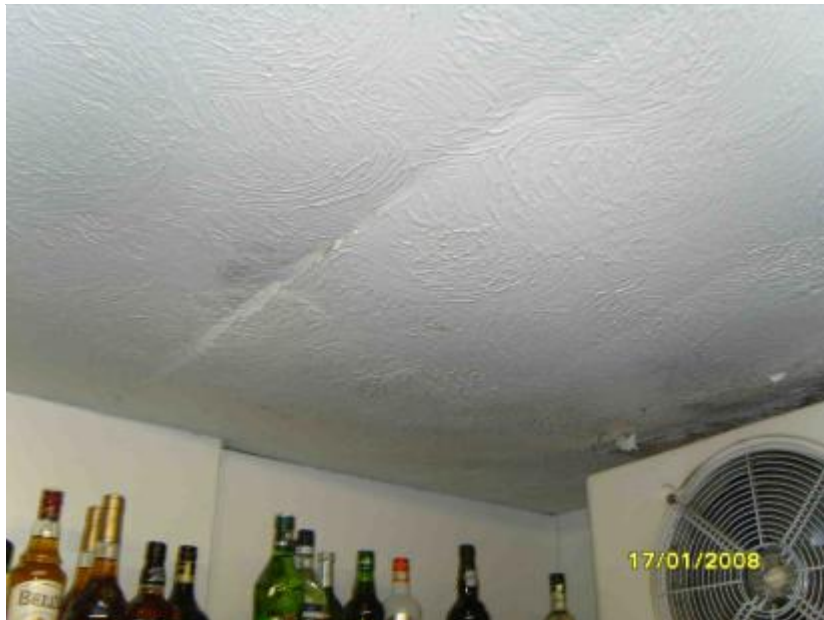
Location ID:	<input type="text" value="9635"/>	Survey Type:	<input type="text" value="T 2"/>
Location Ref:	<input type="text" value="4"/>	Product Type:	<input type="text" value="NADIS"/>
Product:	<input type="text" value="Textured coating"/>	Damage:	<input type="text" value="NADIS"/>
Area:	<input type="text" value="Not Applicable"/>	Treatment:	<input type="text" value="NADIS"/>
Floor:	<input type="text" value="Ground floor"/>	Asbestos Type:	<input type="text" value="NADIS"/>
Room:	<input type="text" value="Cellar"/>	Identification:	<input type="text" value="Identified"/>
Surveyor Name:	<input type="text" value="J D Chilvers"/>	Quantity:	<input type="text"/>

Material Risk Score	<input type="text" value="0"/>
Material Risk Band:	<input type="text" value="NADIS"/>
Priority Risk Score:	<input type="text" value="N/A"/>

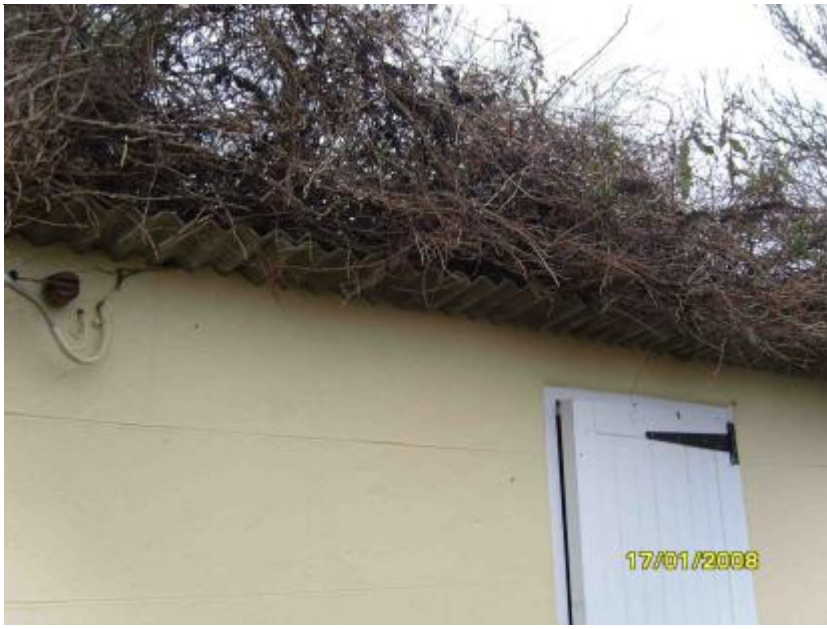
Location ID:	9636	Survey Type:	T 2
Location Ref:	5	Product Type:	Asbestos cement
Product:	Roof sheets	Damage:	Low damage: Scratches or marks
Area:	Not Applicable	Treatment:	Asbestos cement sheets etc
Floor:	Ground floor	Asbestos Type:	Chrysotile
Room:	Sheds / Outbuildings	Identification:	Identified
Surveyor Name:	J D Chilvers	Quantity:	
Drawing Ref:	5	Accessibility:	Easy Accessibility
Asbestos ?	Yes		
Date:	17 January 2008	Material Risk Score:	4
Next Inspection:	16 January 2009	Material Risk Band:	Very Low Risk
		Priority Risk Score:	3

Action:	Apply Warning Labels
---------	----------------------

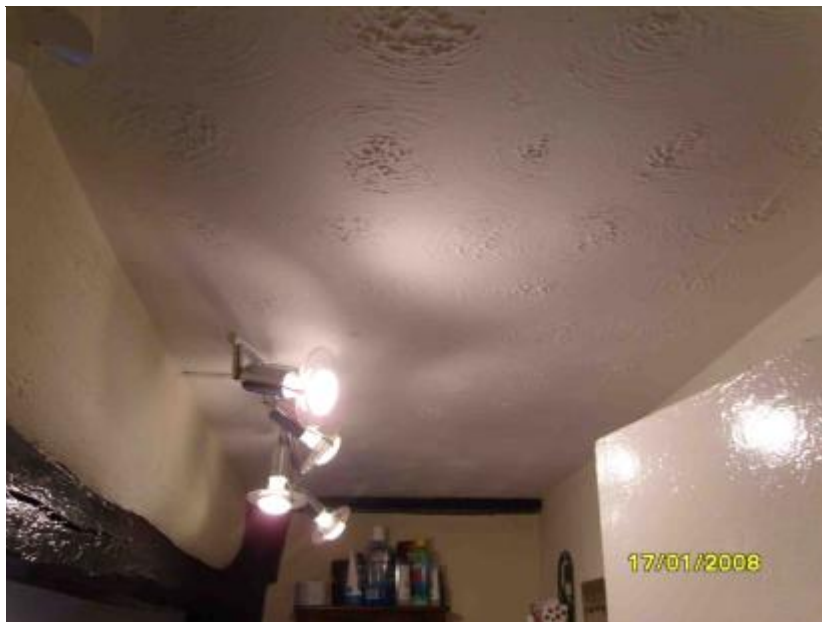
Location ID:	<input type="text" value="9637"/>	Survey Type:	<input type="text" value="T 2"/>
Location Ref:	<input type="text" value="6"/>	Product Type:	<input type="text" value="NADIS"/>
Product:	<input type="text" value="Textured coating"/>	Damage:	<input type="text" value="NADIS"/>
Area:	<input type="text" value="Not Applicable"/>	Treatment:	<input type="text" value="NADIS"/>
Floor:	<input type="text" value="First floor"/>	Asbestos Type:	<input type="text" value="NADIS"/>
Room:	<input type="text" value="Bathroom"/>	Identification:	<input type="text" value="Identified"/>
Surveyor Name:	<input type="text" value="J D Chilvers"/>	Quantity:	<input type="text"/>

Material Risk Score	<input type="text" value="0"/>
Material Risk Band:	<input type="text" value="NADIS"/>
Priority Risk Score:	<input type="text" value="N/A"/>

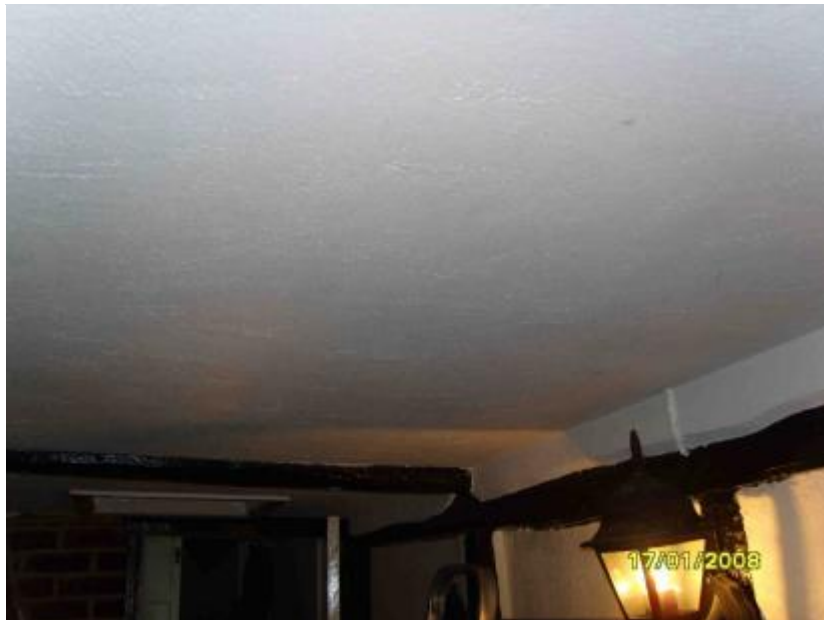
Location ID:	9638	Survey Type:	T 2
Location Ref:	7	Product Type:	Decorative finishes
Product:	Textured coating	Damage:	No visible damage
Area:	Not Applicable	Treatment:	Composite asbestos materials
Floor:	First floor	Asbestos Type:	Chrysotile
Room:	Lounge	Identification:	Presumed
Surveyor Name:	J D Chilvers	Quantity:	
Drawing Ref:	7	Accessibility:	Easy Accessibility
Asbestos ?	Yes		
Date:	17 January 2008		
Next Inspection:	16 January 2009		
		Material Risk Score:	2
		Material Risk Band:	Very Low Risk
		Priority Risk Score:	5
Action:	Apply Warning Labels

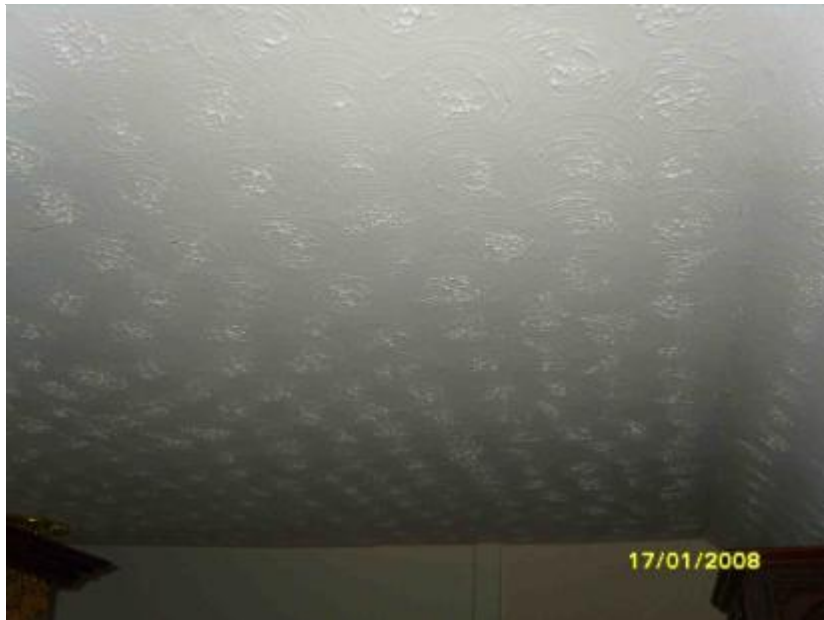
Location ID:	9639	Survey Type:	T 2
Location Ref:	8	Product Type:	Decorative finishes
Product:	Textured coating	Damage:	No visible damage
Area:	Not Applicable	Treatment:	Composite asbestos materials
Floor:	First floor	Asbestos Type:	Chrysotile
Room:	Bedroom	Identification:	Presumed
Surveyor Name:	J D Chilvers	Quantity:	
Drawing Ref:	8	Accessibility:	Easy Accessibility
Asbestos ?	Yes		
Date:	17 January 2008		
Next Inspection:	16 January 2009		
		Material Risk Score:	2
		Material Risk Band:	Very Low Risk
		Priority Risk Score:	5
Action:	Apply Warning Labels

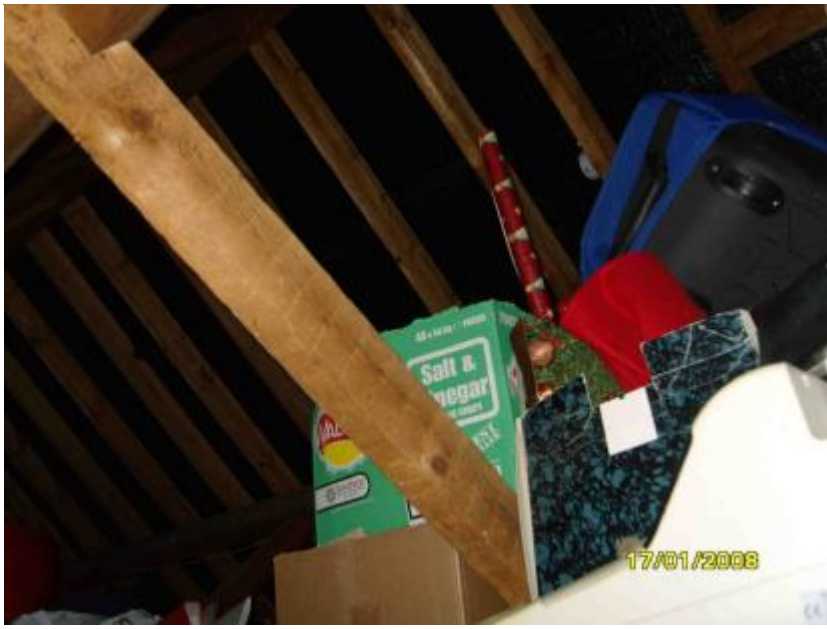
Location ID:	9640	Survey Type:	T 2
Location Ref:	9	Product Type:	Roofing felts
Product:	Roofing felt	Damage:	No visible damage
Area:	Not Applicable	Treatment:	Resins
Floor:	Roof level	Asbestos Type:	Chrysotile
Room:	Loft space	Identification:	Presumed
Surveyor Name:	J D Chilvers	Quantity:	
Drawing Ref:	9	Accessibility:	Medium Accessibility
Asbestos ?	Yes		
Date:	17 January 2008	Material Risk Score:	2
Next Inspection:	16 January 2009	Material Risk Band:	Very Low Risk
		Priority Risk Score:	3

Action:	No Action Required
---------	--------------------

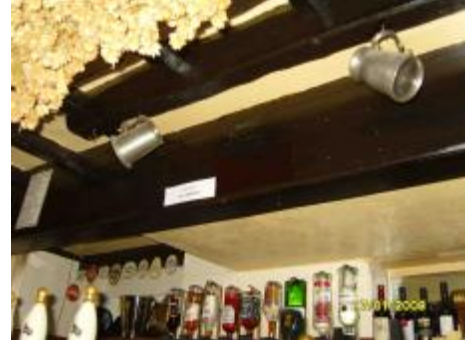
Location ID:	9634
Location Ref:	3
Product:	Beam cladding
Area:	Not Applicable
Floor:	Ground floor
Room:	Bar area
Surveyor Name:	J D Chilvers
Drawing Ref:	3
Asbestos ?	Yes
Date:	17 January 2008

Priority Assessment Algorithm	Variable(s) selected	Score for each	Overall score
Normal Occupant Activity:			
Main type of activity in area:	Low disturbance	1	average
Secondary activities for area:	Low disturbance	1	1
Likelihood Of Disturbance:			
Location:	Large rooms or well-ventilated areas	1	average
Accessibility:	Usually inaccessible or unlikely to be disturbed	0	
Extent/Amount:	<=10 m2 or <=10 m pipe run	1	
Human Exposure Potential:			
Number of occupants:	>10	3	average
Frequency of use of area:	Daily	3	
Average time area is in use:	>1 to <3 hours	1	
Maintenance Activity:			
Type of maintenance activity:	Minor disturbance	0	average
Frequency of maintenance activity	<=1 per year	1	1

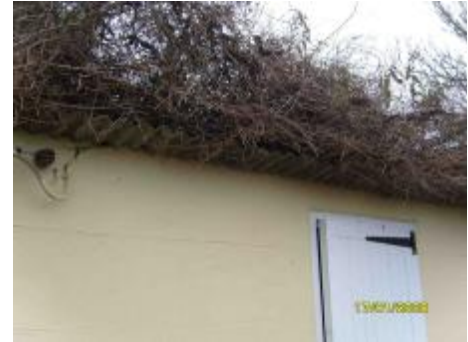
Location ID:	9636
Location Ref:	5
Product:	Roof sheets
Area:	Not Applicable
Floor:	Ground floor
Room:	Sheds / Outbuildings
Surveyor Name:	J D Chilvers
Drawing Ref:	5
Asbestos ?	Yes
Date:	17 January 2008

Priority Assessment Algorithm	Variable(s) selected	Score for each	Overall score
Normal Occupant Activity:			
Main type of activity in area:	Rare disturbance	0	average
Secondary activities for area:	Rare disturbance	0	0
Likelihood Of Disturbance:			
Location:	Outdoors	0	average 1
Accessibility:	Usually inaccessible or unlikely to be disturbed	0	
Extent/Amount:	>10 to <=50 (m2 or pipe run)	2	
Human Exposure Potential:			
Number of occupants:	1 to 3	1	average 1
Frequency of use of area:	Daily	3	
Average time area is in use:	<1 hour	0	
Maintenance Activity:			
Type of maintenance activity:	Minor disturbance	0	average
Frequency of maintenance activity	<=1 per year	1	1

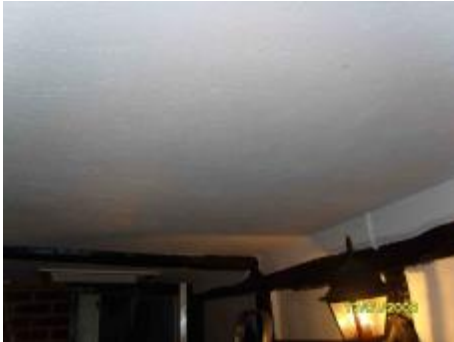
Priority Assessment Algorithm	Variable(s) selected	Score for each	Overall score
Normal Occupant Activity:			
Main type of activity in area:	Low disturbance	1	average 1
Secondary activities for area:	Rare disturbance	0	
Likelihood Of Disturbance:			
Location:	Large rooms or well-ventilated areas	1	average 1
Accessibility:	Usually inaccessible or unlikely to be disturbed	0	
Extent/Amount:	>10 to <=50 (m2 or pipe run)	2	
Human Exposure Potential:			
Number of occupants:	1 to 3	1	average 2
Frequency of use of area:	Daily	3	
Average time area is in use:	>1 to <3 hours	1	
Maintenance Activity:			
Type of maintenance activity:	Minor disturbance	0	average 1
Frequency of maintenance activity	<=1 per year	1

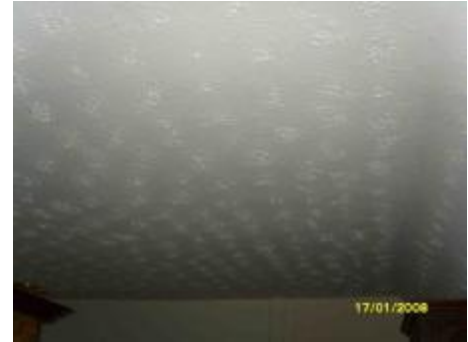
Priority Assessment Algorithm			
Assessment factor	Variable(s) selected	Score for each	Overall score
Normal Occupant Activity:			
Main type of activity in area:	Low disturbance	1	average 1
Secondary activities for area:	Rare disturbance	0	
Likelihood Of Disturbance:			
Location:	Large rooms or well-ventilated areas	1	average 1
Accessibility:	Usually inaccessible or unlikely to be disturbed	0	
Extent/Amount:	>10 to <=50 (m2 or pipe run)	2	
Human Exposure Potential:			
Number of occupants:	1 to 3	1	average 2
Frequency of use of area:	Daily	3	
Average time area is in use:	>1 to <3 hours	1	
Maintenance Activity:			
Type of maintenance activity:	Minor disturbance	0	average 1
Frequency of maintenance activity	<=1 per year	1

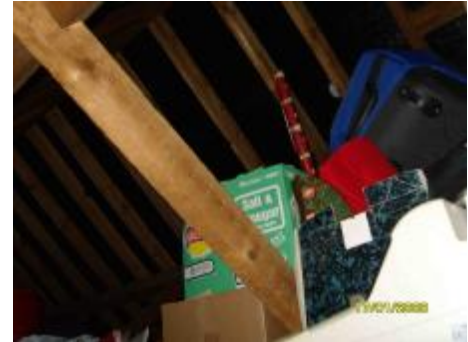
Location ID:	9640
Location Ref:	9
Product:	Roofing felt
Area:	Not Applicable
Floor:	Roof level
Room:	Loft space
Surveyor Name:	J D Chilvers
Drawing Ref:	9
Asbestos ?	Yes
Date:	17 January 2008

Priority Assessment Algorithm	Variable(s) selected	Score for each	Overall score
Normal Occupant Activity:			
Main type of activity in area:	Rare disturbance	0	average
Secondary activities for area:	Rare disturbance	0	0
Likelihood Of Disturbance:			
Location:	Large rooms or well-ventilated areas	1	average 1
Accessibility:	Usually inaccessible or unlikely to be disturbed	0	
Extent/Amount:	>50 m2 or >50 m pipe run	3	
Human Exposure Potential:			
Number of occupants:	1 to 3	1	average 1
Frequency of use of area:	Monthly	1	
Average time area is in use:	<1 hour	0	
Maintenance Activity:			
Type of maintenance activity:	Minor disturbance	0	average
Frequency of maintenance activity	<=1 per year	1	1
