# **Asbestos Survey for**

Hall & Woodhouse Ltd

The Robin Hood 26 The Green Rowland's Castle Hampshire PO9 6AB

Project Number: AS07177 - Robin Hood

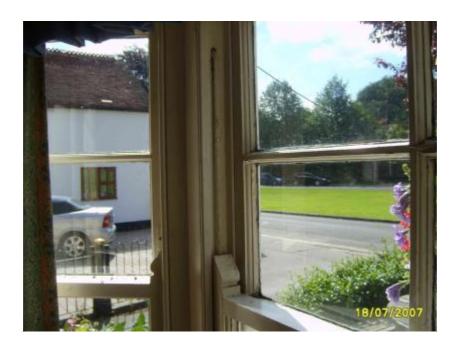
| Site Address: | The Robin Hood, 26 The Green, Rowland's Castle, Hampshire, PO9 6AB | | lient Name: | Hall & WO | oanouse Lta |
|---|--|---|---|---|---|
| Location ID: | 8307 | Survey Type: | | Т3 | |

| Sample<br>Date | Location<br>Ref | Location ID | Drawing<br>Reference | Floor | Room | Asbestos<br>Type | Product<br>Name | Material<br>Risk<br>Score | Material<br>Risk<br>Band | Priority<br>Risk<br>Score | Comments | Action | Survey<br>Type |
|---|---|---|---|---|---|---|---|---|---|---|--|---|---|
| 18/07/07 | 1 | 8307 | 1 | Ground floor | All | NADIS | Sash Cord | 0 | NADIS | N/A | | No Action Required | Т3 |
| 18/07/07 | 3 | 8309 | 3 | Ground floor | WC - mens | Amosite | Cistern | 3 | Very Low<br>Risk | N/A | | Removal | Т3 |

| Site Address: | The Robin Hood, 26 The Green, Rowland's Castle, Hampshire, PO9 6AB | | lient Name: | Hall & WO | oanouse Lta |
|---|--|---|---|---|---|
| Product: | Sash Cord | Damage: | | NADIS | |
| Asbestos ? | No | | | | |

No Action Required

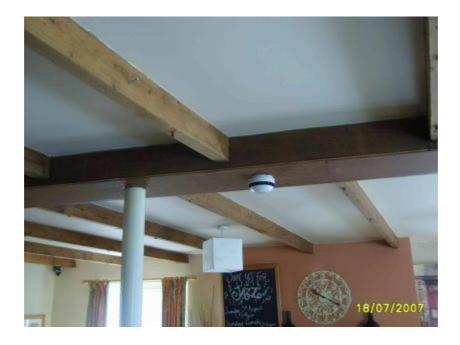
| Sample<br>Date | Location<br>Ref | Location ID | Drawing<br>Reference | Floor | Room | Asbestos<br>Type | Product<br>Name | Material<br>Risk<br>Score | Material<br>Risk<br>Band | Priority<br>Risk<br>Score | Comments | Action | Survey<br>Type |
|---|---|---|---|---|---|---|---|---|---|---|--|---|---|
| 18/07/07 | 2 | 8308 | 2 | Ground floor | Bar area | Not Applicable | Beam cladding | 0 | Not<br>Applicable | N/A | 20/9/07 - Type 3 Survey -<br>destructive access revealed<br>plasterboard and lath &<br>plaster | No Action Required | Т3 |

8308 Т3 Location ID: Survey Type: Location Ref: 2 **Product Type:** Not Applicable Product: Beam cladding Damage: Not Applicable Not Applicable Treatment: Not Applicable Area: Ground floor Not Applicable Floor: Asbestos Type: Bar area Identification: Room: J D Chilvers Surveyor Name: Quantity: Drawing Ref: Accessibility:

20/9/07 - Type 3 Survey - destructive access revealed plasterboard and lath & plaster

Action: No Action Required

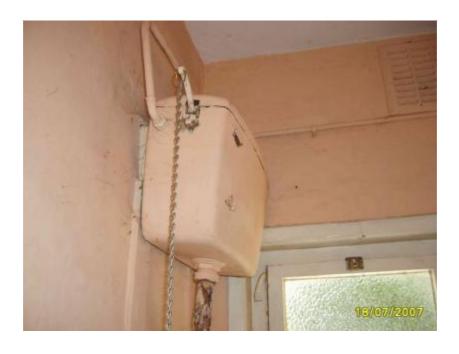
Hall & Woodhouse Ltd Client Name: Site Address: The Robin Hood, 26 The Green, Rowland's Castle, Hampshire, PO9 6AB Project Number: AS07177 - Robin Hood 8309 Т3 Location ID: Survey Type: Location Ref: 3 **Product Type: Plastics** Product: Cistern Damage: No visible damage Not Applicable Treatment: Reinforced plastics Area: Ground floor Amosite Floor: Asbestos Type: WC - mens Strongly Presumed Identification: Room: J D Chilvers Surveyor Name: Quantity: 3 Easy Accessibility Drawing Ref: Accessibility: Asbestos? Yes Material Risk Score 3 18 July 2007 Date: Material Risk Band: Very Low Risk 17 July 2008 Next Inspection: Priority Risk Score: N/A

Removal

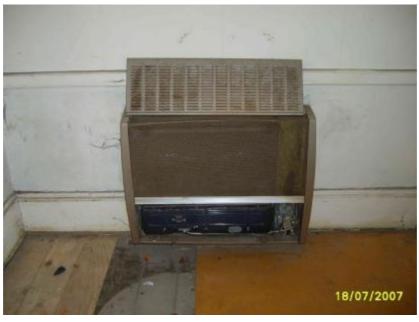
| Sample<br>Date | Location<br>Ref | Location ID | Drawing<br>Reference | Floor | Room | Asbestos<br>Type | Product<br>Name | Material<br>Risk<br>Score | Material<br>Risk<br>Band | Priority<br>Risk<br>Score | Comments | Action | Survey<br>Type |
|---|---|---|---|---|---|---|---|---|---|---|--|---|---|
| 18/07/07 | 4 | 8310 | 4 | First floor | Function Room | Chrysotile | Heater | 3 | Very Low<br>Risk | N/A | | Removal | Т3 |

Hall & Woodhouse Ltd Client Name: Site Address: The Robin Hood, 26 The Green, Rowland's Castle, Hampshire, PO9 6AB Project Number: AS07177 - Robin Hood 8310 Т3 Location ID: Survey Type: Location Ref: 4 **Product Type:** Gaskets Product: Heater Damage: No visible damage Not Applicable Treatment: Composite asbestos materials Area: First floor Chrysotile Floor: Asbestos Type: Function Room Presumed Identification: Room: J D Chilvers Surveyor Name: Quantity: 4 Medium Accessibility Drawing Ref: Accessibility: Asbestos? Yes Material Risk Score 3 18 July 2007 Date: Material Risk Band: Very Low Risk Next Inspection: 17 July 2008 Priority Risk Score: N/A

Removal

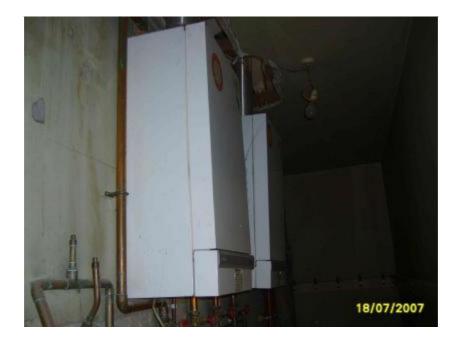
| Location ID: | 8311 | Survey Type: | Т3 |

| Location ID: | 8311 | Survey Type: | Т3 |
|---|---|---|---|
| Product: | Boiler | Damage: | No visible damage |
| Floor: | First floor | Asbestos Type: | Chrysotile |
| Room: | Function Room | Identification: | Presumed |

Age of boilers unknown hence presumption that asbestos based gaskets may be present

Action: Removal

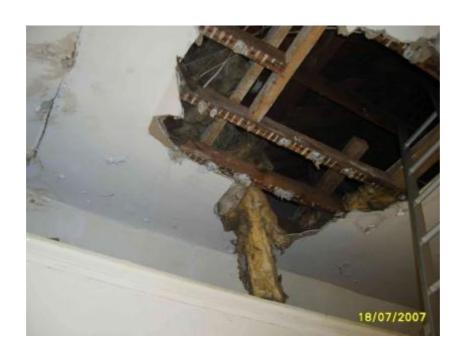
| Site Address: | The Robin Hood, 26 The Green, Rowland's Hampshire, PO9 6AB | | Cilent Name. | Hall & Woodhouse Ltd | |
|---|--|---|---|---|---|
| Location ID: | 8312 | Survey Type | : | Т3 | |

| Sample<br>Date | Location<br>Ref | Location ID | Drawing<br>Reference | Floor | Room | Asbestos<br>Type | Product<br>Name | Material<br>Risk<br>Score | Material<br>Risk<br>Band | Priority<br>Risk<br>Score | Comments | Action | Survey<br>Type |
|---|---|---|---|---|---|---|---|---|---|---|--|---|---|
| 18/07/07 | 6 | 8312 | 6 | First floor | Function Room | NADIS | Ceiling | 0 | NADIS | N/A | | No Action Required | Т3 |

| Site Address: | The Robin Hood, 26 The Green, Rowland's Hampshire, PO9 6AB | | Cilent Name. | Hall & Woodhouse Ltd | |
|---|--|---|---|---|---|
| Product: | Ceiling | Damage: | | NADIS | |
| Asbestos ? | No | | | | |

| Site Address: | The Robin Hood, 26 The Green, Rowland's Hampshire, PO9 6AB | | Cilent Name. | Hall & Woodhouse Ltd | |
|---|--|---|---|---|---|
| Action: | | No Action | Required | | |
