# **Asbestos Survey for**

Hall & Woodhouse Ltd

The Barn Owl Inn Aller Mills Kingkerswell Newton Abbot Devon TQ12 5AN

Project Number: AS04162

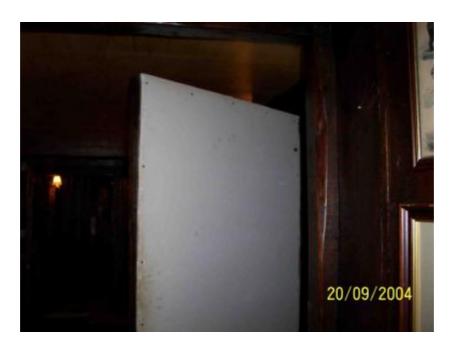
he Barn Owl Inn, Aller Mills, Kingkerswell, Newton Abbot, Jevon, TQ12 5AN		Project Number:		AS04162	
Location ID:	1175	Survey T	ype:		T 2	
Location Ref:	1	Product 7	Гуре:		NADIS	
Product:	Door panel	Damage:			NADIS	
Area:	Not Applicable	Treatmer	nt:		NADIS	
Floor:	Ground floor	Asbestos	туре:		NADIS	
Room:	Bar area	Identifica	tion:		Identified	
Surveyor Name	e: J D Chilvers	Quantity:				
Drawing Ref:	1	Accessib	ility:			
Asbestos ?	No					
Date:	20 September 2004			Material	Risk Score:	0
Next Inspection	n: Not Applicable			Material	Risk Band:	NADIS
•	L			Priority R	tisk Score:	N/A
Action:		No Ad	ction Required

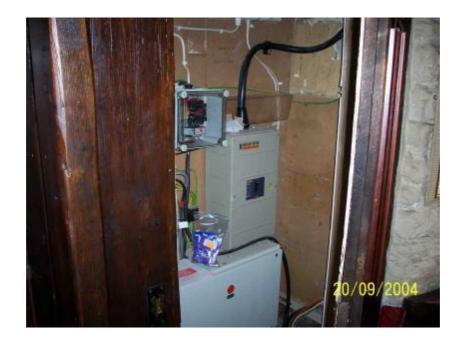
Location ID:	1176	Survey Type:	T 2
Location Ref:	2	Product Type:	Ropes and woven textiles
Product:	Fuse & Switchgear Flashguard	Damage:	No visible damage
Area:	Not Applicable	Treatment:	Composite asbestos materials
Floor:	Ground floor	Asbestos Type:	Chrysotile
Room:	Electrical cupboard	Identification:	Presumed
Surveyor Name:	J D Chilvers	Quantity:	
Drawing Ref:	2	Accessibility:	Medium Accessibility
Asbestos ?	Yes

Material Risk Band: Very Low Risk 20 September 2005 **Next Inspection:** Priority Risk Score:

Action: Apply Warning Labels

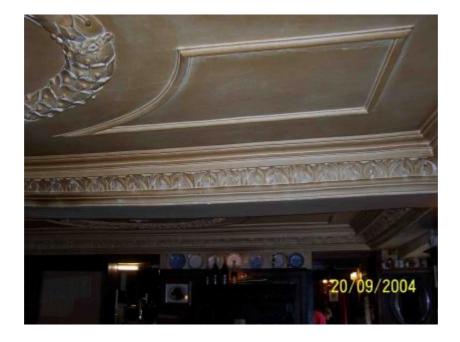
1177 T 2 Location ID: Survey Type: Location Ref: 3 **Product Type:** Asbestos Insulating Board Product: Beam cladding Damage: No visible damage Area: Not Applicable Treatment: AIB painted or encapsulated Floor: Ground floor Amosite Asbestos Type: Bar area Presumed Room: Identification: J D Chilvers Quantity: Surveyor Name: 3 Accessibility: Medium Accessibility Drawing Ref:

> Material Risk Score: 5 Material Risk Band: Low Risk

All beams within the building ar presumed to be clad with ACM's until proven otherwise.

Action: **Apply Warning Labels**

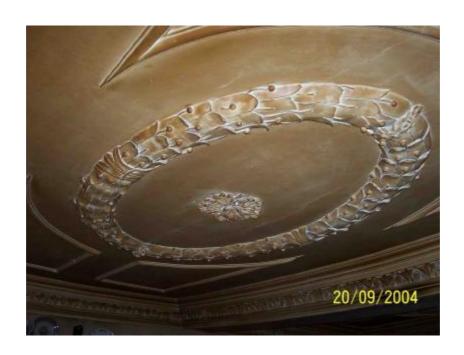
The Barn Owl Inn, Aller Mills, Kingkerswell, Newto Devon, TQ12 5AN		lient Name:	Hall & Wo	oanouse Lta
	5000H, TQT2 07H	F	Project Number:	ASC	)4162
Location ID:	1178	Survey Type:		T 2	
Location Ref:	4	Product Type:		Decorative finished	es
Product:	Ceiling	Damage:		No visible damag	е
Area:	Not Applicable	Treatment:	Con	mposite asbestos m	aterials
Floor:	Ground floor	Asbestos Typ	e:	Chrysotile	
Room:	Bar area	Identification:		Presumed	
Surveyor Name	e: J D Chilvers	Quantity:			
Drawing Ref:	4	Accessibility:		Medium Accessibi	lity
Asbestos ?	Yes				
Date:	20 September 2004			ial Risk Score:	2
Next Inspection	20 September 2005		Mater	rial Risk Band:	Very Low Risk
			Priorit	ty Risk Score:	4

Apply Warning Labels

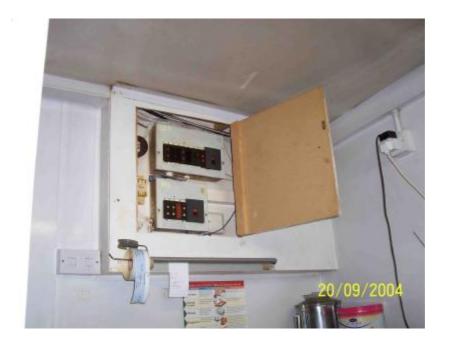
1179 T 2 Location ID: Survey Type: Location Ref: 5 **Product Type:** Ropes and woven textiles Product: Fuse & Switchgear Flashguard Damage: No visible damage Area: Not Applicable Treatment: Composite asbestos materials Ground floor Chrysotile Floor: Asbestos Type: Corridor Presumed Room: Identification: J D Chilvers Quantity: Surveyor Name: Medium Accessibility Drawing Ref:

**Apply Warning Labels**

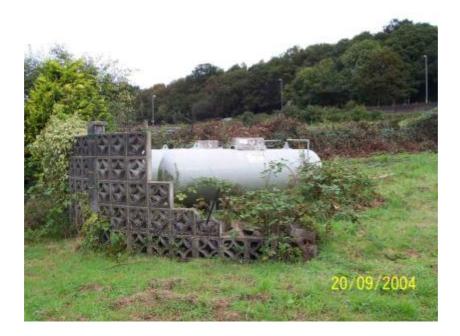
Oito / taai coo.	The Barn Owl Inn, Aller Mills, Kingkerswell, Newton Abbot, Devon, TQ12 5AN		ient Name:	Hall & Woodhouse Ltd	
		Pr	oject Number:	ASC	04162
Location ID:	1180	Survey Type:		T 2	
Location Ref:	6	Product Type:		Gaskets	
Product:	Gasket	Damage:		No visible damag	le
Area:	Not Applicable	Treatment:	Com	posite asbestos m	aterials
Floor:	External	Asbestos Type	:	Chrysotile	
Room:	External	Identification:		Presumed	
Surveyor Name	J D Chilvers	Quantity:			
Drawing Ref:	6	Accessibility:		Medium Accessibi	lity
Asbestos ?	Yes				
Date:	20 September 2004		Materi	al Risk Score:	3
Next Inspection	20 September 2005		Materi	al Risk Band:	Very Low Risk
'			Priority	/ Risk Score:	1

Apply Warning Labels

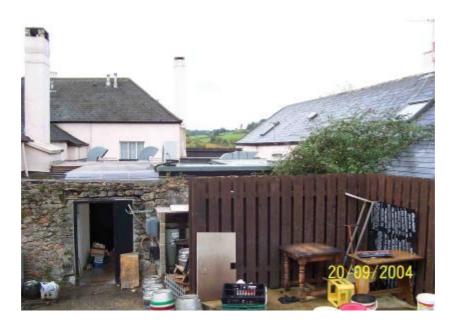
Barn Owl Inn, Aller Mills, Kingkerswell, New n, TQ12 5AN	Client Name:		Hall & Wo	Hall & Woodhouse Ltd	
5000	11, 19(12 0) (14		Project Numb	per: AS	04162	
Location ID:	1181	Survey Typ	pe:	T 2		
Location Ref:	7	Product Ty	/pe:	Roofing felts		
Product:	Roofing felt	Damage:		No visible damag	e	
Area:	Not Applicable	Treatment	:	Resins		
Floor:	External	Asbestos	Гуре:	Chrysotile		
Room:	Roof	Identificati	on:	Presumed		
Surveyor Name:	J D Chilvers	Quantity:				
Drawing Ref:	7	Accessibili	ty:	Medium Accessibi	lity	
Asbestos ?	Yes					
Date:	20 September 2004		l N	laterial Risk Score:	2	
Next Inspection:	20 September 2005	]	IV	laterial Risk Band:	Very Low Risk	
			P	riority Risk Score:	2	
Action:		No Acti	on Required

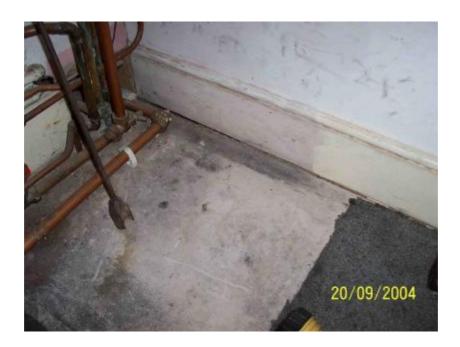
e Barn Owl Inn, Aller Mills, Kingkerswell, New von, TQ12 5AN	Client Name:		Hall & Woodh	ouse Ltd
De	VOII, TQTZ SAIN	Pr	oject Number:	AS0416	32
Location ID:	1182	Survey Type:		T 2	
Location Ref:	8	Product Type:		NADIS	
Product:	Floor covering	Damage:		NADIS	
Area:	Not Applicable	Treatment:		NADIS	
Floor:	First floor	Asbestos Type	:	NADIS	
Room:	Boiler cupboard	Identification:		Identified	
Surveyor Name:	J D Chilvers	Quantity:			
Drawing Ref:	8	Accessibility:			
Asbestos ?	No				
Date:	20 September 2004	]	Materia	al Risk Score:	0
Next Inspection:	Not Applicable		Materia	al Risk Band:	NADIS
·		J	Priority	Risk Score:	N/A
Action:		No Action Re	equired

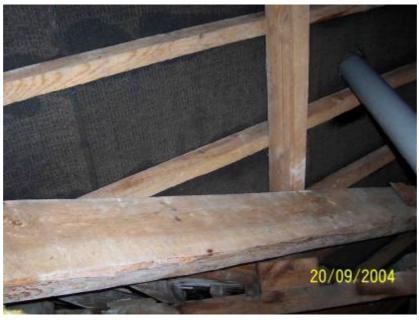
The Barn Owl Inn, Aller Mills, Kingkerswell, Newton Abbot, Devon, TQ12 5AN		ent Name:	Hall & WO	oanouse Lta
	5000H, TQT2 07H	Pro	oject Number:	ASC	)4162
Location ID:	1183	Survey Type:		T 2	
Location Ref:	9	Product Type:		Roofing felts	
Product:	Roofing felt	Damage:		No visible damag	е
Area:	Not Applicable	Treatment:		Resins	
Floor:	Roof level	Asbestos Type:		Chrysotile	
Room:	Loft space	Identification:		Presumed	
Surveyor Name	9: J D Chilvers	Quantity:			
Drawing Ref:	9	Accessibility:		Medium Accessibi	lity
Asbestos ?	Yes				
Date:	20 September 2004			ial Risk Score:	2
Next Inspection	1: 20 September 2005			ial Risk Band:	Very Low Risk
			Priorit	y Risk Score:	2

No Action Required

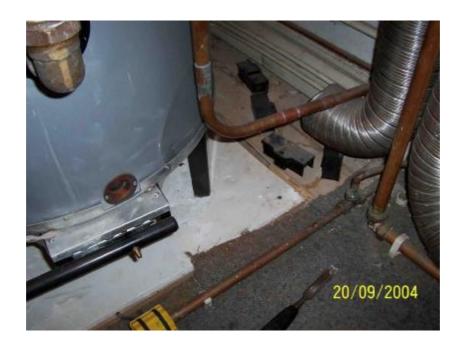
Cite / taal coo.	rn Owl Inn, Aller Mills, Kingkerswell, TQ12 5AN		nt Name:	Hall & Wood	house Ltd
Devon,	TQTZ JAN	Proj	ect Number:	AS04	162
Location ID:	1184	Survey Type:		T 2	
Location Ref:	10	Product Type:		NADIS	
Product:	Boiler Insulating Plinth	Damage:		NADIS	
Area:	Not Applicable	Treatment:		NADIS	
Floor:	First floor	Asbestos Type:		NADIS	
Room:	Boiler cupboard	Identification:		Identified	
Surveyor Name:	J D Chilvers	Quantity:			
Drawing Ref:	10	Accessibility:			
Asbestos ?	No				1
Date:	20 September 2004			Risk Score:	0
Next Inspection:	Not Applicable		Material	Risk Band:	NADIS
			Priority I	Risk Score:	N/A
Action:		No Action Regu	iired

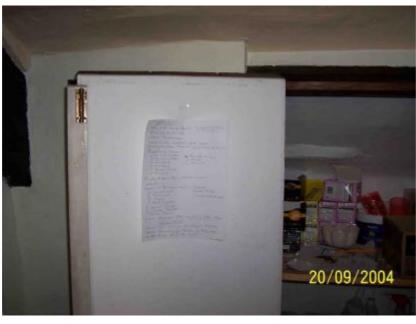
The Barn Owl Inn, Aller Mills, Kingkerswell, Newto Devon, TQ12 5AN		ent Name:	Hall & Woo	oanouse Lta
	BOVOII, TQTZ SAIN	Pro	oject Number:	ASC	)4162
Location ID:	1185	Survey Type:		T 2	
Location Ref:	11	Product Type:		NADIS	
Product:	Door panel	Damage:		NADIS	
Area:	Not Applicable	Treatment:		NADIS	
Floor:	First floor	Asbestos Type:		NADIS	
Room:	Linen Cupboard / Store	Identification:		Identified	
Surveyor Name	e: J D Chilvers	Quantity:			
Drawing Ref:	11	Accessibility:			
Asbestos ?	No				
Date:	20 September 2004		Materia	al Risk Score:	0
Next Inspection	n: Not Applicable		Materia	al Risk Band:	NADIS
			Priority	Risk Score:	N/A

No Action Required

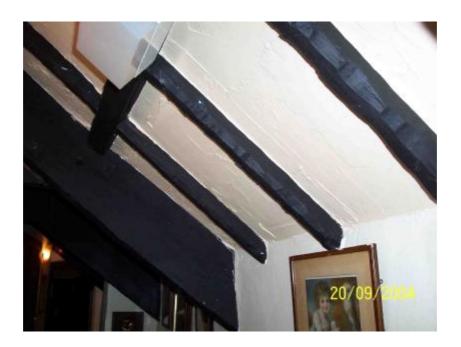
The Barn Owl Inn, Aller Mills, Kingkerswell, Newto Devon, TQ12 5AN	on Abbot,	Client Name: Hall & W		Hall & Wood	house Ltd
	·		Project N	lumber:	AS04	162
Location ID:	1186	Survey T	ype:		T 2	
Location Ref:	12	Product Type: NADIS		NADIS		
Product:	Ceiling	Damage:		t: NADIS		
Area:	Not Applicable	Treatmer	nt:			
Floor:	First floor	Asbestos Type: NADIS		NADIS		
Room:	Corridor	Identifica	tion:	on: Identified		
Surveyor Name	e: J D Chilvers	Quantity:				
Drawing Ref:	12	Accessib	ility:			
Asbestos ?	No					
Date:	20 September 2004			Material	Risk Score:	0
Next Inspection	n: Not Applicable			Material	Risk Band:	NADIS
•				Priority F	Risk Score:	N/A
Action:		No Ad	ction Required

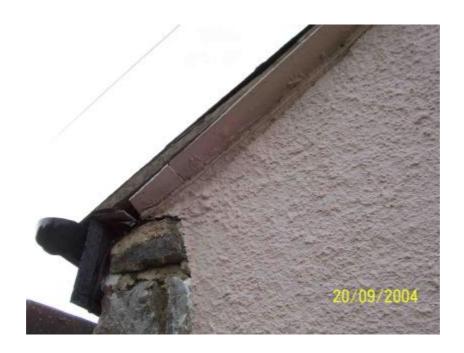
Client Name: Hall & Woodhouse Ltd		odhouse Ltd	
	Pr	oject Number:	AS	04162	
1187	Survey Type:		T 2		
13	Product Type:		Asbestos cement		
Verge Undercloak	Damage:	Low damage: Broken edge boar		ge boards	
Not Applicable T		Asb	Asbestos cement sheets etc		
Roof level	Asbestos Type	s Type: Chrysotile			
External	Identification:		Identified		
e: J D Chilvers	Quantity:				
13	Accessibility:		Medium Accessib	ility	
Yes					
20 September 2004				4	
n: 20 September 2005		Materi	al Risk Band:	Very Low Risk	
		Priority	/ Risk Score:	1	
	Devon, TQ12 5AN  1187  13  Verge Undercloak  Not Applicable  Roof level  External  e: J D Chilvers  13  Yes  20 September 2004	The Barn Owl Inn, Aller Mills, Kingkerswell, Newton Abbot, Devon, TQ12 5AN  1187  Survey Type:  13  Product Type:  Verge Undercloak  Damage:  Not Applicable  Treatment:  Roof level  Asbestos Type  External  Identification:  e:  J D Chilvers  Quantity:  13  Accessibility:  Yes  20 September 2004	Project Number:    1187	The Barn Owl Inn, Aller Mills, Kingkerswell, Newton Abbot, Devon, TQ12 5AN  1187  Survey Type:  13  Product Type:  Asbestos cement Verge Undercloak  Not Applicable  Treatment:  Roof level  Asbestos Type:  External  Identification:  Identified  External  J D Chilvers  Quantity:  13  Accessibility:  Medium Accessibility:  Material Risk Score:  Material Risk Band:

No Action Required

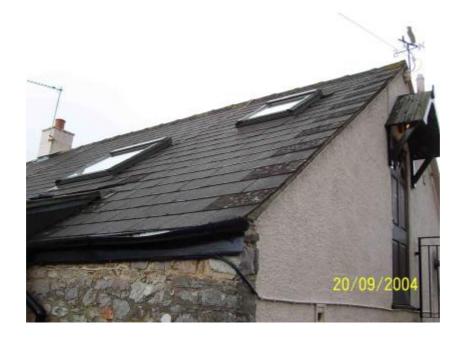
The Barn Owl Inn, Aller Mills, Kingkerswell, Newto Devon, TQ12 5AN		lient Name:	Hall & Woodhouse Ltd	
2000.11, 1 4 12 57 117			roject Number:	ASO	)4162
Location ID:	1188	Survey Type:		T 2	
Location Ref:	14	Product Type: Asbestos cemen		nt	
Product:	Roof Tiles	Damage:	No visible damage		е
Area:	Not Applicable	Treatment: Asbest		pestos cement sheets etc	
Floor:	Roof	Asbestos Type	pestos Type: Chrysotile		
Room:	External	Identification:		Identified	
Surveyor Name	e: J D Chilvers	Quantity:			
Drawing Ref:	14	Accessibility:		Medium Accessibi	lity
Asbestos ?	Yes				
Date:	20 September 2004			ial Risk Score:	3
Next Inspection	n: 20 September 2005			ial Risk Band: y Risk Score:	Very Low Risk 2

No Action Required
