Asbestos Survey for

The Cock Inn
Church Lane
Church End
Sarratt
Hertfordshire
WD3 6HH

Project Number: AS08050 - Cock Inn

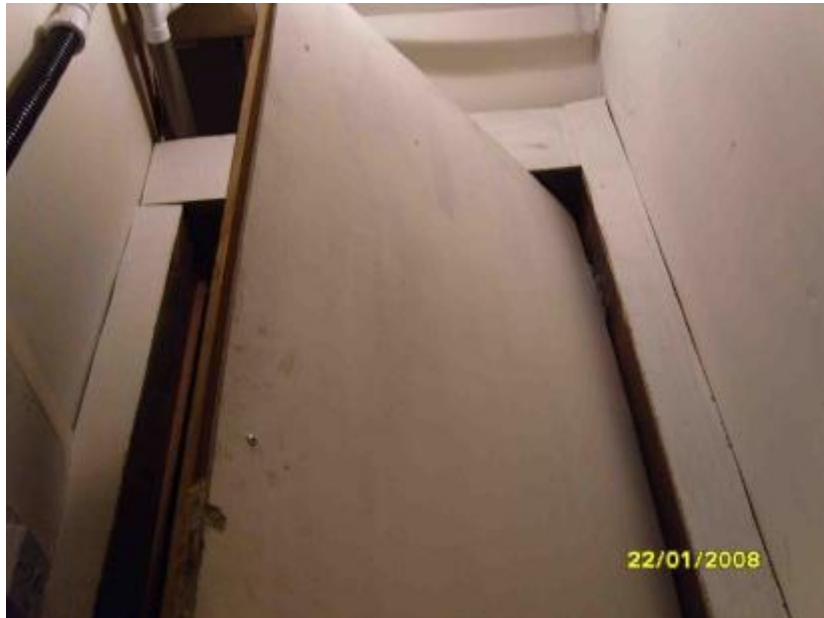
Location ID:	9252	Survey Type:	T 2
Location Ref:	1	Product Type:	NADIS
Product:	Door panel	Damage:	NADIS
Area:	Not Applicable	Treatment:	NADIS
Floor:	Ground floor	Asbestos Type:	NADIS
Room:	Cellar	Identification:	Identified
Surveyor Name:	J D Chilvers	Quantity:	
Drawing Ref:	1	Accessibility:	
Asbestos ?	No		
Date:	22 January 2008		
Next Inspection:	Not Applicable

Material Risk Band: NADIS

No Action Required

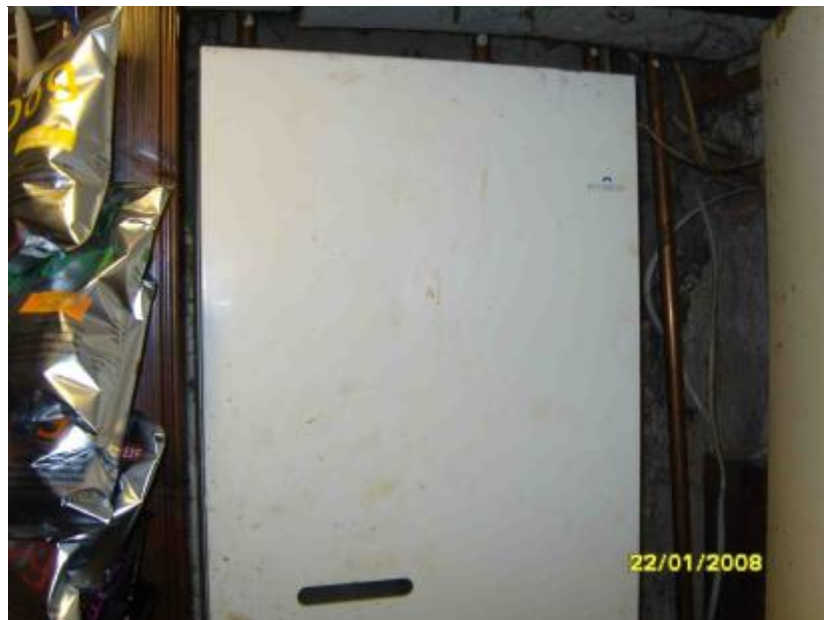
Location ID:	9254	Survey Type:	T 2
Location Ref:	3	Product Type:	Gaskets
Product:	Boiler	Damage:	No visible damage
Area:	Not Applicable	Treatment:	Composite asbestos materials
Floor:	Ground floor	Asbestos Type:	Chrysotile
Room:	Servery	Identification:	Presumed
Surveyor Name:	J D Chilvers	Quantity:	
Drawing Ref:	3	Accessibility:	Medium Accessibility
Asbestos ?	Yes		
Date:	22 January 2008		
Next Inspection:	21 January 2009

Material Risk Band: Very Low Risk

Action: Apply Warning Labels

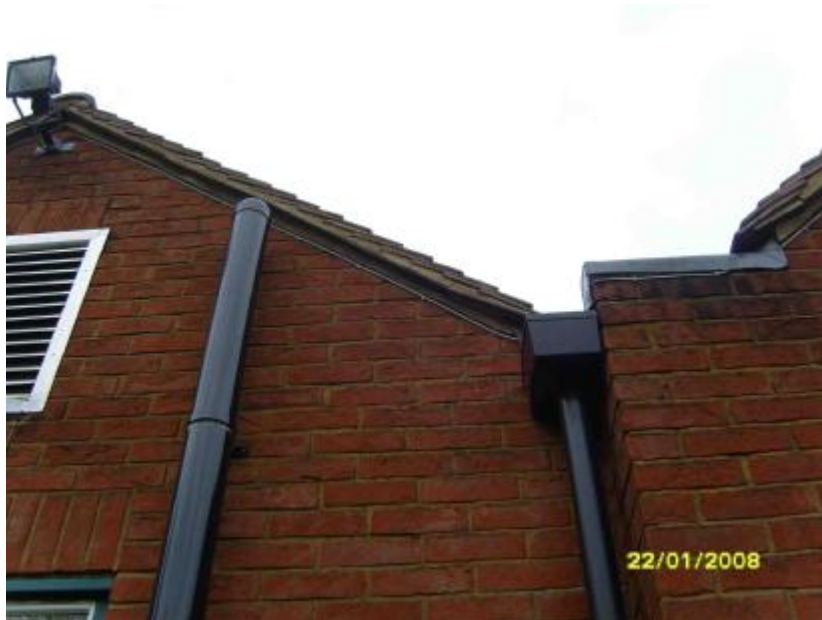
Location ID:	9255	Survey Type:	T 2
Location Ref:	4	Product Type:	Asbestos cement
Product:	Verge Undercloak	Damage:	No visible damage
Area:	Not Applicable	Treatment:	Asbestos cement sheets etc
Floor:	Roof level	Asbestos Type:	Chrysotile
Room:	External	Identification:	Presumed
Surveyor Name:	J D Chilvers	Quantity:	
Drawing Ref:	4	Accessibility:	Difficult Accessibility
Asbestos ?	Yes		
Date:	22 January 2008		
Next Inspection:	21 January 2009

Material Risk Band: Very Low Risk

Action: No Action Required

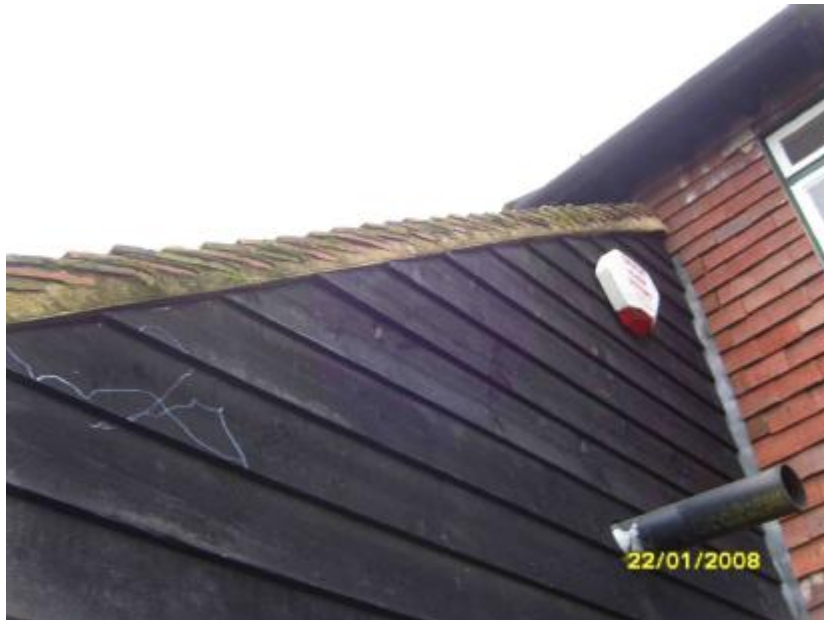
Location ID:	9256	Survey Type:	T 2
Location Ref:	5	Product Type:	Asbestos cement
Product:	Verge Undercloak	Damage:	No visible damage
Area:	Not Applicable	Treatment:	Asbestos cement sheets etc
Floor:	Roof level	Asbestos Type:	Chrysotile
Room:	External	Identification:	Presumed
Surveyor Name:	J D Chilvers	Quantity:	
Drawing Ref:	5	Accessibility:	Difficult Accessibility
Asbestos ?	Yes		
Date:	22 January 2008		
Next Inspection:	21 January 2009

Material Risk Band: Very Low Risk

Action: No Action Required

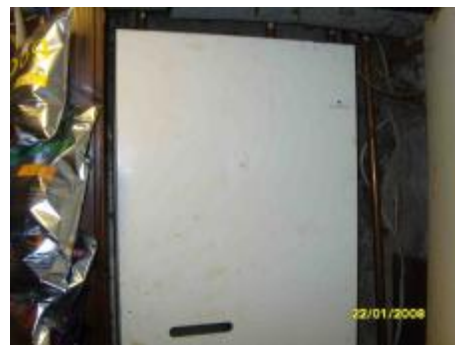
Location ID:	9254
Location Ref:	3
Product:	Boiler
Area:	Not Applicable
Floor:	Ground floor
Room:	Servery
Surveyor Name:	J D Chilvers
Drawing Ref:	3
Asbestos ?	Yes
Date:	22 January 2008

Priority Assessment Algorithm			
Assessment factor	Variable(s) selected	Score for each	Overall score
Normal Occupant Activity:			
Main type of activity in area:	Low disturbance	1	average
Secondary activities for area:	Rare disturbance	0	1
Likelihood Of Disturbance:			
Location:	Large rooms or well-ventilated areas	1	
Accessibility:	Usually inaccessible or unlikely to be disturbed	0	average
Extent/Amount:	Small items strings gaskets	0	0
Human Exposure Potential:			
Number of occupants:	1 to 3	1	
Frequency of use of area:	Daily	3	average
Average time area is in use:	<1 hour	0	1
Maintenance Activity:			
Type of maintenance activity:	Minor disturbance	0	average
Frequency of maintenance activity	<=1 per year	1	1

6

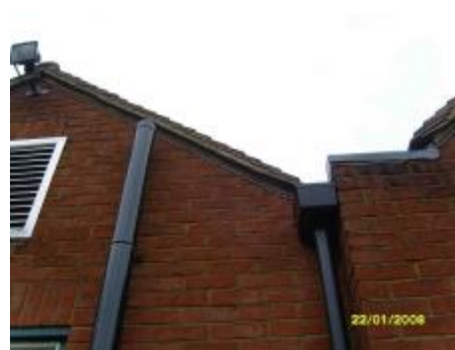
Location ID:	9255
Location Ref:	4
Product:	Verge Undercloak
Area:	Not Applicable
Floor:	Roof level
Room:	External
Surveyor Name:	J D Chilvers
Drawing Ref:	4
Asbestos ?	Yes
Date:	22 January 2008

Total Priority Assessment Score:		1
Material Assessment Score (supplied by surveyor):	Very Low Risk	3
Total of Material and Priority Assessment Scores:		4

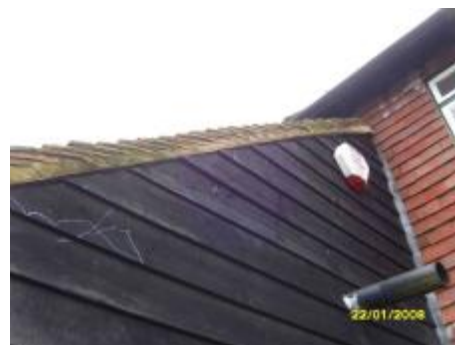
Location ID:	9256
Location Ref:	5
Product:	Verge Undercloak
Area:	Not Applicable
Floor:	Roof level
Room:	External
Surveyor Name:	J D Chilvers
Drawing Ref:	5
Asbestos ?	Yes
Date:	22 January 2008

Total Priority Assessment Score:		1
Material Assessment Score (supplied by surveyor):	Very Low Risk	3
Total of Material and Priority Assessment Scores:		4
