Asbestos Survey for

Hall & Woodhouse Ltd

True Lovers Knot
Tarrant Keyneston
Blandford
Dorset
DT11 9JG

Project Number: AS04121 - True Lovers Knot

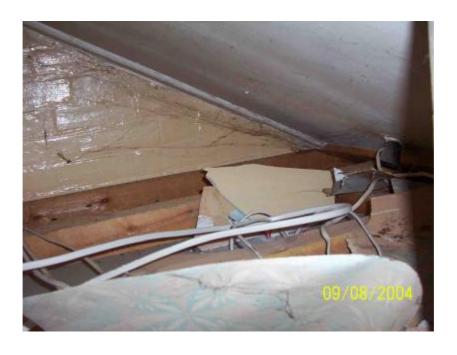
Location ID:	508	Survey Type:	T 2
Location Ref:	1	Product Type:	Asbestos cement
Product:	Debris	Damage:	High damage
Area:	Not Applicable	Treatment:	Asbestos cement sheets etc
Floor:	Ground floor	Asbestos Type:	Chrysotile
Room:	WC - ladies	Identification:	Identified
Surveyor Name:	J D Chilvers	Quantity:	
Drawing Ref:	1	Accessibility:	Medium Accessibility
Asbestos ?	Yes		
Date:	09 August 2004		Material Risk Score 6
Next Inspection:	08 February 2005		Material Risk Band: Low Risk
	,		Priority Risk Score: 4

This material has been left after previous work and is accessible via the hatch into the ceiling. Warning labels should be applied immediately and the debris should be removed as soon as practicable.

Removal

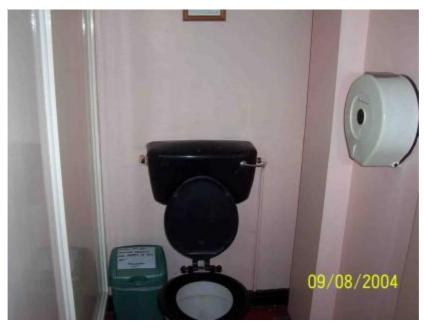
Hall & Woodhouse Ltd Client Name: Site Address: True Lovers Knot, Tarrant Keyneston, Blandford, Dorset, DT11 9JG Project Number: AS04121 - True Lovers Knot T 2 Location ID: 509 Survey Type: Location Ref: 2 **Product Type: Plastics** Product: Cistern Damage: No visible damage Not Applicable Treatment: Reinforced plastics Area: Ground floor Chrysotile Floor: Asbestos Type: WC - ladies Identification: Strongly Presumed Room: J D Chilvers Surveyor Name: Quantity: 2 Easy Accessibility Drawing Ref: Accessibility: Asbestos? Yes Material Risk Score 2 09 August 2004 Date: Material Risk Band: Very Low Risk Next Inspection: 09 August 2005 Priority Risk Score:

Apply Warning Labels

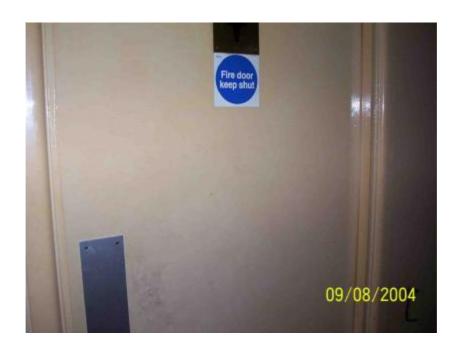
Hall & Woodhouse Ltd Client Name: Site Address: True Lovers Knot, Tarrant Keyneston, Blandford, Dorset, DT11 9JG Project Number: AS04121 - True Lovers Knot T 2 Location ID: 510 Survey Type: Location Ref: 3 **Product Type:** Asbestos cement Product: Fire Door Damage: No visible damage Not Applicable Treatment: Asbestos cement sheets etc Area: Ground floor Chrysotile Floor: Asbestos Type: All Identification: Presumed Room: J D Chilvers Surveyor Name: Quantity: 3 and other locations Medium Accessibility Drawing Ref: Accessibility: Asbestos? Yes Material Risk Score 3 09 August 2004 Date: Material Risk Band: Very Low Risk Next Inspection: 09 August 2005 Priority Risk Score:

Apply Warning Labels

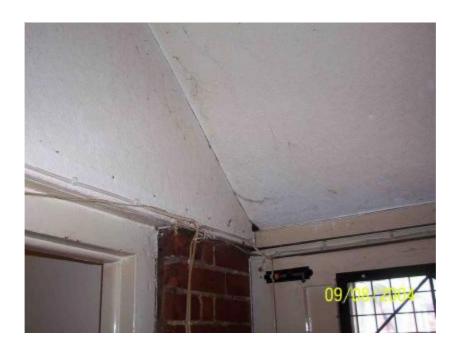
Client Name:	Hall & Woo	odhouse Ltd	
	ue Lovers Knot, Tarrant Keyneston, Blandford, Do 11 9JG	orset,				
		F	Project Number:	AS04121 - Tr	ue Lovers Knot	
Location ID:	511	Survey Type:		T 2		
Location Ref:	4	Product Type:		NADIS		
Product:	Wall	Damage:		NADIS		
Area:	Not Applicable	Treatment:		NADIS		
Floor:	Ground floor	Asbestos Typ	e:	NADIS		
Room:	Lobby	Identification:		Identified		
Surveyor Name:	J D Chilvers	Quantity:				
Drawing Ref:	4	Accessibility:				
Asbestos ?	No					
Date:	09 August 2004		Materia	al Risk Score	0	
Next Inspection:	Not Applicable		Materia	al Risk Band:	NADIS	
. iosti inspositorii	• •		Priority	Risk Score:	N/A

No Action Required

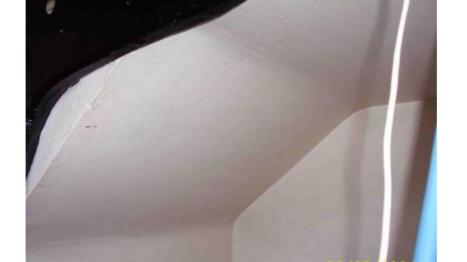
Hall & Woodhouse Ltd Client Name: Site Address: True Lovers Knot, Tarrant Keyneston, Blandford, Dorset, DT11 9JG Project Number: AS04121 - True Lovers Knot T 2 Location ID: 512 Survey Type: Location Ref: 5 **Product Type:** Asbestos cement Product: Cladding Damage: No visible damage Not Applicable Treatment: Asbestos cement sheets etc Area: Ground floor Chrysotile Floor: Asbestos Type: Staircase Identification: Presumed Room: J D Chilvers Surveyor Name: Quantity: 5 Easy Accessibility Drawing Ref: Accessibility: Asbestos? Yes Material Risk Score 3 09 August 2004 Date: Material Risk Band: Very Low Risk Next Inspection: 09 August 2005 Priority Risk Score: 5

Apply Warning Labels

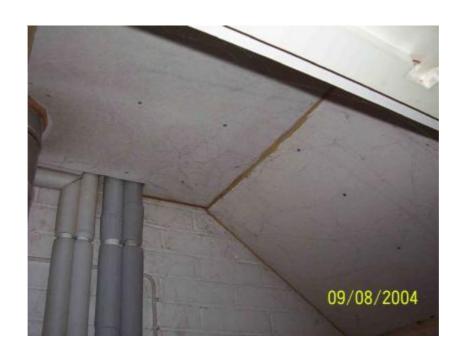
True Lovers Knot, Tarrant Keyneston, Blandford,	Dorset,	Client Name:		Hall & Woodhouse Ltd	
	3111 930		Projec	t Number:	AS04121 - Tru	e Lovers Knot
Location ID:	513	Survey Ty	pe:		T 2	
Location Ref:	6	Product Ty	/pe:		NADIS	
Product:	Cladding	Damage:			NADIS	
Area:	Not Applicable	Treatment	:		NADIS	
Floor:	Ground floor	Asbestos	Гуре:		NADIS	
Room:	Boiler cupboard	Identificati	on:		Identified	
Surveyor Name	e: J D Chilvers	Quantity:				
Drawing Ref:	6	Accessibil	ty:			
Asbestos ?	No					
Date:	09 August 2004				Risk Score	0
Next Inspection	Not Applicable	_]		Materia	Risk Band:	NADIS
•		_		Priority	Risk Score:	N/A

No Action Required

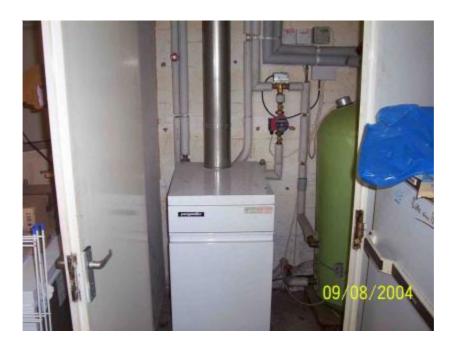
Location ID:	514	Survey Type:	T 2
Location Ref:	7	Product Type:	Gaskets
Product:	Boiler	Damage:	No visible damage
Area:	Not Applicable	Treatment:	Composite asbestos materials
Floor:	Ground floor	Asbestos Type:	Chrysotile
Room:	Boiler cupboard	Identification:	Presumed
Surveyor Name:	J D Chilvers	Quantity:	
Drawing Ref:	7	Accessibility:	Medium Accessibility
Ashestos ?	Yes]

09 August 2004 Material Risk Band: Very Low Risk 09 August 2005

Action: Apply Warning Labels

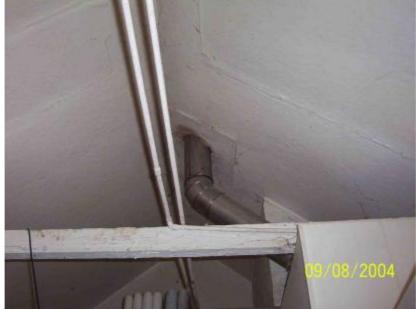
Client Name: Hall & Woodhouse Ltd Site Address: True Lovers Knot, Tarrant Keyneston, Blandford, Dorset, DT11 9JG Project Number: AS04121 - True Lovers Knot Survey Type: T 2 Location ID: 515 Location Ref: 8 **Product Type:** Asbestos cement Product: Flue Damage: No visible damage Not Applicable Treatment: Asbestos cement sheets etc Area: Ground floor Chrysotile Floor: Asbestos Type: Boiler cupboard Strongly Presumed Identification: Room: J D Chilvers Surveyor Name: Quantity: Medium Accessibility Drawing Ref: Accessibility: Asbestos? Yes Material Risk Score 3 09 August 2004 Date: Material Risk Band: Very Low Risk Next Inspection: 09 August 2005

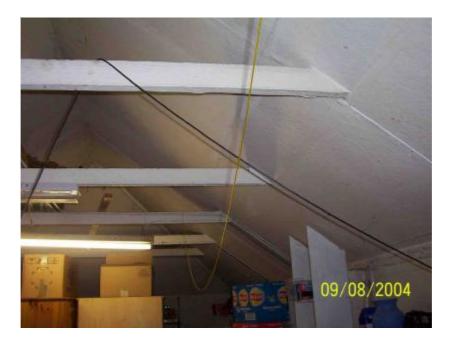
T 2 Location ID: 516 Survey Type: Location Ref: 9 **Product Type: NADIS** Product: Ceiling Damage: **NADIS** Not Applicable Treatment: **NADIS** Area: Ground floor NADIS Floor: Asbestos Type: Store Room Identified Identification: Room: J D Chilvers Surveyor Name: Quantity: Drawing Ref: Accessibility: Asbestos? No

Material Risk Score 0 Material Risk Band: **NADIS** Priority Risk Score: N/A

This ceiling material is identical to the wall material in location 4.

Action: No Action Required

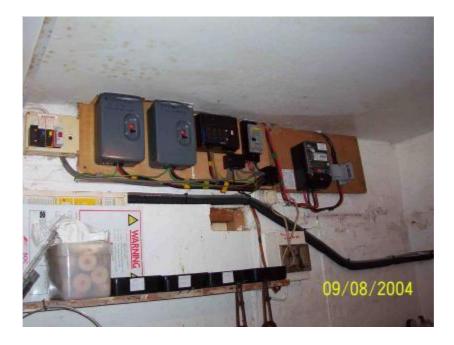
Location ID:	517	Survey Type:	T 2
Location Ref:	10	Product Type:	Ropes and woven textiles
Product:	Fuse & Switchgear Flashguard	Damage:	No visible damage
Area:	Not Applicable	Treatment:	Composite asbestos materials
Floor:	Ground floor	Asbestos Type:	Chrysotile
Room:	Electrical cupboard	Identification:	Presumed
Surveyor Name:	J D Chilvers	Quantity:	
Drawing Ref:	10	Accessibility:	Medium Accessibility

Material Risk Score 3 Material Risk Band: Very Low Risk Priority Risk Score:

Action: Apply Warning Labels

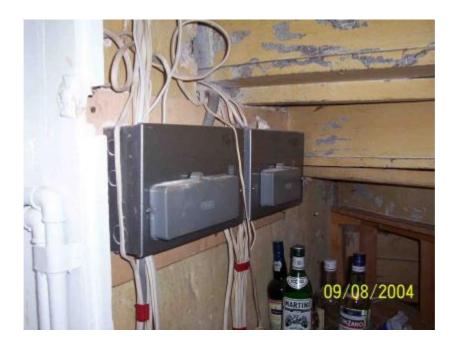
Location ID:	518	Survey Type:	T 2
Location Ref:	11	Product Type:	Ropes and woven textiles
Product:	Fuse & Switchgear Flashguard	Damage:	No visible damage
Area:	Not Applicable	Treatment:	Composite asbestos materials
Floor:	First floor	Asbestos Type:	Chrysotile
Room:	Corridor	Identification:	Presumed
Surveyor Name:	J D Chilvers	Quantity:	
Drawing Ref:	11	Accessibility:	Medium Accessibility

Material Risk Score 3 Material Risk Band: Very Low Risk Priority Risk Score:

Action: Apply Warning Labels

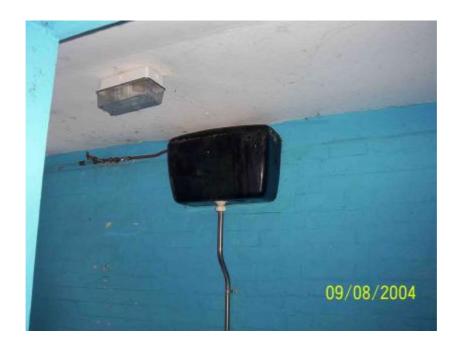
Location ID:	520	Survey Type:	T 2
Location Ref:	13	Product Type:	Plastics
Product:	Cistern	Damage:	No visible damage
Area:	Not Applicable	Treatment:	Reinforced plastics
Floor:	Ground floor	Asbestos Type:	Chrysotile
Room:	WC - mens	Identification:	Strongly Presumed
Surveyor Name:	J D Chilvers	Quantity:	
Drawing Ref:	13	Accessibility:	Medium Accessibility

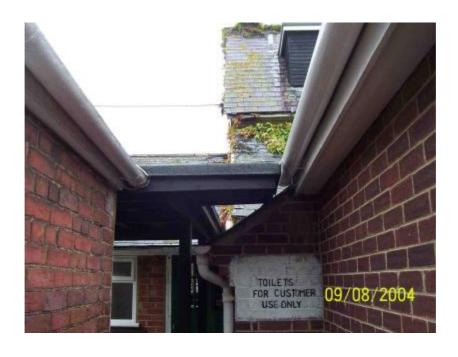
Hall & Woodhouse Ltd Client Name: Site Address: True Lovers Knot, Tarrant Keyneston, Blandford, Dorset, DT11 9JG Project Number: AS04121 - True Lovers Knot T 2 Location ID: 521 Survey Type: Location Ref: 14 **Product Type:** Roofing felts Product: Roofing felt Damage: No visible damage Not Applicable Treatment: Resins Area: External grd floor Chrysotile Floor: Asbestos Type: Roof Identification: Presumed Room: J D Chilvers Surveyor Name: Quantity: 14 Medium Accessibility Drawing Ref: Accessibility: Asbestos? Yes Material Risk Score 2 09 August 2004 Date: Material Risk Band: Very Low Risk Next Inspection: 09 August 2005 Priority Risk Score:

No Action Required

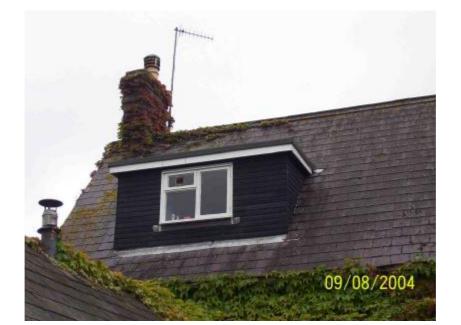
Client Name: Hall & Woodhouse Ltd Site Address: True Lovers Knot, Tarrant Keyneston, Blandford, Dorset, DT11 9JG Project Number: AS04121 - True Lovers Knot Survey Type: T 2 Location ID: 522 Location Ref: 15 **Product Type:** Roofing felts Product: Roofing felt Damage: No visible damage Not Applicable Treatment: Resins Area: Second floor Chrysotile Floor: Asbestos Type: Roof Identification: Presumed Room: J D Chilvers Surveyor Name: Quantity: 15 Medium Accessibility Drawing Ref: Accessibility: Asbestos? Yes Material Risk Score 09 August 2004 Date: Material Risk Band: Very Low Risk Next Inspection: 09 August 2005 Priority Risk Score:

No Action Required
