JTEC Environmental Ltd.

Asbestos Survey for

Hall & Woodhouse Ltd

Barford Inn,
Grovely Road
Barford St Martin
Salisbury
Wiltshire
SP3 4AB

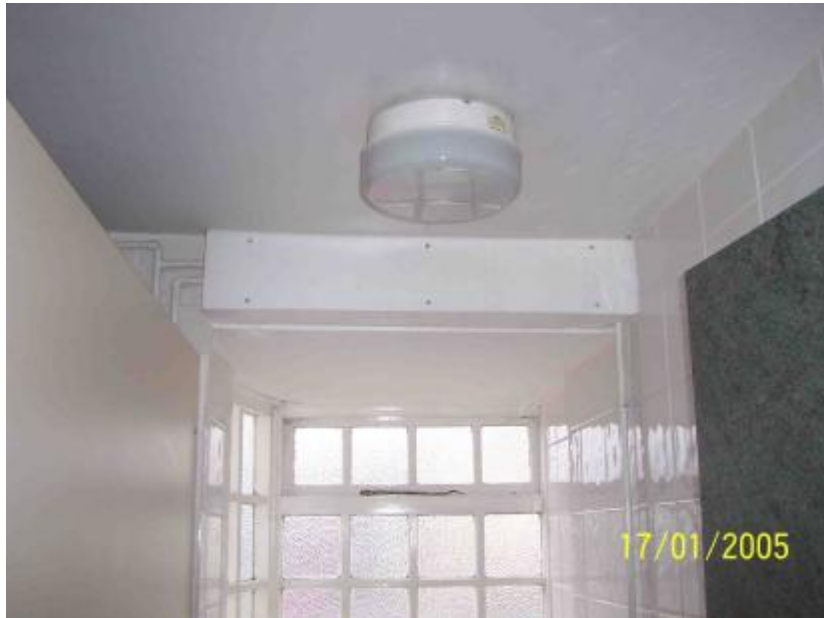
Location ID:	2382	Survey Type:	T 2
Location Ref:	1	Product Type:	Asbestos Insulating Board
Product:	Box panelling	Damage:	No visible damage
Area:	Not Applicable	Treatment:	AIB painted or encapsulated
Floor:	Ground floor	Asbestos Type:	Amosite
Room:	WC	Identification:	Presumed
Surveyor Name:	J D Chilvers	Quantity:	
Drawing Ref:	1	Accessibility:	Medium Accessibility
Asbestos ?	Yes		
Date:	17 January 2005		
Next Inspection:	19 July 2005

Action: Apply Warning Labels

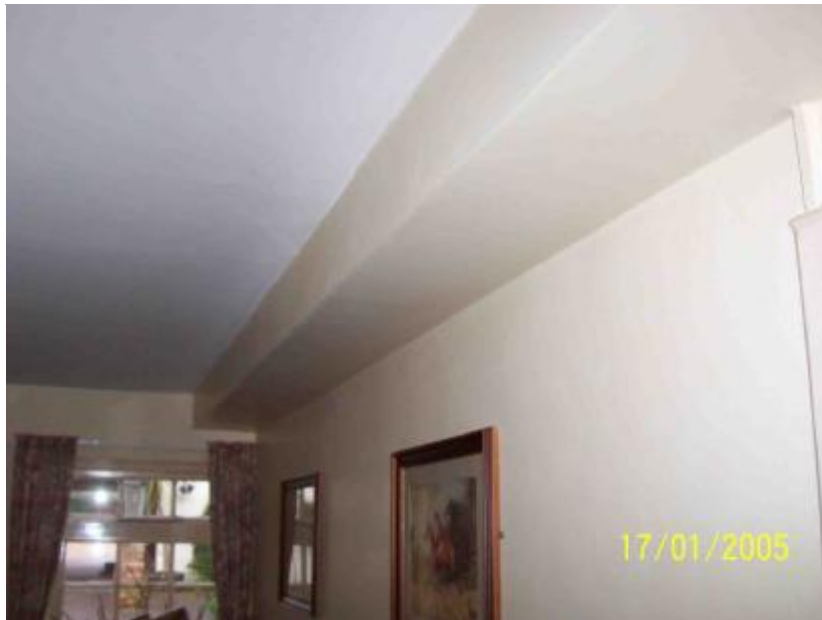
Location ID:	2383	Survey Type:	T 2
Location Ref:	2	Product Type:	Asbestos Insulating Board
Product:	Box panelling	Damage:	No visible damage
Area:	Not Applicable	Treatment:	AIB painted or encapsulated
Floor:	Ground floor	Asbestos Type:	Amosite
Room:	Corridor	Identification:	Presumed
Surveyor Name:	J D Chilvers	Quantity:	
Drawing Ref:	2	Accessibility:	Medium Accessibility
Asbestos ?	Yes		
Date:	17 January 2005		
Next Inspection:	19 July 2005

Action: Apply Warning Labels

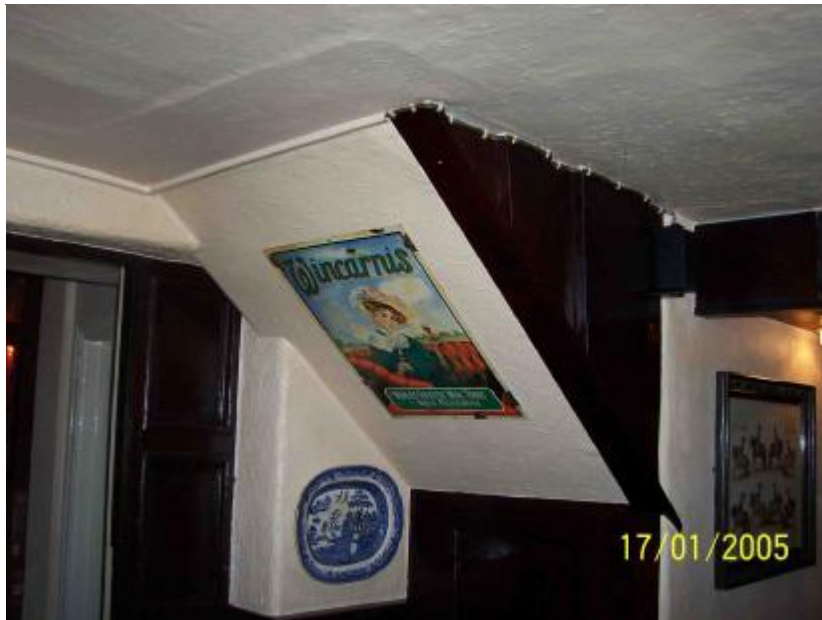
Location ID:	2384	Survey Type:	T 2
Location Ref:	3	Product Type:	Asbestos Insulating Board
Product:	Stair Backing / Cladding	Damage:	No visible damage
Area:	Not Applicable	Treatment:	AIB painted or encapsulated
Floor:	Ground floor	Asbestos Type:	Amosite
Room:	Bar area	Identification:	Presumed
Surveyor Name:	J D Chilvers	Quantity:	
Drawing Ref:	3	Accessibility:	Easy Accessibility
Asbestos ?	Yes		
Date:	17 January 2005		
Next Inspection:	19 July 2005

Action: Apply Warning Labels

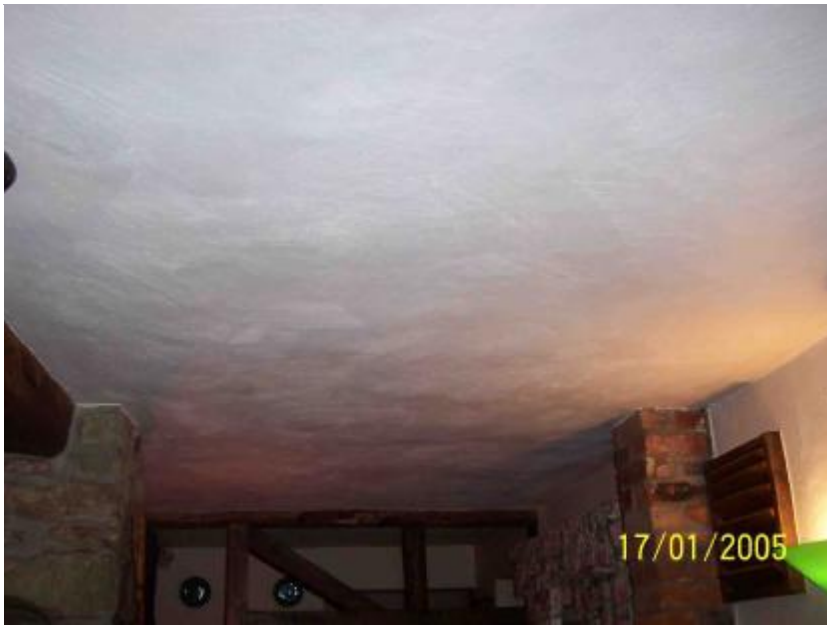
Location ID:	2385	Survey Type:	T 2
Location Ref:	4	Product Type:	Decorative finishes
Product:	Textured coating	Damage:	Low damage: Scratches or marks
Area:	Not Applicable	Treatment:	Composite asbestos materials
Floor:	Ground floor	Asbestos Type:	Chrysotile
Room:	Restaurant	Identification:	Presumed
Surveyor Name:	J D Chilvers	Quantity:	
Drawing Ref:	4	Accessibility:	Medium Accessibility
Asbestos ?	Yes		
Date:	17 January 2005		
Next Inspection:	17 January 2006

Action: Apply Warning Labels

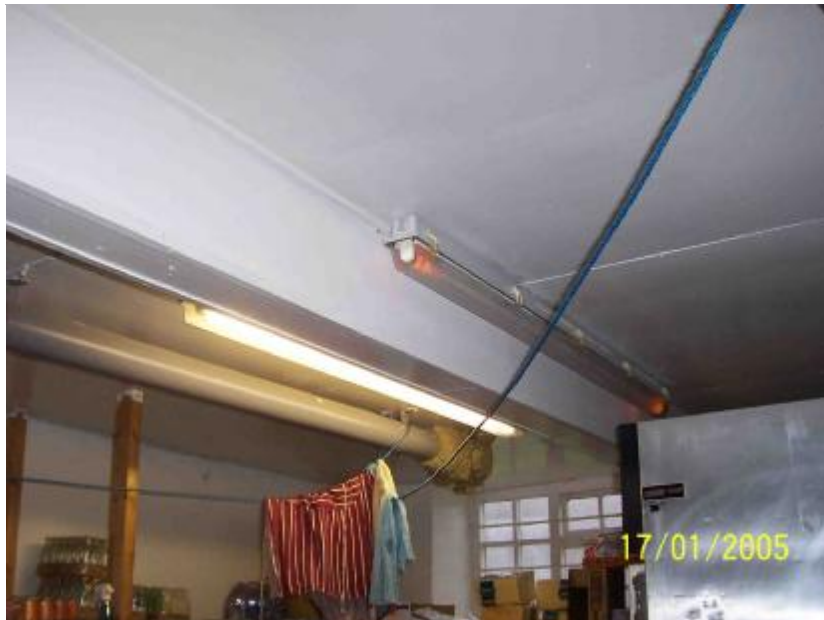
Location ID:	2387	Survey Type:	T 2
Location Ref:	6	Product Type:	Asbestos Insulating Board
Product:	Ceiling & Beam Cladding	Damage:	Low damage: Scratches or marks
Area:	Not Applicable	Treatment:	AIB painted or encapsulated
Floor:	Ground floor	Asbestos Type:	Amosite
Room:	Store Room	Identification:	Identified
Surveyor Name:	J D Chilvers	Quantity:	
Drawing Ref:	6	Accessibility:	Medium Accessibility
Asbestos ?	Yes		
Date:	17 January 2005		
Next Inspection:	19 July 2005

Action: Re-encapsulate and Apply Warning Labels

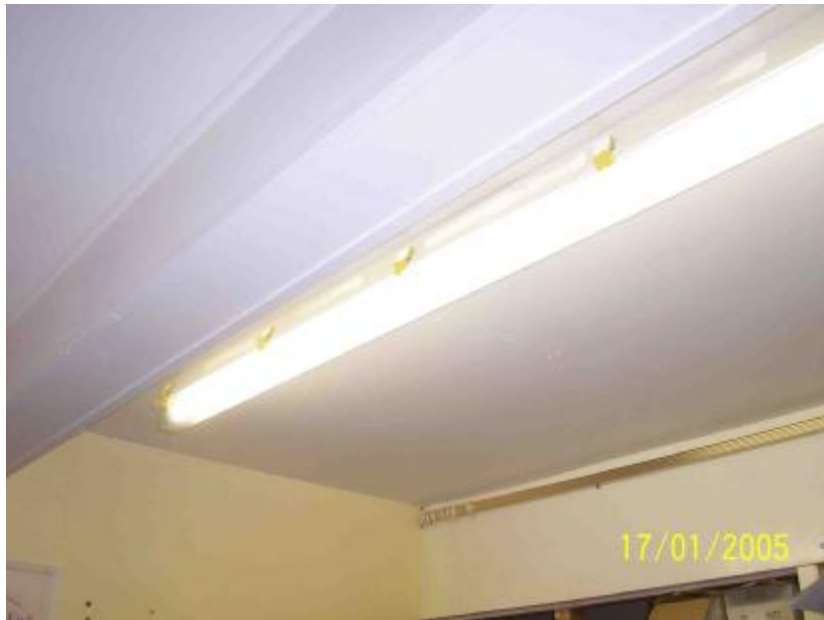
Location ID:	2388	Survey Type:	T 2
Location Ref:	7	Product Type:	Asbestos Insulating Board
Product:	Ceiling & Beam Cladding	Damage:	Low damage: Scratches or marks
Area:	Not Applicable	Treatment:	AIB painted or encapsulated
Floor:	Ground floor	Asbestos Type:	Amosite
Room:	Office	Identification:	Strongly Presumed as previous sample
Surveyor Name:	J D Chilvers	Quantity:	
Drawing Ref:	7	Accessibility:	Medium Accessibility
Asbestos ?	Yes		
Date:	17 January 2005		
Next Inspection:	19 July 2005

Action: Apply Warning Labels

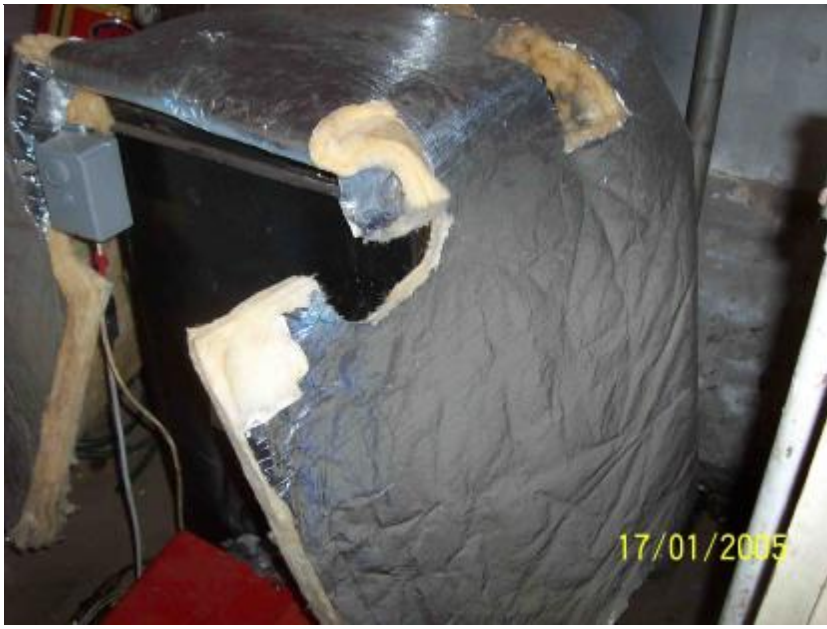
Location ID:	2389	Survey Type:	T 2
Location Ref:	8	Product Type:	Gaskets
Product:	Boiler	Damage:	No visible damage
Area:	Not Applicable	Treatment:	Composite asbestos materials
Floor:	Ground floor	Asbestos Type:	Chrysotile
Room:	Boiler room	Identification:	Presumed
Surveyor Name:	J D Chilvers	Quantity:	
Drawing Ref:	8	Accessibility:	Medium Accessibility
Asbestos ?	Yes		
Date:	17 January 2005		
Next Inspection:	17 January 2006

Action: Apply Warning Labels

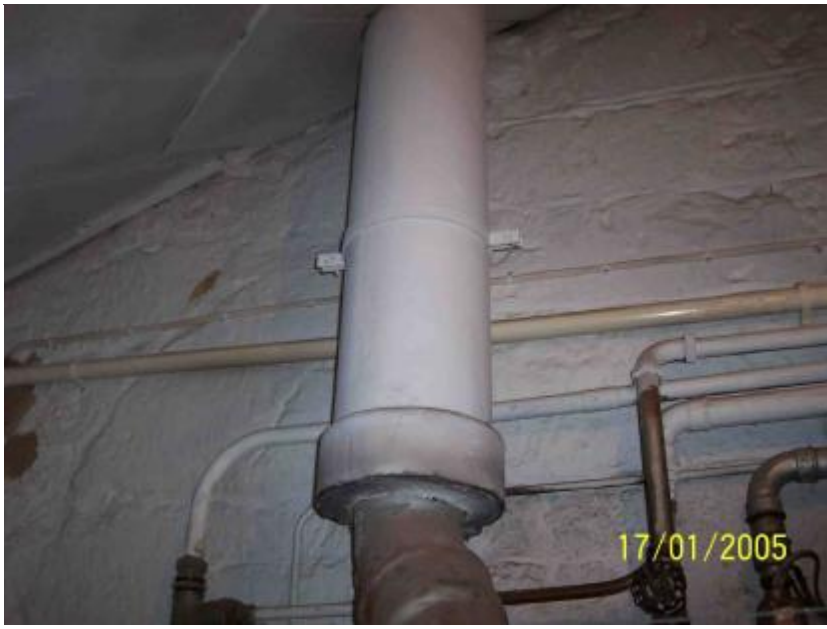
Location ID:	2390	Survey Type:	T 2
Location Ref:	9	Product Type:	Asbestos cement
Product:	Flue	Damage:	Low damage: Scratches or marks
Area:	Not Applicable	Treatment:	Asbestos cement sheets etc
Floor:	Ground floor	Asbestos Type:	Chrysotile
Room:	Boiler room	Identification:	Identified
Surveyor Name:	J D Chilvers	Quantity:	
Drawing Ref:	9	Accessibility:	Easy Accessibility
Asbestos ?	Yes		
Date:	17 January 2005		
Next Inspection:	17 January 2006

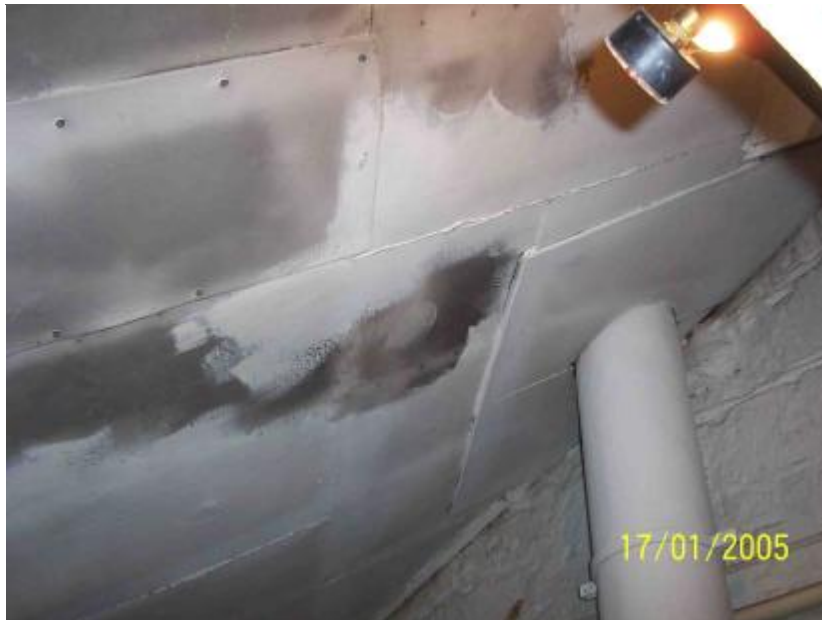
Location ID:	2391	Survey Type:	T 2
Location Ref:	10	Product Type:	NADIS
Product:	Ceiling panel	Damage:	NADIS
Area:	Not Applicable	Treatment:	NADIS
Floor:	Ground floor	Asbestos Type:	NADIS
Room:	Boiler room	Identification:	Identified
Surveyor Name:	J D Chilvers	Quantity:	
Drawing Ref:	10	Accessibility:	
Asbestos ?	No		
Date:	17 January 2005		
Next Inspection:	Not Applicable

Action: No Action Required

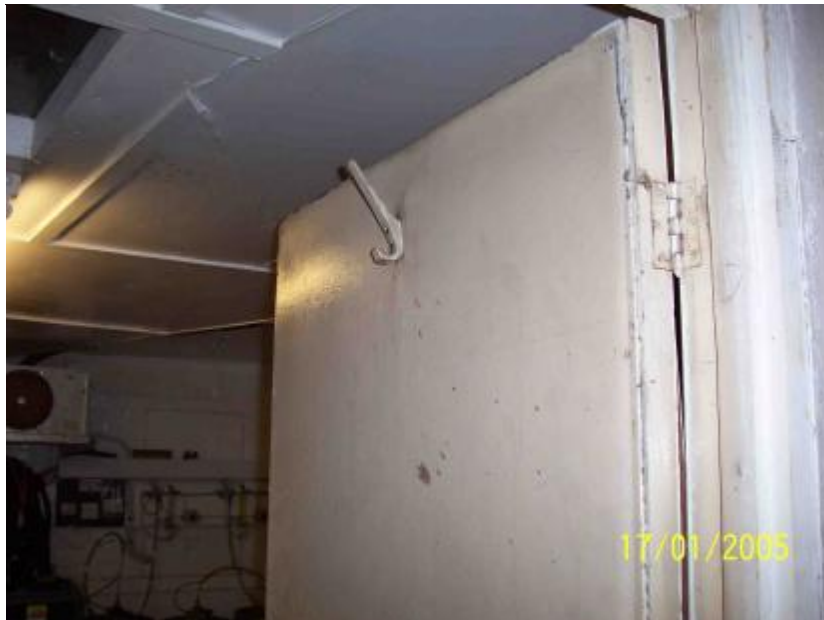
Location ID:	2392	Survey Type:	T 2
Location Ref:	11	Product Type:	Asbestos Insulating Board
Product:	Door panel	Damage:	Low damage: Broken edge boards
Area:	Not Applicable	Treatment:	AIB painted or encapsulated
Floor:	Ground floor	Asbestos Type:	Amosite
Room:	Boiler room	Identification:	Identified
Surveyor Name:	J D Chilvers	Quantity:	
Drawing Ref:	11	Accessibility:	Easy Accessibility
Asbestos ?	Yes		
Date:	17 January 2005		
Next Inspection:	19 July 2005

Action: Re-encapsulate and Apply Warning Labels

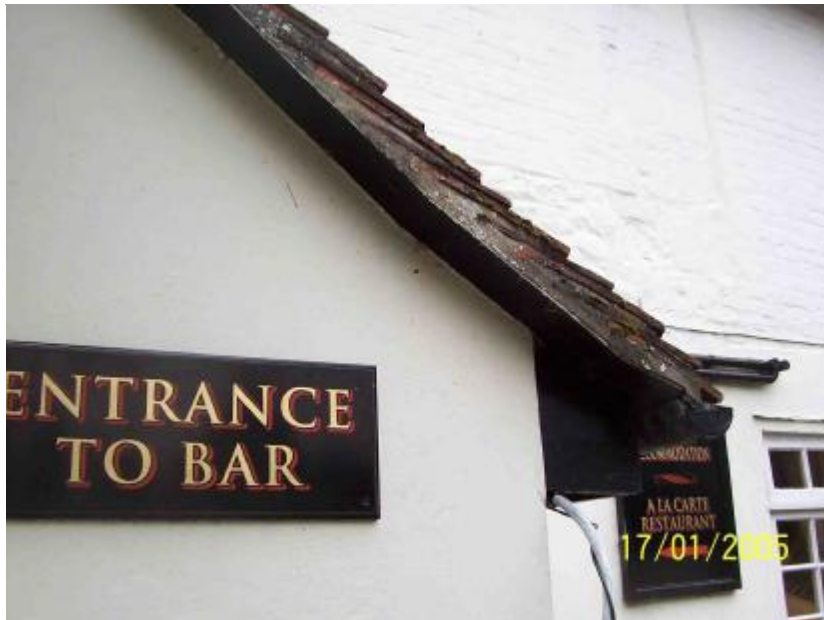
Drawing Ref:	<input style="width: 95%;" type="text" value="27"/>	Accessibility:	<input style="width: 95%;" type="text" value="Medium Accessibility"/>
Asbestos ?	<input style="width: 95%;" type="text" value="Yes"/>	Material Risk Score <input style="width: 95%;" type="text" value="3"/> Material Risk Band: <input style="width: 95%;" type="text" value="Very Low Risk"/> Priority Risk Score: <input style="width: 95%;" type="text" value="N/A"/>	
Date:	<input style="width: 95%;" type="text" value="17 January 2005"/>		
Next Inspection:	<input style="width: 95%;" type="text" value="17 January 2006"/>		
Action:	No Action Required

Material Comments:	All verge undercloaking is presumed an ACM.
---------------------------	---
