Asbestos Survey for

Hall & Woodhouse Ltd

The Wheelwright
Swan Hill Road
Colyford
Devon
EX24 6QQ

Project Number: AS07040- Wheelwright

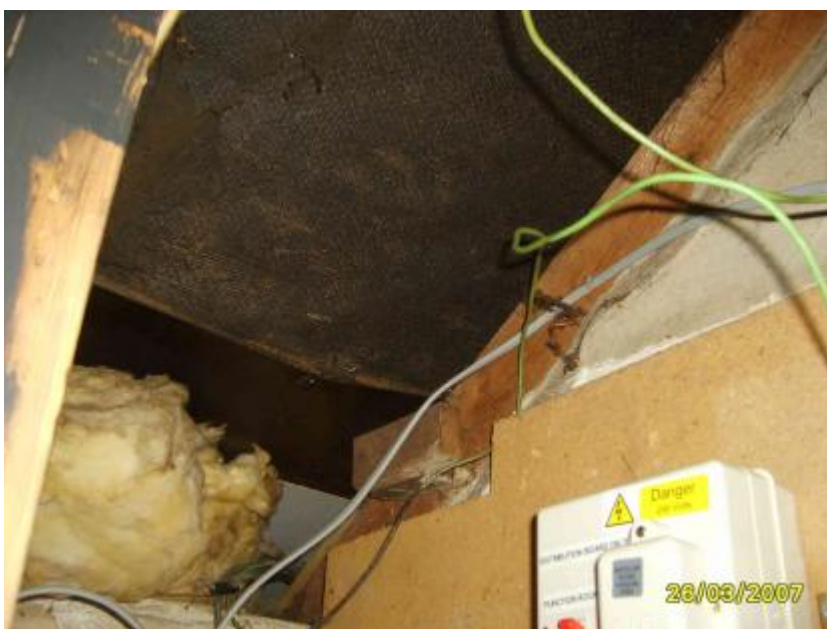
Location ID:	<input type="text" value="9126"/>	Survey Type:	<input type="text" value="T 3"/>
Location Ref:	<input type="text" value="1"/>	Product Type:	<input type="text" value="NADIS"/>
Product:	<input type="text" value="Roofing felt"/>	Damage:	<input type="text" value="NADIS"/>
Area:	<input type="text" value="Not Applicable"/>	Treatment:	<input type="text" value="NADIS"/>
Floor:	<input type="text" value="Roof level"/>	Asbestos Type:	<input type="text" value="NADIS"/>
Room:	<input type="text" value="Loft space"/>	Identification:	<input type="text" value="Identified"/>
Surveyor Name:	<input type="text" value="J D Chilvers"/>	Quantity:	<input type="text"/>

Drawing Ref:	<input type="text" value="1"/>	Accessibility:	<input type="text"/>
Asbestos ?	<input type="text" value="No"/>		
Date:	<input type="text" value="26 March 2007"/>		
Next Inspection:	<input type="text" value="Not Applicable"/>

Material Risk Score	<input type="text" value="0"/>
Material Risk Band:	<input type="text" value="NADIS"/>
Priority Risk Score:	<input type="text" value="N/A"/>

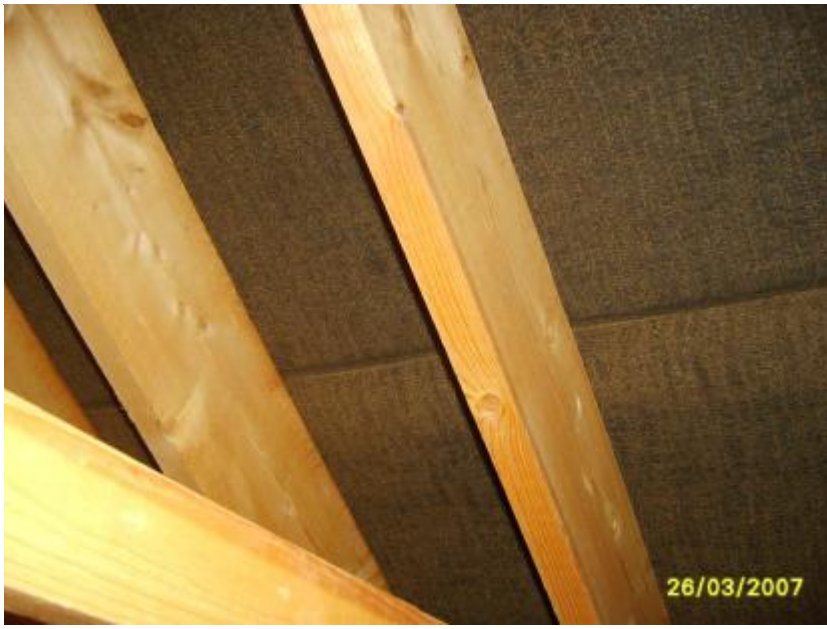
Location ID:	9129	Survey Type:	T 3
Location Ref:	4	Product Type:	NADIS
Product:	Roofing felt	Damage:	NADIS
Area:	Not Applicable	Treatment:	NADIS
Floor:	Roof level	Asbestos Type:	NADIS
Room:	Loft space	Identification:	Identified
Surveyor Name:	J D Chilvers	Quantity:	
Drawing Ref:	4	Accessibility:	
Asbestos ?	No		
Date:	26 March 2007		
Next Inspection:	Not Applicable

Material Risk Score	0
Material Risk Band:	NADIS
Priority Risk Score:	N/A

Action:	No Action Required
---------	--------------------

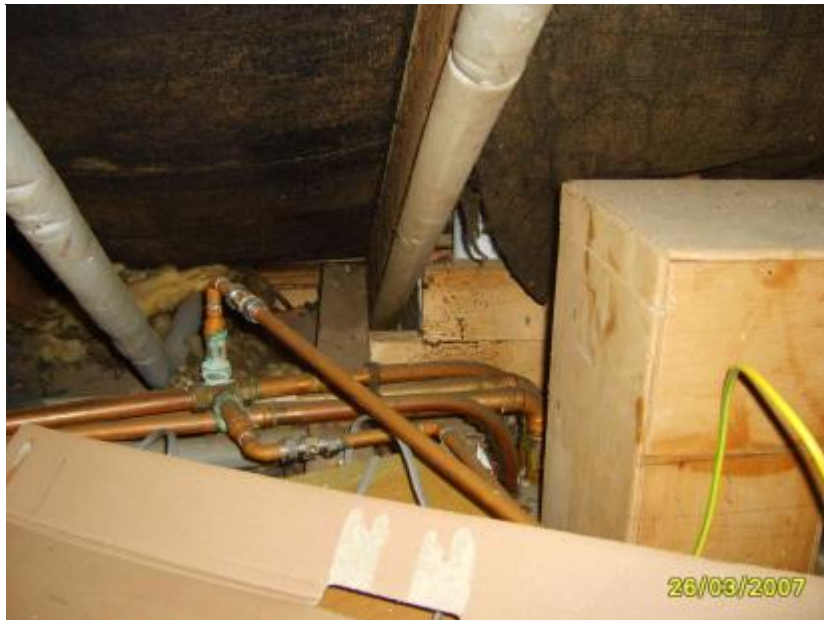
Location ID:	9130	Survey Type:	T 3
Location Ref:	5	Product Type:	Asbestos cement
Product:	Roof Tile	Damage:	Low damage: Broken edge Tiles
Area:	Not Applicable	Treatment:	Asbestos cement sheets etc
Floor:	Roof level	Asbestos Type:	Chrysotile
Room:	Loft space	Identification:	Identified
Surveyor Name:	J D Chilvers	Quantity:	
Drawing Ref:	5	Accessibility:	Difficult Accessibility
Asbestos ?	Yes		
Date:	26 March 2007		
Next Inspection:	25 March 2008		
		Material Risk Score:	4
		Material Risk Band:	Very Low Risk
		Priority Risk Score:	2
Action:	Removal

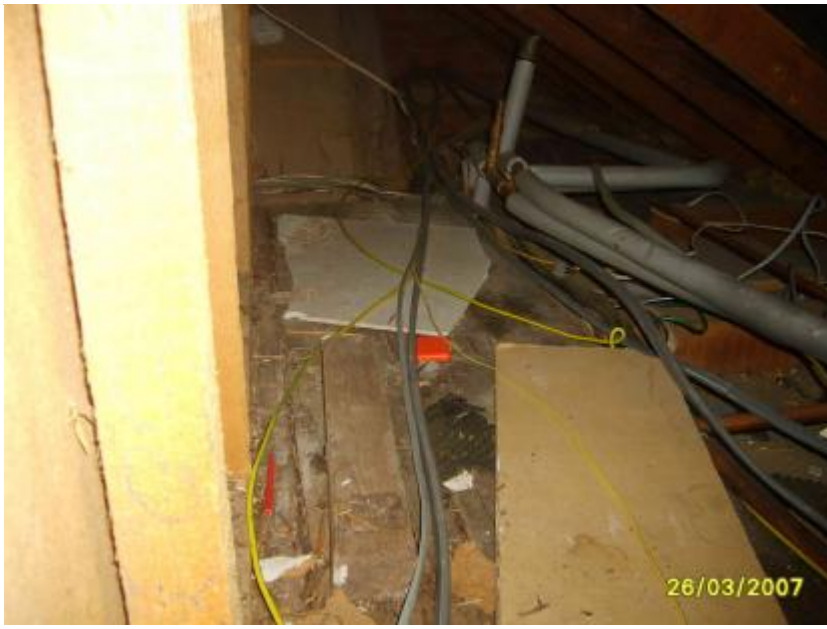
Location ID:	9131	Survey Type:	T 3
Location Ref:	6	Product Type:	NADIS
Product:	Debris	Damage:	NADIS
Area:	Not Applicable	Treatment:	NADIS
Floor:	Roof level	Asbestos Type:	NADIS
Room:	Loft space	Identification:	Identified
Surveyor Name:	J D Chilvers	Quantity:	
Drawing Ref:	6	Accessibility:	
Asbestos ?	No		
Date:	26 March 2007		
Next Inspection:	Not Applicable

Material Risk Score	0
Material Risk Band:	NADIS
Priority Risk Score:	N/A

Action:	No Action Required
---------	--------------------

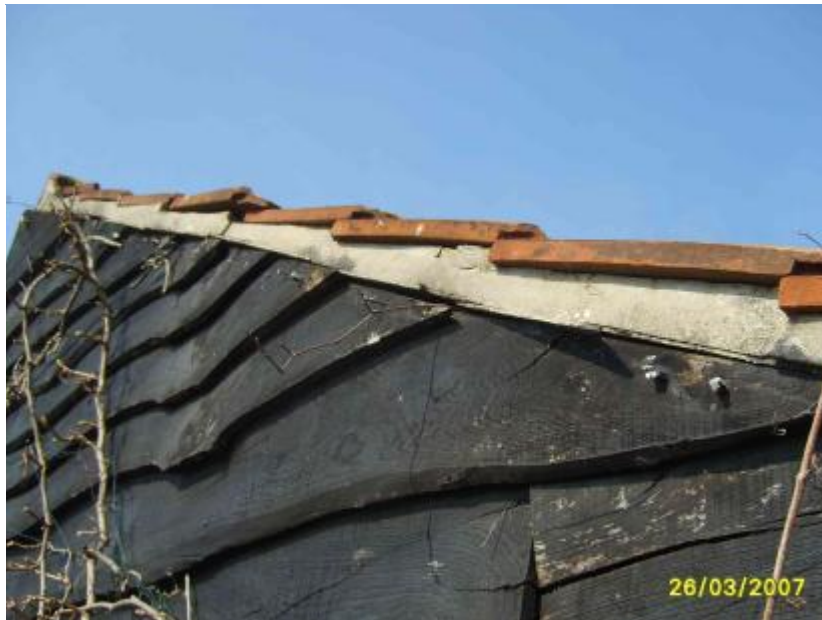
Location ID:	9132	Survey Type:	T 3
Location Ref:	7	Product Type:	Asbestos cement
Product:	Verge Undercloak	Damage:	Low damage: Broken edge Tiles
Area:	Not Applicable	Treatment:	Asbestos cement sheets etc
Floor:	Roof level	Asbestos Type:	Chrysotile
Room:	External	Identification:	Identified
Surveyor Name:	J D Chilvers	Quantity:	
Drawing Ref:	7	Accessibility:	Medium Accessibility
Asbestos ?	Yes		
Date:	26 March 2007		
Next Inspection:	25 March 2008		
		Material Risk Score:	4
		Material Risk Band:	Very Low Risk
		Priority Risk Score:	1
Action:	No Action Required

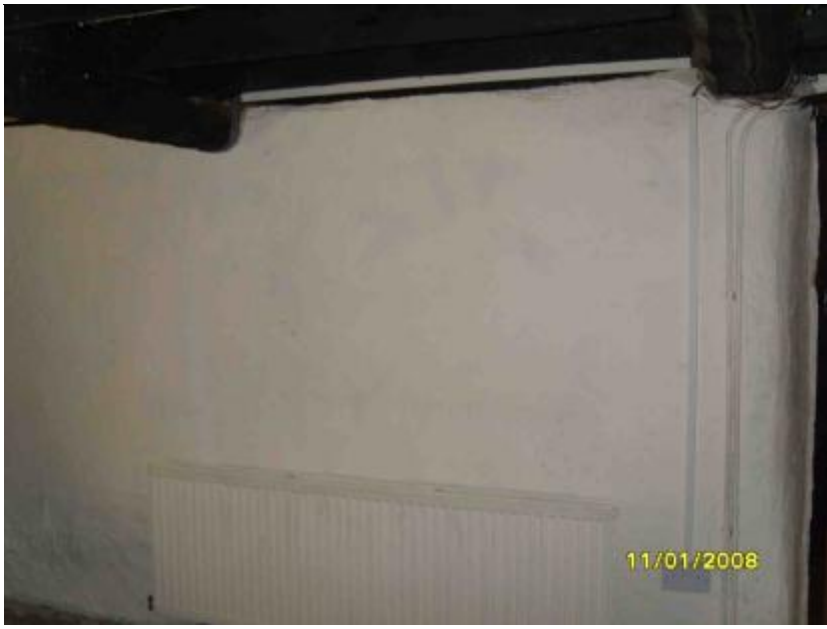
Location ID:	9166	Survey Type:	T 3
Location Ref:	8	Product Type:	NADIS
Product:	Textured coating	Damage:	NADIS
Area:	Not Applicable	Treatment:	NADIS
Floor:	Ground floor	Asbestos Type:	NADIS
Room:	Bar area	Identification:	Identified
Surveyor Name:	J D Chilvers	Quantity:	
Drawing Ref:	8	Accessibility:	
Asbestos ?	No		
Date:	11 January 2008		
Next Inspection:	Not Applicable

Material Risk Score	0
Material Risk Band:	NADIS
Priority Risk Score:	N/A

Action:	No Action Required
---------	--------------------

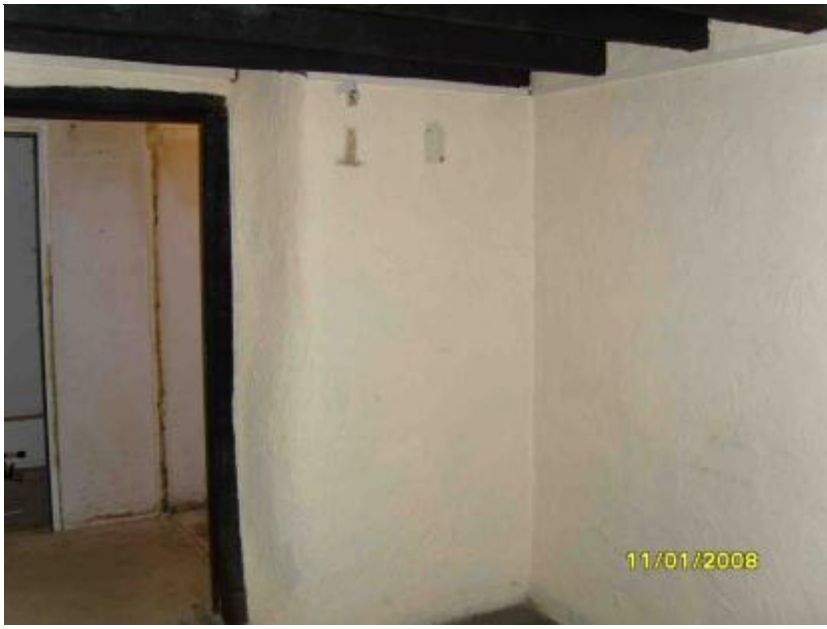
Location ID:	9167	Survey Type:	T 3
Location Ref:	9	Product Type:	NADIS
Product:	Textured coating	Damage:	NADIS
Area:	Not Applicable	Treatment:	NADIS
Floor:	Ground floor	Asbestos Type:	NADIS
Room:	Bar area	Identification:	Identified
Surveyor Name:	J D Chilvers	Quantity:	
Drawing Ref:	9	Accessibility:	
Asbestos ?	No		
Date:	11 January 2008		
Next Inspection:	Not Applicable

Material Risk Score	0
Material Risk Band:	NADIS
Priority Risk Score:	N/A

Action:	No Action Required
---------	--------------------

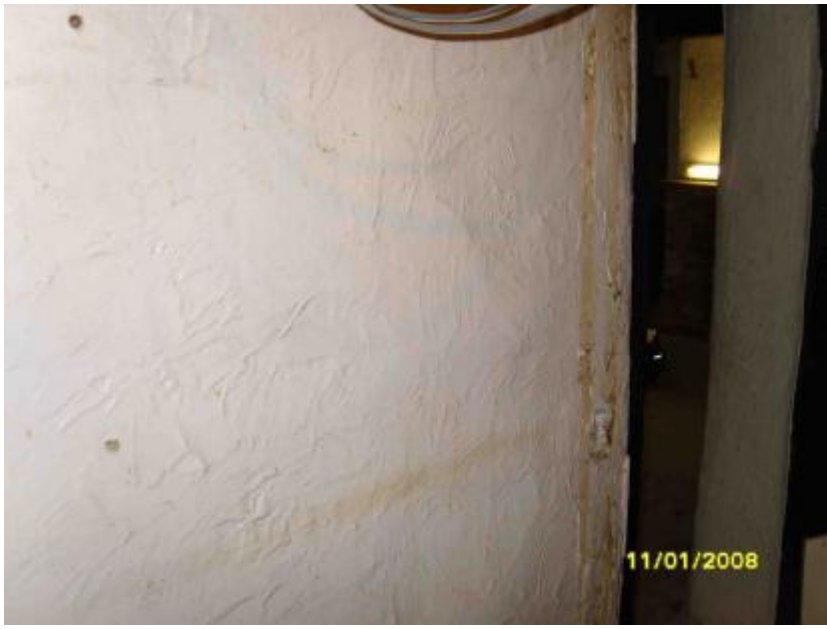
Location ID:	9168	Survey Type:	T 3
Location Ref:	10	Product Type:	NADIS
Product:	Textured coating	Damage:	NADIS
Area:	Not Applicable	Treatment:	NADIS
Floor:	Ground floor	Asbestos Type:	NADIS
Room:	Passageway	Identification:	Identified
Surveyor Name:	J D Chilvers	Quantity:	
Drawing Ref:	10	Accessibility:	
Asbestos ?	No		
Date:	11 January 2008		
Next Inspection:	Not Applicable

Material Risk Score	0
Material Risk Band:	NADIS
Priority Risk Score:	N/A

Action:	No Action Required
---------	--------------------

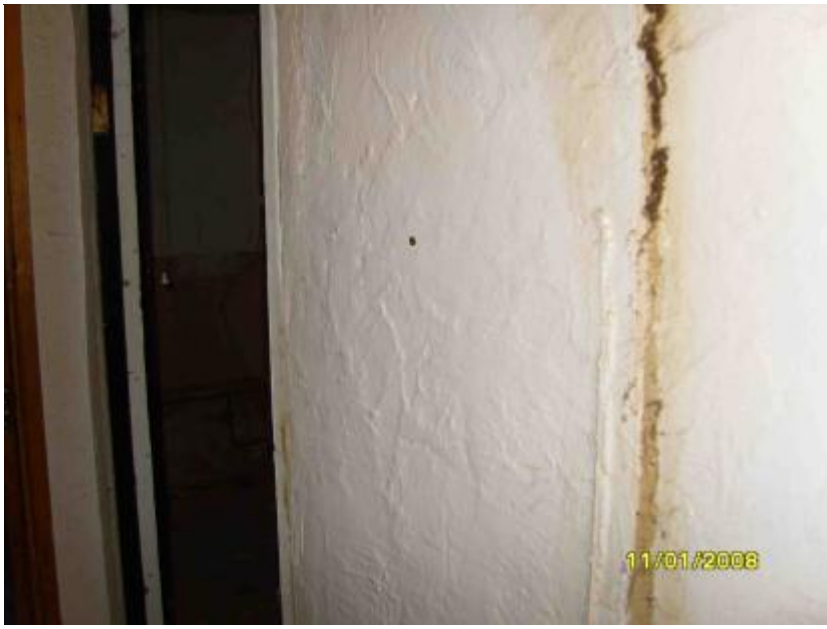
Location ID:	9169	Survey Type:	T 3
Location Ref:	11	Product Type:	NADIS
Product:	Textured coating	Damage:	NADIS
Area:	Not Applicable	Treatment:	NADIS
Floor:	Ground floor	Asbestos Type:	NADIS
Room:	Passageway	Identification:	Identified
Surveyor Name:	J D Chilvers	Quantity:	
Drawing Ref:	11	Accessibility:	
Asbestos ?	No		
Date:	11 January 2008		
Next Inspection:	Not Applicable

Material Risk Score	0
Material Risk Band:	NADIS
Priority Risk Score:	N/A

Action:	No Action Required
---------	--------------------

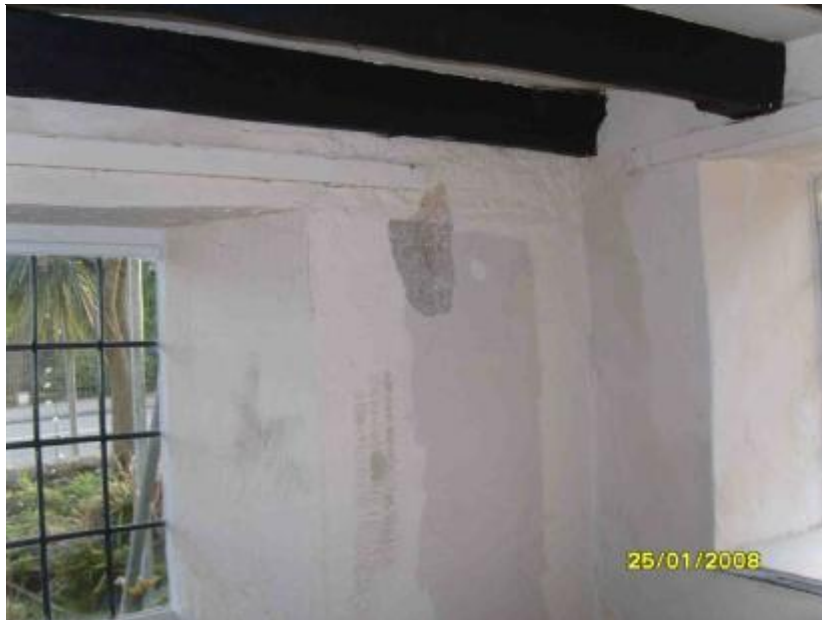
Location ID:	9192	Survey Type:	T 3
Location Ref:	13	Product Type:	Asbestos Insulating Board
Product:	Wall board	Damage:	Low damage
Area:	Not Applicable	Treatment:	AIB painted or encapsulated
Floor:	Ground floor	Asbestos Type:	Amosite & Chrysotile
Room:		Identification:	Identified
Surveyor Name:	J D Chilvers	Quantity:	2m2
Drawing Ref:	13	Accessibility:	
Asbestos ?	Yes		
Date:	25 January 2008		
Next Inspection:	26 July 2008

Material Risk Score	6
Material Risk Band:	Low Risk
Priority Risk Score:	N/A

Action:	Encapsulate and Apply Warning Labels
---------	--------------------------------------
