Asbestos Survey for

Hall & Woodhouse Ltd

The Onslow Arms
Loxwood
Billingshurst
West Sussex
RH14 0HD

Project Number: AS07203 - The Onslow Arms

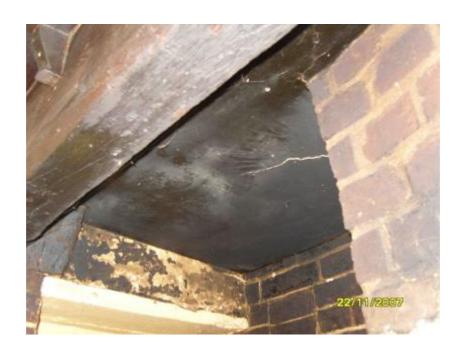
Cito / taai ooo.	The Onslow Arms, Loxwood, Billingshurst, West Su		ient Name:	Hall & Woodhouse Ltd		
	KN 14 UND	Pr	oject Number:	AS07203 - The	Onslow Arms	
Location ID:	8805	Survey Type:		T 2		
Location Ref:	1	Product Type:		NADIS		
Product:	Soffit	Damage:		NADIS		
Area:	Not Applicable	Treatment:		NADIS		
Floor:	Ground floor	Asbestos Type		NADIS		
Room:	Bar area	Identification:		Identified		
Surveyor Name	J D Chilvers	Quantity:				
Drawing Ref:	1	Accessibility:				
Asbestos ?	No					
Date:	22 November 2007		Materia	I Risk Score	0	
Next Inspection	. Not Applicable		Materia	I Risk Band:	NADIS	
			Priority	Risk Score:	N/A	
Action:		No Action Re	quired

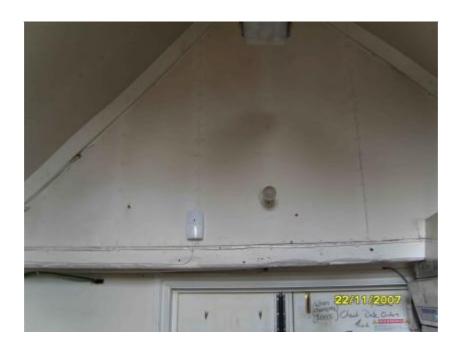
Location ID:	8806	Survey Type:		T 2	
Location Ref:	2	Product Type:		NADIS	
Product:	Wall board	Damage:		NADIS	
Area:	Not Applicable	Treatment:		NADIS	
Floor:	Ground floor	Asbestos Type	э:	NADIS	
Room:	Store Room	Identification:		Identified	
Surveyor Name	g: J D Chilvers	Quantity:

Drawing Ref:	2	Accessibility:			
Asbestos ?	No			Г	
Date:	22 November 2007		Materia	al Risk Score	0
Next Inspection	Not Applicable		Materia	al Risk Band:	NADIS
140Xt IIIOpcotioi			Priority	Risk Score:	N/A

No Action Required

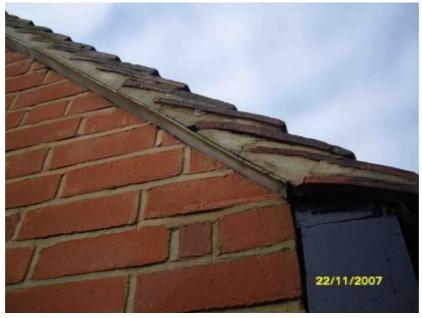
Site Address:	The Onslow Arms, Loxwood, Billingshurst, West Sus		Client Name:	Hall & Woo	dhouse Ltd
	RH14 0HD		roject Number:	AS07203 - The	e Onslow Arms
Location ID:	8807	Survey Type:		T 2	
				NADIS	
Location Ref:	3	Product Type:		NADI5	
Product:	Verge Undercloak	Damage:		NADIS	
Area:	Not Applicable	Treatment:		NADIS	
Floor:	Ground floor	Asbestos Type	e:	NADIS	
Room:	Kitchen	Identification:		Identified	
Surveyor Name	e: J D Chilvers	Quantity:			
Drawing Ref:	3	Accessibility:			
Asbestos ?	No				
Date:	22 November 2007		Materia	al Risk Score	0
Next Inspection	n: Not Applicable		Materia	al Risk Band:	NADIS
140Xt Hopouloi			Priority	Risk Score:	N/A

No Action Required

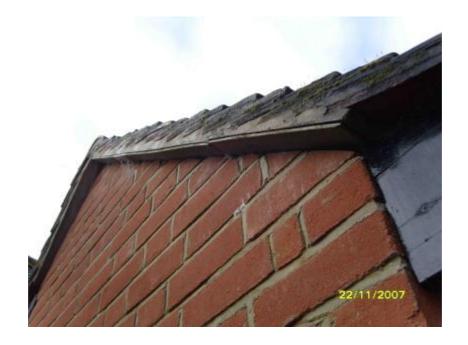
Client Name:	Hall & Woo	odhouse Ltd
	The Onslow Arms, Loxwood, Billingshurst, West SuRH14 0HD	ussex,			
		ı	Project Number:	AS07203 - Th	e Onslow Arms
		<u> </u>			
Location ID:	8808	Survey Type:		T 2	
Location Ref:	4	Product Type	:	NADIS	
Product:	Verge Undercloak	Damage:		NADIS	
Area:	Not Applicable	Treatment:		NADIS	
Floor:	Ground floor	Asbestos Typ	e:	NADIS	
Room:	Disabled toilet	Identification:	Strongly	Presumed as previo	ous sample
Surveyor Nam	e: J D Chilvers	Quantity:			
Drawing Ref:	4	Accessibility:			
Asbestos ?	No				
Date:	22 November 2007		Materi	al Risk Score	0
Next Inspectio	n: Not Applicable		Materi	al Risk Band:	NADIS
			Priorit	y Risk Score:	N/A

Material as kitchen undercloak Material Comments:

No Action Required

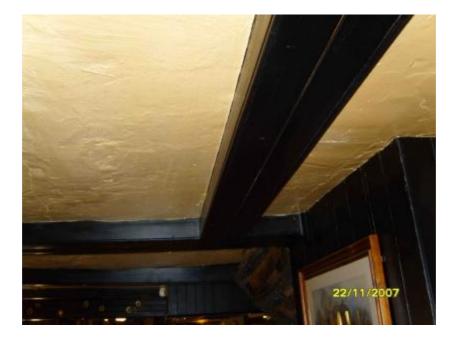
Hall & Woodhouse Ltd Client Name: Site Address: The Onslow Arms, Loxwood, Billingshurst, West Sussex, RH14 0HD Project Number: AS07203 - The Onslow Arms 8809 T 2 Location ID: Survey Type: Location Ref: 5 **Product Type:** Asbestos Insulating Board Product: Beam cladding Damage: No visible damage Not Applicable Treatment: AIB painted or encapsulated Area: Ground floor Amosite Floor: Asbestos Type: Presumed Bar area Identification: Room: J D Chilvers Surveyor Name: Quantity: 5 Medium Accessibility Drawing Ref: Accessibility: Asbestos? Yes Material Risk Score 5 22 November 2007 Date:

Low Risk

Location ID: 8809 5 Location Ref: Beam cladding Product: Not Applicable Area: Ground floor Floor: Bar area Room: J D Chilvers Surveyor Name: 5 Drawing Ref: Yes Asbestos? Date: 22 November 2007

Total Priority Assessment Score:		5
Material Assessment Score (supplied by surveyor):	Low Risk	5
Total of Material and Priority Assessment Scores:		10

Action: **Apply Warning Labels**
