Asbestos Survey for

Hall & Woodhouse Ltd

The Chestnut Horse

Project Number: AS07215 - Chestnut Horse

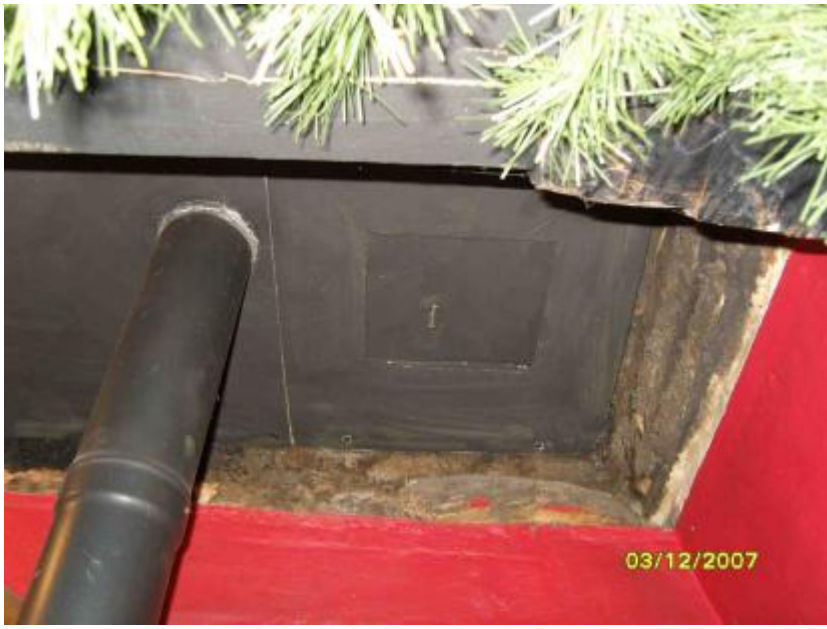
Location ID:	10453	Survey Type:	T 2
Location Ref:	2	Product Type:	NADIS
Product:	Register Plate	Damage:	NADIS
Area:	Not Applicable	Treatment:	NADIS
Floor:	Ground floor	Asbestos Type:	NADIS
Room:	Restaurant	Identification:	Identified
Surveyor Name:	J D Chilvers	Quantity:	
Drawing Ref:	2	Accessibility:	
Asbestos ?	No		
Date:	03 December 2007		
Next Inspection:	Not Applicable

Material Risk Score	0
Material Risk Band:	NADIS
Priority Risk Score:	N/A

Action:	No Action Required
---------	--------------------

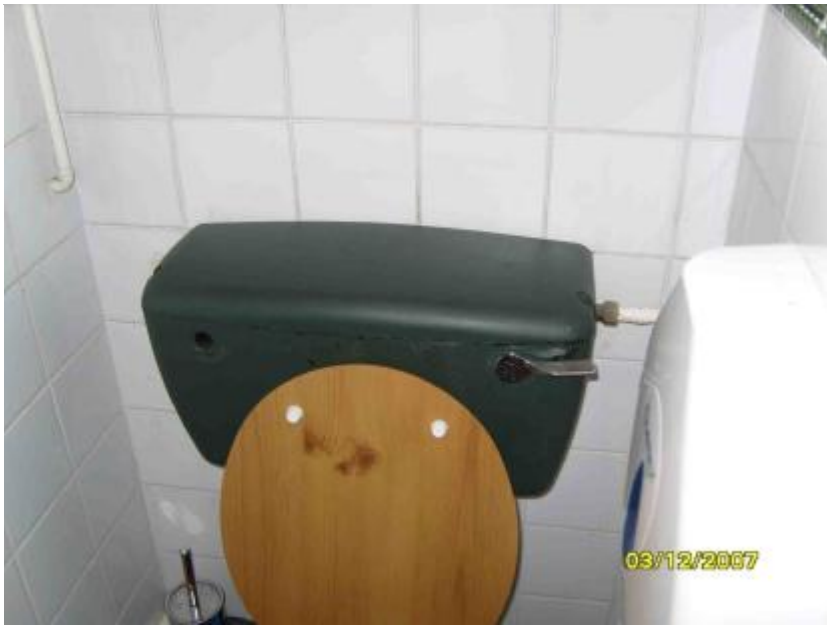
Location ID:	10454	Survey Type:	T 2
Location Ref:	3	Product Type:	Plastics
Product:	Cistern / Toilet seat	Damage:	Low damage: Scratches or marks
Area:	Not Applicable	Treatment:	Reinforced plastics
Floor:	Ground floor	Asbestos Type:	Amosite
Room:	WC - mens	Identification:	Identified
Surveyor Name:	J D Chilvers	Quantity:	
Drawing Ref:	3	Accessibility:	Easy Accessibility
Asbestos ?	Yes		
Date:	03 December 2007		
Next Inspection:	02 December 2008

Material Risk Score: 4

Material Risk Band: Very Low Risk

Priority Risk Score: 4

Action: Apply Warning Labels

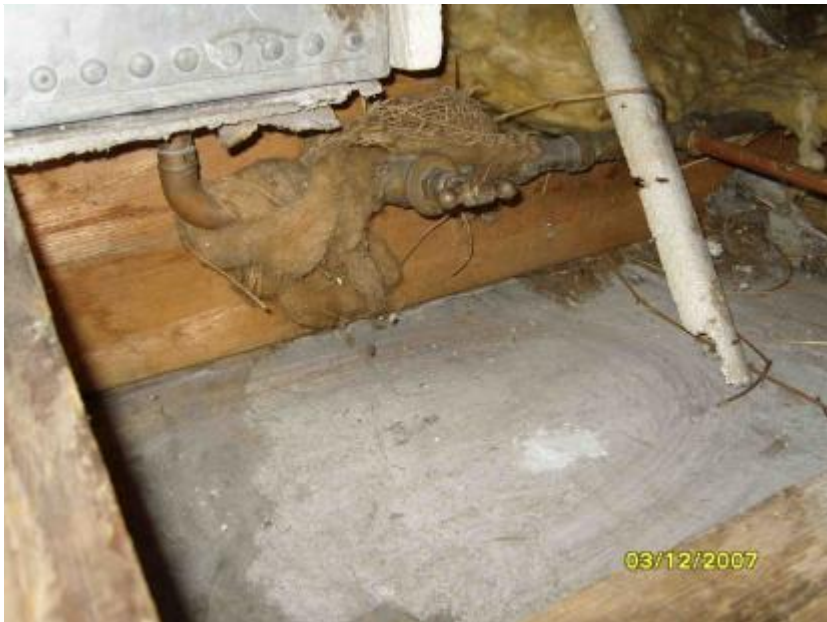
Location ID:	<input type="text" value="10455"/>	Survey Type:	<input type="text" value="T 2"/>
Location Ref:	<input type="text" value="4"/>	Product Type:	<input type="text" value="NADIS"/>
Product:	<input type="text" value="Ceiling"/>	Damage:	<input type="text" value="NADIS"/>
Area:	<input type="text" value="Not Applicable"/>	Treatment:	<input type="text" value="NADIS"/>
Floor:	<input type="text" value="Roof level"/>	Asbestos Type:	<input type="text" value="NADIS"/>
Room:	<input type="text" value="Loft space"/>	Identification:	<input type="text" value="Identified"/>
Surveyor Name:	<input type="text" value="J D Chilvers"/>	Quantity:	<input type="text"/>

Drawing Ref:	<input type="text" value="4"/>	Accessibility:	<input type="text"/>
Asbestos ?	<input type="text" value="No"/>		
Date:	<input type="text" value="03 December 2007"/>		
Next Inspection:	<input type="text" value="Not Applicable"/>

Material Risk Score	<input type="text" value="0"/>
Material Risk Band:	<input type="text" value="NADIS"/>
Priority Risk Score:	<input type="text" value="N/A"/>

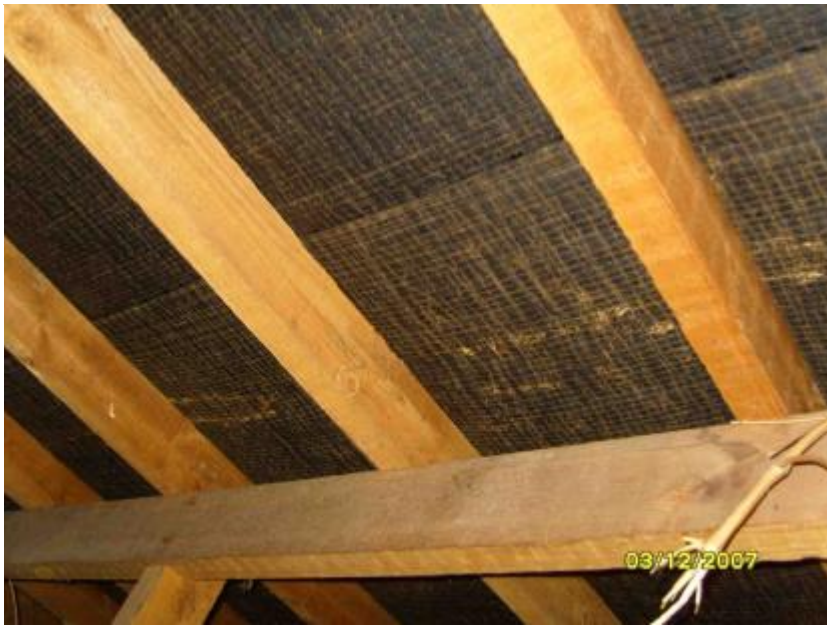
Location ID:	10456	Survey Type:	T 2
Location Ref:	5	Product Type:	NADIS
Product:	Roofing felt	Damage:	NADIS
Area:	Not Applicable	Treatment:	NADIS
Floor:	Roof level	Asbestos Type:	NADIS
Room:	Loft space	Identification:	Identified
Surveyor Name:	J D Chilvers	Quantity:	
Drawing Ref:	5	Accessibility:	
Asbestos ?	No		
Date:	03 December 2007		
Next Inspection:	Not Applicable

Material Risk Score	0
Material Risk Band:	NADIS
Priority Risk Score:	N/A

Action:	No Action Required
---------	--------------------

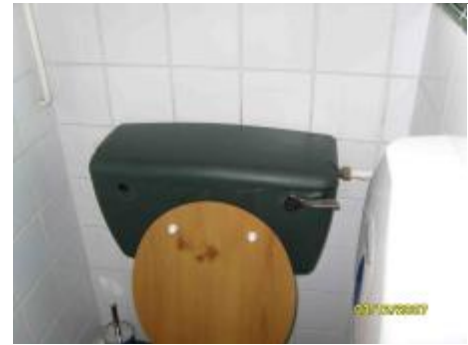
Location ID:	10454
Location Ref:	3
Product:	Cistern / Toilet seat
Area:	Not Applicable
Floor:	Ground floor
Room:	WC - mens
Surveyor Name:	J D Chilvers
Drawing Ref:	3
Asbestos ?	Yes
Date:	03 December 2008

Priority Assessment Algorithm	Variable(s) selected	Score for each	Overall score
Normal Occupant Activity:			
Main type of activity in area:	Low disturbance	1	average
Secondary activities for area:	Low disturbance	1	1
Likelihood Of Disturbance:			
Location:	Rooms up to 100 m2	2	average
Accessibility:	Usually inaccessible or unlikely to be disturbed	0	
Extent/Amount:	Small items strings gaskets	0	
Human Exposure Potential:			
Number of occupants:	1 to 3	1	average
Frequency of use of area:	Daily	3	
Average time area is in use:	<1 hour	0	
Maintenance Activity:			
Type of maintenance activity:	Minor disturbance	0	average
Frequency of maintenance activity	<=1 per year	1	1

Total Priority Assessment Score:	4
Material Assessment Score (supplied by surveyor):	Very Low Risk
Total of Material and Priority Assessment Scores:	8
