# **Asbestos Survey for**

Hall & Woodhouse Ltd

The Green Dragon  
12 Bishopric  
Horsham  
West Sussex  
RH12 1QR

Project Number: AS09129 - Green Dragon Horsham

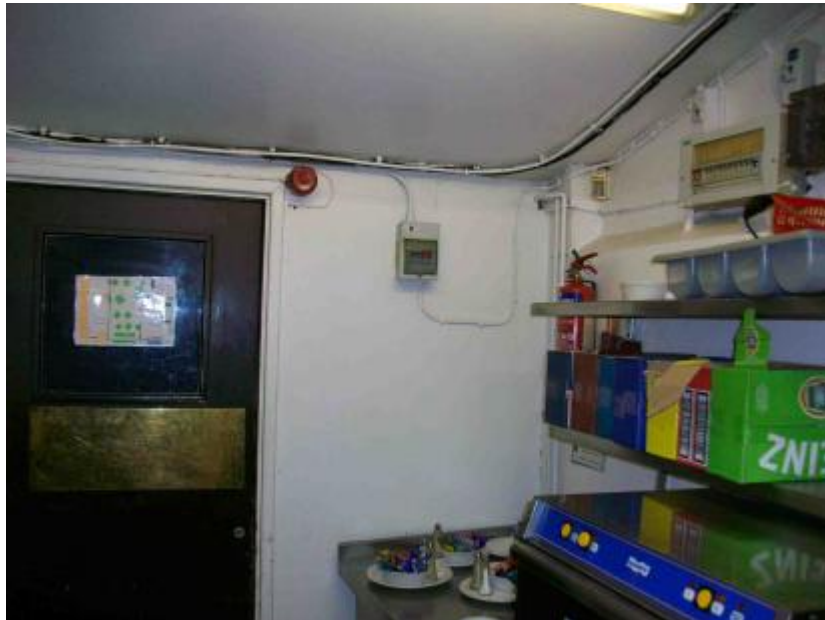
Location ID:	<input type="text" value="11963"/>	Survey Type:	<input type="text" value="T 2"/>
Location Ref:	<input type="text" value="1"/>	Product Type:	<input type="text" value="NADIS"/>
Product:	<input type="text" value="Wall panel"/>	Damage:	<input type="text" value="NADIS"/>
Area:	<input type="text" value="Not Applicable"/>	Treatment:	<input type="text" value="NADIS"/>
Floor:	<input type="text" value="Ground floor"/>	Asbestos Type:	<input type="text" value="NADIS"/>
Room:	<input type="text" value="Kitchen"/>	Identification:	<input type="text" value="Identified"/>
Surveyor Name:	<input type="text" value="J D Chilvers"/>	Quantity:	<input type="text"/>

Material Risk Score	<input type="text" value="0"/>
Material Risk Band:	<input type="text" value="NADIS"/>
Priority Risk Score:	<input type="text" value="N/A"/>

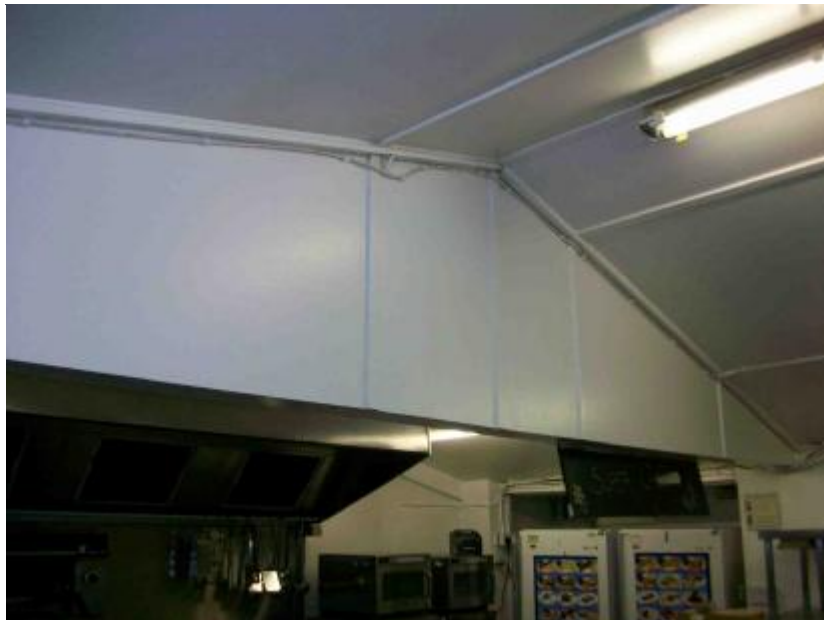
Location ID:	<input type="text" value="11964"/>	Survey Type:	<input type="text" value="T 2"/>
Location Ref:	<input type="text" value="2"/>	Product Type:	<input type="text" value="Asbestos Insulating Board"/>
Product:	<input type="text" value="Bulkhead"/>	Damage:	<input type="text" value="No visible damage"/>
Area:	<input type="text" value="Not Applicable"/>	Treatment:	<input type="text" value="AIB painted or encapsulated"/>
Floor:	<input type="text" value="Ground floor"/>	Asbestos Type:	<input type="text" value="Amosite"/>
Room:	<input type="text" value="Kitchen"/>	Identification:	<input type="text" value="Presumed"/>
Surveyor Name:	<input type="text" value="J D Chilvers"/>	Quantity:	<input type="text"/>

Material Risk Score	<input type="text" value="5"/>
Material Risk Band:	<input type="text" value="Low Risk"/>
Priority Risk Score:	<input type="text" value="5"/>

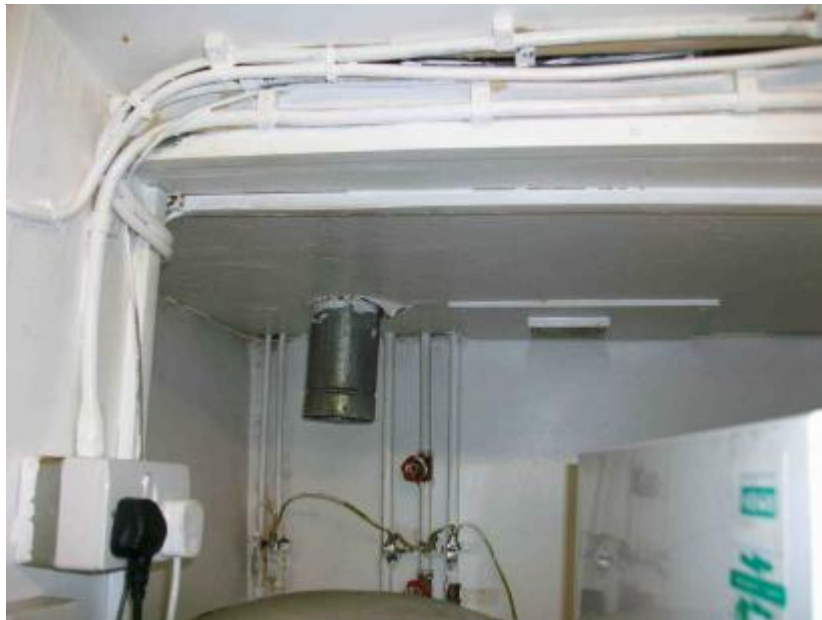
Location ID:	<input type="text" value="11965"/>	Survey Type:	<input type="text" value="T 2"/>
Location Ref:	<input type="text" value="3"/>	Product Type:	<input type="text" value="Ropes and woven textiles"/>
Product:	<input type="text" value="Flue"/>	Damage:	<input type="text" value="No visible damage"/>
Area:	<input type="text" value="Not Applicable"/>	Treatment:	<input type="text" value="Composite asbestos materials"/>
Floor:	<input type="text" value="Ground floor"/>	Asbestos Type:	<input type="text" value="Chrysotile"/>
Room:	<input type="text" value="Kitchen"/>	Identification:	<input type="text" value="Presumed"/>
Surveyor Name:	<input type="text" value="J D Chilvers"/>	Quantity:	<input type="text"/>

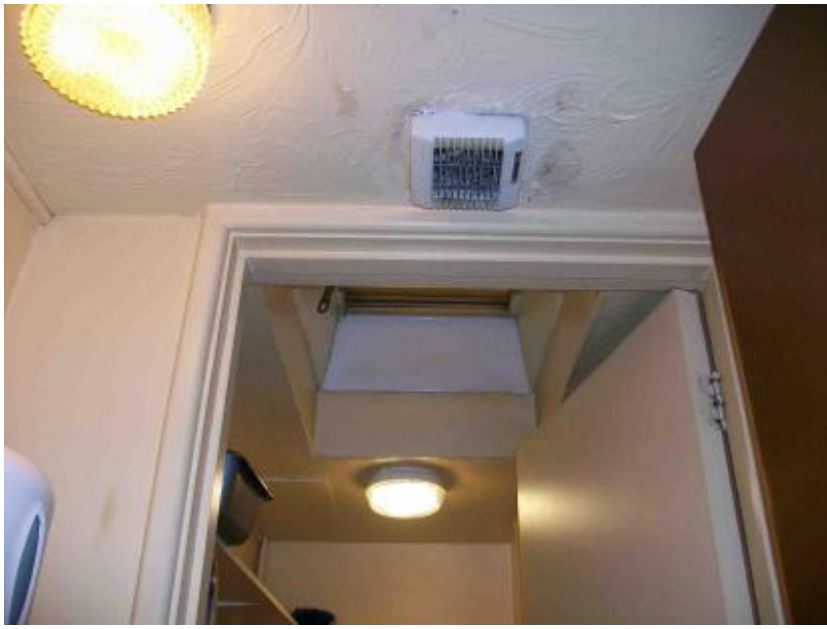
Location ID:	<input type="text" value="11966"/>	Survey Type:	<input type="text" value="T 2"/>
Location Ref:	<input type="text" value="4"/>	Product Type:	<input type="text" value="NADIS"/>
Product:	<input type="text" value="Textured coating"/>	Damage:	<input type="text" value="NADIS"/>
Area:	<input type="text" value="Not Applicable"/>	Treatment:	<input type="text" value="NADIS"/>
Floor:	<input type="text" value="Ground floor"/>	Asbestos Type:	<input type="text" value="NADIS"/>
Room:	<input type="text" value="Store Room"/>	Identification:	<input type="text" value="Identified"/>
Surveyor Name:	<input type="text" value="J D Chilvers"/>	Quantity:	<input type="text"/>

Material Risk Score	<input type="text" value="0"/>
Material Risk Band:	<input type="text" value="NADIS"/>
Priority Risk Score:	<input type="text" value="N/A"/>

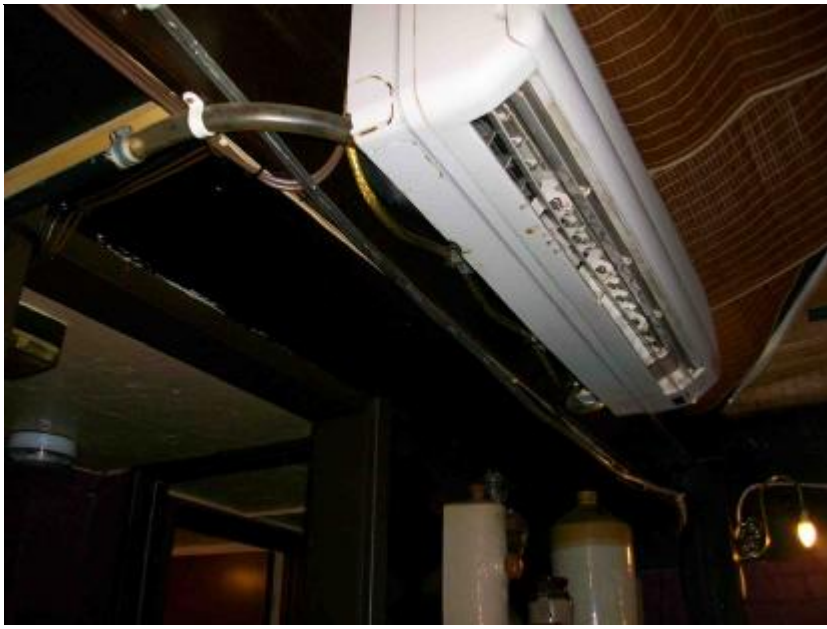
Location ID:	<input type="text" value="11967"/>	Survey Type:	<input type="text" value="T 2"/>
Location Ref:	<input type="text" value="5"/>	Product Type:	<input type="text" value="NADIS"/>
Product:	<input type="text" value="Soffit"/>	Damage:	<input type="text" value="NADIS"/>
Area:	<input type="text" value="Not Applicable"/>	Treatment:	<input type="text" value="NADIS"/>
Floor:	<input type="text" value="Ground floor"/>	Asbestos Type:	<input type="text" value="NADIS"/>
Room:	<input type="text" value="Drinking Area"/>	Identification:	<input type="text" value="Identified"/>
Surveyor Name:	<input type="text" value="J D Chilvers"/>	Quantity:	<input type="text"/>

Material Risk Score	<input type="text" value="0"/>
Material Risk Band:	<input type="text" value="NADIS"/>
Priority Risk Score:	<input type="text" value="N/A"/>

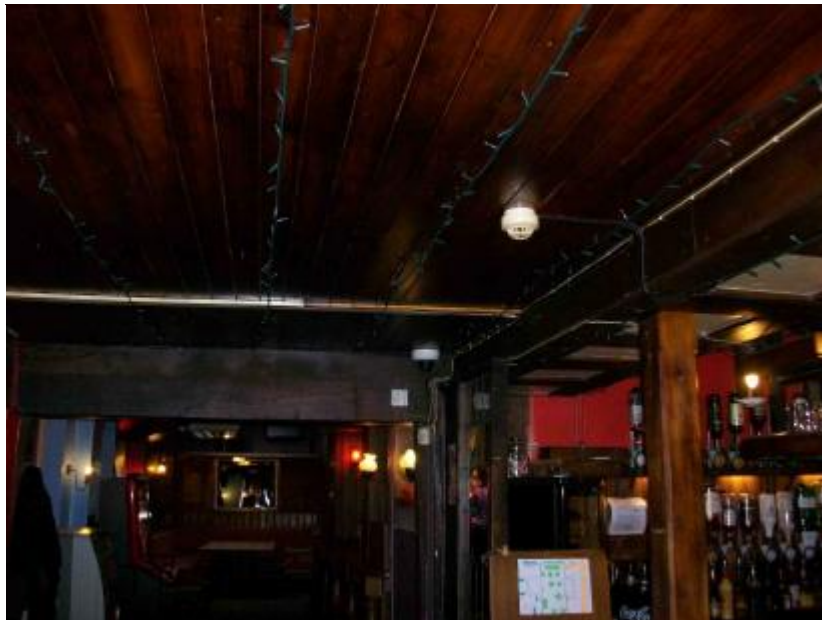
Location ID:	<input type="text" value="11968"/>	Survey Type:	<input type="text" value="T 2"/>
Location Ref:	<input type="text" value="6"/>	Product Type:	<input type="text" value="Asbestos Insulating Board"/>
Product:	<input type="text" value="Beam cladding"/>	Damage:	<input type="text" value="No visible damage"/>
Area:	<input type="text" value="Not Applicable"/>	Treatment:	<input type="text" value="AIB painted or encapsulated"/>
Floor:	<input type="text" value="Ground floor"/>	Asbestos Type:	<input type="text" value="Amosite"/>
Room:	<input type="text" value="Bar area"/>	Identification:	<input type="text" value="Presumed"/>
Surveyor Name:	<input type="text" value="J D Chilvers"/>	Quantity:	<input type="text"/>

Material Risk Score	<input type="text" value="5"/>
Material Risk Band:	<input type="text" value="Low Risk"/>
Priority Risk Score:	<input type="text" value="5"/>

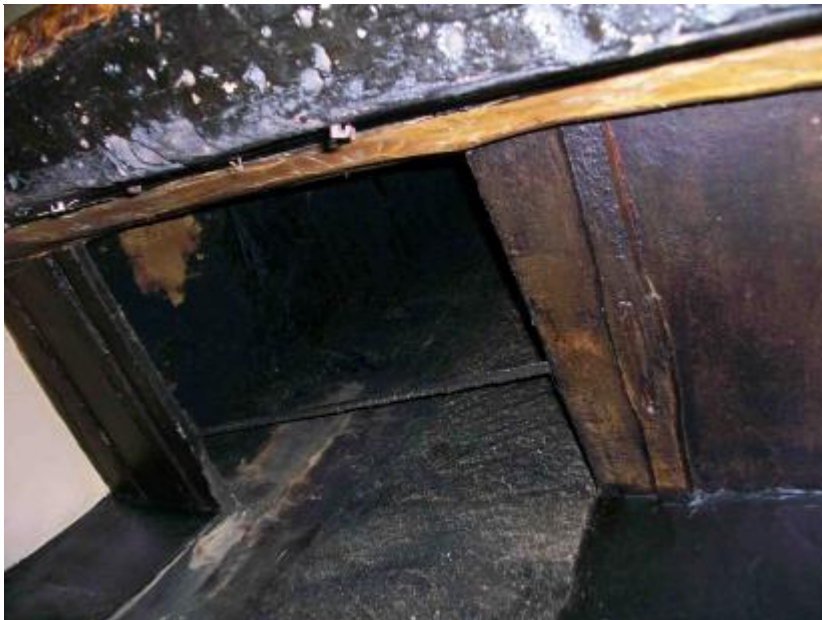
Location ID:	<input type="text" value="11969"/>	Survey Type:	<input type="text" value="T 2"/>
Location Ref:	<input type="text" value="7"/>	Product Type:	<input type="text" value="Asbestos cement"/>
Product:	<input type="text" value="Register Plate"/>	Damage:	<input type="text" value="No visible damage"/>
Area:	<input type="text" value="Not Applicable"/>	Treatment:	<input type="text" value="Asbestos cement sheets etc"/>
Floor:	<input type="text" value="Ground floor"/>	Asbestos Type:	<input type="text" value="Chrysotile"/>
Room:	<input type="text" value="Bar area"/>	Identification:	<input type="text" value="Presumed"/>
Surveyor Name:	<input type="text" value="J D Chilvers"/>	Quantity:	<input type="text"/>

Material Risk Score	<input type="text" value="3"/>
Material Risk Band:	<input type="text" value="Very Low Risk"/>
Priority Risk Score:	<input type="text" value="5"/>

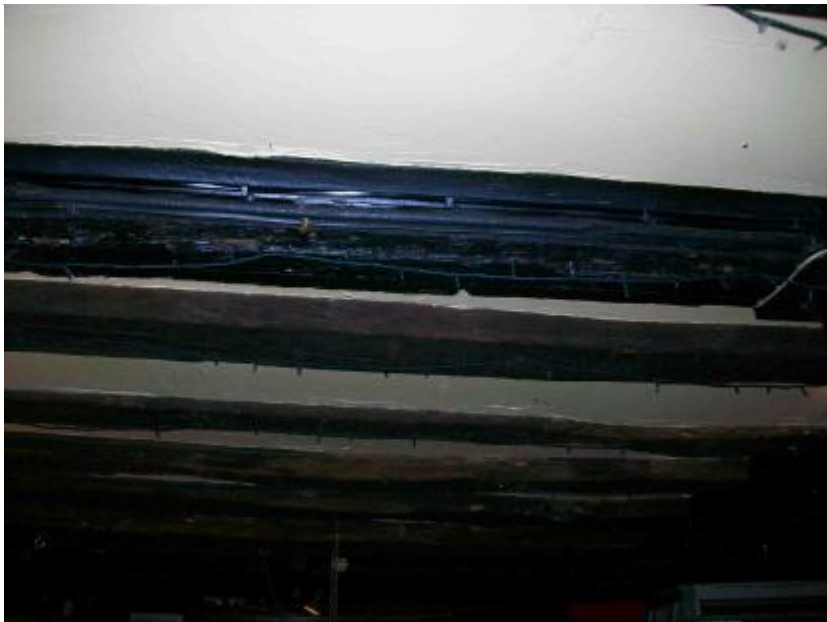
Location ID:	<input type="text" value="11970"/>	Survey Type:	<input type="text" value="T 2"/>
Location Ref:	<input type="text" value="8"/>	Product Type:	<input type="text" value="NADIS"/>
Product:	<input type="text" value="Ceiling"/>	Damage:	<input type="text" value="NADIS"/>
Area:	<input type="text" value="Not Applicable"/>	Treatment:	<input type="text" value="NADIS"/>
Floor:	<input type="text" value="Ground floor"/>	Asbestos Type:	<input type="text" value="NADIS"/>
Room:	<input type="text" value="Bar area"/>	Identification:	<input type="text" value="Identified"/>
Surveyor Name:	<input type="text" value="J D Chilvers"/>	Quantity:	<input type="text"/>

Material Risk Score	<input type="text" value="0"/>
Material Risk Band:	<input type="text" value="NADIS"/>
Priority Risk Score:	<input type="text" value="N/A"/>

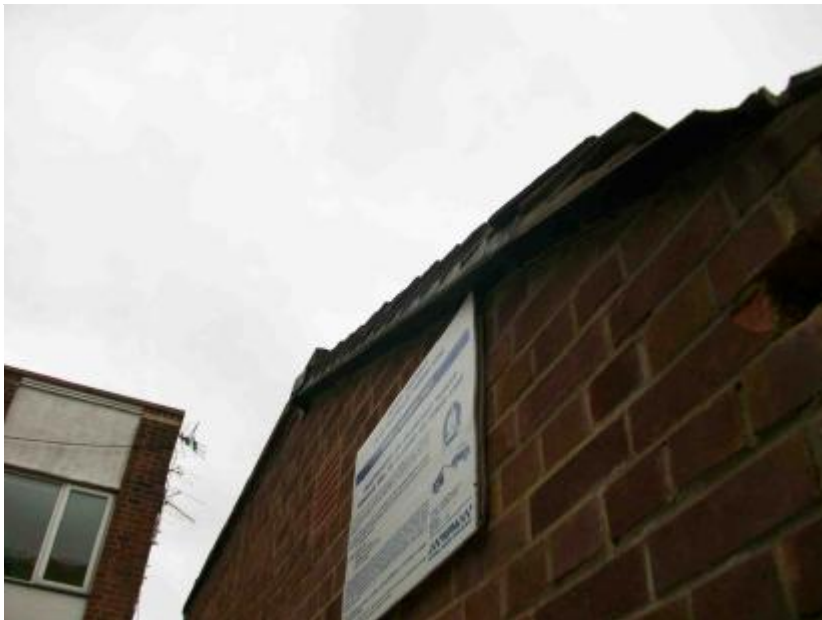
Location ID:	<input type="text" value="11971"/>	Survey Type:	<input type="text" value="T 2"/>
Location Ref:	<input type="text" value="9"/>	Product Type:	<input type="text" value="Asbestos cement"/>
Product:	<input type="text" value="Verge Undercloak"/>	Damage:	<input type="text" value="Low damage: Scratches or marks"/>
Area:	<input type="text" value="Not Applicable"/>	Treatment:	<input type="text" value="Asbestos cement sheets etc"/>
Floor:	<input type="text" value="Roof level"/>	Asbestos Type:	<input type="text" value="Chrysotile"/>
Room:	<input type="text" value="External"/>	Identification:	<input type="text" value="Identified"/>
Surveyor Name:	<input type="text" value="J D Chilvers"/>	Quantity:	<input type="text"/>

Material Risk Score	<input type="text" value="4"/>
Material Risk Band:	<input type="text" value="Very Low Risk"/>
Priority Risk Score:	<input type="text" value="1"/>

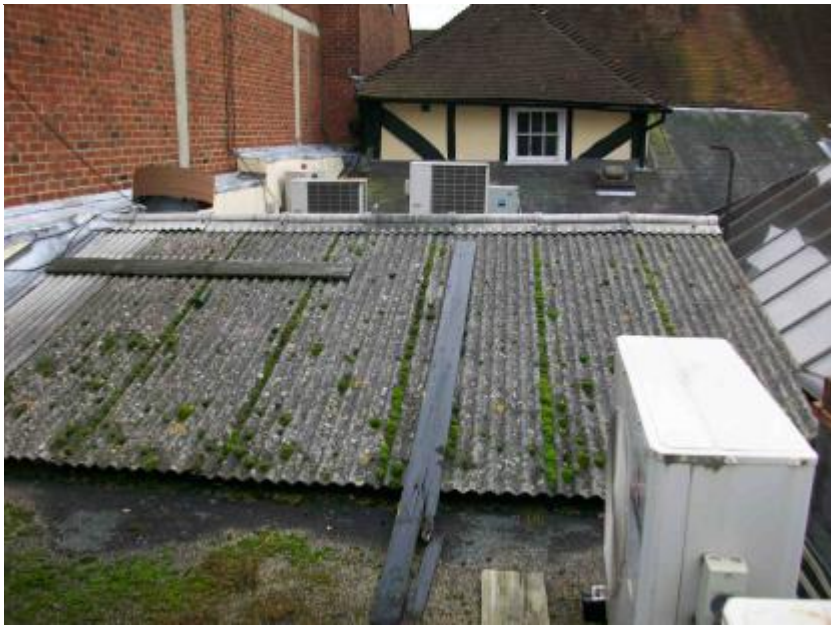
<b>Location ID:</b>	<input style="width: 95%;" type="text" value="11972"/>	<b>Survey Type:</b>	<input style="width: 95%;" type="text" value="T 2"/>						
<b>Location Ref:</b>	<input style="width: 95%;" type="text" value="10"/>	<b>Product Type:</b>	<input style="width: 95%;" type="text" value="NADIS"/>						
<b>Product:</b>	<input style="width: 95%;" type="text" value="Roofing Sheets"/>	<b>Damage:</b>	<input style="width: 95%;" type="text" value="NADIS"/>						
<b>Area:</b>	<input style="width: 95%;" type="text" value="Not Applicable"/>	<b>Treatment:</b>	<input style="width: 95%;" type="text" value="NADIS"/>						
<b>Floor:</b>	<input style="width: 95%;" type="text" value="Roof level"/>	<b>Asbestos Type:</b>	<input style="width: 95%;" type="text" value="NADIS"/>						
<b>Room:</b>	<input style="width: 95%;" type="text" value="External"/>	<b>Identification:</b>	<input style="width: 95%;" type="text" value="Identified"/>						
<b>Surveyor Name:</b>	<input style="width: 95%;" type="text" value="J D Chilvers"/>	<b>Quantity:</b>	<input style="width: 95%;" type="text"/>						
<b>Drawing Ref:</b>	<input style="width: 95%;" type="text" value="10"/>	<b>Accessibility:</b>	<input style="width: 95%;" type="text"/>						
<b>Asbestos ?</b>	<input style="width: 95%;" type="text" value="No"/>

<b>Material Risk Score</b>	<input style="width: 30%;" type="text" value="0"/>	<b>Material Risk Band:</b>	<input style="width: 30%;" type="text" value="NADIS"/>	<b>Priority Risk Score:</b>	<input style="width: 30%;" type="text" value="1"/>
<b>Material Risk Score</b>	<input style="width: 30%;" type="text" value="0"/>								
<b>Material Risk Band:</b>	<input style="width: 30%;" type="text" value="NADIS"/>								
<b>Priority Risk Score:</b>	<input style="width: 30%;" type="text" value="1"/>								
<b>Date:</b>	<input style="width: 95%;" type="text" value="18 November 2009"/>								
<b>Next Inspection:</b>	<input style="width: 95%;" type="text" value="Not Applicable"/>

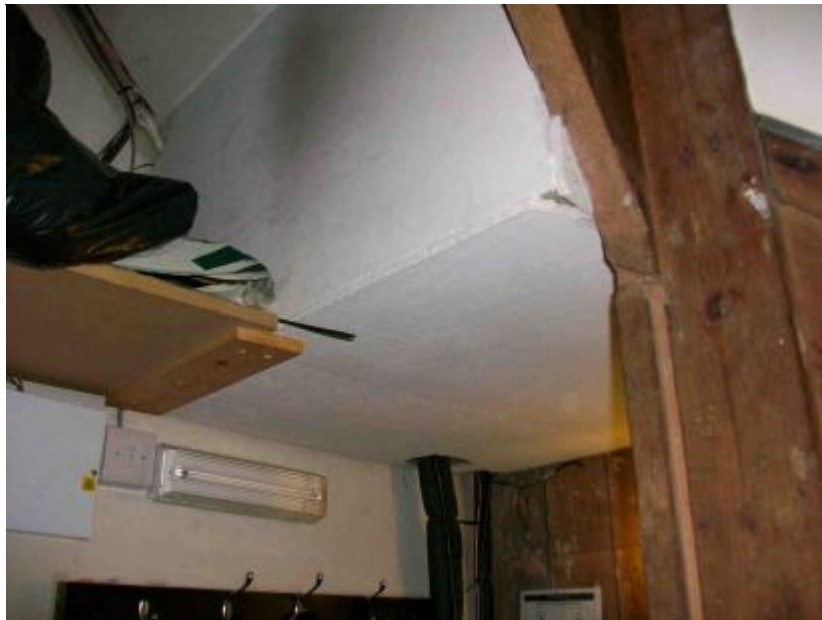
Location ID:	<input type="text" value="11973"/>	Survey Type:	<input type="text" value="T 2"/>
Location Ref:	<input type="text" value="11"/>	Product Type:	<input type="text" value="NADIS"/>
Product:	<input type="text" value="Stair Backing / Cladding"/>	Damage:	<input type="text" value="NADIS"/>
Area:	<input type="text" value="Not Applicable"/>	Treatment:	<input type="text" value="NADIS"/>
Floor:	<input type="text" value="Ground floor"/>	Asbestos Type:	<input type="text" value="NADIS"/>
Room:	<input type="text" value="Understair Cupboard"/>	Identification:	<input type="text" value="Identified"/>
Surveyor Name:	<input type="text" value="J D Chilvers"/>	Quantity:	<input type="text"/>

Material Risk Score	<input type="text" value="0"/>
Material Risk Band:	<input type="text" value="NADIS"/>
Priority Risk Score:	<input type="text" value="N/A"/>

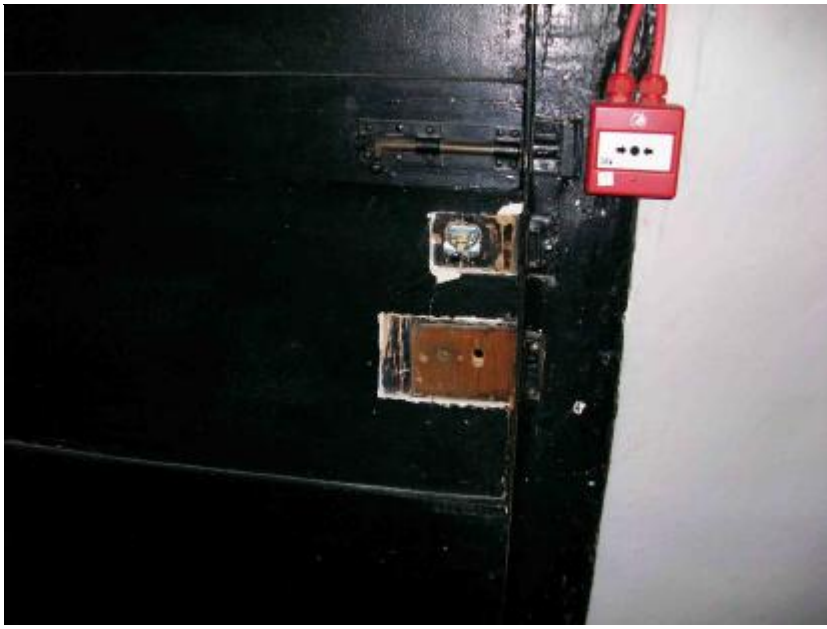
<b>Location ID:</b>	<input style="width: 95%;" type="text" value="11974"/>	<b>Survey Type:</b>	<input style="width: 95%;" type="text" value="T 2"/>						
<b>Location Ref:</b>	<input style="width: 95%;" type="text" value="12"/>	<b>Product Type:</b>	<input style="width: 95%;" type="text" value="NADIS"/>						
<b>Product:</b>	<input style="width: 95%;" type="text" value="Door panel"/>	<b>Damage:</b>	<input style="width: 95%;" type="text" value="NADIS"/>						
<b>Area:</b>	<input style="width: 95%;" type="text" value="Not Applicable"/>	<b>Treatment:</b>	<input style="width: 95%;" type="text" value="NADIS"/>						
<b>Floor:</b>	<input style="width: 95%;" type="text" value="First floor"/>	<b>Asbestos Type:</b>	<input style="width: 95%;" type="text" value="NADIS"/>						
<b>Room:</b>	<input style="width: 95%;" type="text" value="Staff Room"/>	<b>Identification:</b>	<input style="width: 95%;" type="text" value="Identified"/>						
<b>Surveyor Name:</b>	<input style="width: 95%;" type="text" value="J D Chilvers"/>	<b>Quantity:</b>	<input style="width: 95%;" type="text"/>						
<b>Drawing Ref:</b>	<input style="width: 95%;" type="text" value="12"/>	<b>Accessibility:</b>	<input style="width: 95%;" type="text"/>						
<b>Asbestos ?</b>	<input style="width: 95%;" type="text" value="No"/>

<b>Material Risk Score</b>	<input style="width: 30%;" type="text" value="0"/>	<b>Material Risk Band:</b>	<input style="width: 30%;" type="text" value="NADIS"/>	<b>Priority Risk Score:</b>	<input style="width: 30%;" type="text" value="N/A"/>
<b>Material Risk Score</b>	<input style="width: 30%;" type="text" value="0"/>								
<b>Material Risk Band:</b>	<input style="width: 30%;" type="text" value="NADIS"/>								
<b>Priority Risk Score:</b>	<input style="width: 30%;" type="text" value="N/A"/>								
<b>Date:</b>	<input style="width: 95%;" type="text" value="18 November 2009"/>								
<b>Next Inspection:</b>	<input style="width: 95%;" type="text" value="Not Applicable"/>

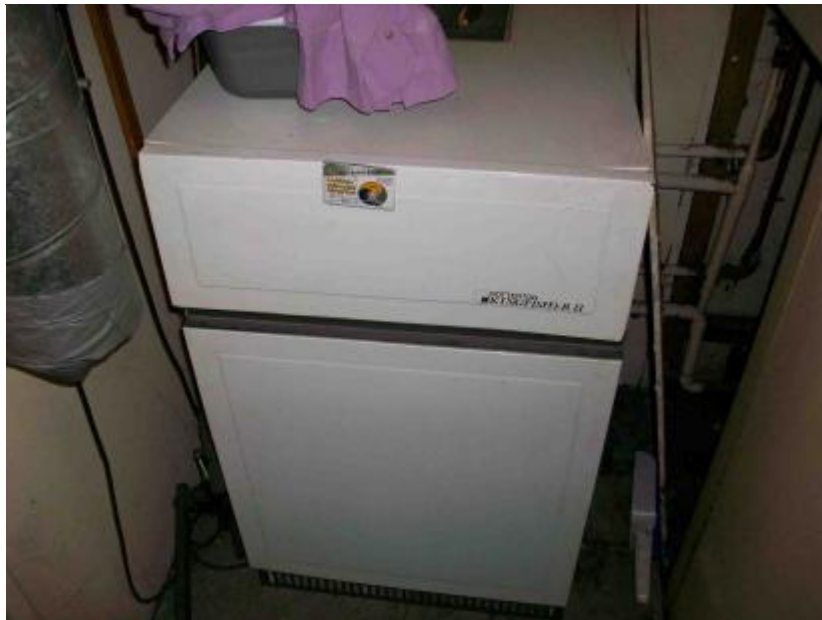
Location ID:	<input type="text" value="11975"/>	Survey Type:	<input type="text" value="T 2"/>						
Location Ref:	<input type="text" value="13"/>	Product Type:	<input type="text" value="Gaskets"/>						
Product:	<input type="text" value="Boiler"/>	Damage:	<input type="text" value="No visible damage"/>						
Area:	<input type="text" value="Not Applicable"/>	Treatment:	<input type="text" value="Composite asbestos materials"/>						
Floor:	<input type="text" value="First floor"/>	Asbestos Type:	<input type="text" value="Chrysotile"/>						
Room:	<input type="text" value="Boiler cupboard"/>	Identification:	<input type="text" value="Presumed"/>						
Surveyor Name:	<input type="text" value="J D Chilvers"/>	Quantity:	<input type="text"/>						
Drawing Ref:	<input type="text" value="13"/>	Accessibility:	<input type="text" value="Medium Accessibility"/>						
Asbestos ?	<input type="text" value="Yes"/>

Material Risk Score	<input type="text" value="3"/>	Material Risk Band:	<input type="text" value="Very Low Risk"/>	Priority Risk Score:	<input type="text" value="4"/>
Material Risk Score	<input type="text" value="3"/>								
Material Risk Band:	<input type="text" value="Very Low Risk"/>								
Priority Risk Score:	<input type="text" value="4"/>								
Date:	<input type="text" value="18 November 2009"/>								
Next Inspection:	<input type="text" value="18 November 2010"/>

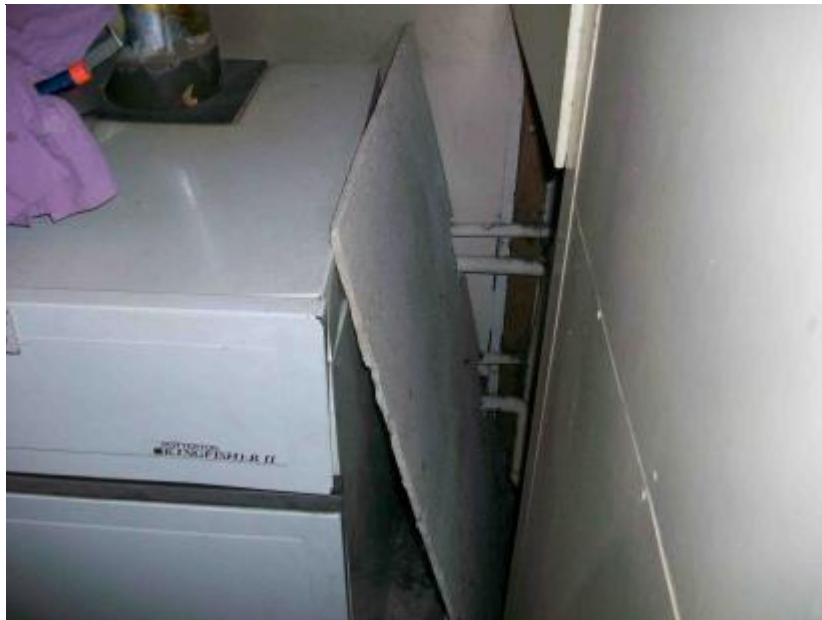
Location ID:	<input type="text" value="11976"/>	Survey Type:	<input type="text" value="T 2"/>
Location Ref:	<input type="text" value="14"/>	Product Type:	<input type="text" value="NADIS"/>
Product:	<input type="text" value="Heat Shield"/>	Damage:	<input type="text" value="NADIS"/>
Area:	<input type="text" value="Not Applicable"/>	Treatment:	<input type="text" value="NADIS"/>
Floor:	<input type="text" value="First floor"/>	Asbestos Type:	<input type="text" value="NADIS"/>
Room:	<input type="text" value="Boiler cupboard"/>	Identification:	<input type="text" value="Identified"/>
Surveyor Name:	<input type="text" value="J D Chilvers"/>	Quantity:	<input type="text"/>

Material Risk Score	<input type="text" value="0"/>
Material Risk Band:	<input type="text" value="NADIS"/>
Priority Risk Score:	<input type="text" value="N/A"/>

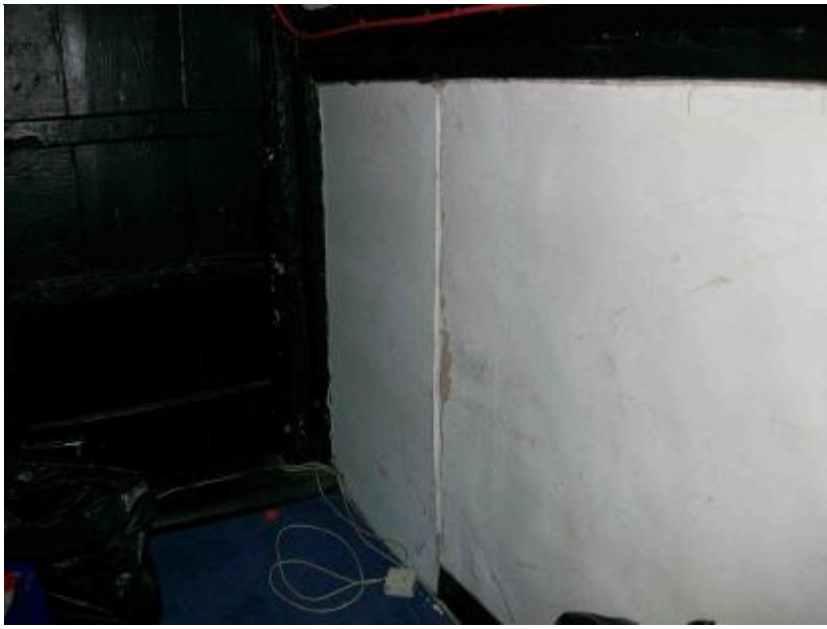
Location ID:	11977	Survey Type:	T 2
Location Ref:	15	Product Type:	NADIS
Product:	Heat Shield	Damage:	NADIS
Area:	Not Applicable	Treatment:	NADIS
Floor:	First floor	Asbestos Type:	NADIS
Room:	Store cupboard	Identification:	Identified
Surveyor Name:	J D Chilvers	Quantity:	
Drawing Ref:	14	Accessibility:	
Asbestos ?	No		
Date:	18 November 2009		
Next Inspection:	Not Applicable

Material Risk Score	0
Material Risk Band:	NADIS
Priority Risk Score:	N/A

Material Comments:	Area between staff flat and managers flat
--------------------	---

Action:	No Action Required
---------	--------------------

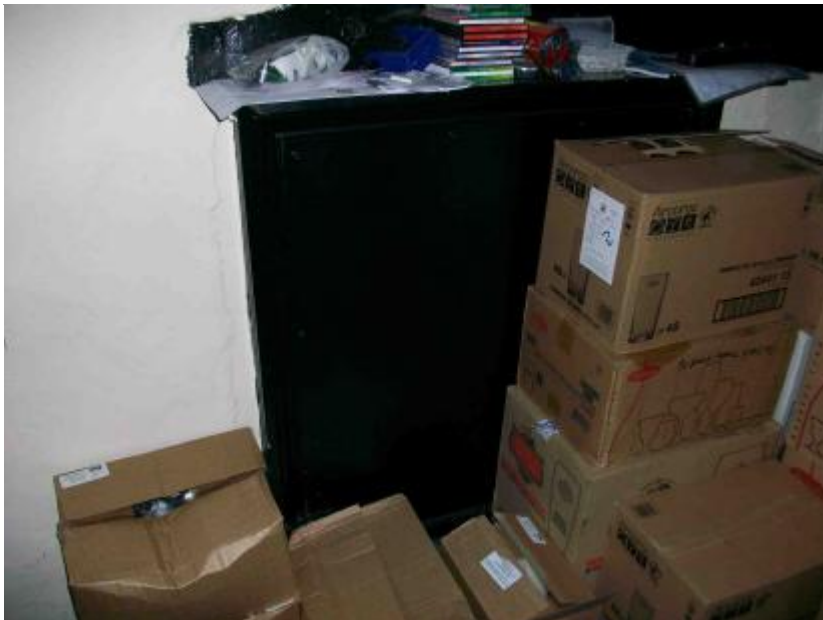
Location ID:	<input type="text" value="11978"/>	Survey Type:	<input type="text" value="T 2"/>
Location Ref:	<input type="text" value="16"/>	Product Type:	<input type="text" value="Asbestos Insulating Board"/>
Product:	<input type="text" value="Fireplace cladding"/>	Damage:	<input type="text" value="No visible damage"/>
Area:	<input type="text" value="Not Applicable"/>	Treatment:	<input type="text" value="AIB painted or encapsulated"/>
Floor:	<input type="text" value="First floor"/>	Asbestos Type:	<input type="text" value="Amosite"/>
Room:	<input type="text" value="Store Room"/>	Identification:	<input type="text" value="Presumed"/>
Surveyor Name:	<input type="text" value="J D Chilvers"/>	Quantity:	<input type="text"/>

Material Risk Score	<input type="text" value="5"/>
Material Risk Band:	<input type="text" value="Low Risk"/>
Priority Risk Score:	<input type="text" value="3"/>

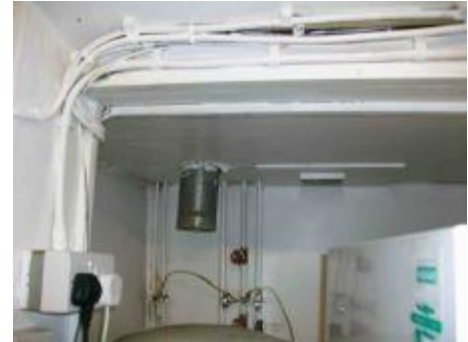
Location ID:	11965
Location Ref:	3
Product:	Flue
Area:	Not Applicable
Floor:	Ground floor
Room:	Kitchen
Surveyor Name:	J D Chilvers
Drawing Ref:	3
Asbestos ?	Yes
Date:	18 November 2009

Priority Assessment Algorithm	Variable(s) selected	Score for each	Overall score
<b>Normal Occupant Activity:</b>			
Main type of activity in area:	Low disturbance	1	average 1
Secondary activities for area:	Rare disturbance	0	
<b>Likelihood Of Disturbance:</b>			
Location:	Large rooms or well-ventilated areas	1	average 0
Accessibility:	Usually inaccessible or unlikely to be disturbed	0	
Extent/Amount:	Small items strings gaskets	0	
<b>Human Exposure Potential:</b>			
Number of occupants:	1 to 3	1	average 2
Frequency of use of area:	Daily	3	
Average time area is in use:	>1 to <3 hours	1	
<b>Maintenance Activity:</b>			
Type of maintenance activity:	Minor disturbance	0	average 1
Frequency of maintenance activity	<=1 per year	1

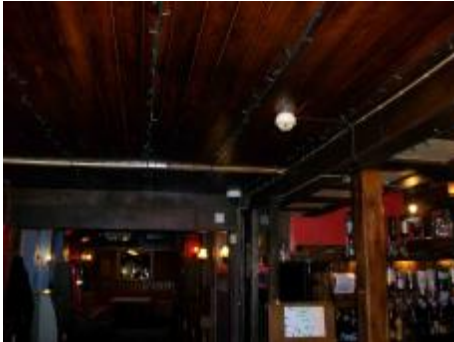
Location ID:	11968
Location Ref:	6
Product:	Beam cladding
Area:	Not Applicable
Floor:	Ground floor
Room:	Bar area
Surveyor Name:	J D Chilvers
Drawing Ref:	6
Asbestos ?	Yes
Date:	18 November 2009

Priority Assessment Algorithm	Variable(s) selected	Score for each	Overall score
<b>Normal Occupant Activity:</b>			
Main type of activity in area:	Low disturbance	1	average 1
Secondary activities for area:	Rare disturbance	0	
<b>Likelihood Of Disturbance:</b>			
Location:	Large rooms or well-ventilated areas	1	average 1
Accessibility:	Usually inaccessible or unlikely to be disturbed	0	
Extent/Amount:	<=10 m2 or <=10 m pipe run	1	
<b>Human Exposure Potential:</b>			
Number of occupants:	>10	3	average 3
Frequency of use of area:	Daily	3	
Average time area is in use:	>3 to <6 hours	2	
<b>Maintenance Activity:</b>			
Type of maintenance activity:	Minor disturbance	0	average 0
Frequency of maintenance activity	Unlikely to be disturbed	0

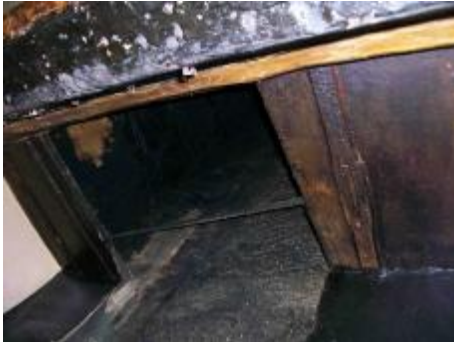
Location ID:	<input style="width: 85%;" type="text" value="11969"/>
Location Ref:	<input style="width: 85%;" type="text" value="7"/>
Product:	<input style="width: 85%;" type="text" value="Register Plate"/>
Area:	<input style="width: 85%;" type="text" value="Not Applicable"/>
Floor:	<input style="width: 85%;" type="text" value="Ground floor"/>
Room:	<input style="width: 85%;" type="text" value="Bar area"/>
Surveyor Name:	<input style="width: 85%;" type="text" value="J D Chilvers"/>
Drawing Ref:	<input style="width: 85%;" type="text" value="7"/>
Asbestos ?	<input style="width: 85%;" type="text" value="Yes"/>
Date:	<input style="width: 85%;" type="text" value="18 November 2009"/>

Priority Assessment Algorithm	Variable(s) selected	Score for each	Overall score
<b>Normal Occupant Activity:</b>			
Main type of activity in area:	Low disturbance	1	average 1
Secondary activities for area:	Rare disturbance	0	
<b>Likelihood Of Disturbance:</b>			
Location:	Large rooms or well-ventilated areas	1	average 1
Accessibility:	Usually inaccessible or unlikely to be disturbed	0	
Extent/Amount:	<=10 m2 or <=10 m pipe run	1	
<b>Human Exposure Potential:</b>			
Number of occupants:	>10	3	average 3
Frequency of use of area:	Daily	3	
Average time area is in use:	>3 to <6 hours	2	
<b>Maintenance Activity:</b>			
Type of maintenance activity:	Minor disturbance	0	average 0
Frequency of maintenance activity	Unlikely to be disturbed	0

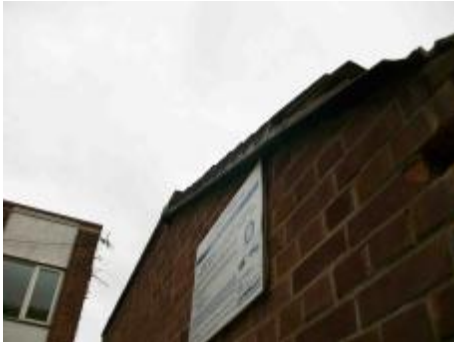
Location ID:	<input style="width: 95%;" type="text" value="11971"/>
Location Ref:	<input style="width: 95%;" type="text" value="9"/>
Product:	<input style="width: 95%;" type="text" value="Verge Undercloak"/>
Area:	<input style="width: 95%;" type="text" value="Not Applicable"/>
Floor:	<input style="width: 95%;" type="text" value="Roof level"/>
Room:	<input style="width: 95%;" type="text" value="External"/>
Surveyor Name:	<input style="width: 95%;" type="text" value="J D Chilvers"/>
Drawing Ref:	<input style="width: 95%;" type="text" value="9"/>
Asbestos ?	<input style="width: 95%;" type="text" value="Yes"/>
Date:	<input style="width: 95%;" type="text" value="18 November 2009"/>

Priority Assessment Algorithm			
Assessment factor	Variable(s) selected	Score for each	Overall score
<b>Normal Occupant Activity:</b>			
Main type of activity in area:	Rare disturbance	0	average
Secondary activities for area:	Rare disturbance	0	0
<b>Likelihood Of Disturbance:</b>			
Location:	Outdoors	0	
Accessibility:	Usually inaccessible or unlikely to be disturbed	0	average
Extent/Amount:	<=10 m2 or <=10 m pipe run	1	0
<b>Human Exposure Potential:</b>			
Number of occupants:	1 to 3	1	
Frequency of use of area:	Daily	3	average
Average time area is in use:	<1 hour	0	1
<b>Maintenance Activity:</b>			
Type of maintenance activity:	Minor disturbance	0	average
Frequency of maintenance activity	Unlikely to be disturbed	0	0

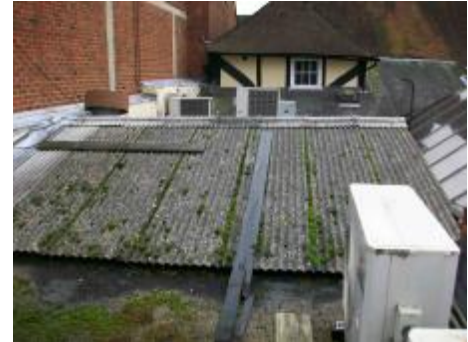
Location ID:	11972
Location Ref:	10
Product:	Roofing Sheets
Area:	Not Applicable
Floor:	Roof level
Room:	External
Surveyor Name:	J D Chilvers
Drawing Ref:	10
Asbestos ?	No
Date:	18 November 2009

Priority Assessment Algorithm	Variable(s) selected	Score for each	Overall score
<b>Normal Occupant Activity:</b>			
Main type of activity in area:	Rare disturbance	0	average
Secondary activities for area:	Rare disturbance	0	0
<b>Likelihood Of Disturbance:</b>			
Location:	Outdoors	0	
Accessibility:	Usually inaccessible or unlikely to be disturbed	0	average
Extent/Amount:	<=10 m2 or <=10 m pipe run	1	0
<b>Human Exposure Potential:</b>			
Number of occupants:	1 to 3	1	
Frequency of use of area:	Daily	3	average
Average time area is in use:	<1 hour	0	1
<b>Maintenance Activity:</b>			
Type of maintenance activity:	Minor disturbance	0	average
Frequency of maintenance activity	Unlikely to be disturbed	0	0

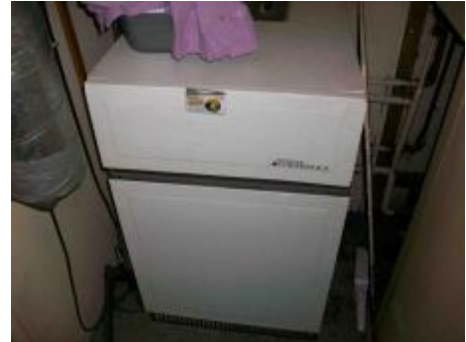
Location ID:	11975
Location Ref:	13
Product:	Boiler
Area:	Not Applicable
Floor:	First floor
Room:	Boiler cupboard
Surveyor Name:	J D Chilvers
Drawing Ref:	13
Asbestos ?	Yes
Date:	18 November 2009

Priority Assessment Algorithm			
Assessment factor	Variable(s) selected	Score for each	Overall score
<b>Normal Occupant Activity:</b>			
Main type of activity in area:	Low disturbance	1	average 1
Secondary activities for area:	Rare disturbance	0	
<b>Likelihood Of Disturbance:</b>			
Location:	Rooms up to 100 m2	2	average 1
Accessibility:	Usually inaccessible or unlikely to be disturbed	0	
Extent/Amount:	Small items strings gaskets	0	
<b>Human Exposure Potential:</b>			
Number of occupants:	1 to 3	1	average 1
Frequency of use of area:	Daily	3	
Average time area is in use:	<1 hour	0	
<b>Maintenance Activity:</b>			
Type of maintenance activity:	Minor disturbance	0	average 1
Frequency of maintenance activity	<=1 per year	1

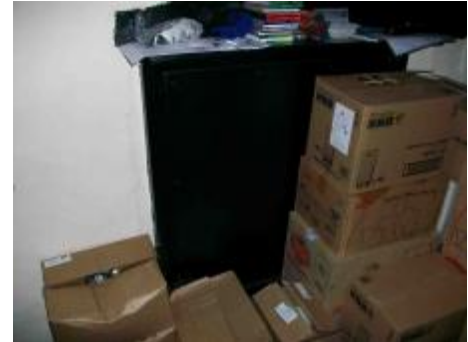
Location ID:	11978
Location Ref:	16
Product:	Fireplace cladding
Area:	Not Applicable
Floor:	First floor
Room:	Store Room
Surveyor Name:	J D Chilvers
Drawing Ref:	16
Asbestos ?	Yes
Date:	18 November 2009

Priority Assessment Algorithm			
Assessment factor	Variable(s) selected	Score for each	Overall score
<b>Normal Occupant Activity:</b>			
Main type of activity in area:	Rare disturbance	0	average
Secondary activities for area:	Rare disturbance	0	0
<b>Likelihood Of Disturbance:</b>			
Location:	Rooms up to 100 m2	2	
Accessibility:	Usually inaccessible or unlikely to be disturbed	0	average
Extent/Amount:	<=10 m2 or <=10 m pipe run	1	1
<b>Human Exposure Potential:</b>			
Number of occupants:	1 to 3	1	
Frequency of use of area:	Daily	3	average
Average time area is in use:	<1 hour	0	1
<b>Maintenance Activity:</b>			
Type of maintenance activity:	Minor disturbance	0	average
Frequency of maintenance activity	<=1 per year	1	1
