# **Asbestos Survey for**

Hall & Woodhouse Ltd

Wheatsheaf (Midhurst)

Project Number: AS05070 - Wheatsheaf Midhurst

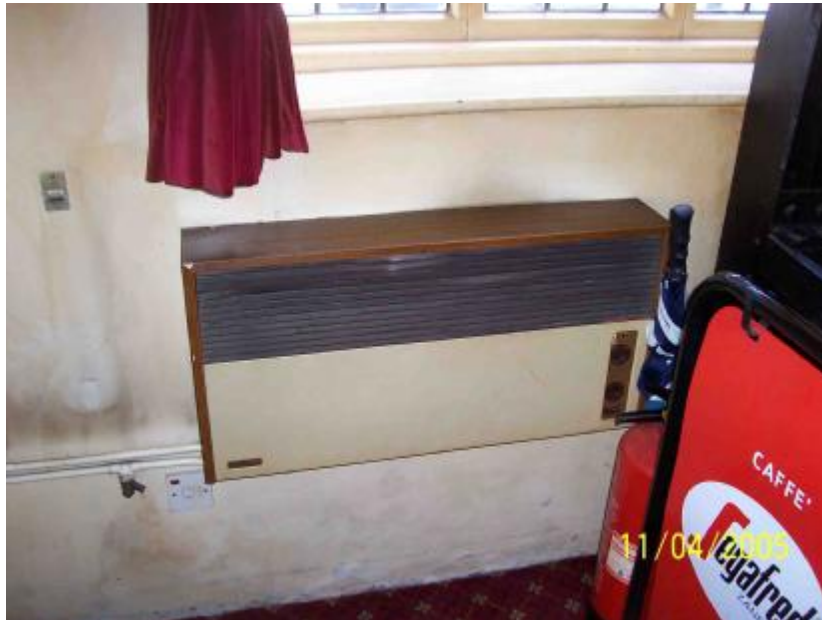
Location ID:	<input type="text" value="3143"/>	Survey Type:	<input type="text" value="T 2"/>
Location Ref:	<input type="text" value="1"/>	Product Type:	<input type="text" value="Asbestos cement"/>
Product:	<input type="text" value="Heater"/>	Damage:	<input type="text" value="No visible damage"/>
Area:	<input type="text" value="Not Applicable"/>	Treatment:	<input type="text" value="Asbestos cement sheets etc"/>
Floor:	<input type="text" value="Ground floor"/>	Asbestos Type:	<input type="text" value="Chrysotile"/>
Room:	<input type="text" value="Bar area"/>	Identification:	<input type="text" value="Presumed"/>
Surveyor Name:	<input type="text" value="J D Chilvers"/>	Quantity:	<input type="text"/>

Material Risk Score	<input type="text" value="3"/>
Material Risk Band:	<input type="text" value="Very Low Risk"/>
Priority Risk Score:	<input type="text" value="5"/>

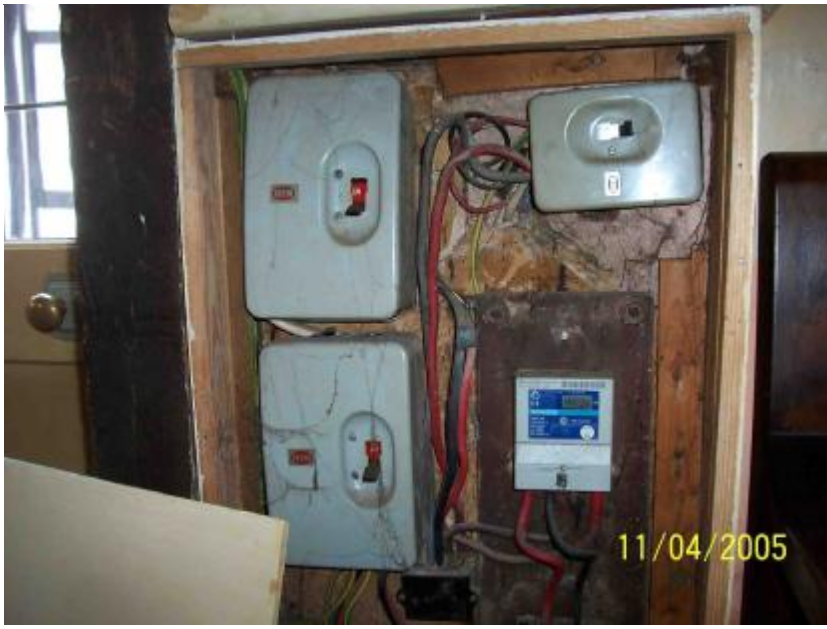
<b>Location ID:</b>	<input style="width: 95%;" type="text" value="3144"/>	<b>Survey Type:</b>	<input style="width: 95%;" type="text" value="T 2"/>						
<b>Location Ref:</b>	<input style="width: 95%;" type="text" value="2"/>	<b>Product Type:</b>	<input style="width: 95%;" type="text" value="Ropes and woven textiles"/>						
<b>Product:</b>	<input style="width: 95%;" type="text" value="Fuse &amp; Switchgear Flashguard"/>	<b>Damage:</b>	<input style="width: 95%;" type="text" value="No visible damage"/>						
<b>Area:</b>	<input style="width: 95%;" type="text" value="Not Applicable"/>	<b>Treatment:</b>	<input style="width: 95%;" type="text" value="Composite asbestos materials"/>						
<b>Floor:</b>	<input style="width: 95%;" type="text" value="Ground floor"/>	<b>Asbestos Type:</b>	<input style="width: 95%;" type="text" value="Chrysotile"/>						
<b>Room:</b>	<input style="width: 95%;" type="text" value="Bar area"/>	<b>Identification:</b>	<input style="width: 95%;" type="text" value="Presumed"/>						
<b>Surveyor Name:</b>	<input style="width: 95%;" type="text" value="J D Chilvers"/>	<b>Quantity:</b>	<input style="width: 95%;" type="text"/>						
<b>Drawing Ref:</b>	<input style="width: 95%;" type="text" value="2"/>	<b>Accessibility:</b>	<input style="width: 95%;" type="text" value="Medium Accessibility"/>						
<b>Asbestos ?</b>	<input style="width: 95%;" type="text" value="Yes"/>

<b>Material Risk Score</b>	<input style="width: 20%;" type="text" value="3"/>	<b>Material Risk Band:</b>	<input style="width: 20%;" type="text" value="Very Low Risk"/>	<b>Priority Risk Score:</b>	<input style="width: 20%;" type="text" value="3"/>
<b>Material Risk Score</b>	<input style="width: 20%;" type="text" value="3"/>								
<b>Material Risk Band:</b>	<input style="width: 20%;" type="text" value="Very Low Risk"/>								
<b>Priority Risk Score:</b>	<input style="width: 20%;" type="text" value="3"/>								
<b>Date:</b>	<input style="width: 95%;" type="text" value="11 April 2005"/>								
<b>Next Inspection:</b>	<input style="width: 95%;" type="text" value="11 April 2006"/>

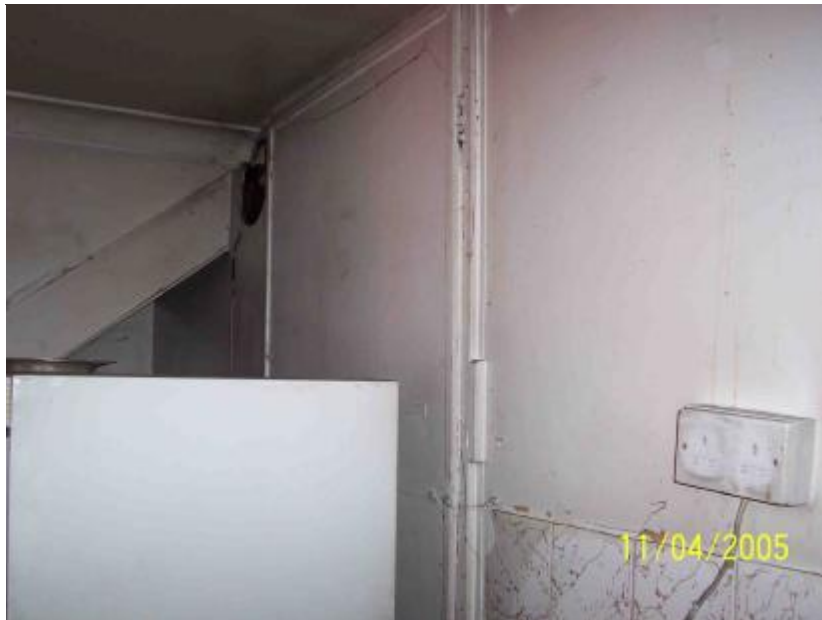
Material Risk Score	<input type="text" value="7"/>	Material Risk Band:	<input type="text" value="Medium Risk"/>	Priority Risk Score:	<input type="text" value="6"/>
Material Risk Score	<input type="text" value="7"/>								
Material Risk Band:	<input type="text" value="Medium Risk"/>								
Priority Risk Score:	<input type="text" value="6"/>								
Date:	<input type="text" value="11 April 2005"/>								
Next Inspection:	<input type="text" value="10 July 2005"/>

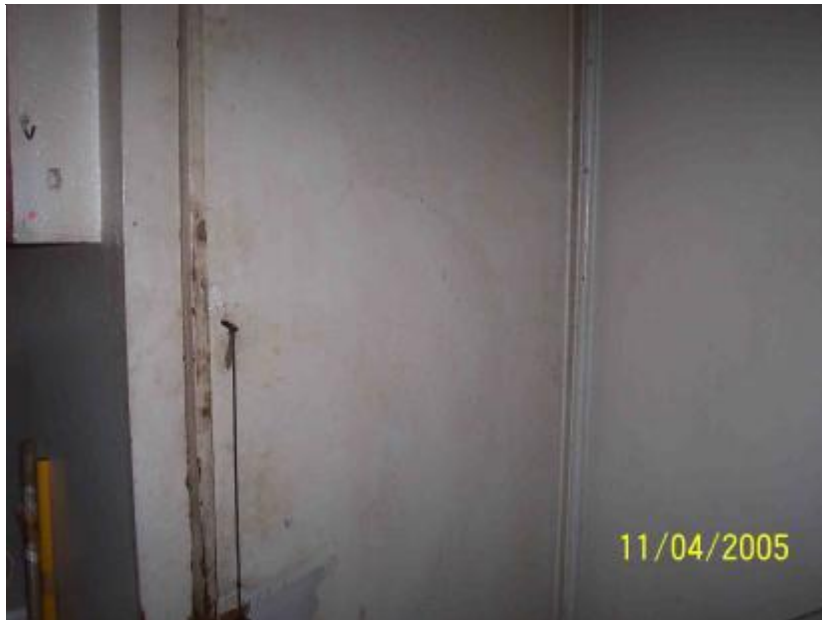
Material Risk Score	8
Material Risk Band:	Medium Risk
Priority Risk Score:	6

Material Comments: Removal required as area is due for refurbishment.

Action: Removal

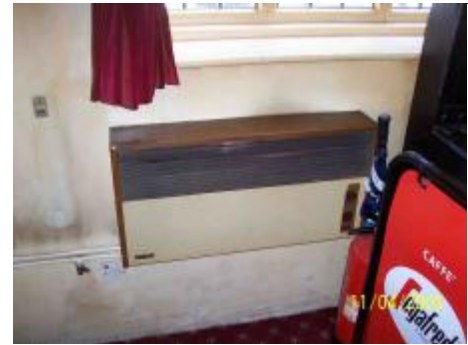
Location ID:	3143
Location Ref:	1
Product:	Heater
Area:	Not Applicable
Floor:	Ground floor
Room:	Bar area
Surveyor Name:	J D Chilvers
Drawing Ref:	1
Asbestos ?	Yes
Date:	11 April 2005

Priority Assessment Algorithm	Variable(s) selected	Score for each	Overall score
<b>Normal Occupant Activity:</b>			
Main type of activity in area:	Low disturbance	1	average
Secondary activities for area:	Low disturbance	1	1
<b>Likelihood Of Disturbance:</b>			
Location:	Large rooms or well-ventilated areas	1	average
Accessibility:	Usually inaccessible or unlikely to be disturbed	0	
Extent/Amount:	<=10 m2 or <=10 m pipe run	1	
<b>Human Exposure Potential:</b>			
Number of occupants:	>10	3	average
Frequency of use of area:	Daily	3	
Average time area is in use:	>1 to <3 hours	1	
<b>Maintenance Activity:</b>			
Type of maintenance activity:	Low disturbance	1	average
Frequency of maintenance activity	<=1 per year	1	1

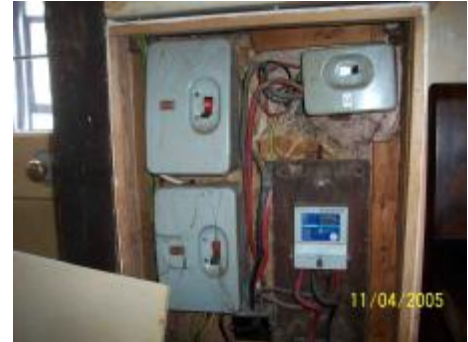
Location ID:	3144
Location Ref:	2
Product:	Fuse & Switchgear Flashguard
Area:	Not Applicable
Floor:	Ground floor
Room:	Bar area
Surveyor Name:	J D Chilvers
Drawing Ref:	2
Asbestos ?	Yes
Date:	11 April 2005

Priority Assessment Algorithm			
Assessment factor	Variable(s) selected	Score for each	Overall score
<b>Normal Occupant Activity:</b>			
Main type of activity in area:	Rare disturbance	0	average
Secondary activities for area:	Rare disturbance	0	0
<b>Likelihood Of Disturbance:</b>			
Location:	Large rooms or well-ventilated areas	1	
Accessibility:	Occasionally likely to be disturbed	1	average
Extent/Amount:	Small items strings gaskets	0	1
<b>Human Exposure Potential:</b>			
Number of occupants:	1 to 3	1	
Frequency of use of area:	Monthly	1	average
Average time area is in use:	<1 hour	0	1
<b>Maintenance Activity:</b>			
Type of maintenance activity:	Low disturbance	1	average
Frequency of maintenance activity	<=1 per year	1	1

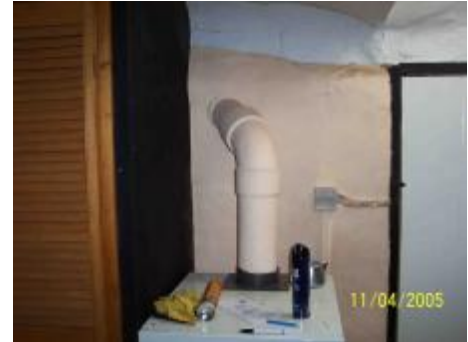
Location ID:	3156
Location Ref:	14
Product:	Flue
Area:	Not Applicable
Floor:	First floor
Room:	Boiler room
Surveyor Name:	J D Chilvers
Drawing Ref:	13
Asbestos ?	Yes
Date:	11 April 2005

Priority Assessment Algorithm	Variable(s) selected	Score for each	Overall score
<b>Normal Occupant Activity:</b>			
Main type of activity in area:	Rare disturbance	0	average
Secondary activities for area:	Rare disturbance	0	0
<b>Likelihood Of Disturbance:</b>			
Location:	Rooms up to 100 m2	2	average
Accessibility:	Occasionally likely to be disturbed	1	
Extent/Amount:	<=10 m2 or <=10 m pipe run	1	
<b>Human Exposure Potential:</b>			
Number of occupants:	1 to 3	1	average
Frequency of use of area:	Monthly	1	
Average time area is in use:	<1 hour	0	
<b>Maintenance Activity:</b>			
Type of maintenance activity:	Minor disturbance	0	average
Frequency of maintenance activity	Unlikely to be disturbed	0	0

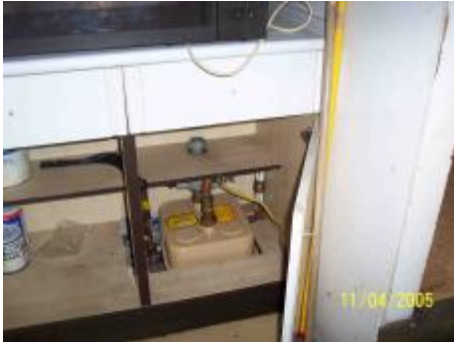
Location ID:	3158
Location Ref:	16
Product:	Gas meter
Area:	Not Applicable
Floor:	Ground floor
Room:	Kitchen
Surveyor Name:	J D Chilvers
Drawing Ref:	16
Asbestos ?	Yes
Date:	11 April 2005

Priority Assessment Algorithm	Variable(s) selected	Score for each	Overall score
<b>Normal Occupant Activity:</b>			
Main type of activity in area:	Rare disturbance	0	average
Secondary activities for area:	Rare disturbance	0	0
<b>Likelihood Of Disturbance:</b>			
Location:	Rooms up to 100 m2	2	average
Accessibility:	Usually inaccessible or unlikely to be disturbed	0	
Extent/Amount:	Small items strings gaskets	0	
<b>Human Exposure Potential:</b>			
Number of occupants:	1 to 3	1	average
Frequency of use of area:	Monthly	1	
Average time area is in use:	<1 hour	0	
<b>Maintenance Activity:</b>			
Type of maintenance activity:	Minor disturbance	0	average
Frequency of maintenance activity	Unlikely to be disturbed	0	0

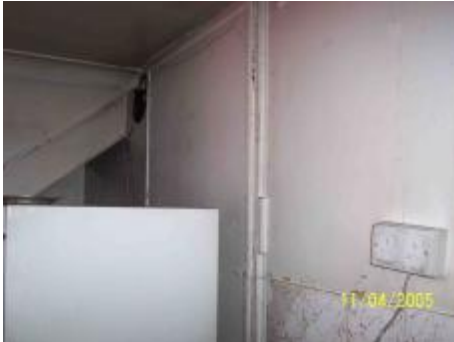
Location ID:	3159
Location Ref:	17
Product:	Door panel
Area:	Not Applicable
Floor:	Ground floor
Room:	Kitchen
Surveyor Name:	J D Chilvers
Drawing Ref:	17
Asbestos ?	Yes
Date:	11 April 2005

Priority Assessment Algorithm	Variable(s) selected	Score for each	Overall score
<b>Normal Occupant Activity:</b>			
Main type of activity in area:	Low disturbance	1	average
Secondary activities for area:	Low disturbance	1	1
<b>Likelihood Of Disturbance:</b>			
Location:	Rooms up to 100 m2	2	average
Accessibility:	Easily disturbed	2	
Extent/Amount:	<=10 m2 or <=10 m pipe run	1	
<b>Human Exposure Potential:</b>			
Number of occupants:	1 to 3	1	average
Frequency of use of area:	Daily	3	
Average time area is in use:	>3 to <6 hours	2	
<b>Maintenance Activity:</b>			
Type of maintenance activity:	Low disturbance	1	average
Frequency of maintenance activity	<=1 per year	1	1

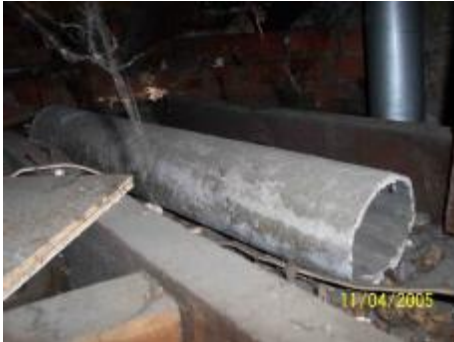
Location ID:	3164
Location Ref:	22
Product:	Flue pipe
Area:	Not Applicable
Floor:	Roof level
Room:	Loft space
Surveyor Name:	J D Chilvers
Drawing Ref:	21
Asbestos ?	Yes
Date:	11 April 2005

Priority Assessment Algorithm	Variable(s) selected	Score for each	Overall score
<b>Normal Occupant Activity:</b>			
Main type of activity in area:	Rare disturbance	0	average
Secondary activities for area:	Rare disturbance	0	0
<b>Likelihood Of Disturbance:</b>			
Location:	Confined spaces	3	average
Accessibility:	Usually inaccessible or unlikely to be disturbed	0	
Extent/Amount:	<=10 m2 or <=10 m pipe run	1	
<b>Human Exposure Potential:</b>			
Number of occupants:	1 to 3	1	average
Frequency of use of area:	Infrequent	0	
Average time area is in use:	<1 hour	0	
<b>Maintenance Activity:</b>			
Type of maintenance activity:	Minor disturbance	0	average
Frequency of maintenance activity	Unlikely to be disturbed	0	0

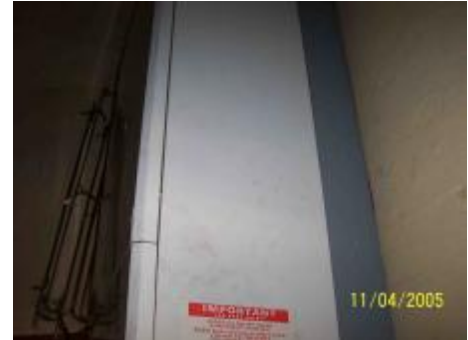
Location ID:	3165
Location Ref:	23
Product:	Boiler
Area:	Not Applicable
Floor:	Ground floor
Room:	Boiler room
Surveyor Name:	J D Chilvers
Drawing Ref:	22
Asbestos ?	Yes
Date:	11 April 2005

Priority Assessment Algorithm	Variable(s) selected	Score for each	Overall score
<b>Normal Occupant Activity:</b>			
Main type of activity in area:	Rare disturbance	0	average
Secondary activities for area:	Rare disturbance	0	0
<b>Likelihood Of Disturbance:</b>			
Location:	Rooms up to 100 m2	2	average
Accessibility:	Occasionally likely to be disturbed	1	
Extent/Amount:	Small items strings gaskets	0	
<b>Human Exposure Potential:</b>			
Number of occupants:	1 to 3	1	average
Frequency of use of area:	Monthly	1	
Average time area is in use:	<1 hour	0	
<b>Maintenance Activity:</b>			
Type of maintenance activity:	Low disturbance	1	average
Frequency of maintenance activity	Unlikely to be disturbed	0	1

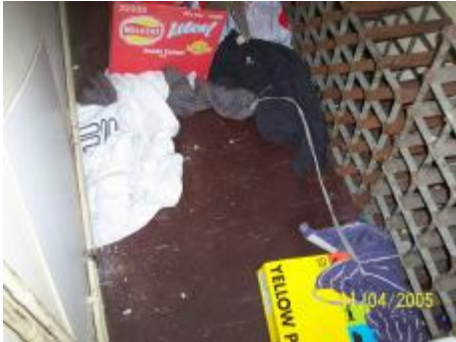
Location ID:	3169
Location Ref:	27
Product:	Floor tiles
Area:	Not Applicable
Floor:	Ground floor
Room:	Understair Cupboard
Surveyor Name:	J D Chilvers
Drawing Ref:	26
Asbestos ?	Yes
Date:	11 April 2005

Priority Assessment Algorithm	Variable(s) selected	Score for each	Overall score
<b>Normal Occupant Activity:</b>			
Main type of activity in area:	Low disturbance	1	average
Secondary activities for area:	Low disturbance	1	1
<b>Likelihood Of Disturbance:</b>			
Location:	Rooms up to 100 m2	2	
Accessibility:	Occasionally likely to be disturbed	1	average
Extent/Amount:	<=10 m2 or <=10 m pipe run	1	1
<b>Human Exposure Potential:</b>			
Number of occupants:	1 to 3	1	
Frequency of use of area:	Daily	3	average
Average time area is in use:	<1 hour	0	1
<b>Maintenance Activity:</b>			
Type of maintenance activity:	Minor disturbance	0	average
Frequency of maintenance activity	Unlikely to be disturbed	0	0
