Asbestos Survey for

Hall & Woodhouse Ltd

The Stag
Balls Cross
Petworth
West Sussex
GU28 9JP

Project Number: AS08002 - The Stag

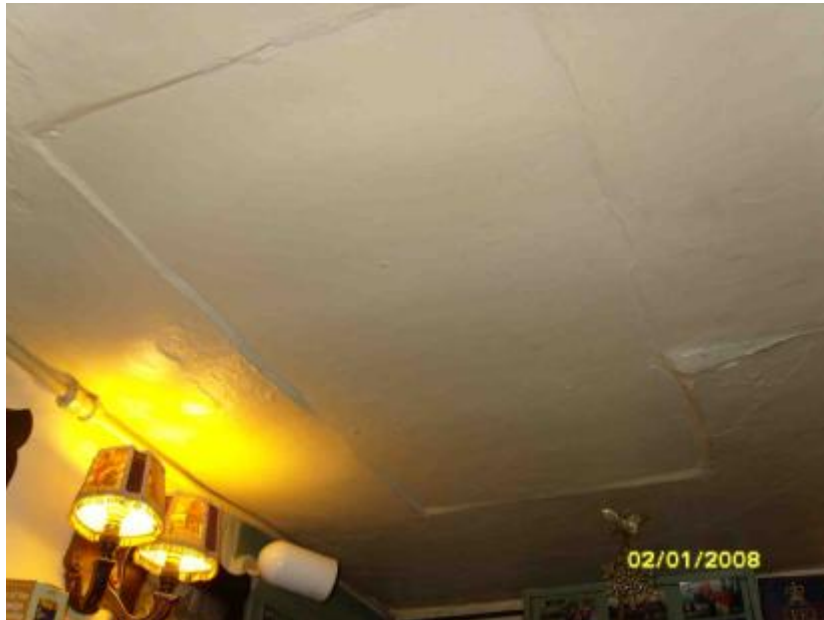
| Location Ref: | <input type="text" value="1"/> | Product Type: | <input type="text" value="Asbestos cement"/> |

| Product: | <input type="text" value="Panel"/> | Damage: | <input type="text" value="No visible damage"/> |
| Floor: | <input type="text" value="Ground floor"/> | Asbestos Type: | <input type="text" value="Chrysotile"/> |
| Room: | <input type="text" value="Bar area"/> | Identification: | <input type="text" value="Strongly Presumed"/> |

| Material Risk Band: | <input type="text" value="Very Low Risk"/> |

| Action: | <input type="text" value="Apply Warning Labels"/> |

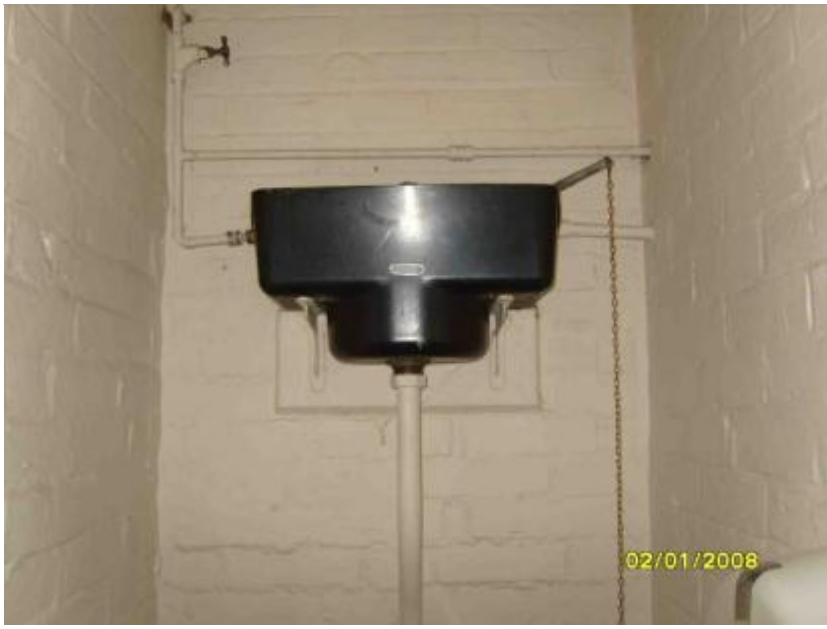
| Location Ref: | <input type="text" value="2"/> | Product Type: | <input type="text" value="Plastics"/> |

| Product: | <input type="text" value="Cistern / Toilet seat"/> | Damage: | <input type="text" value="No visible damage"/> |
| Floor: | <input type="text" value="Ground floor"/> | Asbestos Type: | <input type="text" value="Amosite"/> |
| Room: | <input type="text" value="WC - mens"/> | Identification: | <input type="text" value="Presumed"/> |

| Material Risk Band: | <input type="text" value="Very Low Risk"/> |

| Action: | <input type="text" value="Apply Warning Labels"/> |

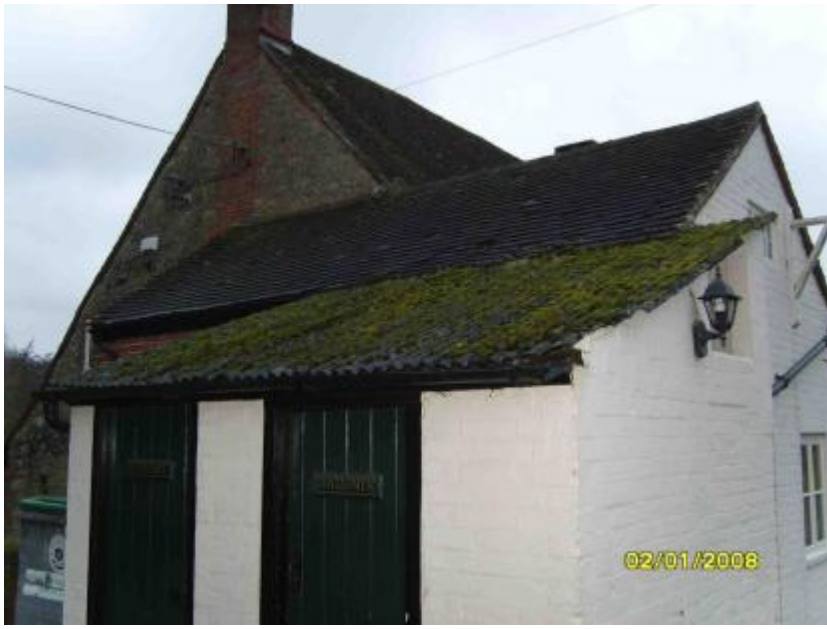
| Location Ref: | <input type="text" value="3"/> | Product Type: | <input type="text" value="Asbestos cement"/> |

| Product: | <input type="text" value="Roof sheets"/> | Damage: | <input type="text" value="Low damage: Scratches or marks"/> |
| Floor: | <input type="text" value="Roof level"/> | Asbestos Type: | <input type="text" value="Chrysotile"/> |
| Room: | <input type="text" value="External"/> | Identification: | <input type="text" value="Identified"/> |

| Action: | <input type="text" value="No Action Required"/> |

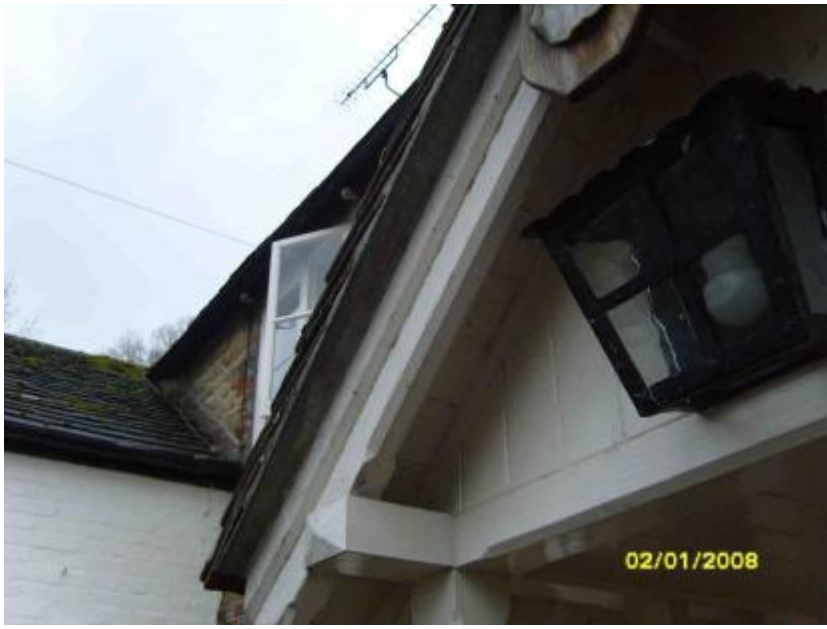
| Product: | Verge Undercloak | Damage: | Low damage: Scratches or marks |

| Action: | No Action Required |

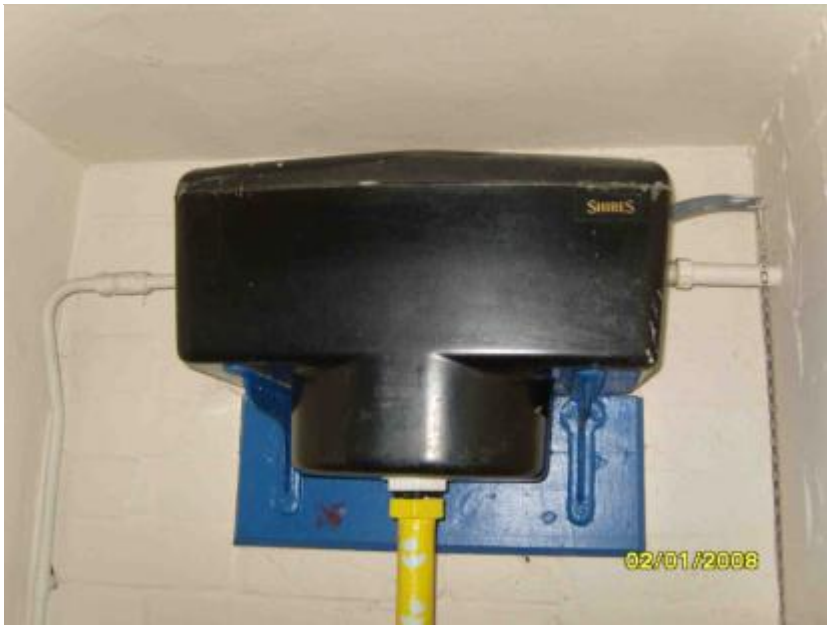
| Product: | <input type="text" value="Cistern / Toilet seat"/> | Damage: | <input type="text" value="No visible damage"/> |

| Action: | <input type="text" value="Apply Warning Labels"/> |

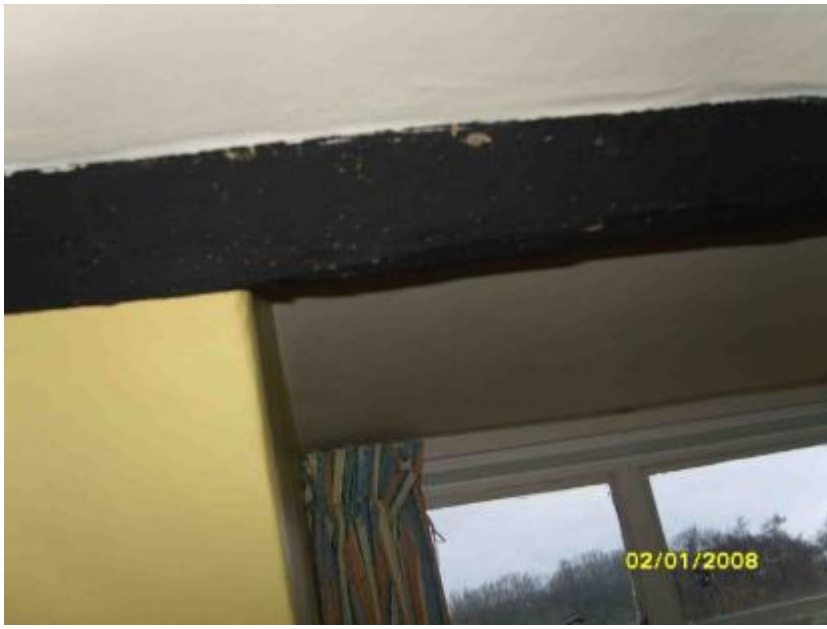
| Product: | <input type="text" value="Soffit"/> | Damage: | <input type="text" value="No visible damage"/> |

| Action: | <input type="text" value="Apply Warning Labels"/> |
