# **Asbestos Survey for**

Hall & Woodhouse Ltd

Stour Inn  
Blandford St Mary  
Blandford  
Dorset  
DT11 9ND

Project Number: AS05042 - Stour Inn

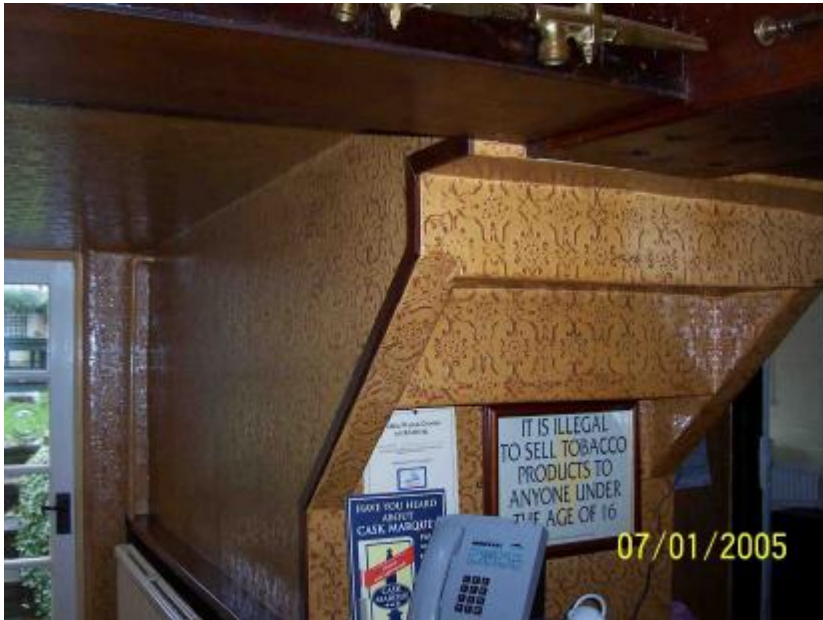
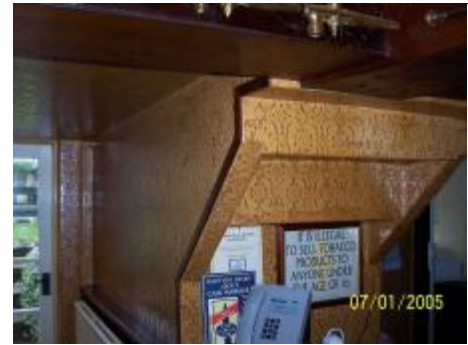
Location ID:	<input style="width: 95%;" type="text" value="2847"/>	Survey Type:	<input style="width: 95%;" type="text" value="T 2"/>
Location Ref:	<input style="width: 95%;" type="text" value="1"/>	Product Type:	<input style="width: 95%;" type="text" value="Asbestos Insulating Board"/>
Product:	<input style="width: 95%;" type="text" value="Stair Backing / Cladding"/>	Damage:	<input style="width: 95%;" type="text" value="No visible damage"/>
Area:	<input style="width: 95%;" type="text" value="Not Applicable"/>	Treatment:	<input style="width: 95%;" type="text" value="AIB painted or encapsulated"/>
Floor:	<input style="width: 95%;" type="text" value="Ground floor"/>	Asbestos Type:	<input style="width: 95%;" type="text" value="Amosite"/>
Room:	<input style="width: 95%;" type="text" value="Bar area"/>	Identification:	<input style="width: 95%;" type="text" value="Presumed"/>
Surveyor Name:	<input style="width: 95%;" type="text" value="J D Chilvers"/>	Quantity:	<input style="width: 95%;" type="text"/>

Material Risk Score	<input style="width: 95%;" type="text" value="5"/>
Material Risk Band:	<input style="width: 95%;" type="text" value="Low Risk"/>
Priority Risk Score:	<input style="width: 95%;" type="text" value="5"/>

Location ID:	2847
Location Ref:	1
Product:	Stair Backing / Cladding
Area:	Not Applicable
Floor:	Ground floor
Room:	Bar area
Surveyor Name:	J D Chilvers
Drawing Ref:	1
Asbestos ?	Yes
Date:	07 January 2005

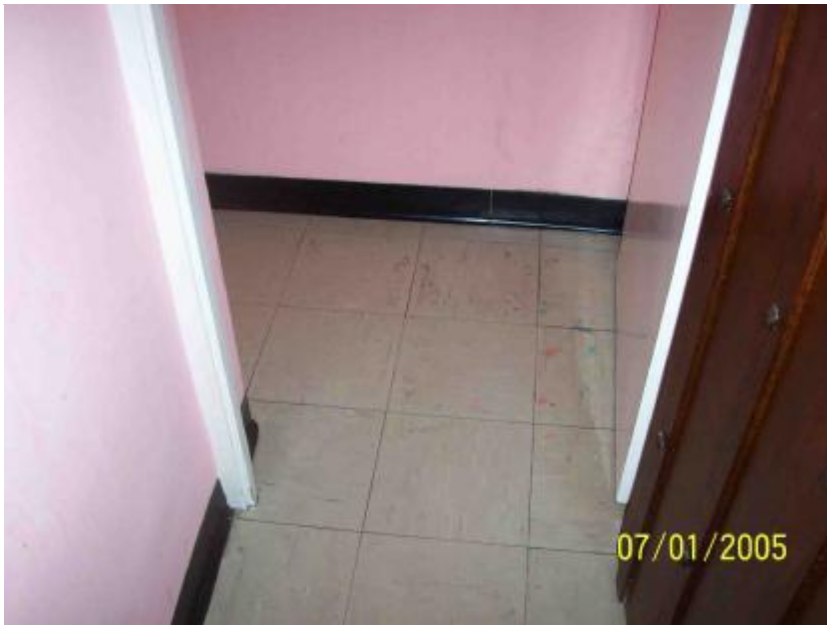
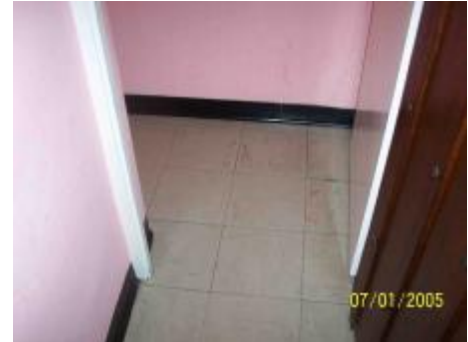
Location ID:	2848	Survey Type:	T 2
Location Ref:	2	Product Type:	Vinyl floor tiles
Product:	Floor tiles	Damage:	Low damage: Scratches or marks
Area:	Not Applicable	Treatment:	Vinyl tiles
Floor:	Ground floor	Asbestos Type:	Chrysotile
Room:	WC - ladies	Identification:	Presumed
Surveyor Name:	J D Chilvers	Quantity:	
Drawing Ref:	2	Accessibility:	Easy Accessibility
Asbestos ?	Yes		
Date:	07 January 2005	Material Risk Score:	3
Next Inspection:	07 January 2006	Material Risk Band:	Very Low Risk
		Priority Risk Score:	4

Location ID:	2848
Location Ref:	2
Product:	Floor tiles
Area:	Not Applicable
Floor:	Ground floor
Room:	WC - ladies
Surveyor Name:	J D Chilvers
Drawing Ref:	2
Asbestos ?	Yes
Date:	07 January 2005

Action:	No Action Required
---------	--------------------

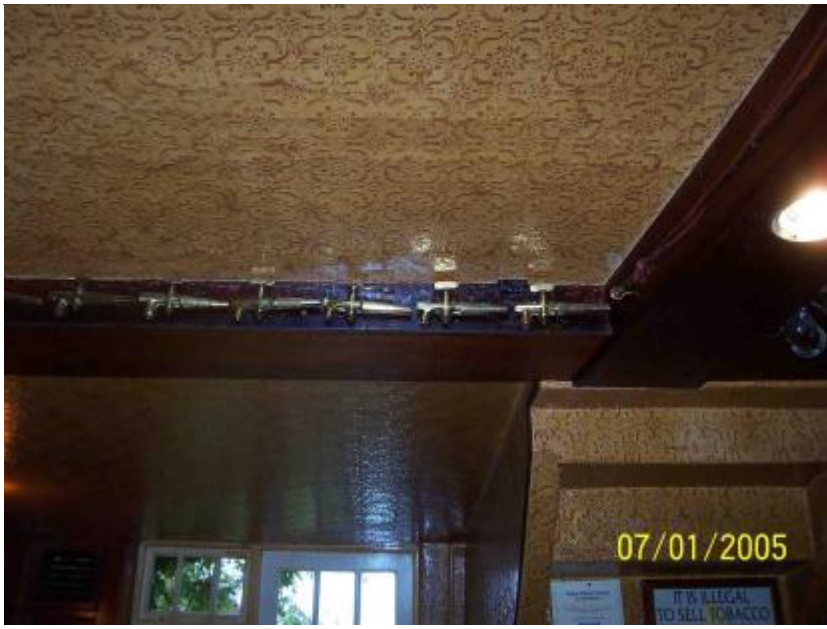
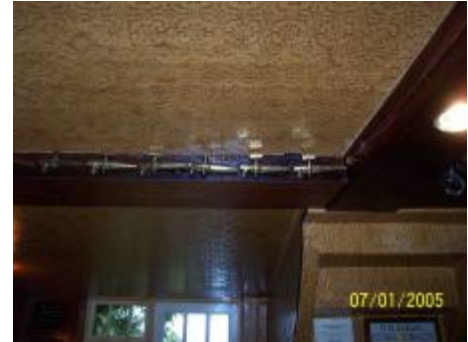
Location ID:	2849	Survey Type:	T 2
Location Ref:	3	Product Type:	Asbestos Insulating Board
Product:	Beam cladding	Damage:	No visible damage
Area:	Not Applicable	Treatment:	AIB painted or encapsulated
Floor:	Ground floor	Asbestos Type:	Amosite
Room:	Bar area	Identification:	Presumed
Surveyor Name:	J D Chilvers	Quantity:	
Drawing Ref:	3	Accessibility:	Medium Accessibility
Asbestos ?	Yes		
Date:	07 January 2005		
Next Inspection:	09 July 2005

Material Risk Score	5
Material Risk Band:	Low Risk
Priority Risk Score:	5

Location ID:	2849
Location Ref:	3
Product:	Beam cladding
Area:	Not Applicable
Floor:	Ground floor
Room:	Bar area
Surveyor Name:	J D Chilvers
Drawing Ref:	3
Asbestos ?	Yes
Date:	07 January 2005

Action:	Apply Warning Labels
---------	----------------------

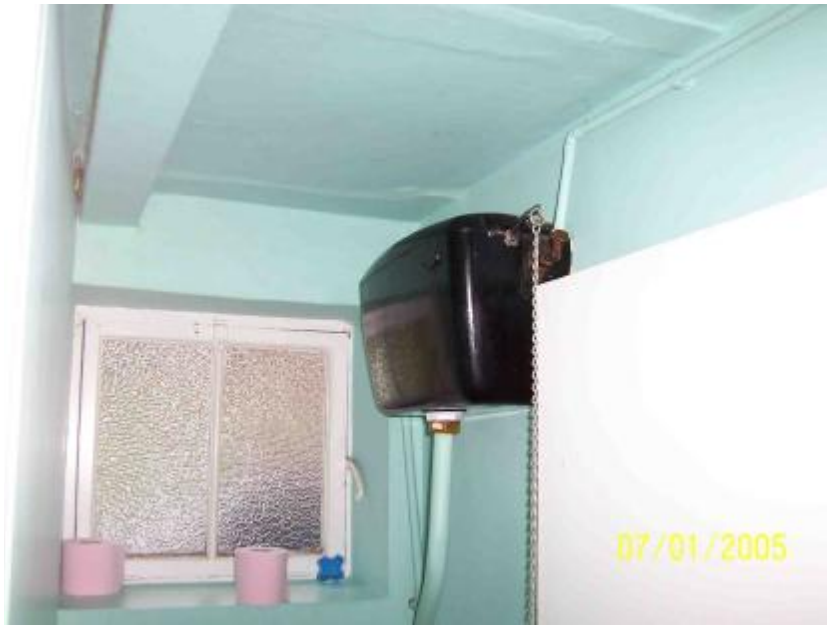
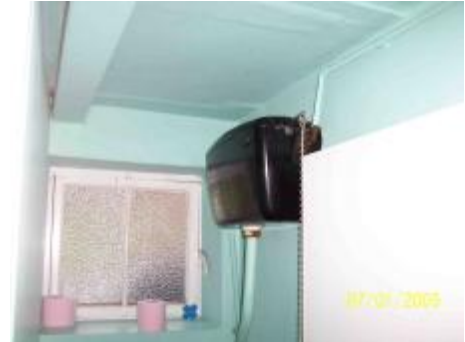
Location ID:	2850	Survey Type:	T 2
Location Ref:	4	Product Type:	Plastics
Product:	Cistern	Damage:	Low damage: Scratches or marks
Area:	Not Applicable	Treatment:	Reinforced plastics
Floor:	Ground floor	Asbestos Type:	Chrysotile
Room:	WC - mens	Identification:	Presumed
Surveyor Name:	J D Chilvers	Quantity:	
Drawing Ref:	4	Accessibility:	Medium Accessibility
Asbestos ?	Yes		
Date:	07 January 2005	Material Risk Score:	3
Next Inspection:	07 January 2006	Material Risk Band:	Very Low Risk
		Priority Risk Score:	3

Location ID:	2850
Location Ref:	4
Product:	Cistern
Area:	Not Applicable
Floor:	Ground floor
Room:	WC - mens
Surveyor Name:	J D Chilvers
Drawing Ref:	4
Asbestos ?	Yes
Date:	07 January 2005

Action:	Apply Warning Labels
---------	----------------------

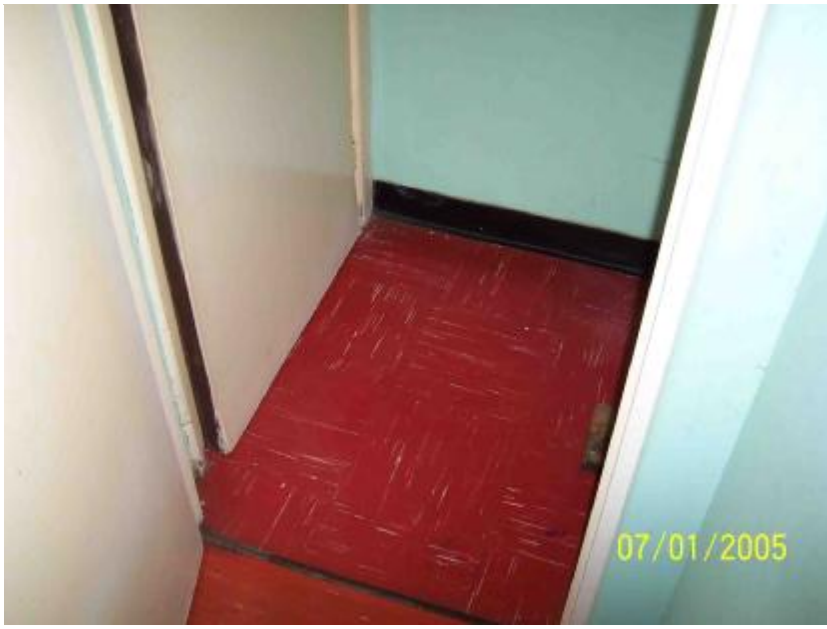
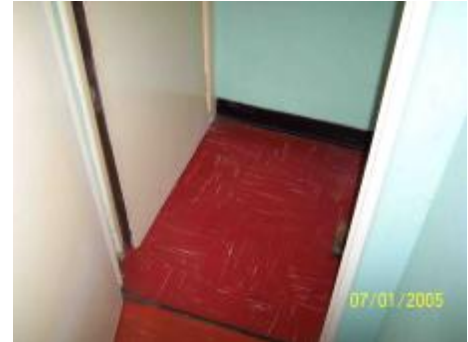
Location ID:	2851	Survey Type:	T 2
Location Ref:	5	Product Type:	Vinyl floor tiles
Product:	Floor tiles	Damage:	Low damage: Scratches or marks
Area:	Not Applicable	Treatment:	Vinyl tiles
Floor:	Ground floor	Asbestos Type:	Chrysotile
Room:	WC - mens	Identification:	Presumed
Surveyor Name:	J D Chilvers	Quantity:	
Drawing Ref:	5	Accessibility:	Easy Accessibility
Asbestos ?	Yes		
Date:	07 January 2005	Material Risk Score:	3
Next Inspection:	07 January 2006	Material Risk Band:	Very Low Risk
		Priority Risk Score:	4

Location ID:	<input style="width: 95%;" type="text" value="2851"/>
Location Ref:	<input style="width: 95%;" type="text" value="5"/>
Product:	<input style="width: 95%;" type="text" value="Floor tiles"/>
Area:	<input style="width: 95%;" type="text" value="Not Applicable"/>
Floor:	<input style="width: 95%;" type="text" value="Ground floor"/>
Room:	<input style="width: 95%;" type="text" value="WC - mens"/>
Surveyor Name:	<input style="width: 95%;" type="text" value="J D Chilvers"/>
Drawing Ref:	<input style="width: 95%;" type="text" value="5"/>
Asbestos ?	<input style="width: 95%;" type="text" value="Yes"/>
Date:	<input style="width: 95%;" type="text" value="07 January 2005"/>

Action:	No Action Required
---------	--------------------

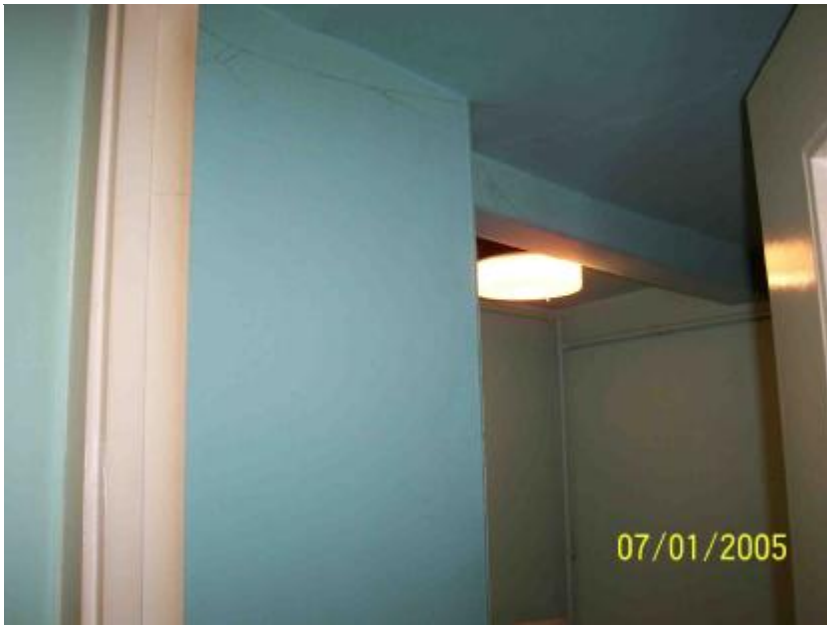
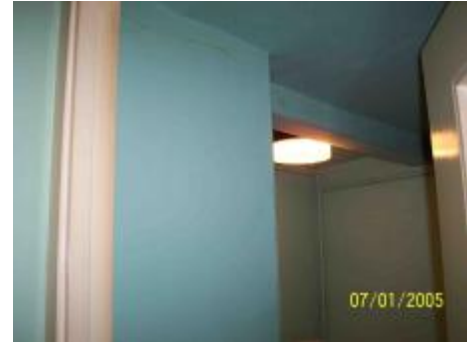
Location ID:	2852	Survey Type:	T 2
Location Ref:	6	Product Type:	Asbestos Insulating Board
Product:	Wall	Damage:	No visible damage
Area:	Not Applicable	Treatment:	AIB painted or encapsulated
Floor:	Ground floor	Asbestos Type:	Amosite
Room:	WC - mens	Identification:	Presumed
Surveyor Name:	J D Chilvers	Quantity:	
Drawing Ref:	6	Accessibility:	Medium Accessibility
Asbestos ?	Yes		
Date:	07 January 2005		
Next Inspection:	09 July 2005

Material Risk Score	5
Material Risk Band:	Low Risk
Priority Risk Score:	3

Location ID:	2852
Location Ref:	6
Product:	Wall
Area:	Not Applicable
Floor:	Ground floor
Room:	WC - mens
Surveyor Name:	J D Chilvers
Drawing Ref:	6
Asbestos ?	Yes
Date:	07 January 2005

Action:	Apply Warning Labels
---------	----------------------

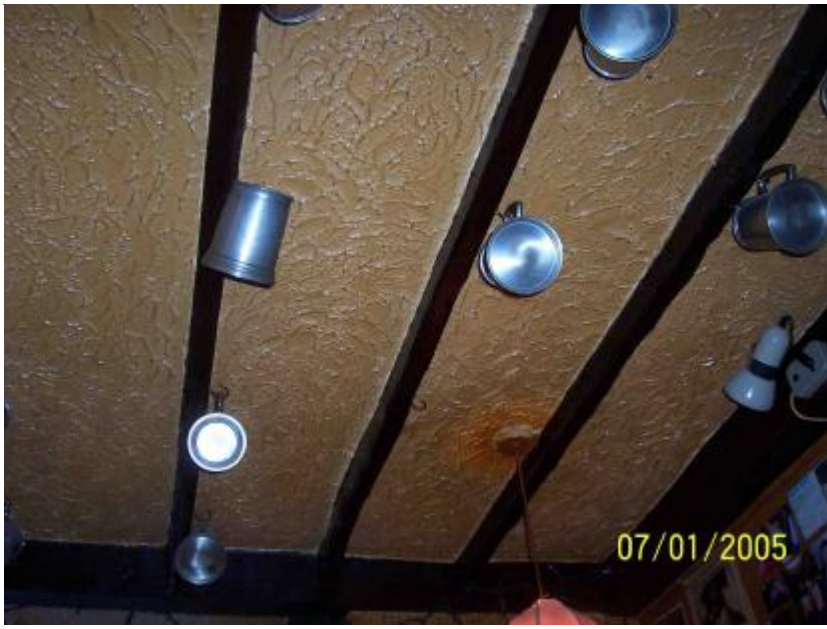
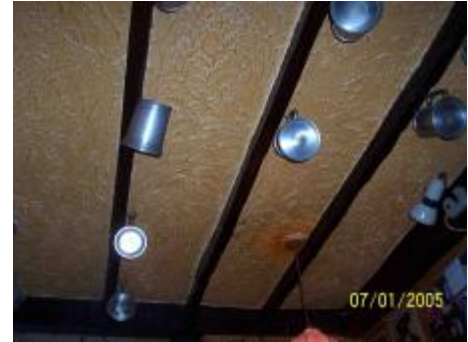
Location ID:	2853	Survey Type:	T 2
Location Ref:	7	Product Type:	Decorative finishes
Product:	Textured coating	Damage:	No visible damage
Area:	Not Applicable	Treatment:	Composite asbestos materials
Floor:	Ground floor	Asbestos Type:	Chrysotile
Room:	Bar area	Identification:	Presumed
Surveyor Name:	J D Chilvers	Quantity:	
Drawing Ref:	7	Accessibility:	Medium Accessibility
Asbestos ?	Yes		
Date:	07 January 2005	Material Risk Score:	2
Next Inspection:	07 January 2006	Material Risk Band:	Very Low Risk
		Priority Risk Score:	5

Location ID:	2853
Location Ref:	7
Product:	Textured coating
Area:	Not Applicable
Floor:	Ground floor
Room:	Bar area
Surveyor Name:	J D Chilvers
Drawing Ref:	7
Asbestos ?	Yes
Date:	07 January 2005

Action:	Apply Warning Labels
---------	----------------------

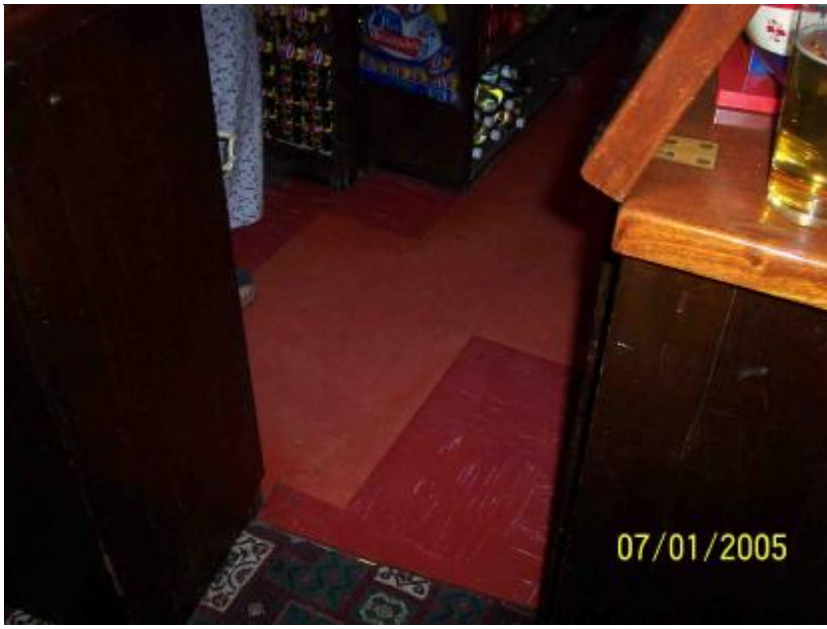
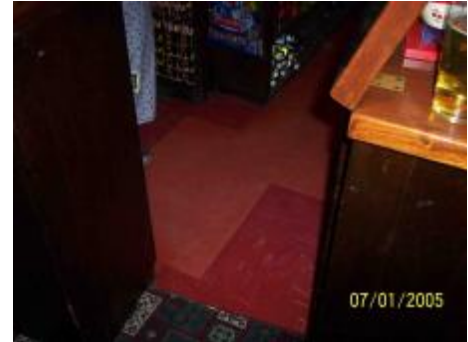
Location ID:	2854	Survey Type:	T 2
Location Ref:	8	Product Type:	Vinyl floor tiles
Product:	Floor tiles	Damage:	Low damage: Scratches or marks
Area:	Not Applicable	Treatment:	Vinyl tiles
Floor:	Ground floor	Asbestos Type:	Chrysotile
Room:	Bar area	Identification:	Presumed
Surveyor Name:	J D Chilvers	Quantity:	
Drawing Ref:	8	Accessibility:	Easy Accessibility
Asbestos ?	Yes		
Date:	07 January 2005	Material Risk Score:	3
Next Inspection:	07 January 2006	Material Risk Band:	Very Low Risk
		Priority Risk Score:	4

Location ID:	<input style="width: 95%;" type="text" value="2854"/>
Location Ref:	<input style="width: 95%;" type="text" value="8"/>
Product:	<input style="width: 95%;" type="text" value="Floor tiles"/>
Area:	<input style="width: 95%;" type="text" value="Not Applicable"/>
Floor:	<input style="width: 95%;" type="text" value="Ground floor"/>
Room:	<input style="width: 95%;" type="text" value="Bar area"/>
Surveyor Name:	<input style="width: 95%;" type="text" value="J D Chilvers"/>
Drawing Ref:	<input style="width: 95%;" type="text" value="8"/>
Asbestos ?	<input style="width: 95%;" type="text" value="Yes"/>
Date:	<input style="width: 95%;" type="text" value="07 January 2005"/>

Action:	No Action Required
---------	--------------------

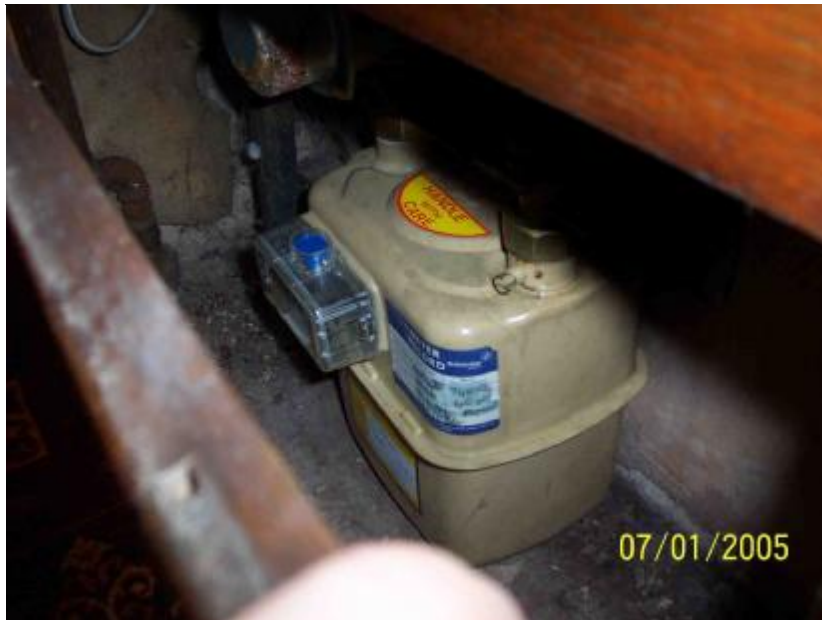
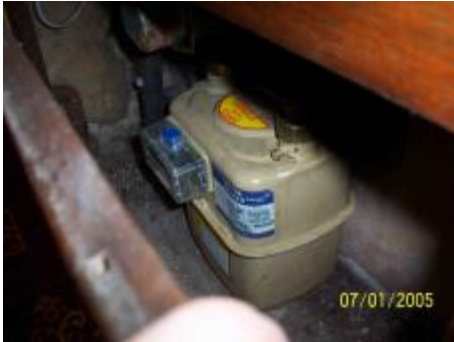
Location ID:	2855	Survey Type:	T 2
Location Ref:	9	Product Type:	Gaskets
Product:	Gas meter	Damage:	No visible damage
Area:	Not Applicable	Treatment:	Composite asbestos materials
Floor:	Ground floor	Asbestos Type:	Chrysotile
Room:	Bar area	Identification:	Presumed
Surveyor Name:	J D Chilvers	Quantity:	
Drawing Ref:	9	Accessibility:	Medium Accessibility
Asbestos ?	Yes		
Date:	07 January 2005		
Next Inspection:	07 January 2006

Material Risk Score	3
Material Risk Band:	Very Low Risk
Priority Risk Score:	2

Location ID:	2855
Location Ref:	9
Product:	Gas meter
Area:	Not Applicable
Floor:	Ground floor
Room:	Bar area
Surveyor Name:	J D Chilvers
Drawing Ref:	9
Asbestos ?	Yes
Date:	07 January 2005

Action:	Apply Warning Labels
---------	----------------------

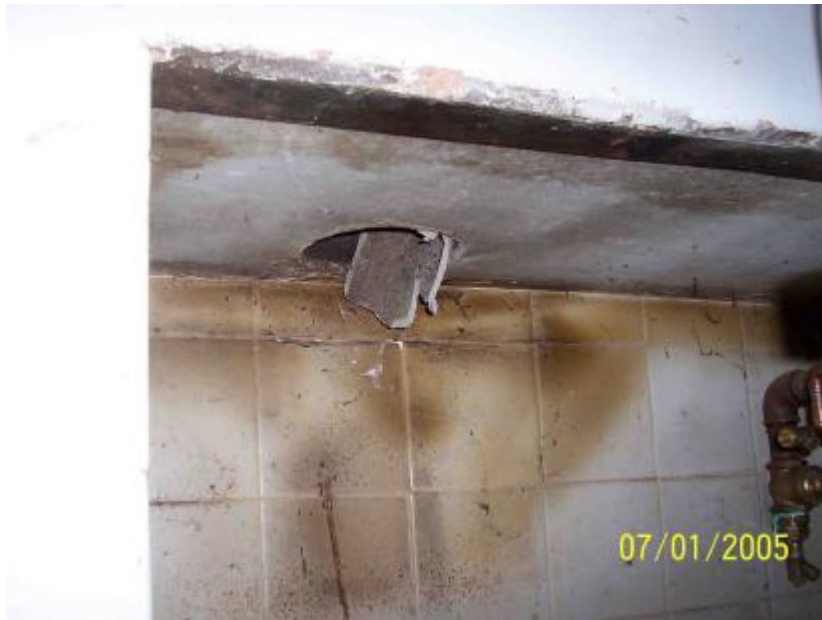
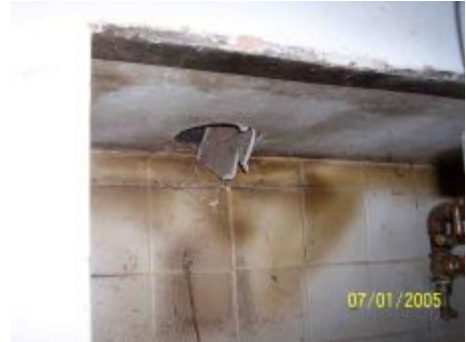
Location ID:	2857	Survey Type:	T 2
Location Ref:	11	Product Type:	Asbestos cement
Product:	Flue	Damage:	High damage: Visible debris
Area:	Not Applicable	Treatment:	Asbestos cement sheets etc
Floor:	Ground floor	Asbestos Type:	Chrysotile
Room:	Store Room	Identification:	Identified
Surveyor Name:	J D Chilvers	Quantity:	
Drawing Ref:	11	Accessibility:	Easy Accessibility
Asbestos ?	Yes		
Date:	07 January 2005		
Next Inspection:	09 July 2005		
		Material Risk Score:	6
		Material Risk Band:	Low Risk
		Priority Risk Score:	4
Action:	Removal

Location ID:	2857
Location Ref:	11
Product:	Flue
Area:	Not Applicable
Floor:	Ground floor
Room:	Store Room
Surveyor Name:	J D Chilvers
Drawing Ref:	11
Asbestos ?	Yes
Date:	07 January 2005

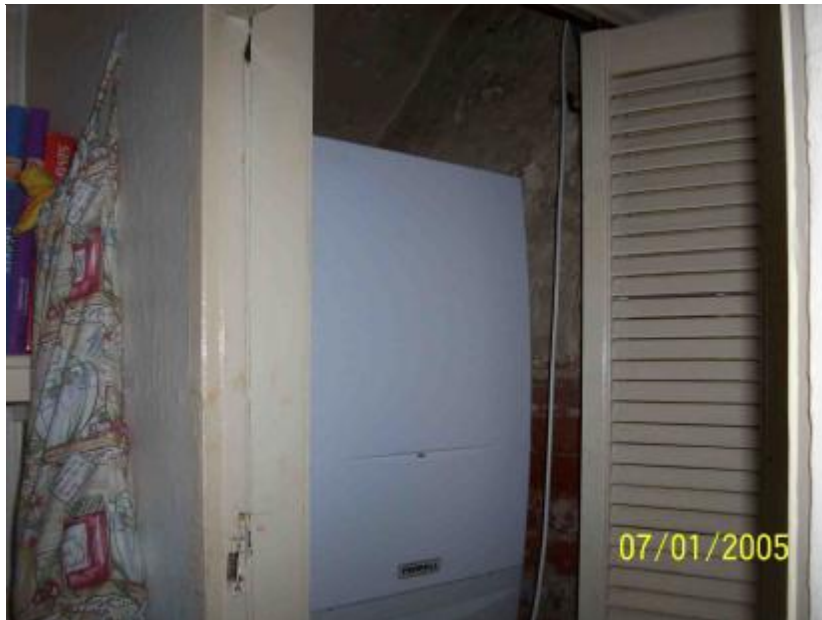
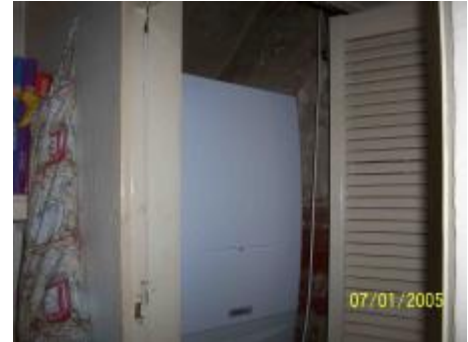
Location ID:	2858	Survey Type:	T 2
Location Ref:	12	Product Type:	Asbestos Insulating Board
Product:	Cladding	Damage:	Low damage: Scratches or marks
Area:	Not Applicable	Treatment:	Unsealed AIB
Floor:	Ground floor	Asbestos Type:	Amosite
Room:	Store Room	Identification:	Identified
Surveyor Name:	J D Chilvers	Quantity:	
Drawing Ref:	12	Accessibility:	Easy Accessibility
Asbestos ?	Yes		
Date:	07 January 2005		
Next Inspection:	07 April 2005

Material Risk Score	7
Material Risk Band:	Medium Risk
Priority Risk Score:	4

Location ID:	2858
Location Ref:	12
Product:	Cladding
Area:	Not Applicable
Floor:	Ground floor
Room:	Store Room
Surveyor Name:	J D Chilvers
Drawing Ref:	12
Asbestos ?	Yes
Date:	07 January 2005

Action:	Encapsulate and Apply Warning Labels
---------	--------------------------------------

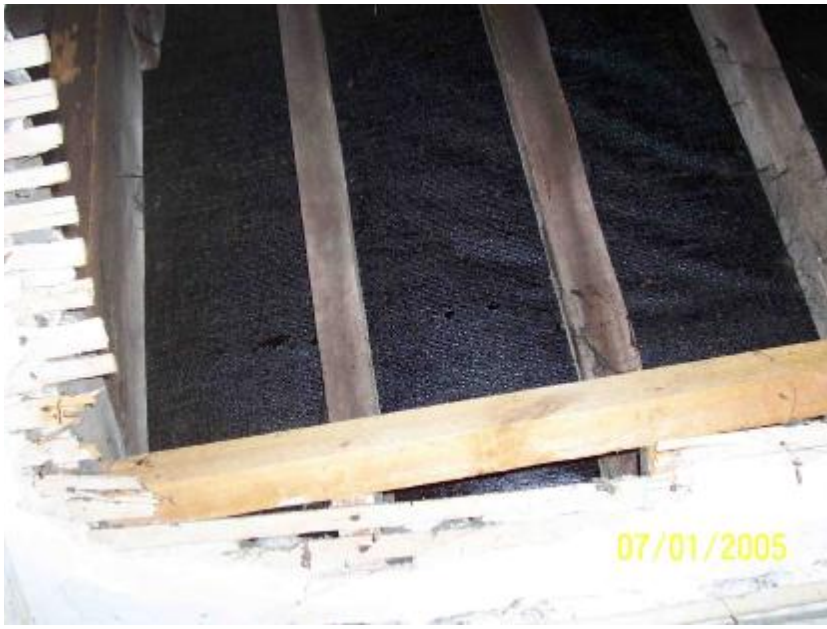
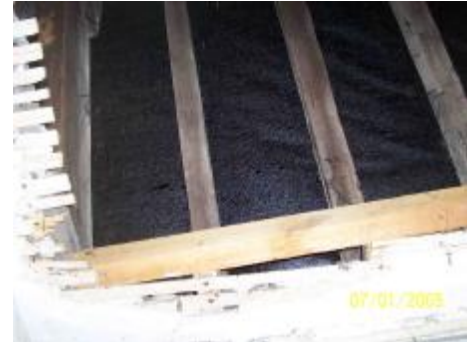
Location ID:	2859	Survey Type:	T 2
Location Ref:	13	Product Type:	Roofing felts
Product:	Roofing felt	Damage:	Low damage
Area:	Not Applicable	Treatment:	Resins
Floor:	Roof level	Asbestos Type:	Chrysotile
Room:	Loft space	Identification:	Strongly Presumed
Surveyor Name:	J D Chilvers	Quantity:	
Drawing Ref:	13	Accessibility:	Difficult Accessibility
Asbestos ?	Yes		
Date:	07 January 2005	Material Risk Score:	3
Next Inspection:	07 January 2006	Material Risk Band:	Very Low Risk
		Priority Risk Score:	1

Location ID:	<input style="width: 95%;" type="text" value="2859"/>
Location Ref:	<input style="width: 95%;" type="text" value="13"/>
Product:	<input style="width: 95%;" type="text" value="Roofing felt"/>
Area:	<input style="width: 95%;" type="text" value="Not Applicable"/>
Floor:	<input style="width: 95%;" type="text" value="Roof level"/>
Room:	<input style="width: 95%;" type="text" value="Loft space"/>
Surveyor Name:	<input style="width: 95%;" type="text" value="J D Chilvers"/>
Drawing Ref:	<input style="width: 95%;" type="text" value="13"/>
Asbestos ?	<input style="width: 95%;" type="text" value="Yes"/>
Date:	<input style="width: 95%;" type="text" value="07 January 2005"/>

Action:	No Action Required
---------	--------------------

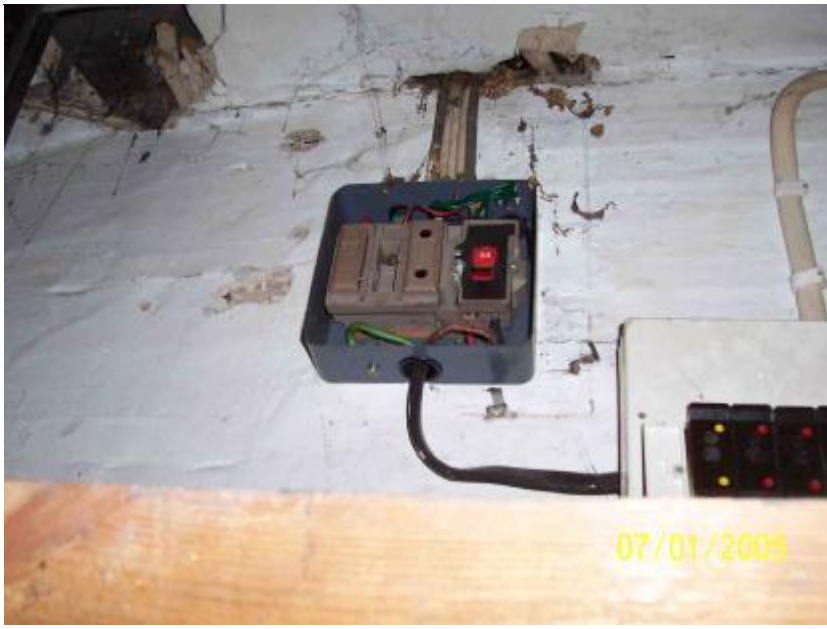
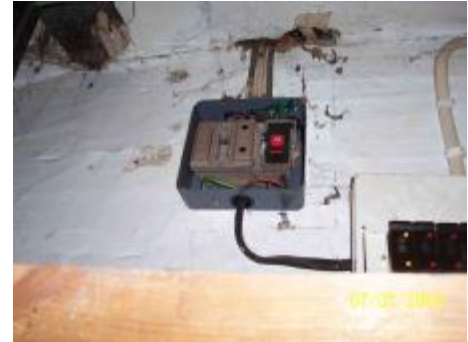
Location ID:	<input type="text" value="2860"/>	Survey Type:	<input type="text" value="T 2"/>						
Location Ref:	<input type="text" value="14"/>	Product Type:	<input type="text" value="Ropes and woven textiles"/>						
Product:	<input type="text" value="Fuse &amp; Switchgear Flashguard"/>	Damage:	<input type="text" value="No visible damage"/>						
Area:	<input type="text" value="Not Applicable"/>	Treatment:	<input type="text" value="Composite asbestos materials"/>						
Floor:	<input type="text" value="Ground floor"/>	Asbestos Type:	<input type="text" value="Chrysotile"/>						
Room:	<input type="text" value="Cellar"/>	Identification:	<input type="text" value="Presumed"/>						
Surveyor Name:	<input type="text" value="J D Chilvers"/>	Quantity:	<input type="text"/>						
Drawing Ref:	<input type="text" value="14"/>	Accessibility:	<input type="text" value="Medium Accessibility"/>						
Asbestos ?	<input type="text" value="Yes"/>

Material Risk Score	<input type="text" value="3"/>	Material Risk Band:	<input type="text" value="Very Low Risk"/>	Priority Risk Score:	<input type="text" value="3"/>
Material Risk Score	<input type="text" value="3"/>								
Material Risk Band:	<input type="text" value="Very Low Risk"/>								
Priority Risk Score:	<input type="text" value="3"/>								
Date:	<input type="text" value="07 January 2005"/>								
Next Inspection:	<input type="text" value="07 January 2006"/>

Location ID:	2860
Location Ref:	14
Product:	Fuse & Switchgear Flashguard
Area:	Not Applicable
Floor:	Ground floor
Room:	Cellar
Surveyor Name:	J D Chilvers
Drawing Ref:	14
Asbestos ?	Yes
Date:	07 January 2005

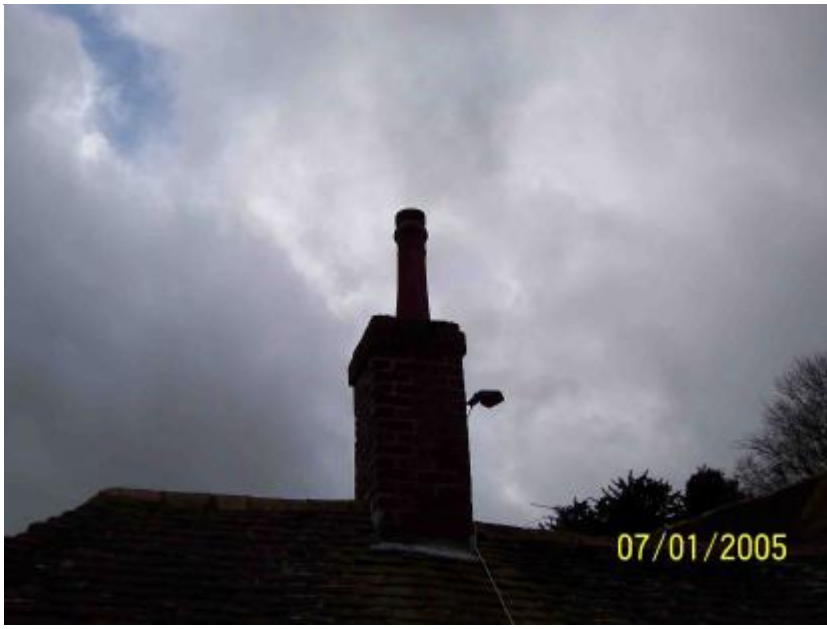
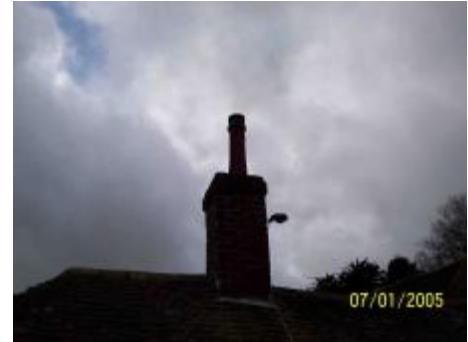
Location ID:	2861	Survey Type:	T 2
Location Ref:	15	Product Type:	Asbestos cement
Product:	Flue pipe cowl	Damage:	No visible damage
Area:	Not Applicable	Treatment:	Asbestos cement sheets etc
Floor:	Roof level	Asbestos Type:	Chrysotile
Room:	External	Identification:	Presumed
Surveyor Name:	J D Chilvers	Quantity:	
Drawing Ref:	15	Accessibility:	Difficult Accessibility
Asbestos ?	Yes		
Date:	07 January 2005	Material Risk Score:	3
Next Inspection:	07 January 2006	Material Risk Band:	Very Low Risk
		Priority Risk Score:	1

Location ID:	2861
Location Ref:	15
Product:	Flue pipe cowl
Area:	Not Applicable
Floor:	Roof level
Room:	External
Surveyor Name:	J D Chilvers
Drawing Ref:	15
Asbestos ?	Yes
Date:	07 January 2005

Action:	No Action Required
---------	--------------------

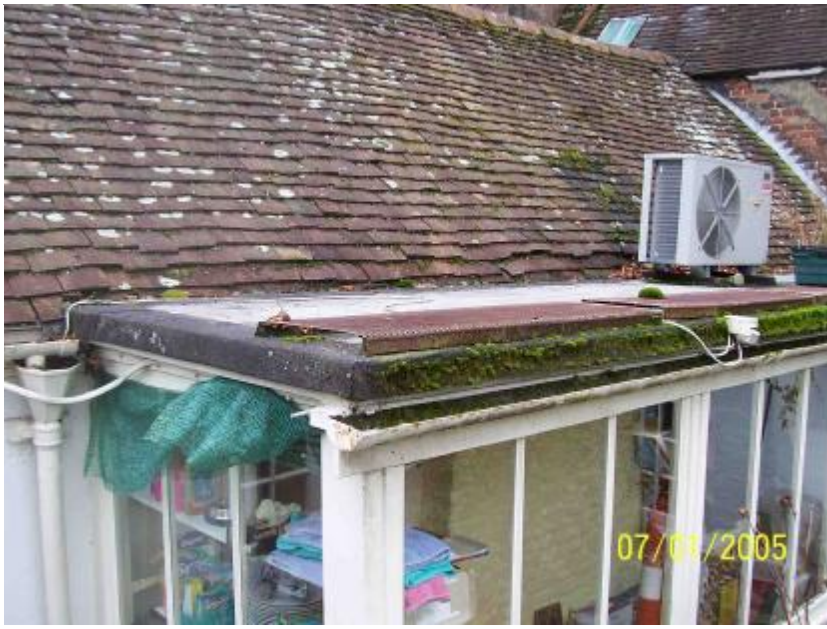
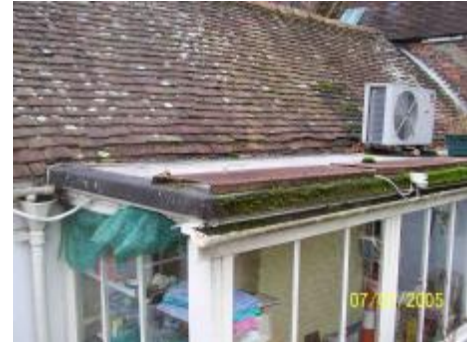
Location ID:	2862	Survey Type:	T 2
Location Ref:	16	Product Type:	Roofing felts
Product:	Roofing felt	Damage:	Low damage
Area:	Not Applicable	Treatment:	Resins
Floor:	Roof level	Asbestos Type:	Chrysotile
Room:	Flat roof area	Identification:	Presumed
Surveyor Name:	J D Chilvers	Quantity:	
Drawing Ref:	16	Accessibility:	Medium Accessibility
Asbestos ?	Yes		
Date:	07 January 2005	Material Risk Score:	3
Next Inspection:	07 January 2006	Material Risk Band:	Very Low Risk
		Priority Risk Score:	2

Location ID:	2862
Location Ref:	16
Product:	Roofing felt
Area:	Not Applicable
Floor:	Roof level
Room:	Flat roof area
Surveyor Name:	J D Chilvers
Drawing Ref:	16
Asbestos ?	Yes
Date:	07 January 2005

Action: No Action Required
