Asbestos Survey for

Hall & Woodhouse Ltd

Norfolk Arms
Crawley Road
Roffey
Horsham
West Sussex
RH12 4NB

Project Number: AS07220 - Norfolk Arms

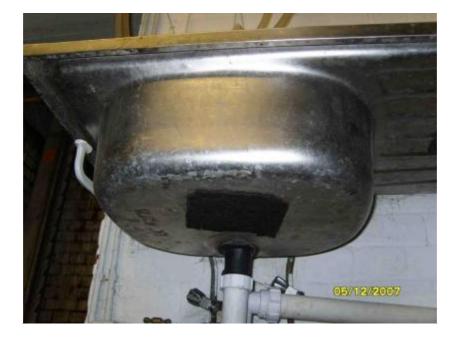
Norfolk Arms, Crawley Road, Roffey, Horsham, We		ient Name:	Hall & Wo	odhouse Ltd
	Sussex, RH12 4NB	Pr	oject Number:	AS07220 -	Norfolk Arms
Location ID:	8965	Survey Type:		T 2	
Location Ref:	1	Product Type:		Resins	
Product:	Sink Pad	Damage:	No visible damage		
Area:	Not Applicable	Treatment:		Resins	
Floor:	Basement	Asbestos Type		Chrysotile	
Room:	Cellar	Identification:		Presumed	
Surveyor Name	e: J D Chilvers	Quantity:			
Drawing Ref:	1	Accessibility:		Medium Accessibi	lity
Asbestos ?	Yes				
Date:	05 December 2007		Materi	al Risk Score	2
Next Inspection	o 04 December 2008		Materi	al Risk Band:	Very Low Risk
TOXE HISPOOLIO			Priority	/ Risk Score:	3

Apply Warning Labels

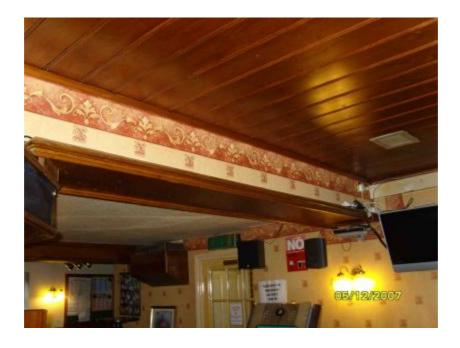
Location ID:	8966	Survey Type:	T 2
Location Ref:	2	Product Type:	Asbestos Insulating Board
Product:	Beam cladding	Damage:	No visible damage
Area:	Not Applicable	Treatment:	AIB painted or encapsulated
Floor:	Ground floor	Asbestos Type:	Amosite
Room:	Bar area	Identification:	Presumed
Surveyor Name:	J D Chilvers	Quantity:	5m2
Drawing Ref:	2	Accessibility:	Medium Accessibility
Asbestos ?	Yes

Material Comments: All structural beams may be clad with ACMs underneath external wood panelling

Action: Apply Warning Labels

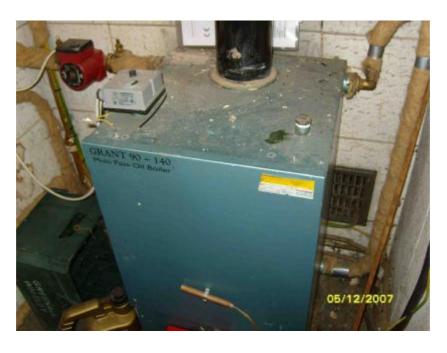
Client Name: Hall & Woodhouse Ltd Site Address: Norfolk Arms, Crawley Road, Roffey, Horsham, West Sussex, RH12 4NB Project Number: AS07220 - Norfolk Arms 8967 Survey Type: T 2 Location ID: Location Ref: 3 **Product Type:** Gaskets Product: Boiler Damage: No visible damage Area: Not Applicable Treatment: Composite asbestos materials Ground floor Chrysotile Floor: Asbestos Type: Boiler room Presumed Identification: Room: J D Chilvers Surveyor Name: Quantity: 3 Medium Accessibility Drawing Ref: Accessibility: Asbestos? Yes Material Risk Score 3 05 December 2007 Date: Material Risk Band: Very Low Risk Next Inspection: 04 December 2008 Priority Risk Score:

Apply Warning Labels

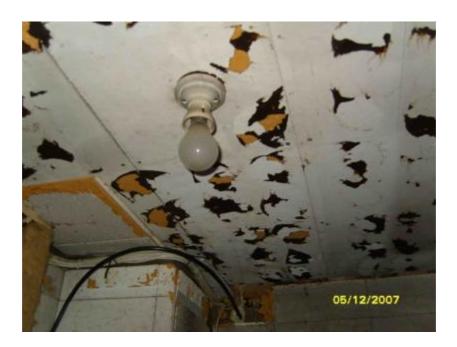
Client Name: Hall & Woodhouse Ltd Site Address: Norfolk Arms, Crawley Road, Roffey, Horsham, West Sussex, RH12 4NB Project Number: AS07220 - Norfolk Arms 8968 Survey Type: T 2 Location ID: Location Ref: 4 **Product Type:** Asbestos Insulating Board Product: Ceiling Damage: Low damage: Scratches or marks Area: Not Applicable Treatment: Unsealed AIB Ground floor Amosite Floor: Asbestos Type: Boiler room Identified Identification: Room: J D Chilvers 6m2 Surveyor Name: Quantity: Easy Accessibility Drawing Ref: Accessibility: Asbestos? Yes

Action: **Encapsulate and Apply Warning Labels**

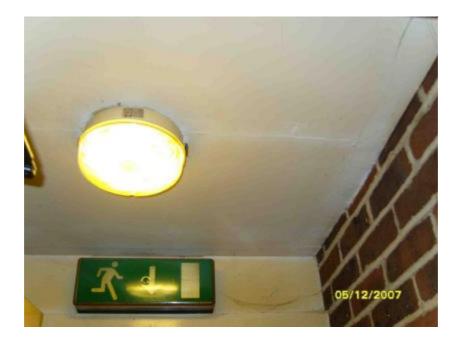
Location ID:	8969	Survey Type:	T 2
Location Ref:	5	Product Type:	Asbestos Insulating Board
Product:	Ceiling	Damage:	Low damage: Scratches or marks
Area:	Not Applicable	Treatment:	Unsealed AIB
Floor:	Ground floor	Asbestos Type:	Amosite
Room:	Lobby	Identification:	Identified
Surveyor Name:	J D Chilvers	Quantity:	2m2
Drawing Ref:	5	Accessibility:	Easy Accessibility

Material Comments: Material identical to location 4

Action: Re-encapsulate and Apply Warning Labels

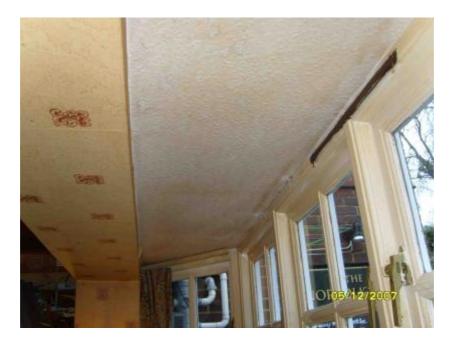
Client Name: Hall & Woodhouse Ltd Site Address: Norfolk Arms, Crawley Road, Roffey, Horsham, West Sussex, RH12 4NB Project Number: AS07220 - Norfolk Arms 8970 Survey Type: T 2 Location ID: Location Ref: 6 **Product Type:** Asbestos Insulating Board Product: Ceiling Damage: No visible damage Area: Not Applicable Treatment: AIB painted or encapsulated Ground floor Amosite Floor: Asbestos Type: Bar area Strongly Presumed Identification: Room: J D Chilvers Surveyor Name: 2m2 Quantity: 6 Easy Accessibility Drawing Ref: Accessibility: Asbestos? Yes Material Risk Score 5 05 December 2007 Date: Material Risk Band: Low Risk

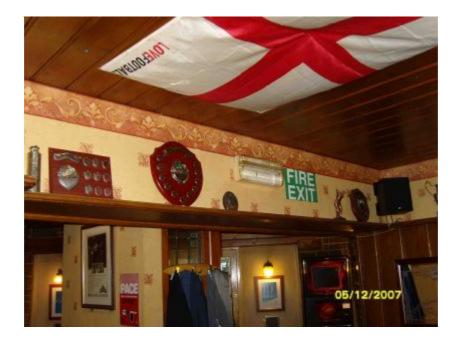
Location ID:	8971	Survey Type:	T 2
Location Ref:	7	Product Type:	Asbestos Insulating Board
Product:	Beam cladding	Damage:	No visible damage
Area:	Not Applicable	Treatment:	AIB painted or encapsulated
Floor:	Ground floor	Asbestos Type:	Amosite
Room:	Bar area	Identification:	Presumed
Surveyor Name:	J D Chilvers	Quantity:	5m2
Drawing Ref:	7	Accessibility:	Medium Accessibility
Asbestos ?	Yes

Material Comments: All structural beams may be clad with ACMs underneath external wood panelling

Action: Apply Warning Labels

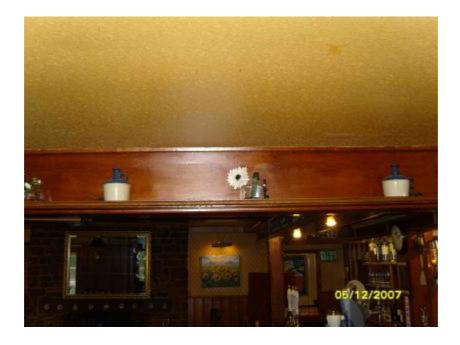
8972 T 2 Location ID: Survey Type: Location Ref: 8 **Product Type:** Asbestos Insulating Board Product: Beam cladding Damage: No visible damage Not Applicable Treatment: AIB painted or encapsulated Area: Ground floor Amosite Floor: Asbestos Type: Presumed Bar area Identification: Room: J D Chilvers 5m2 Surveyor Name: Quantity: 8 Medium Accessibility Drawing Ref: Accessibility: Asbestos? Yes

Material Comments: All structural beams may be clad with ACMs underneath external wood panelling

Action: **Apply Warning Labels**

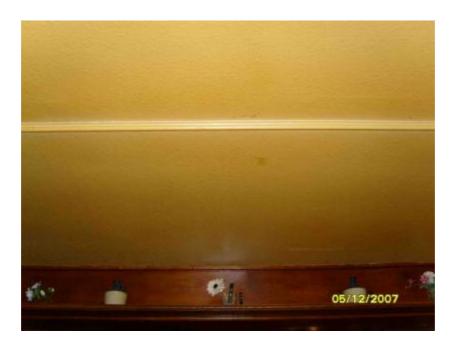
F			ient Name:	Hall & Woo	dhouse Ltd	
	Norfolk Arms, Crawley Road, Roffey, Horsham, We Sussex, RH12 4NB	est				
		Pi	roject Number:	AS07220 - N	Norfolk Arms	
Location ID:	8973	Survey Type:		T 2		
Location Ref:	9	Product Type:	Asb	estos Insulating Bo	oard	
Product:	Ceiling	Damage:		No visible damage		
Area:	Not Applicable	Treatment:	AIB p	AIB painted or encapsulated		
Floor:	Ground floor	Asbestos Type	:	Amosite		
Room:	Bar area	Identification:		Strongly Presumed		
Surveyor Name	J D Chilvers	Quantity:		15m2		
Drawing Ref:	9	Accessibility:		Easy Accessibility	,	
Asbestos ?	Yes			ſ		
Date:	05 December 2007		Material	Risk Score	5	
Next Inspection	05 June 2008		Material	Risk Band:	Low Risk	
Toxt mopoulor			Priority	Risk Score:	5

Apply Warning Labels

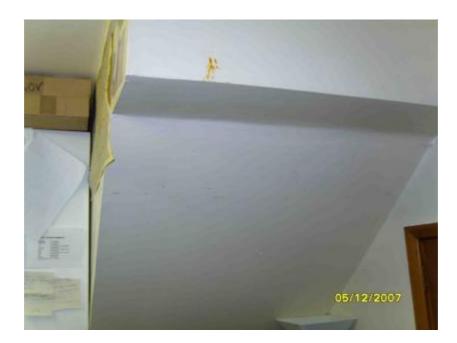
8974 T 2 Location ID: Survey Type: Location Ref: 10 **Product Type:** Asbestos Insulating Board Product: Stair Backing / Cladding Damage: No visible damage Not Applicable Treatment: AIB painted or encapsulated Area: Ground floor Amosite Floor: Asbestos Type: Kitchen Strongly Presumed Identification: Room: J D Chilvers 2m2 Surveyor Name: Quantity: 10 Easy Accessibility Drawing Ref: Accessibility:

Action: **Apply Warning Labels**

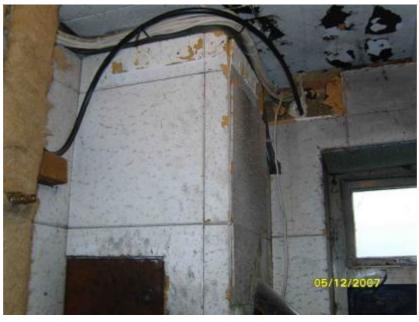
F		C	ient Name:	Hall & Woo	dhouse Ltd
	Norfolk Arms, Crawley Road, Roffey, Horsham, We Sussex, RH12 4NB	st			
		Pi	roject Number:	AS07220 - N	Norfolk Arms
Location ID:	8975	Survey Type:		T 2	
Location Ref:	11	Product Type:		NADIS	
Product:	Tiles	Damage:		NADIS	
Area:	Not Applicable	Treatment:		NADIS	
Floor:	Ground floor	Asbestos Type	:	NADIS	
Room:	Boiler room	Identification:		Identified	
Surveyor Name	e: J D Chilvers	Quantity:			
Drawing Ref:	11	Accessibility:			
Asbestos ?	No				
Date:	05 December 2007		Material	Risk Score	0
Next Inspection	n: Not Applicable		Material	Risk Band:	NADIS
TTOXE ITISPECTION			Priority	Risk Score:	N/A

No Action Required

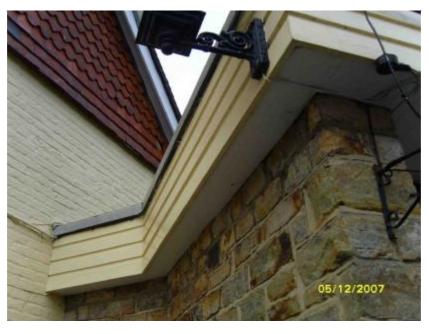
lient Name:	Hall & Woo	dhouse Ltd	
	Norfolk Arms, Crawley Road, Roffey, Horsham, Wo Sussex, RH12 4NB	est				
		Pr	roject Number:	AS07220 - N	Norfolk Arms	
Location ID:	8976	Survey Type:		T 2		
Location Ref:	12	Product Type:	Asb	estos Insulating Bo	oard	
Product:	Soffit	Damage:		No visible damage		
Area:	Not Applicable	Treatment:	AIB p	AIB painted or encapsulated		
Floor:	Ground floor	Asbestos Type	:	Amosite		
Room:	External	Identification:		Presumed		
Surveyor Name	J D Chilvers	Quantity:		2m2		
Drawing Ref:	12	Accessibility:	M	ledium Accessibili	ty	
Asbestos ?	Yes			Г		
Date:	05 December 2007		Material	Risk Score	5	
Next Inspection	• 05 June 2008	I	Material	Risk Band:	Low Risk	
Tront mopoduon			Priority	Risk Score:	2

Apply Warning Labels

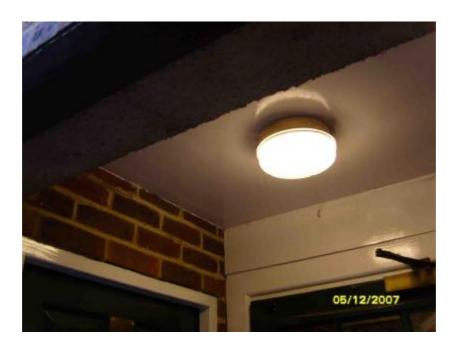
8977 T 2 Location ID: Survey Type: Location Ref: 13 **Product Type:** Asbestos Insulating Board Product: Ceiling Damage: No visible damage Not Applicable Treatment: AIB painted or encapsulated Area: Ground floor Amosite Floor: Asbestos Type: Porch Identification: Strongly Presumed as previous sample Room: J D Chilvers Surveyor Name: 2m2 Quantity: 13 Easy Accessibility Drawing Ref: Accessibility: Asbestos? Yes

Action: **Apply Warning Labels**
