Asbestos Survey for

Hall & Woodhouse Ltd

The White Hart Inn Wrington Road Congresbury North Somerset BS49 5AR

JTEC Environmental Ltd.
Project Number: 018 - White Hart Congres
Survey Date: 14 January 2008
Printed On: 27 March 2008
Page: Page 1 of 1

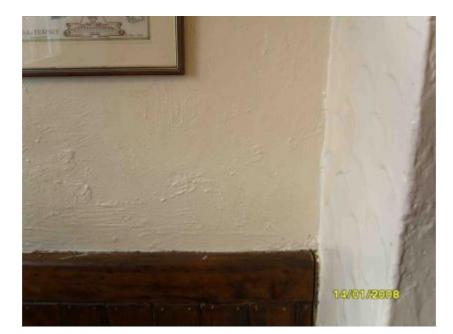
The White Hart Inn, Wrington Road, Congresbury, Somerset, BS49 5AR	North	Client Name:	Hall & Wo	oodhouse Ltd	
	Solieisel, DS49 SAN		Project Number:	AS08018 - Whit	e Hart Congresbury	
Location ID:	9440	Survey Typ	e:	T 2		
Location Ref:	1	Product Ty	pe:	Decorative finishes		
Product:	Textured coating	Damage:	Low	Low damage: Scratches or marks		
Area:	Not Applicable	Treatment:	Co	Composite asbestos materials		
Floor:	Ground floor	Asbestos T	уре:	Chrysotile		
Room:	Bar area	Identificatio	on:	Identified		
Surveyor Name	e: J D Chilvers	Quantity:				
Drawing Ref:	1	Accessibilit	y:	Easy Accessibili	ty	
Asbestos ?	Yes				[]	
Date:	14 January 2008		Mate	rial Risk Score	3	
Next Inspectior	13 January 2009		Mate	rial Risk Band:	Very Low Risk	
			Priori	ity Risk Score:	5

Apply Warning Labels

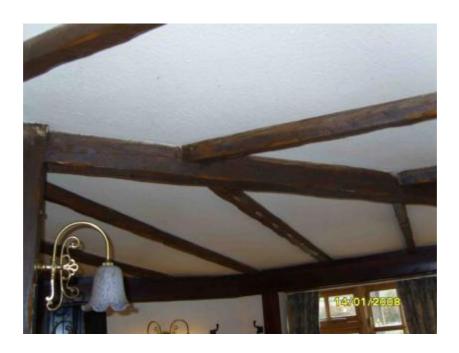
Site Address: The	The White Hart Inn, Wrington Road, Congresbury, North Somerset, BS49 5AR		Client Name:	Hall & Woodhouse Ltd		
			Project Number:	AS08018 - Whit	e Hart Congresbury	
Location ID:	9441	Survey Type	:	T 2		
Location Ref:	2	Product Type	ə:	Decorative finishes		
Product:	Textured coating	Damage:	Low	Low damage: Scratches or marks		
Area:	Not Applicable	Treatment:	Co	Composite asbestos materials		
Floor:	Ground floor	Asbestos Ty	pe:	Chrysotile		
Room:	Bar area	Identification	:	Identified		
Surveyor Name:	J D Chilvers	Quantity:				
Drawing Ref:	2	Accessibility	:	Easy Accessibili	ty	
Asbestos ?	Yes					
Date:	14 January 2008		Mater	ial Risk Score	3	
Next Inspection:	13 January 2009		Material		Very Low Risk	
- L			Priorit	ty Risk Score:	5	
Action:		Apply Warr	ing Labels

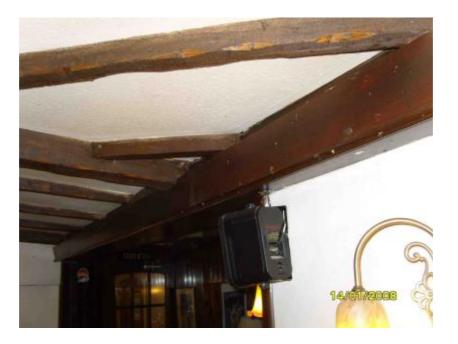
The White Hart Inn, Wrington Road, Congresbury,		lient Name:	Hall & Woo	odhouse Ltd	
	Somerset, BS49 5AR	Pr	roject Number:	AS08018 - White	Hart Congresbury	
Location ID:	9442	Survey Type:		T 2		
Location Ref:	3	Product Type:	A	sbestos Insulating B	oard	
Product:	Beam cladding	Damage:		No visible damage		
Area:	Not Applicable	Treatment:	All	AIB painted or encapsulated		
Floor:	Ground floor	Asbestos Type	:	Amosite		
Room:	Bar area	Identification:		Presumed		
Surveyor Nam	e: J D Chilvers	Quantity:				
Drawing Ref:	3	Accessibility:		Medium Accessibili	ity	
Asbestos ?	Yes				[]	
Date:	14 January 2008		Mater	ial Risk Score	5	
Next Inspectio	n: 15 July 2008		Mater	ial Risk Band:	Low Risk	
			Priorit	y Risk Score:	5	
Action:		Apply Warning	g Labels

Material Comments: AIB may be present around all structural beams under external finishes.

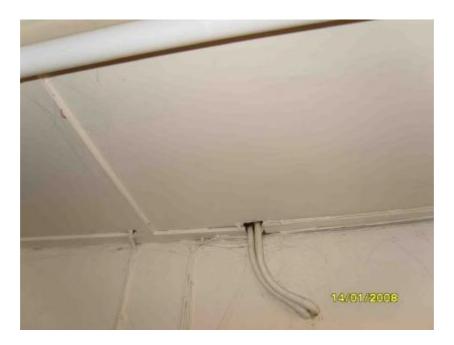
lient Name:	Hall & Woodhouse Ltd	
	The White Hart Inn, Wrington Road, Congresbury, Somerset, BS49 5AR		roject Number:	AS08018 - White	Hart Congresbury
Location ID:	9443	Survey Type:		T 2	
Location Ref:	4	Product Type:		NADIS	
Product:	Ceiling	Damage:		NADIS	
Area:	Not Applicable	Treatment:		NADIS	
Floor:	Ground floor	Asbestos Type	e:	NADIS	
Room:	Wash up area	Identification:		Identified	
Surveyor Nam	e: J D Chilvers	Quantity:			
Drawing Ref:	4	Accessibility:			
Asbestos ?	No]			
Date:	14 January 2008]		ial Risk Score	0
Next Inspectio	n: Not Applicable			ial Risk Band:	NADIS
			Priorit	y Risk Score:	N/A
Action:		No Action Re	equired

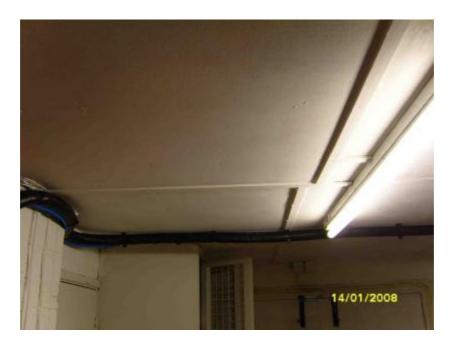
The White Hart Inn, Wrington Road, Congresbury		ient Name:	Hall & Woo	odhouse Ltd	
	Somerset, BS49 5AR	Pr	oject Number:	AS08018 - White	Hart Congresbury	
Location ID:	9444	Survey Type:		Τ2		
Location ID.						
Location Ref:	5	Product Type:	A	sbestos Insulating B	oard	
Product:	Ceiling panels	Damage:	Low o	Low damage: Scratches or marks		
Area:	Not Applicable	Treatment:	All	AIB painted or encapsulated		
Floor:	Ground floor	Asbestos Type	:	Amosite		
Room:	Cellar	Identification:		Identified		
Surveyor Nam	e: J D Chilvers	Quantity:				
Drawing Ref:	5	Accessibility:		Easy Accessibility	1	
Asbestos ?	Yes					
Date:	14 January 2008	7	Mater	ial Risk Score	6	
Next Inspectio	n: 15 July 2008]	Mater	ial Risk Band:	Low Risk	
			Priorit	y Risk Score:	4	
Action:		Apply Warning	g Labels

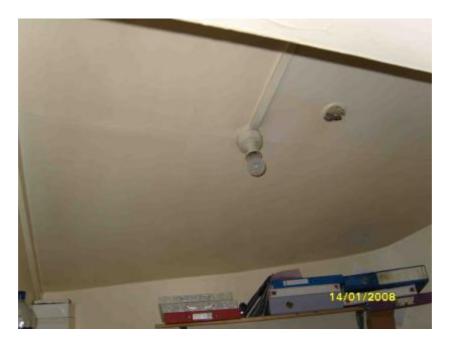
The White Hart Inn, Wrington Road, Congresbury,		lient Name:	Hall & Woo	odhouse Ltd	
	Somerset, BS49 5AR	Pr	roject Number:	AS08018 - White	Hart Congresbury	
		1				
Location ID:	9445	Survey Type:		T 2		
Location Ref:	6	Product Type:	A	Asbestos Insulating Board		
Product:	Ceiling panels	Damage:	Low o	Low damage: Scratches or marks		
Area:	Not Applicable	Treatment:	All	AIB painted or encapsulated		
Floor:	Ground floor	Asbestos Type	:	Amosite		
Room:	Office	Identification:		Presumed		
Surveyor Nam	e: J D Chilvers	Quantity:				
Drawing Ref:	6	Accessibility:		Easy Accessibility	/	
Asbestos ?	Yes					
Date:	14 January 2008			al Risk Score	6	
Next Inspection	n: 15 July 2008		Material Risk Band		Low Risk	
· · · · · · · · · · · · · · · · · · ·	····		Priorit	y Risk Score:	5	
Action:		Apply Warning	Labels

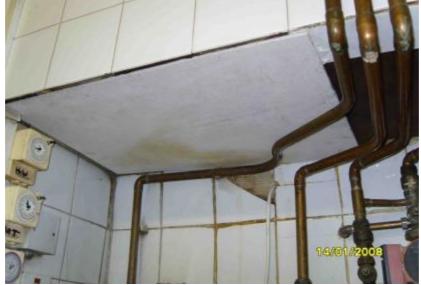
The White Hart Inn, Wrington Road, Congresbury, North Somerset, BS49 5AR		ent Name:	Hall & Woodhouse Ltd	
	Somerset, BS49 SAR	Pro	oject Number:	AS08018 - White	Hart Congresbury
Location ID:	9446	Survey Type:		T 2	
Location Ref:	7	Product Type:		NADIS	
Product:	Ceiling	Damage:		NADIS	
Area:	Not Applicable	Treatment:		NADIS	
Floor:	Ground floor	Asbestos Type:		NADIS	
Room:	Prep Room	Identification:		Identified	
Surveyor Nam	e: J D Chilvers	Quantity:			
Drawing Ref:	7	Accessibility:			
Asbestos ?	No				
Date:	14 January 2008			al Risk Score	0
Next Inspectio	n: Not Applicable		Materi	ial Risk Band:	NADIS
			Priorit	y Risk Score:	N/A
Action:		No Action Rec	quired		
	T

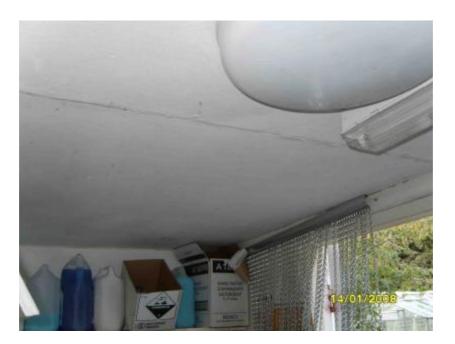
lient Name:	Hall & Woodhouse Ltd		
	The White Hart Inn, Wrington Road, Congresbur Somerset, BS49 5AR		roject Number:	AS08018 - White	Hart Congresbury	
Location ID:	9447	Survey Type:		T 2		
Location Ref:	8	Product Type:	A	Asbestos Insulating Board		
Product:	Ceiling panels	Damage:	Low	Low damage: Scratches or marks		
Area:	Not Applicable	Treatment:	AI	AIB painted or encapsulated		
Floor:	Ground floor	Asbestos Type	:	Amosite		
Room:	Kitchen	Identification:		Presumed		
Surveyor Name	J D Chilvers	Quantity:				
Drawing Ref:	8	Accessibility:		Easy Accessibility	ý	
Asbestos ?	Yes					
Date:	14 January 2008		Mater	ial Risk Score	6	
Next Inspectior	15 July 2008		Mater	ial Risk Band:	Low Risk	
			Priorit	y Risk Score:	5	
Action:		Apply Warning	g Labels

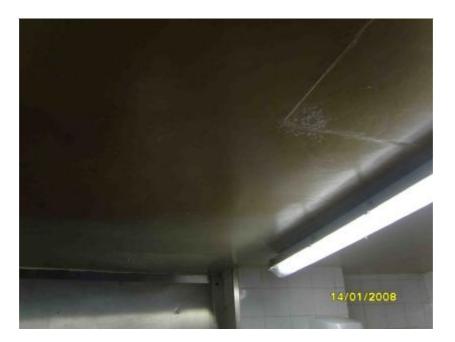
The White Hart Inn, Wrington Road, Congresbury,		ient Name:	Hall & Woo	odhouse Ltd	
	Somerset, BS49 5AR	Pr	oject Number:	AS08018 - White	Hart Congresbury	
Location ID:	9448	Survey Type:	Туре: Т 2			
Location Ref:	9	Product Type:	A	Asbestos Insulating Board		
Product:	Ceiling panels	Damage:	Low o	Low damage: Scratches or marks		
Area:	Not Applicable	Treatment:	Ale	AIB painted or encapsulated		
Floor:	Ground floor	Asbestos Type	:	Amosite		
Room:	Kitchen	Identification:		Presumed		
Surveyor Nam	e: J D Chilvers	Quantity:				
Drawing Ref:	9	Accessibility:		Easy Accessibility	1	
Asbestos ?	Yes					
Date:	14 January 2008		Materi	al Risk Score	6	
Next Inspectio	n: 15 July 2008		Materi	ial Risk Band:	Low Risk	
			Priorit	y Risk Score:	5	
Action:		Apply Warning	Labels

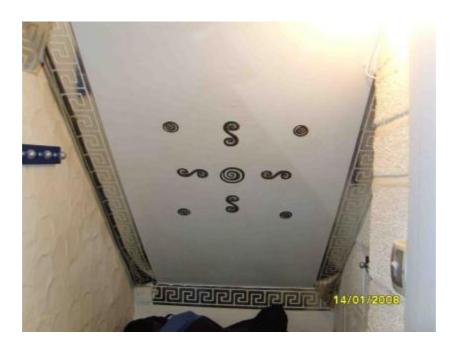
The White Hart Inn, Wrington Road, Congresbury, North Somerset, BS49 5AR		Client Name:	Hall & Woo	odhouse Ltd	
			Project Number:	AS08018 - White	Hart Congresbury	
Location ID:	9449	Survey Type:		T 2		
Location ID.						
Location Ref:	10	Product Type	: A	sbestos Insulating B	oard	
Product:	Stair Backing / Cladding	Damage:	Low o	Low damage: Scratches or marks		
Area:	Not Applicable	Treatment:	All	AIB painted or encapsulated		
Floor:	Ground floor	Asbestos Typ	e:	Amosite		
Room:	Understair Cupboard	Identification:		Identified		
Surveyor Name	J D Chilvers	Quantity:				
Drawing Ref:	10	Accessibility:		Easy Accessibility	/	
Asbestos ?	Yes					
Date:	14 January 2008		Materi	ial Risk Score	6	
Next Inspection	. 15 July 2008		Mater	ial Risk Band:	Low Risk	
тиелт пізресцоп			Priorit	y Risk Score:	4	
Action:		Apply Warnir	Labels

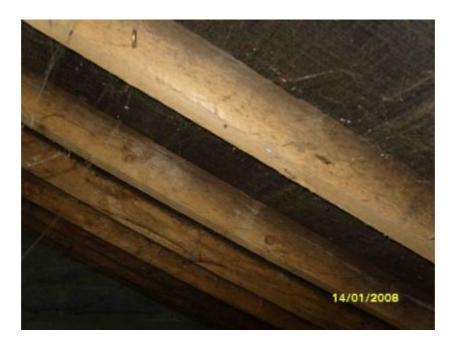
_			Clie	nt Name:	Hall & Wo	odhouse Ltd
	The White Hart Inn, Wrington Road, Congresbury, North Somerset, BS49 5AR					
			Proj	ect Number:	AS08018 - White	e Hart Congresbury
Location ID:	9450	Survey Ty	vpe:		T 2	
Location Ref:	11	Product T	ype:		Roofing felts	
Product:	Roofing felt	Damage:			No visible damag	e
Area:	Not Applicable	Treatmen	t:		Resins	
Floor:	Roof level	Asbestos	Туре:		Chrysotile	
Room:	Loft space	Identificat	ion:		Presumed	
Surveyor Name	e: J D Chilvers	Quantity:				
Drawing Ref:	11	Accessibil	ity:		Medium Accessibi	lity
Asbestos ?	Yes		_			
Date:	14 January 2008			Materi	ial Risk Score	2
Next Inspectior	13 January 2009	1		Mater	ial Risk Band:	Very Low Risk
				Priorit	y Risk Score:	2
Action:		Apply W	arning La	abels

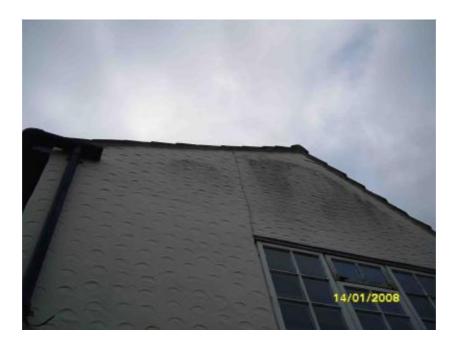
e White Hart Inn, Wrington Road, Congresbury, North merset, BS49 5AR		Client Name:	Hall & Woodhouse Ltd		
50			Project Number:	AS08018 - Whit	AS08018 - White Hart Congresbury	
Location ID:	9451	Survey Type:		T 2		
Location Ref:	12	Product Type	:	Asbestos cement		
Product:	Verge Undercloak	Damage:		No visible damage		
Area:	Not Applicable	Treatment:	As	Asbestos cement sheets etc Chrysotile Presumed		
Floor:	Roof level	Asbestos Typ	e:			
Room:	External	Identification:				
Surveyor Name:	J D Chilvers	Quantity:				
Drawing Ref:	12	Accessibility:		Difficult Accessibility		
Asbestos ?	Yes					
Date:	14 January 2008			ial Risk Score	3	
Next Inspection:	13 January 2009		Mater	ial Risk Band:	Very Low Risk	
· L			Priorit	y Risk Score:	2	
Action:		No Action F	Required

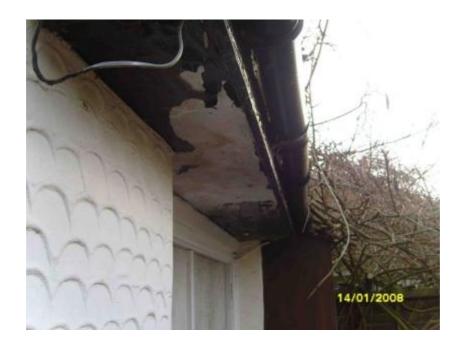
The White Hart Inn, Wrington Road, Congresbury,		ient Name:	Hall & Wo	odhouse Ltd	
	Somerset, BS49 5AR		Project Number: AS08018 -		- White Hart Congresbury	
Location ID:	9452	Survey Type:		T 2		
Location Ref:	13	Product Type:	A	sbestos Insulating E	loard	
Product:	Soffit	Damage:	Low o	lamage: Scratches	or marks	
Area:	Not Applicable	Treatment:	Ale	3 painted or encaps	ulated	
Floor:	Ground floor	Asbestos Type		Amosite		
Room:	External	Identification:		Presumed		
Surveyor Nam	e: J D Chilvers	Quantity:				
Drawing Ref:	13	Accessibility:		Easy Accessibilit	y	
Asbestos ?	Yes]	
Date:	14 January 2008		Materi	al Risk Score	6	
Next Inspection	n: 15 July 2008		Mater	al Risk Band:	Low Risk	
			Priorit	y Risk Score:	1	
Action:	Re-e	ncapsulate and App	ly Warning Labels
