**Asbestos Re-Inspection Survey for**  
Hall & Woodhouse Ltd  
**at**  
The Hankridge Arms  
Hankridge Way  
Riverside  
Taunton  
Somerset  
TA1 1LR

Project Number: AS04033 - Hankridge Arms

The survey was carried out on 31/7/2014 by John Chilvers

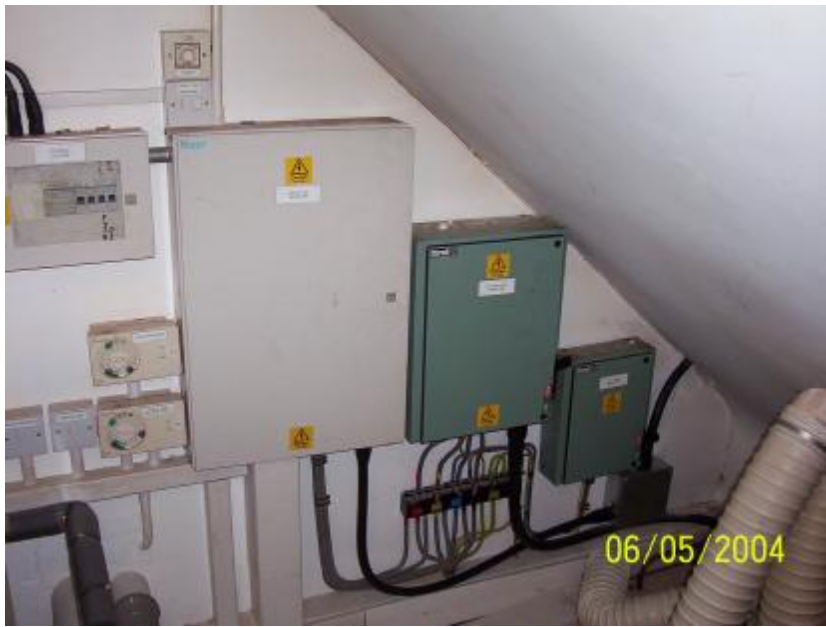
Location ID:	<input type="text" value="6727"/>	Survey Type:	<input type="text" value="MS"/>
Location Ref:	<input type="text" value="1"/>	Product Type:	<input type="text" value="Not Applicable"/>
Product:	<input type="text" value="Fuse &amp; Switchgear Flashguard"/>	Damage:	<input type="text" value="Not Applicable"/>
Area:	<input type="text" value="Not Applicable"/>	Treatment:	<input type="text" value="Not Applicable"/>
Floor:	<input type="text" value="Ground floor"/>	Asbestos Type:	<input type="text" value="Not Applicable"/>
Room:	<input type="text" value="Electrical cupboard"/>	Identification:	<input type="text"/>
Surveyor Name:	<input type="text" value="J D Chilvers"/>	Quantity:	<input type="text"/>

Drawing Ref:	<input type="text" value="1"/>		
Asbestos ?	<input type="text" value="No"/>		
Date:	<input type="text" value="06 May 2004"/>		
Next Inspection:	<input type="text" value="Not Applicable"/>

Material Risk Score:	<input type="text" value="0"/>
Material Risk Band:	<input type="text" value="Not Applicable"/>
Priority Risk Score:	<input type="text" value="N/A"/>

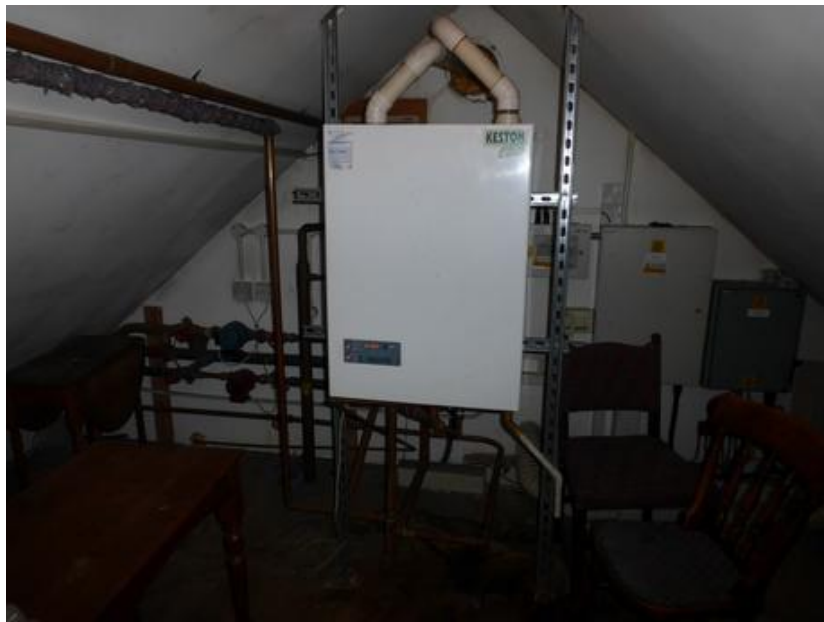
Location ID:	<input type="text" value="6728"/>	Survey Type:	<input type="text" value="MS"/>
Location Ref:	<input type="text" value="2"/>	Product Type:	<input type="text" value="Not Applicable"/>
Product:	<input type="text" value="Boiler"/>	Damage:	<input type="text" value="Not Applicable"/>
Area:	<input type="text" value="Not Applicable"/>	Treatment:	<input type="text" value="Not Applicable"/>
Floor:	<input type="text" value="Roof level"/>	Asbestos Type:	<input type="text" value="Not Applicable"/>
Room:	<input type="text" value="Boiler room"/>	Identification:	<input type="text"/>
Surveyor Name:	<input type="text" value="J D Chilvers"/>	Quantity:	<input type="text"/>
Drawing Ref:	<input type="text" value="2"/>		
Asbestos ?	<input type="text" value="No"/>		
Date:	<input type="text" value="06 May 2004"/>		
Next Inspection:	<input type="text" value="Not Applicable"/>

Material Risk Score:	<input type="text" value="0"/>
Material Risk Band:	<input type="text" value="Not Applicable"/>
Priority Risk Score:	<input type="text" value="N/A"/>

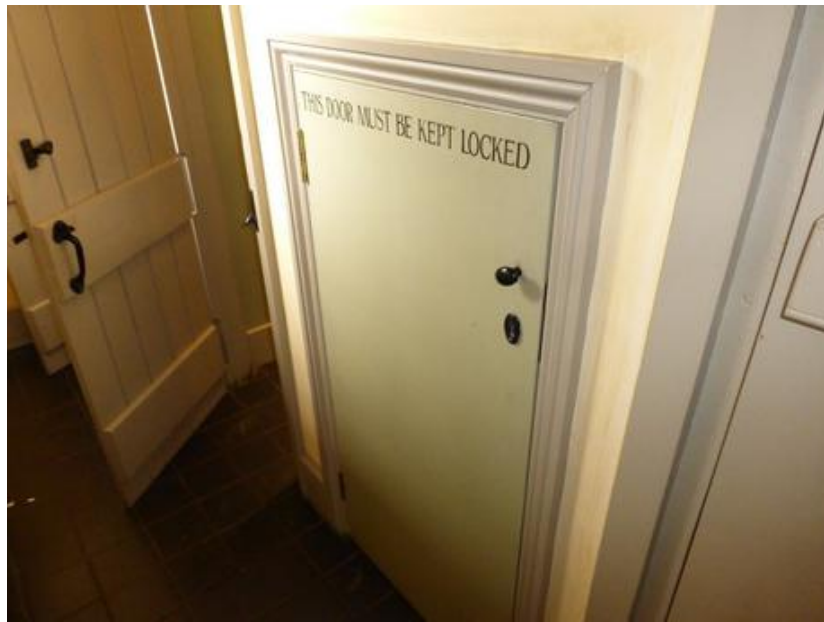
Location ID:	<input type="text" value="6730"/>	Survey Type:	<input type="text" value="MS"/>
Location Ref:	<input type="text" value="4"/>	Product Type:	<input type="text" value="Not Applicable"/>
Product:	<input type="text" value="Fire Door"/>	Damage:	<input type="text" value="Not Applicable"/>
Area:	<input type="text" value="Not Applicable"/>	Treatment:	<input type="text" value="Not Applicable"/>
Floor:	<input type="text" value="Ground floor"/>	Asbestos Type:	<input type="text" value="Not Applicable"/>
Room:	<input type="text" value="Understair Cupboard"/>	Identification:	<input type="text"/>
Surveyor Name:	<input type="text" value="J D Chilvers"/>	Quantity:	<input type="text"/>
Drawing Ref:	<input type="text" value="4"/>		
Asbestos ?	<input type="text" value="No"/>		
Date:	<input type="text" value="06 May 2004"/>		
Next Inspection:	<input type="text" value="Not Applicable"/>

Material Risk Score:	<input type="text" value="0"/>
Material Risk Band:	<input type="text" value="Not Applicable"/>
Priority Risk Score:	<input type="text" value="N/A"/>

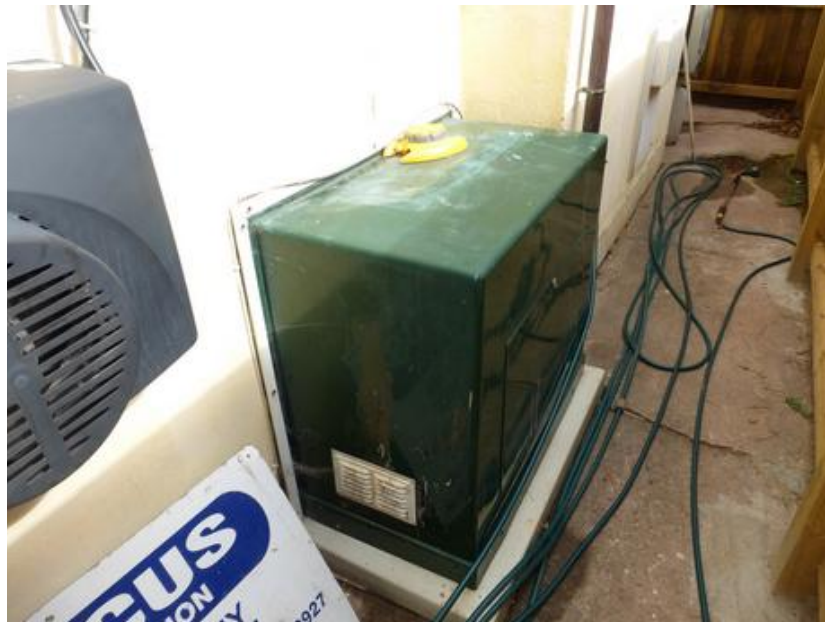
Location	Product type and name		Extent	Accessibility	Condition	Surface treatment	Asbestos Type	Sample	Sample no	Material Risk Score	Priority Risk Score	Total Score
Not Applicable, Ground floor, Gas cupboard	Gaskets	Gas meter		Difficult Accessibility	No visible damage	Composite asbestos materials	Chrysotile	Presumed	5	3		N/A

Location ID:	<input type="text" value="6731"/>	Survey Type:	<input type="text" value="RI"/>
Location Ref:	<input type="text" value="5"/>	Product Type:	<input type="text" value="Gaskets"/>
Product:	<input type="text" value="Gas meter"/>	Damage:	<input type="text" value="No visible damage"/>
Area:	<input type="text" value="Not Applicable"/>	Treatment:	<input type="text" value="Composite asbestos materials"/>
Floor:	<input type="text" value="Ground floor"/>	Asbestos Type:	<input type="text" value="Chrysotile"/>
Room:	<input type="text" value="Gas cupboard"/>	Identification:	<input type="text" value="Presumed"/>
Surveyor Name:	<input type="text" value="J D Chilvers"/>	Quantity:	<input type="text"/>

Drawing Ref:	<input type="text" value="5"/>		
Asbestos ?	<input type="text" value="Yes"/>		
Date:	<input type="text" value="31 July 2014"/>		
Next Inspection:	<input type="text" value="31 July 2015"/>

Material Risk Score:	<input type="text" value="3"/>
Material Risk Band:	<input type="text" value="Very Low Risk"/>
Priority Risk Score:	<input type="text" value="N/A"/>

31/07/14	5	6731	Not Applicable	Ground floor	Gas cupboard	Gaskets	Chrysotile	3	Gaskets presumed within gas meter		RI
2x Inspection(s) for Sample Number: 5

Sample Date	Location Ref	Location ID	Area	Floor	Room	Component	Asbestos Type	Material Risk Score	Comments	Action	Survey Type
06/05/04	1	6727	Not Applicable	Ground floor	Electrical cupboard	Not Applicable	Not Applicable	0		No Action Required	MS
1x Inspection(s) for Sample Number: 1											
06/05/04	2	6728	Not Applicable	Roof level	Boiler room	Not Applicable	Not Applicable	0	New boiler	No Action Required	MS
1x Inspection(s) for Sample Number: 2											
06/05/04	3	6729	Not Applicable	All	All	Not Applicable	Not Applicable	0	New doors	No Action Required	MS
1x Inspection(s) for Sample Number: 3											
06/05/04	4	6730	Not Applicable	Ground floor	Understair Cupboard	Not Applicable	Not Applicable	0	New door	No Action Required	MS
1x Inspection(s) for Sample Number: 4											
06/05/04	5	6731	Not Applicable	Ground floor	Gas cupboard	Gaskets	Chrysotile	3	Gaskets presumed within gas meter	Continuing monitoring at recommended frequencies	MS
