# **Asbestos Survey for**

**Hall & Woodhouse Ltd**

**The Halfway  
Bath Road  
Newbury  
Berkshire  
RG20 8NR**

**Project Number:** AS06053 - Halfway Newbury

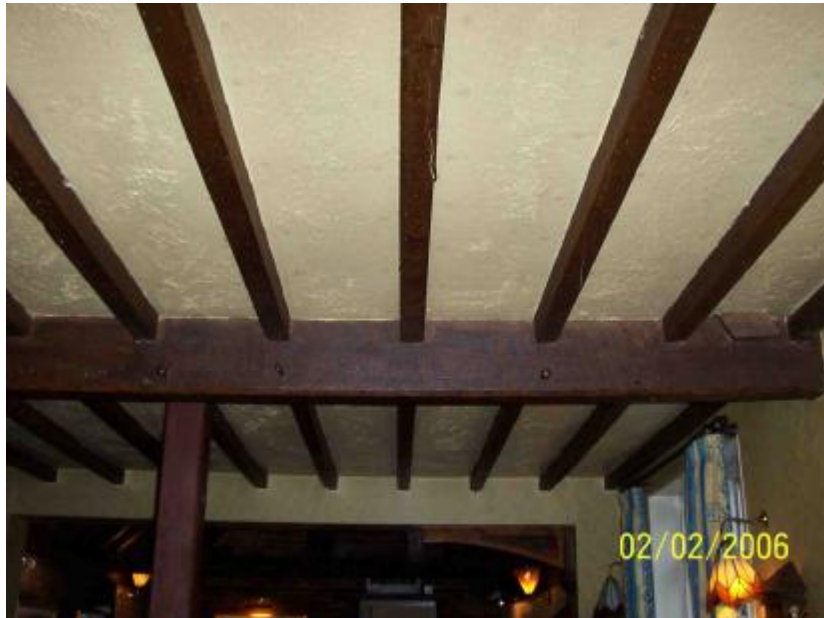
Location ID:	5561	Survey Type:	T 2
Location Ref:	1	Product Type:	NADIS
Product:	Textured coating	Damage:	NADIS
Area:	Not Applicable	Treatment:	NADIS
Floor:	Ground floor	Asbestos Type:	NADIS
Room:	Bar area	Identification:	Identified
Surveyor Name:	J D Chilvers	Quantity:	
Drawing Ref:	1	Accessibility:	
Asbestos ?	No		
Date:	02 February 2006		
Next Inspection:	Not Applicable

Priority Risk Score: N/A

Action: No Action Required

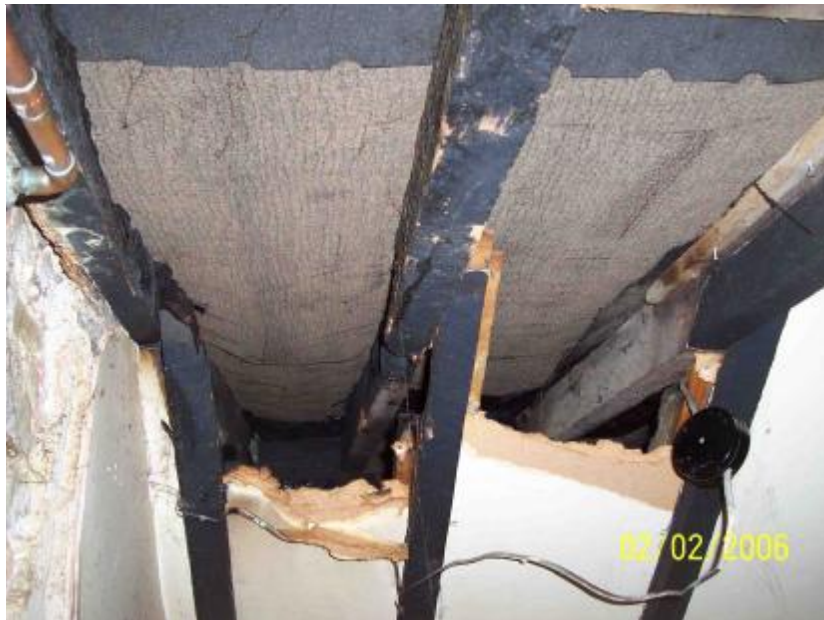
Location ID:	5562	Survey Type:	T 2
Location Ref:	2	Product Type:	Roofing felts
Product:	Roofing felt	Damage:	Low damage
Area:	Not Applicable	Treatment:	Resins
Floor:	Ground floor	Asbestos Type:	Chrysotile
Room:	Servery	Identification:	Presumed
Surveyor Name:	J D Chilvers	Quantity:	
Drawing Ref:	2	Accessibility:	Medium Accessibility
Asbestos ?	Yes		
Date:	02 February 2006		
Next Inspection:	02 February 2007

Priority Risk Score: 2

Action: No Action Required

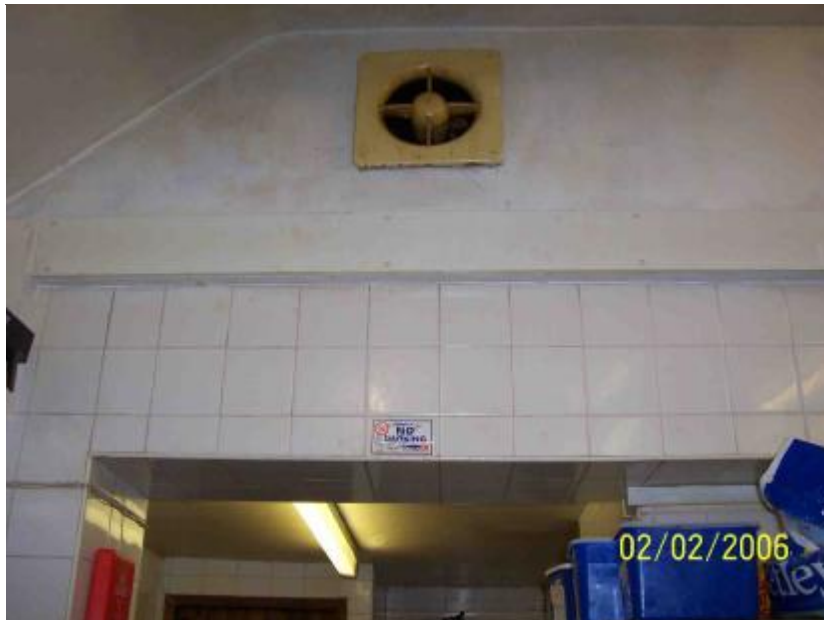
Location ID:	5563	Survey Type:	T 2
Location Ref:	3	Product Type:	Asbestos Insulating Board
Product:	Beam cladding	Damage:	No visible damage
Area:	Not Applicable	Treatment:	AIB painted or encapsulated
Floor:	Ground floor	Asbestos Type:	Amosite
Room:	Kitchen	Identification:	Presumed
Surveyor Name:	J D Chilvers	Quantity:	
Drawing Ref:	3	Accessibility:	Medium Accessibility
Asbestos ?	Yes		
Date:	02 February 2006		
Next Inspection:	04 August 2006

Priority Risk Score: 4

Material Comments: ACM's are presumed around all structural beams

Action: Apply Warning Labels

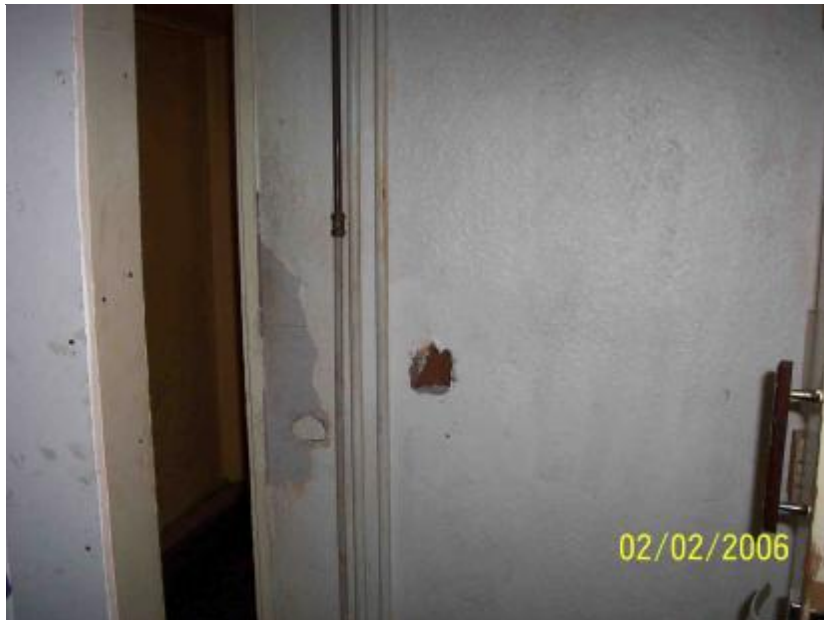
Location ID:	5564	Survey Type:	T 2
Location Ref:	4	Product Type:	Asbestos Insulating Board
Product:	Wall board	Damage:	Low damage: Broken edge boards
Area:	Not Applicable	Treatment:	Unsealed AIB
Floor:	Ground floor	Asbestos Type:	Amosite
Room:	Store Room	Identification:	Identified
Surveyor Name:	J D Chilvers	Quantity:	
Drawing Ref:	4	Accessibility:	Easy Accessibility
Asbestos ?	Yes		
Date:	02 February 2006		
Next Inspection:	03 May 2006

Priority Risk Score: 6

Action: Encapsulate and Apply Warning Labels

Material Comments: If material is not removed during refurbishment works, then the area must be physically protected and encapsulated during refurbishment works.

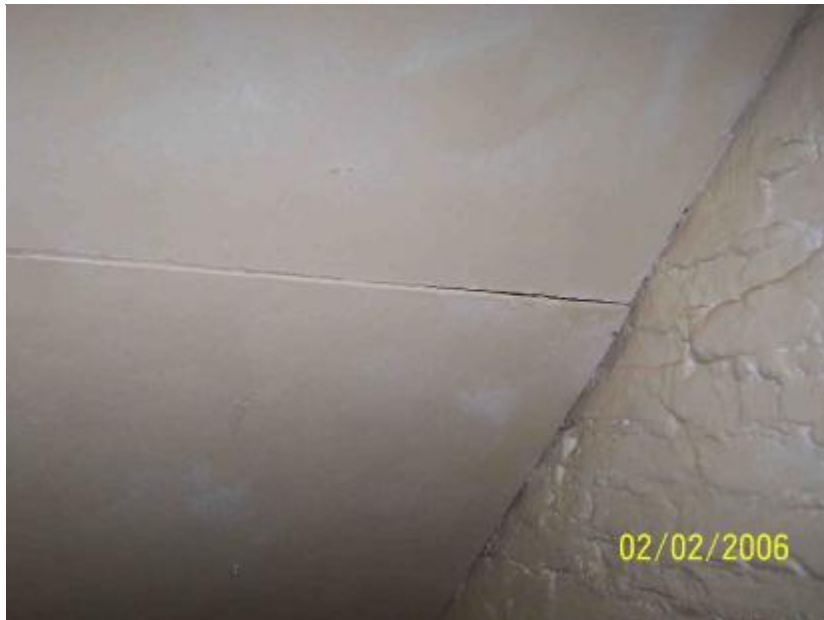
Location ID:	5565	Survey Type:	T 2
Location Ref:	5	Product Type:	NADIS
Product:	Stair Backing / Cladding	Damage:	NADIS
Area:	Not Applicable	Treatment:	NADIS
Floor:	Ground floor	Asbestos Type:	NADIS
Room:	Understair Cupboard	Identification:	Identified
Surveyor Name:	J D Chilvers	Quantity:	
Drawing Ref:	5	Accessibility:	
Asbestos ?	No		
Date:	02 February 2006		
Next Inspection:	Not Applicable

Priority Risk Score: N/A

Action: No Action Required

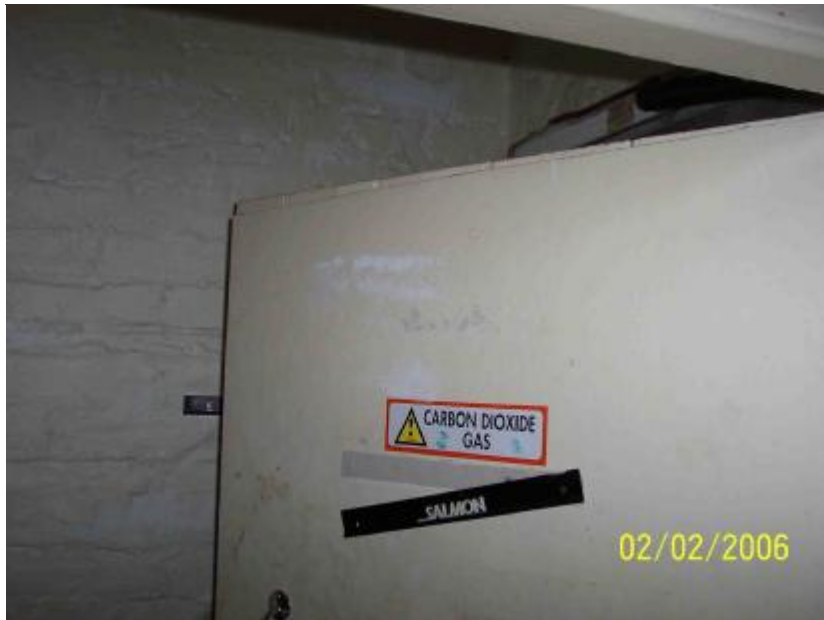
Location ID:	5566	Survey Type:	T 2
Location Ref:	6	Product Type:	NADIS
Product:	Door panel	Damage:	NADIS
Area:	Not Applicable	Treatment:	NADIS
Floor:	Ground floor	Asbestos Type:	NADIS
Room:	Store Room	Identification:	Identified
Surveyor Name:	J D Chilvers	Quantity:	
Drawing Ref:	6	Accessibility:	
Asbestos ?	No		
Date:	02 February 2006		
Next Inspection:	Not Applicable

Priority Risk Score: N/A

Action: No Action Required

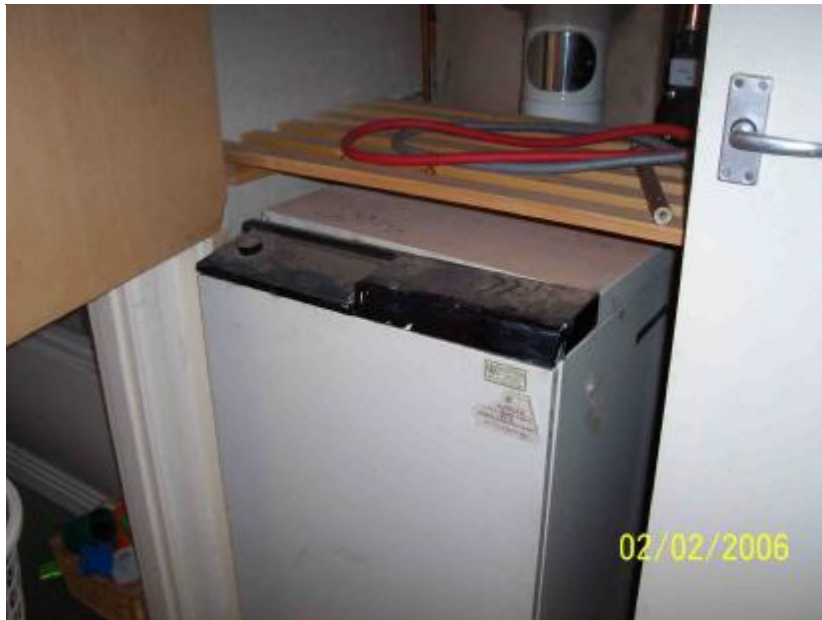
Location ID:	5567	Survey Type:	T 2
Location Ref:	7	Product Type:	Gaskets
Product:	Boiler	Damage:	No visible damage
Area:	Not Applicable	Treatment:	Composite asbestos materials
Floor:	First floor	Asbestos Type:	Chrysotile
Room:	Boiler cupboard	Identification:	Presumed
Surveyor Name:	J D Chilvers	Quantity:	
Drawing Ref:	7	Accessibility:	Medium Accessibility
Asbestos ?	Yes		
Date:	02 February 2006		
Next Inspection:	02 February 2007

Priority Risk Score: 3

Material Comments: Panelled surround is modern asbestos free material

Action: Apply Warning Labels

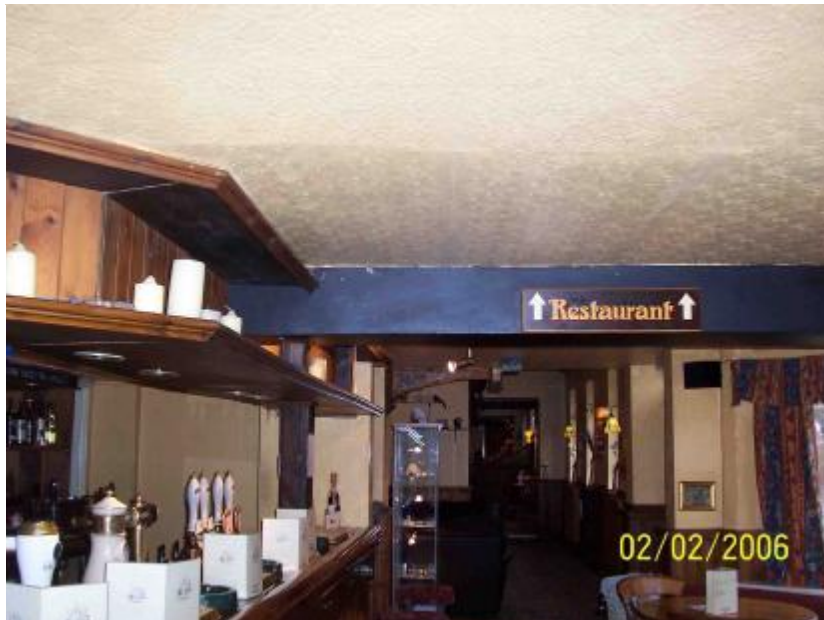
Location ID:	5568	Survey Type:	T 2
Location Ref:	8	Product Type:	Asbestos Insulating Board
Product:	Beam cladding	Damage:	No visible damage
Area:	Not Applicable	Treatment:	AIB painted or encapsulated
Floor:	Ground floor	Asbestos Type:	Amosite
Room:	Restaurant	Identification:	Presumed
Surveyor Name:	J D Chilvers	Quantity:	
Drawing Ref:	8	Accessibility:	Medium Accessibility
Asbestos ?	Yes		
Date:	02 February 2006		
Next Inspection:	04 August 2006

Priority Risk Score: 4

Material Comments: ACM's are presumed around all structural beams

Action: Apply Warning Labels

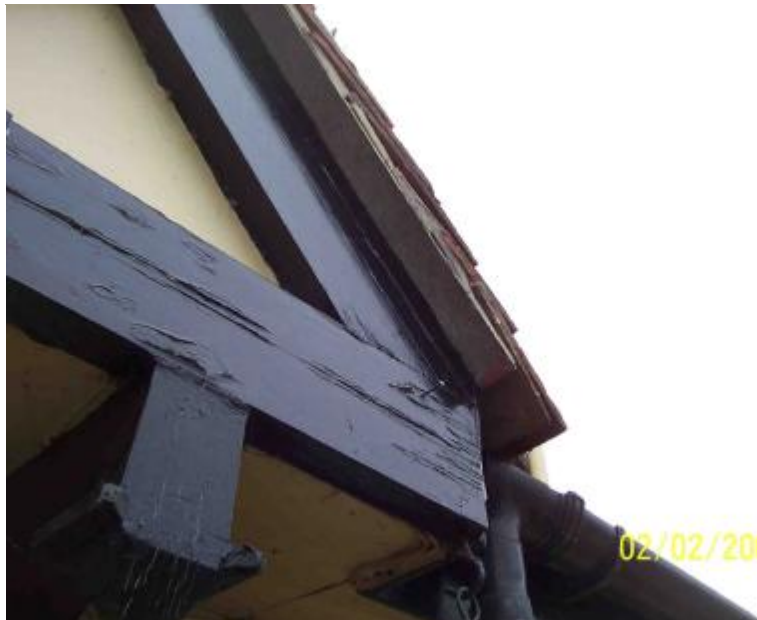
Location ID:	5569	Survey Type:	T 2
Location Ref:	9	Product Type:	Asbestos cement
Product:	Verge Undercloak	Damage:	No visible damage
Area:	Not Applicable	Treatment:	Asbestos cement sheets etc
Floor:	Ground floor	Asbestos Type:	Chrysotile
Room:	Porch	Identification:	Strongly Presumed
Surveyor Name:	J D Chilvers	Quantity:	
Drawing Ref:	9	Accessibility:	Easy Accessibility
Asbestos ?	Yes		
Date:	02 February 2006		
Next Inspection:	02 February 2007

Priority Risk Score: 2

Action: No Action Required

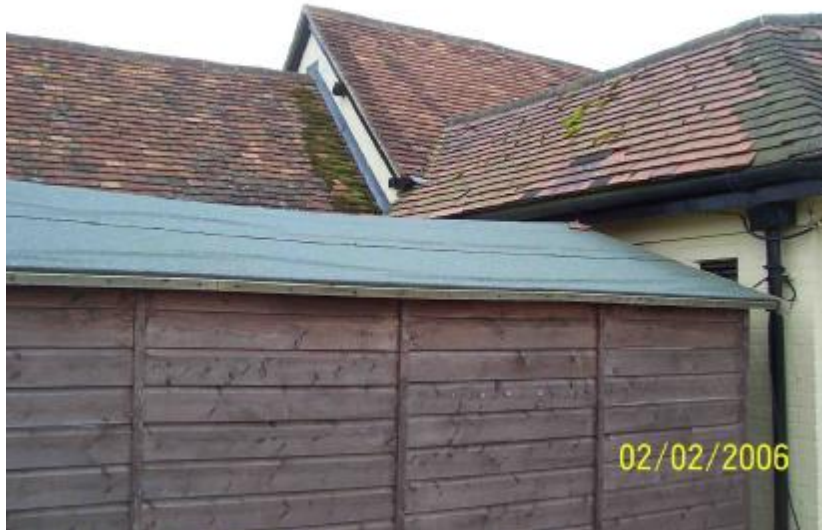
Location ID:	5570	Survey Type:	T 2
Location Ref:	10	Product Type:	Roofing felts
Product:	Roofing felt	Damage:	Low damage
Area:	Not Applicable	Treatment:	Resins
Floor:	Ground floor	Asbestos Type:	Chrysotile
Room:	Sheds / Outbuildings	Identification:	Presumed
Surveyor Name:	J D Chilvers	Quantity:	
Drawing Ref:	10	Accessibility:	Medium Accessibility
Asbestos ?	Yes		
Date:	02 February 2006		
Next Inspection:	02 February 2007

Priority Risk Score: 2

Action: No Action Required

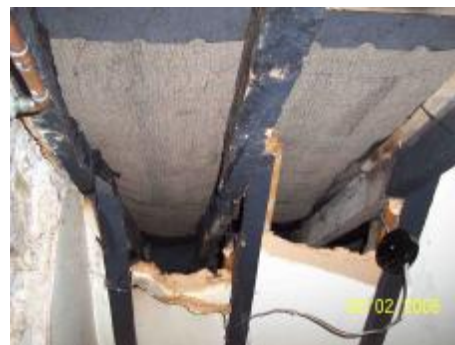
Location ID:	5562
Location Ref:	2
Product:	Roofing felt
Area:	Not Applicable
Floor:	Ground floor
Room:	Servery
Surveyor Name:	J D Chilvers
Drawing Ref:	2
Asbestos ?	Yes
Date:	02 February 2006

Priority Assessment Algorithm			
Assessment factor	Variable(s) selected	Score for each	Overall score
<b>Normal Occupant Activity:</b>			
Main type of activity in area:	Rare disturbance	0	average
Secondary activities for area:	Rare disturbance	0	0
<b>Likelihood Of Disturbance:</b>			
Location:	Rooms up to 100 m2	2	average 1
Accessibility:	Usually inaccessible or unlikely to be disturbed	0	
Extent/Amount:	>10 to <=50 (m2 or pipe run)	2	
<b>Human Exposure Potential:</b>			
Number of occupants:	1 to 3	1	average 0
Frequency of use of area:	Infrequent	0	
Average time area is in use:	<1 hour	0	
<b>Maintenance Activity:</b>			
Type of maintenance activity:	Minor disturbance	0	average
Frequency of maintenance activity	<=1 per year	1	1

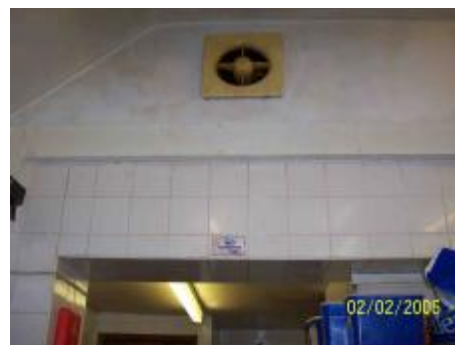
Location ID:	5563
Location Ref:	3
Product:	Beam cladding
Area:	Not Applicable
Floor:	Ground floor
Room:	Kitchen
Surveyor Name:	J D Chilvers
Drawing Ref:	3
Asbestos ?	Yes
Date:	02 February 2006

Priority Assessment Algorithm			
Assessment factor	Variable(s) selected	Score for each	Overall score
<b>Normal Occupant Activity:</b>			
Main type of activity in area:	Rare disturbance	0	average
Secondary activities for area:	Rare disturbance	0	0
<b>Likelihood Of Disturbance:</b>			
Location:	Large rooms or well-ventilated areas	1	average 1
Accessibility:	Occasionally likely to be disturbed	1	
Extent/Amount:	<=10 m2 or <=10 m pipe run	1	
<b>Human Exposure Potential:</b>			
Number of occupants:	1 to 3	1	average 2
Frequency of use of area:	Daily	3	
Average time area is in use:	>1 to <3 hours	1	
<b>Maintenance Activity:</b>			
Type of maintenance activity:	Minor disturbance	0	average
Frequency of maintenance activity	<=1 per year	1	1

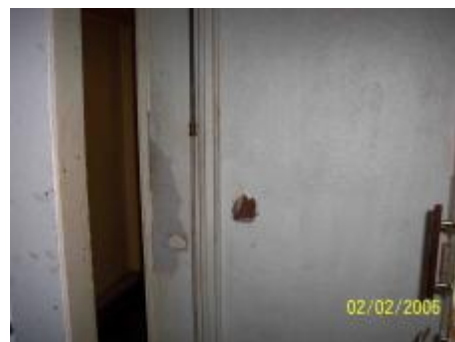
Location ID:	5564
Location Ref:	4
Product:	Wall board
Area:	Not Applicable
Floor:	Ground floor
Room:	Store Room
Surveyor Name:	J D Chilvers
Drawing Ref:	4
Asbestos ?	Yes
Date:	02 February 2006

Priority Assessment Algorithm			
Assessment factor	Variable(s) selected	Score for each	Overall score
<b>Normal Occupant Activity:</b>			
Main type of activity in area:	Periodic disturbance	2	average
Secondary activities for area:	Low disturbance	1	2
<b>Likelihood Of Disturbance:</b>			
Location:	Rooms up to 100 m2	2	average
Accessibility:	Occasionally likely to be disturbed	1	
Extent/Amount:	<=10 m2 or <=10 m pipe run	1	
<b>Human Exposure Potential:</b>			
Number of occupants:	1 to 3	1	average
Frequency of use of area:	Daily	3	
Average time area is in use:	>1 to <3 hours	1	
<b>Maintenance Activity:</b>			
Type of maintenance activity:	Low disturbance	1	average
Frequency of maintenance activity	<=1 per year	1	1

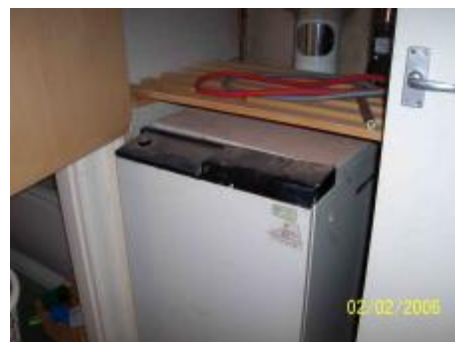
Location ID:	5567
Location Ref:	7
Product:	Boiler
Area:	Not Applicable
Floor:	First floor
Room:	Boiler cupboard
Surveyor Name:	J D Chilvers
Drawing Ref:	7
Asbestos ?	Yes
Date:	02 February 2006

Priority Assessment Algorithm			
Assessment factor	Variable(s) selected	Score for each	Overall score
<b>Normal Occupant Activity:</b>			
Main type of activity in area:	Rare disturbance	0	average
Secondary activities for area:	Rare disturbance	0	0
<b>Likelihood Of Disturbance:</b>			
Location:	Rooms up to 100 m2	2	average 1
Accessibility:	Usually inaccessible or unlikely to be disturbed	0	
Extent/Amount:	Small items strings gaskets	0	
<b>Human Exposure Potential:</b>			
Number of occupants:	1 to 3	1	average 1
Frequency of use of area:	Daily	3	
Average time area is in use:	<1 hour	0	
<b>Maintenance Activity:</b>			
Type of maintenance activity:	Minor disturbance	0	average
Frequency of maintenance activity	<=1 per year	1	1

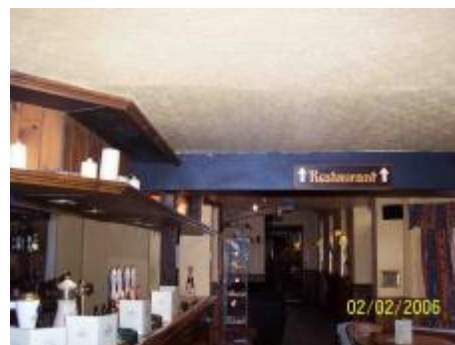
Location ID:	5568
Location Ref:	8
Product:	Beam cladding
Area:	Not Applicable
Floor:	Ground floor
Room:	Restaurant
Surveyor Name:	J D Chilvers
Drawing Ref:	8
Asbestos ?	Yes
Date:	02 February 2006

Priority Assessment Algorithm			
Assessment factor	Variable(s) selected	Score for each	Overall score
<b>Normal Occupant Activity:</b>			
Main type of activity in area:	Rare disturbance	0	average
Secondary activities for area:	Rare disturbance	0	0
<b>Likelihood Of Disturbance:</b>			
Location:	Large rooms or well-ventilated areas	1	average 1
Accessibility:	Occasionally likely to be disturbed	1	
Extent/Amount:	<=10 m2 or <=10 m pipe run	1	
<b>Human Exposure Potential:</b>			
Number of occupants:	1 to 3	1	average 2
Frequency of use of area:	Daily	3	
Average time area is in use:	>1 to <3 hours	1	
<b>Maintenance Activity:</b>			
Type of maintenance activity:	Minor disturbance	0	average
Frequency of maintenance activity	<=1 per year	1	1

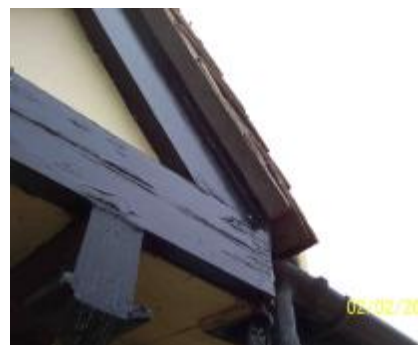
Location ID:	5569
Location Ref:	9
Product:	Verge Undercloak
Area:	Not Applicable
Floor:	Ground floor
Room:	Porch
Surveyor Name:	J D Chilvers
Drawing Ref:	9
Asbestos ?	Yes
Date:	02 February 2006

Priority Assessment Algorithm			
Assessment factor	Variable(s) selected	Score for each	Overall score
<b>Normal Occupant Activity:</b>			
Main type of activity in area:	Rare disturbance	0	average
Secondary activities for area:	Rare disturbance	0	0
<b>Likelihood Of Disturbance:</b>			
Location:	Outdoors	0	average 0
Accessibility:	Usually inaccessible or unlikely to be disturbed	0	
Extent/Amount:	<=10 m2 or <=10 m pipe run	1	
<b>Human Exposure Potential:</b>			
Number of occupants:	1 to 3	1	average 1
Frequency of use of area:	Daily	3	
Average time area is in use:	<1 hour	0	
<b>Maintenance Activity:</b>			
Type of maintenance activity:	Minor disturbance	0	average
Frequency of maintenance activity	<=1 per year	1	1

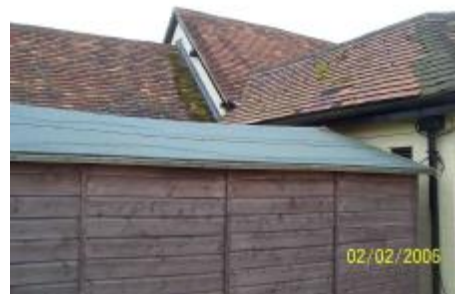
Location ID:	5570
Location Ref:	10
Product:	Roofing felt
Area:	Not Applicable
Floor:	Ground floor
Room:	Sheds / Outbuildings
Surveyor Name:	J D Chilvers
Drawing Ref:	10
Asbestos ?	Yes
Date:	02 February 2006

Priority Assessment Algorithm			
Assessment factor	Variable(s) selected	Score for each	Overall score
<b>Normal Occupant Activity:</b>			
Main type of activity in area:	Rare disturbance	0	average
Secondary activities for area:	Rare disturbance	0	0
<b>Likelihood Of Disturbance:</b>			
Location:	Outdoors	0	average 1
Accessibility:	Usually inaccessible or unlikely to be disturbed	0	
Extent/Amount:	>10 to <=50 (m2 or pipe run)	2	
<b>Human Exposure Potential:</b>			
Number of occupants:	1 to 3	1	average 0
Frequency of use of area:	Infrequent	0	
Average time area is in use:	<1 hour	0	
<b>Maintenance Activity:</b>			
Type of maintenance activity:	Minor disturbance	0	average
Frequency of maintenance activity	<=1 per year	1	1
