Asbestos Survey for

Hall & Woodhouse Ltd

Sweet Home Inn
25 Ringwood Road
Poole
Dorset
BH14 0RF

Project Number: AS04143 - Sweet Home Inn

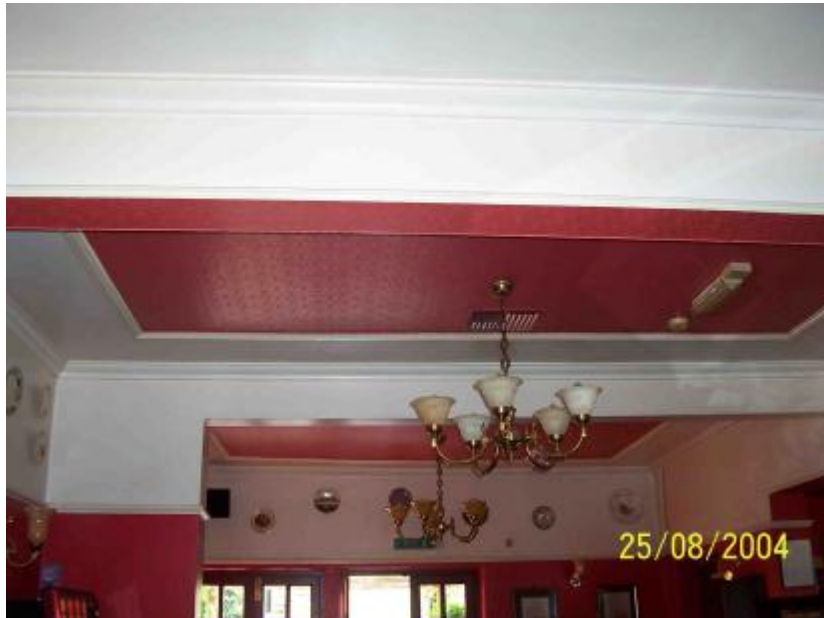
Location ID:	804	Survey Type:	T 2
Location Ref:	1	Product Type:	Asbestos Insulating Board
Product:	Beam cladding	Damage:	No visible damage
Area:	Not Applicable	Treatment:	AIB painted or encapsulated
Floor:	Ground floor	Asbestos Type:	Amosite
Room:	Bar area	Identification:	Presumed
Surveyor Name:	J D Chilvers	Quantity:	
Drawing Ref:	1	Accessibility:	Medium Accessibility
Asbestos ?	Yes		
Date:	25 August 2004		
Next Inspection:	24 February 2005

Material Risk Score	5
Material Risk Band:	Low Risk
Priority Risk Score:	6

Action:	Apply Warning Labels
---------	----------------------

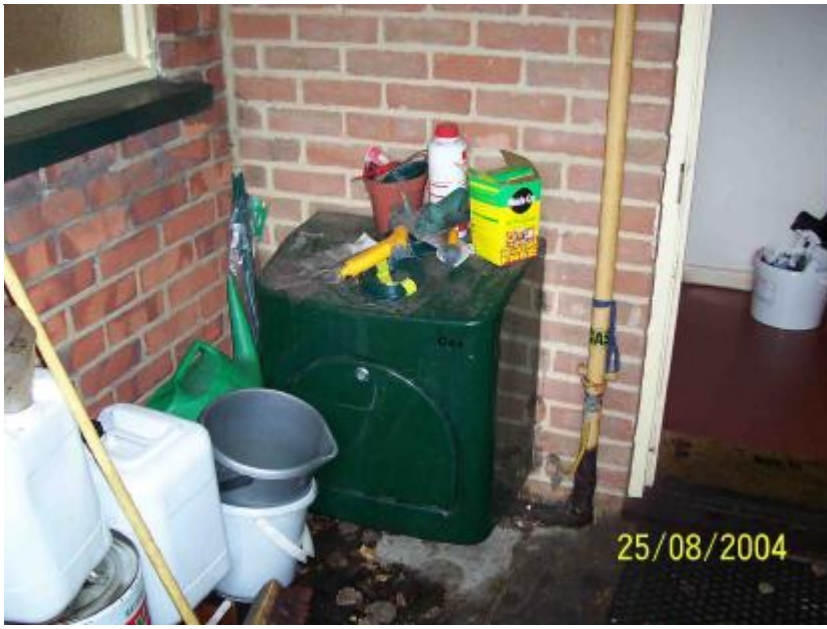
Location ID:	805	Survey Type:	T 2
Location Ref:	2	Product Type:	Gaskets
Product:	Gas meter	Damage:	No visible damage
Area:	Not Applicable	Treatment:	Composite asbestos materials
Floor:	External ground floor	Asbestos Type:	Chrysotile
Room:	Gas cupboard	Identification:	Presumed
Surveyor Name:	J D Chilvers	Quantity:	
Drawing Ref:	2	Accessibility:	Medium Accessibility
Asbestos ?	Yes		
Date:	25 August 2004		
Next Inspection:	25 August 2005

Material Risk Score	3
Material Risk Band:	Very Low Risk
Priority Risk Score:	1

Action: Apply Warning Labels

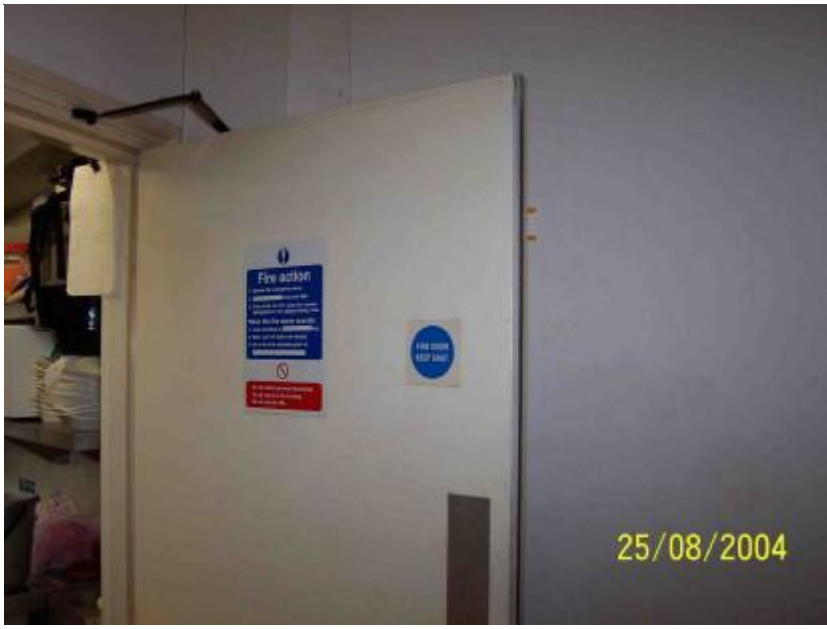
Location ID:	806	Survey Type:	T 2
Location Ref:	3	Product Type:	Asbestos cement
Product:	Fire Door	Damage:	No visible damage
Area:	Not Applicable	Treatment:	Asbestos cement sheets etc
Floor:	All Floors	Asbestos Type:	Chrysotile
Room:	All	Identification:	Presumed
Surveyor Name:	J D Chilvers	Quantity:	
Drawing Ref:	3 and others	Accessibility:	Medium Accessibility
Asbestos ?	Yes		
Date:	25 August 2004		
Next Inspection:	25 August 2005

Material Risk Score	3
Material Risk Band:	Very Low Risk
Priority Risk Score:	6

Action:	Apply Warning Labels
---------	----------------------

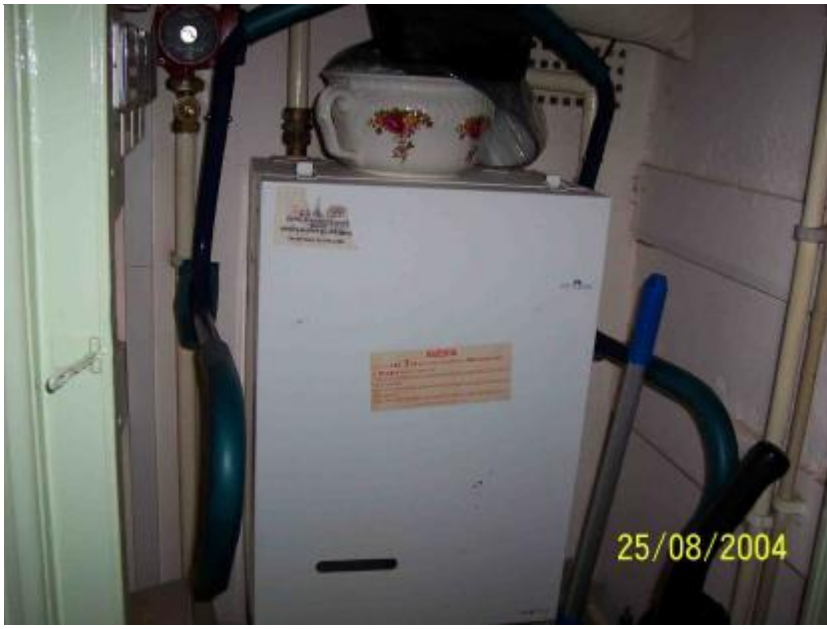
Location ID:	807	Survey Type:	T 2
Location Ref:	4	Product Type:	Gaskets
Product:	Boiler	Damage:	No visible damage
Area:	Not Applicable	Treatment:	Composite asbestos materials
Floor:	First floor	Asbestos Type:	Chrysotile
Room:	Boiler cupboard	Identification:	Presumed
Surveyor Name:	J D Chilvers	Quantity:	
Drawing Ref:	4	Accessibility:	Medium Accessibility
Asbestos ?	Yes		
Date:	25 August 2004	Material Risk Score:	3
Next Inspection:	25 August 2005	Material Risk Band:	Very Low Risk
		Priority Risk Score:	3

Action:	Apply Warning Labels
---------	----------------------

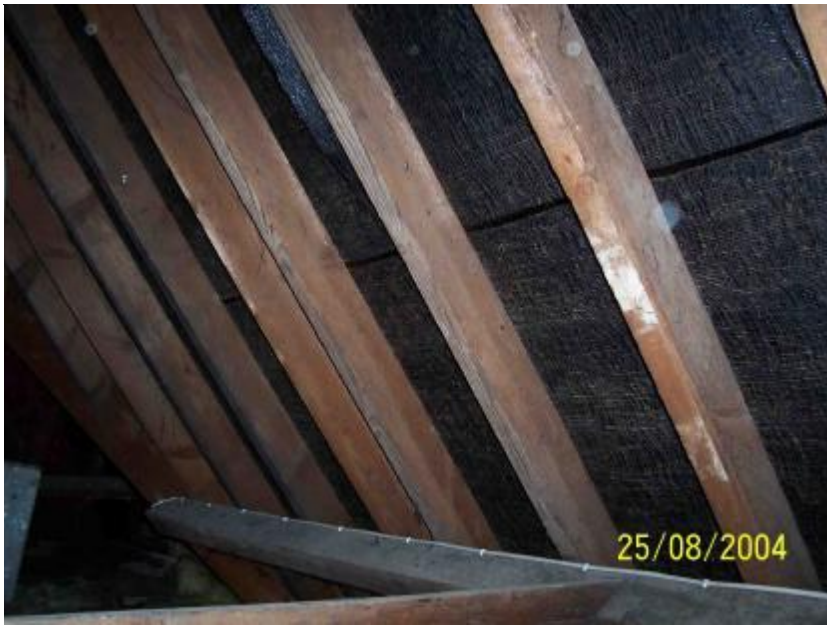
Location ID:	808	Survey Type:	T 2
Location Ref:	5	Product Type:	Roofing felts
Product:	Roofing felt	Damage:	No visible damage
Area:	Not Applicable	Treatment:	Resins
Floor:	Roof level	Asbestos Type:	Chrysotile
Room:	Loft space	Identification:	Presumed
Surveyor Name:	J D Chilvers	Quantity:	
Drawing Ref:	5	Accessibility:	Medium Accessibility
Asbestos ?	Yes		
Date:	25 August 2004	Material Risk Score:	2
Next Inspection:	25 August 2005	Material Risk Band:	Very Low Risk
		Priority Risk Score:	2

Action:	No Action Required
---------	--------------------

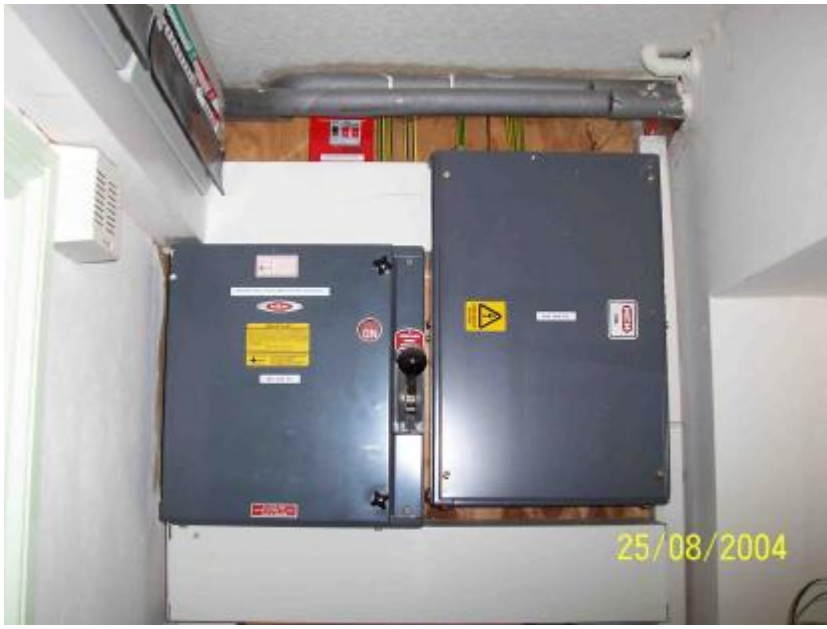
Location ID:	809	Survey Type:	T 2
Location Ref:	6	Product Type:	Ropes and woven textiles
Product:	Fuse & Switchgear Flashguard	Damage:	No visible damage
Area:	Not Applicable	Treatment:	Composite asbestos materials
Floor:	Ground floor	Asbestos Type:	Chrysotile
Room:	Kitchen	Identification:	Presumed
Surveyor Name:	J D Chilvers	Quantity:	
Drawing Ref:	6	Accessibility:	Medium Accessibility
Asbestos ?	Yes		
Date:	25 August 2004		
Next Inspection:	25 August 2005

Material Risk Score	3
Material Risk Band:	Very Low Risk
Priority Risk Score:	5

Action: Apply Warning Labels

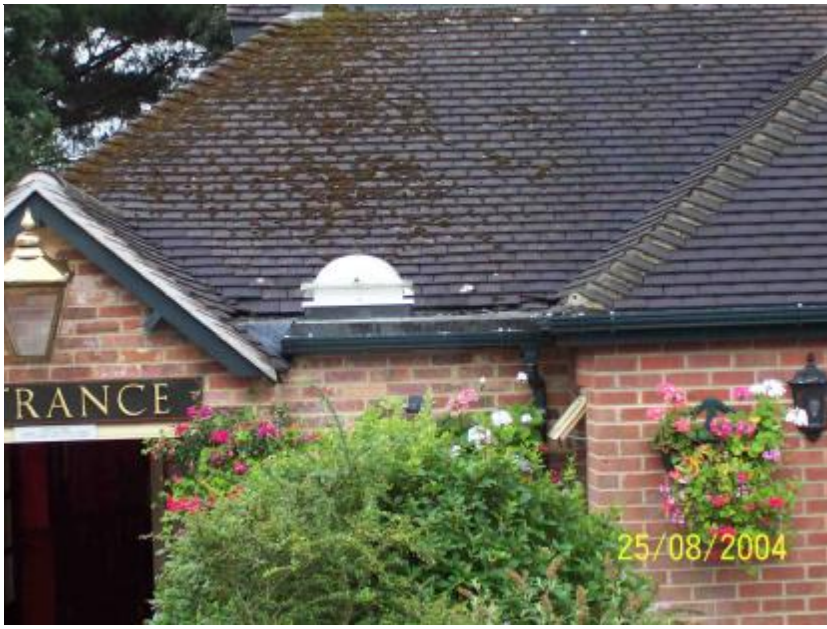
Location ID:	810	Survey Type:	T 2
Location Ref:	7	Product Type:	Roofing felts
Product:	Roofing felt	Damage:	No visible damage
Area:	Not Applicable	Treatment:	Resins
Floor:	External	Asbestos Type:	Chrysotile
Room:	Flat roof area	Identification:	Presumed
Surveyor Name:	J D Chilvers	Quantity:	
Drawing Ref:	7	Accessibility:	Medium Accessibility
Asbestos ?	Yes		
Date:	25 August 2004		
Next Inspection:	25 August 2005

Material Risk Score	2
Material Risk Band:	Very Low Risk
Priority Risk Score:	2

Action: No Action Required

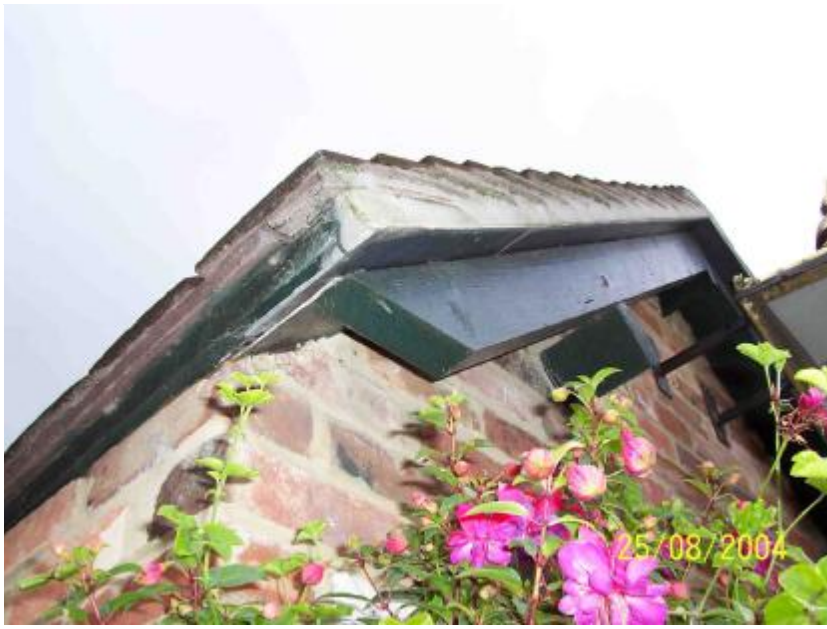
Location ID:	811	Survey Type:	T 2
Location Ref:	8	Product Type:	NADIS
Product:	Verge Undercloak	Damage:	NADIS
Area:	Not Applicable	Treatment:	NADIS
Floor:	Roof level	Asbestos Type:	NADIS
Room:	External	Identification:	Identified
Surveyor Name:	J D Chilvers	Quantity:	
Drawing Ref:	8	Accessibility:	
Asbestos ?	No		
Date:	25 August 2004		
Next Inspection:	Not Applicable

Material Risk Score	0
Material Risk Band:	NADIS
Priority Risk Score:	N/A

Action: No Action Required

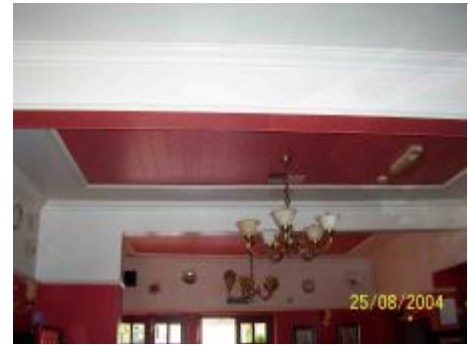
Location ID:	804
Location Ref:	1
Product:	Beam cladding
Area:	Not Applicable
Floor:	Ground floor
Room:	Bar area
Surveyor Name:	J D Chilvers
Drawing Ref:	1
Asbestos ?	Yes
Date:	25 August 2004

Priority Assessment Algorithm			
Assessment factor	Variable(s) selected	Score for each	Overall score
Normal Occupant Activity:			
Main type of activity in area:	Low disturbance	1	average
Secondary activities for area:	Low disturbance	1	1
Likelihood Of Disturbance:			
Location:	Large rooms or well-ventilated areas	1	
Accessibility:	Usually inaccessible or unlikely to be disturbed	0	average
Extent/Amount:	>10 to <=50 (m2 or pipe run)	2	1
Human Exposure Potential:			
Number of occupants:	>10	3	
Frequency of use of area:	Daily	3	average
Average time area is in use:	>3 to <6 hours	2	3
Maintenance Activity:			
Type of maintenance activity:	Low disturbance	1	average
Frequency of maintenance activity	<=1 per year	1	1

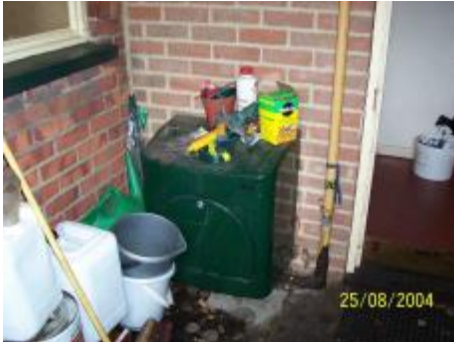
Location ID:	805
Location Ref:	2
Product:	Gas meter
Area:	Not Applicable
Floor:	External ground floor
Room:	Gas cupboard
Surveyor Name:	J D Chilvers
Drawing Ref:	2
Asbestos ?	Yes
Date:	25 August 2004

Priority Assessment Algorithm	Variable(s) selected	Score for each	Overall score
Normal Occupant Activity:			
Main type of activity in area:	Rare disturbance	0	average
Secondary activities for area:	Rare disturbance	0	0
Likelihood Of Disturbance:			
Location:	Outdoors	0	
Accessibility:	Usually inaccessible or unlikely to be disturbed	0	average
Extent/Amount:	Small items strings gaskets	0	0
Human Exposure Potential:			
Number of occupants:	None	0	
Frequency of use of area:	Monthly	1	average
Average time area is in use:	<1 hour	0	0
Maintenance Activity:			
Type of maintenance activity:	Minor disturbance	0	average
Frequency of maintenance activity	<=1 per year	1	1

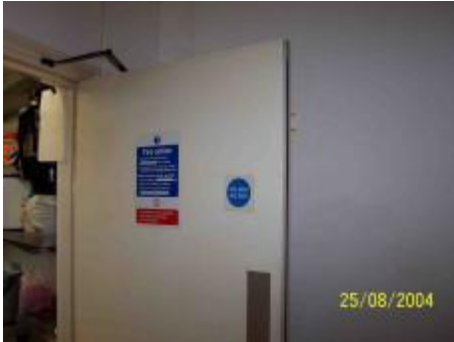
Location ID:	806
Location Ref:	3
Product:	Fire Door
Area:	Not Applicable
Floor:	All Floors
Room:	All
Surveyor Name:	J D Chilvers
Drawing Ref:	3 and others
Asbestos ?	Yes
Date:	25 August 2004

Priority Assessment Algorithm	Variable(s) selected	Score for each	Overall score
Normal Occupant Activity:			
Main type of activity in area:	Low disturbance	1	average
Secondary activities for area:	Low disturbance	1	1
Likelihood Of Disturbance:			
Location:	Rooms up to 100 m2	2	average
Accessibility:	Usually inaccessible or unlikely to be disturbed	0	
Extent/Amount:	<=10 m2 or <=10 m pipe run	1	
Human Exposure Potential:			
Number of occupants:	>10	3	average
Frequency of use of area:	Daily	3	
Average time area is in use:	>3 to <6 hours	2	
Maintenance Activity:			
Type of maintenance activity:	Minor disturbance	0	average
Frequency of maintenance activity	<=1 per year	1	1

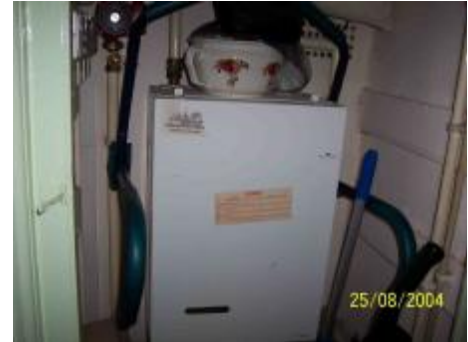
Location ID:	<input style="width: 95%;" type="text" value="807"/>
Location Ref:	<input style="width: 95%;" type="text" value="4"/>
Product:	<input style="width: 95%;" type="text" value="Boiler"/>
Area:	<input style="width: 95%;" type="text" value="Not Applicable"/>
Floor:	<input style="width: 95%;" type="text" value="First floor"/>
Room:	<input style="width: 95%;" type="text" value="Boiler cupboard"/>
Surveyor Name:	<input style="width: 95%;" type="text" value="J D Chilvers"/>
Drawing Ref:	<input style="width: 95%;" type="text" value="4"/>
Asbestos ?	<input style="width: 95%;" type="text" value="Yes"/>
Date:	<input style="width: 95%;" type="text" value="25 August 2004"/>

Priority Assessment Algorithm	Variable(s) selected	Score for each	Overall score
Normal Occupant Activity:			
Main type of activity in area:	Rare disturbance	0	average
Secondary activities for area:	Rare disturbance	0	0
Likelihood Of Disturbance:			
Location:	Confined spaces	3	average 1
Accessibility:	Usually inaccessible or unlikely to be disturbed	0	
Extent/Amount:	Small items strings gaskets	0	
Human Exposure Potential:			
Number of occupants:	None	0	average 1
Frequency of use of area:	Weekly	2	
Average time area is in use:	<1 hour	0	
Maintenance Activity:			
Type of maintenance activity:	Minor disturbance	0	average
Frequency of maintenance activity	<=1 per year	1	1

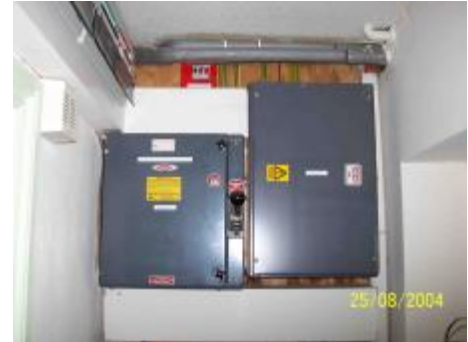
Location ID:	809
Location Ref:	6
Product:	Fuse & Switchgear Flashguard
Area:	Not Applicable
Floor:	Ground floor
Room:	Kitchen
Surveyor Name:	J D Chilvers
Drawing Ref:	6
Asbestos ?	Yes
Date:	25 August 2004

Priority Assessment Algorithm	Variable(s) selected	Score for each	Overall score
Normal Occupant Activity:			
Main type of activity in area:	Low disturbance	1	average
Secondary activities for area:	Low disturbance	1	1
Likelihood Of Disturbance:			
Location:	Large rooms or well-ventilated areas	1	average
Accessibility:	Occasionally likely to be disturbed	1	
Extent/Amount:	Small items strings gaskets	0	
Human Exposure Potential:			
Number of occupants:	1 to 3	1	average
Frequency of use of area:	Daily	3	
Average time area is in use:	>3 to <6 hours	2	
Maintenance Activity:			
Type of maintenance activity:	Low disturbance	1	average
Frequency of maintenance activity	<=1 per year	1	1

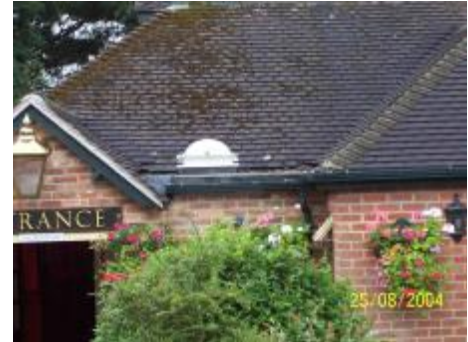
Location ID:	810
Location Ref:	7
Product:	Roofing felt
Area:	Not Applicable
Floor:	External
Room:	Flat roof area
Surveyor Name:	J D Chilvers
Drawing Ref:	7
Asbestos ?	Yes
Date:	25 August 2004

Priority Assessment Algorithm	Variable(s) selected	Score for each	Overall score
Normal Occupant Activity:			
Main type of activity in area:	Rare disturbance	0	average
Secondary activities for area:	Rare disturbance	0	0
Likelihood Of Disturbance:			
Location:	Outdoors	0	average 1
Accessibility:	Usually inaccessible or unlikely to be disturbed	0	
Extent/Amount:	>10 to <=50 (m2 or pipe run)	2	
Human Exposure Potential:			
Number of occupants:	None	0	average 0
Frequency of use of area:	Infrequent	0	
Average time area is in use:	<1 hour	0	
Maintenance Activity:			
Type of maintenance activity:	Low disturbance	1	average
Frequency of maintenance activity	<=1 per year	1	1
