Asbestos Refurbishment/Demolition Survey for

Hall & Woodhouse Ltd

The Gatwick
42 High Street
Horley
Surrey
RH6 7BB

Project Number: AS14014 - The Gatwick Refurb

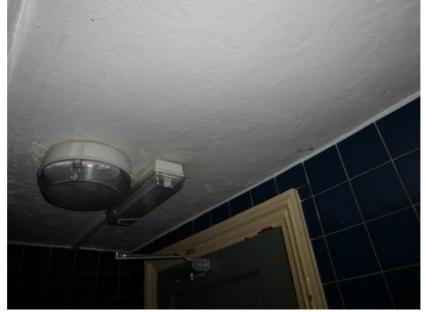
Site Address:	The Gatwick, 42 High Street, Horley, Surrey,		nt Name:	Hall & Woo	dhouse Ltd
		Proje	ect Number:	AS14014 - The	Gatwick Refurb
Location ID:	5588	Survey Type:		RDS	
Location Ref:	1	Product Type:		NADIS	
Product:	Textured coating	Damage:		NADIS	
Area:	Not Applicable	Treatment:		NADIS	
Floor:	Ground floor	Asbestos Type:		NADIS	
Room:	WC	Identification:		Identified	
Surveyor Name	J D Chilvers	Quantity:			
Drawing Ref:	1				
Asbestos ?	No				
Date:	07 February 2014			al Risk Score:	0
Next Inspection	n: Not Applicable			al Risk Band:	NADIS
			Priority	Risk Score:	N/A
Action:		No Action Requ	ired		
	1/2 / 5		Para Maria	1 1

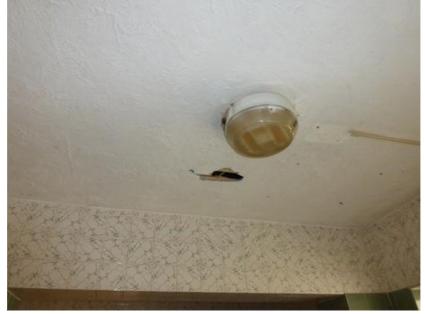
Site Address:	The Gatwick, 42 High Street, Horley, Surre		t Name:	Hall & Woodhouse Ltd
		Proje	ect Number:	S14014 - The Gatwick Refurb
Location ID:	5589	Survey Type:		RDS
Location Ref:	2	Product Type:		NADIS
Product:	Textured coating	Damage:		NADIS
Area:	Not Applicable	Treatment:		NADIS
Floor:	Ground floor	Asbestos Type:		NADIS
Room:	WC	Identification:		Identified
Surveyor Name	J D Chilvers	Quantity:		
Drawing Ref:	2			
Asbestos ?	No			
Date:	07 February 2014		Material R	
Next Inspection	Not Applicable		Material R	
			Priority Ris	sk Score: N/A
Action:		No Action Requi	red

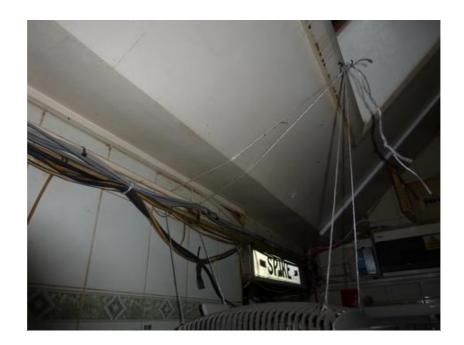
Location	Product type and	name	Extent	Accessibility	Condition	Surface treatment	Asbestos Type	Sample	Sample no	Material Risk Score	Priority Risk Score	Total Score
Not Applicable, Ground floor, Wash up area	Asbestos cement	Panel			No visible damage	Asbestos cement sheets etc	Chrysotile	Presumed	5	3		N/A

Site Address:	he Gatwick, 42 High Street, Horley, Surrey,	by: Location ID	Clie	ent Name:	Hall & Wo	odhouse Ltd
			Pro	ject Number:	AS14014 - The	e Gatwick Refurb
Location ID:	5592	Survey Typ	e:		RDS	
Location Ref:	5	Product Typ	oe:		Asbestos cemer	nt
Product:	Panel	Damage:			No visible damag	je
Area:	Not Applicable	Treatment:		Ast	pestos cement she	ets etc
Floor:	Ground floor	Asbestos T	ype:		Chrysotile	
Room:	Wash up area	Identificatio	n:		Presumed	
Surveyor Name:	J D Chilvers	Quantity:				
Drawing Ref:	5					
Asbestos ?	Yes					
Date:	07 February 2014			Materi	al Risk Score:	3
Next Inspection:	07 February 2015				ial Risk Band:	Very Low Risk
				Priority	y Risk Score:	N/A
Action:		No Actio	n Req	uired
