Asbestos Survey for

Hall & Woodhouse Ltd

The Lion
Nyetimber Lane
Pagham
Bognor Regis
West Sussex
PO21 3JX

Project Number: AS08020 - Lion

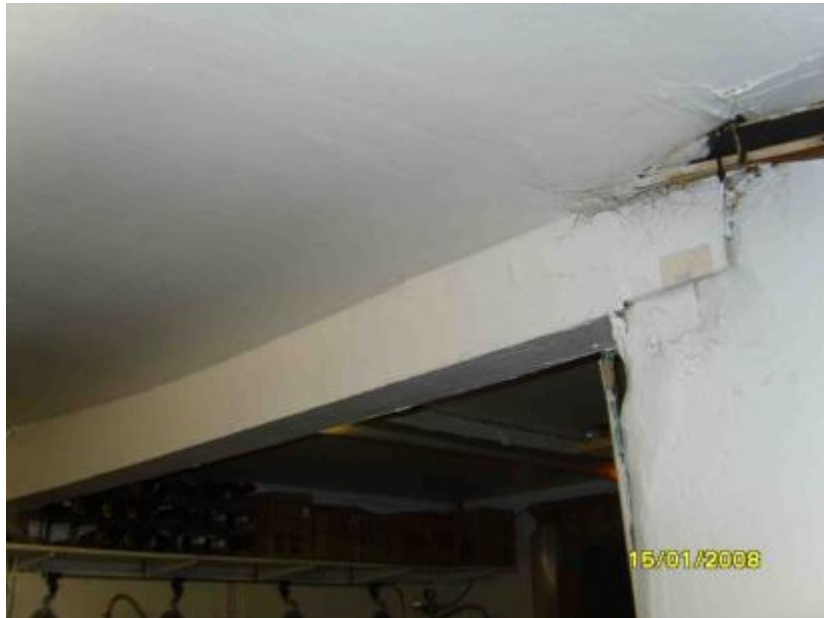
Location ID:	9703	Survey Type:	T 2
Location Ref:	1	Product Type:	NADIS
Product:	Beam cladding	Damage:	NADIS
Area:	Not Applicable	Treatment:	NADIS
Floor:	Ground floor	Asbestos Type:	NADIS
Room:	Cellar	Identification:	Identified
Surveyor Name:	J D Chilvers	Quantity:	
Drawing Ref:	1	Accessibility:	
Asbestos ?	No		
Date:	15 January 2008		
Next Inspection:	Not Applicable

Priority Risk Score: N/A

Action: No Action Required

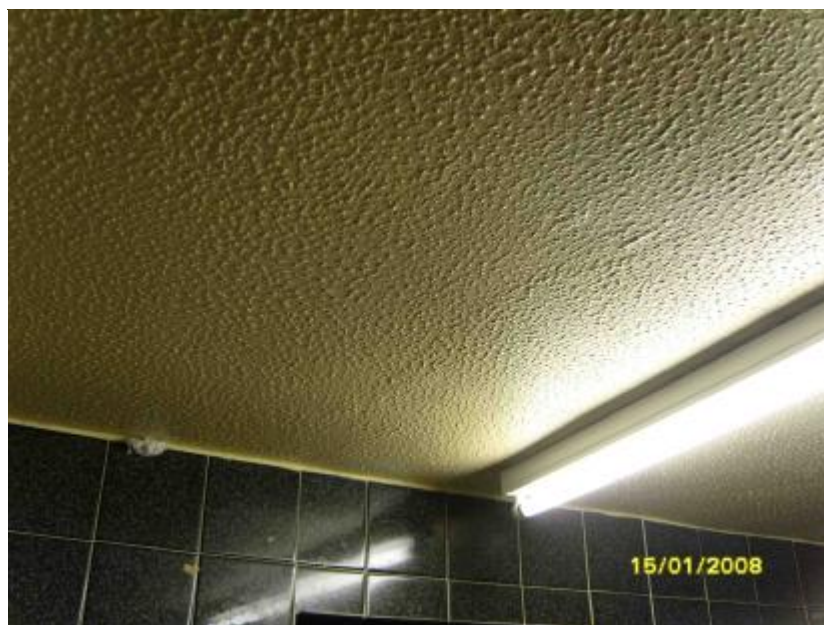
Location ID:	9704	Survey Type:	T 2
Location Ref:	2	Product Type:	Decorative finishes
Product:	Textured coating	Damage:	No visible damage
Area:	Not Applicable	Treatment:	Composite asbestos materials
Floor:	Ground floor	Asbestos Type:	Chrysotile
Room:	WC - mens	Identification:	Identified
Surveyor Name:	J D Chilvers	Quantity:	
Drawing Ref:	2	Accessibility:	Easy Accessibility
Asbestos ?	Yes		
Date:	15 January 2008		
Next Inspection:	14 January 2009

Priority Risk Score: 4

Action: Apply Warning Labels

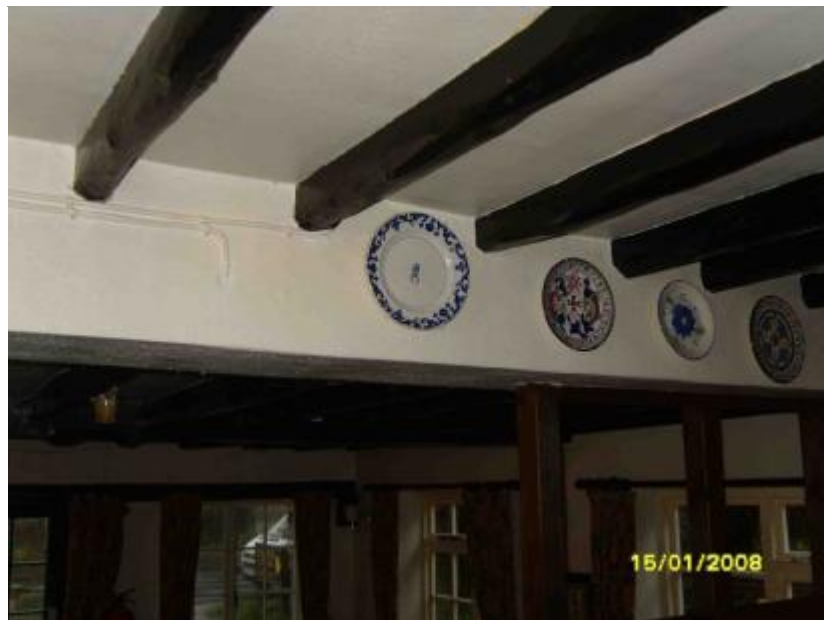
Location ID:	9706	Survey Type:	T 2
Location Ref:	4	Product Type:	Asbestos Insulating Board
Product:	Beam cladding	Damage:	No visible damage
Area:	Not Applicable	Treatment:	AIB painted or encapsulated
Floor:	Ground floor	Asbestos Type:	Amosite
Room:	Restaurant	Identification:	Presumed
Surveyor Name:	J D Chilvers	Quantity:	
Drawing Ref:	4	Accessibility:	Medium Accessibility
Asbestos ?	Yes		
Date:	15 January 2008		
Next Inspection:	16 July 2008

Priority Risk Score: 5

Material Comments: All structural beams are presumed to be clad with ACMs under external finishes unless otherwise stated.

Action: Apply Warning Labels

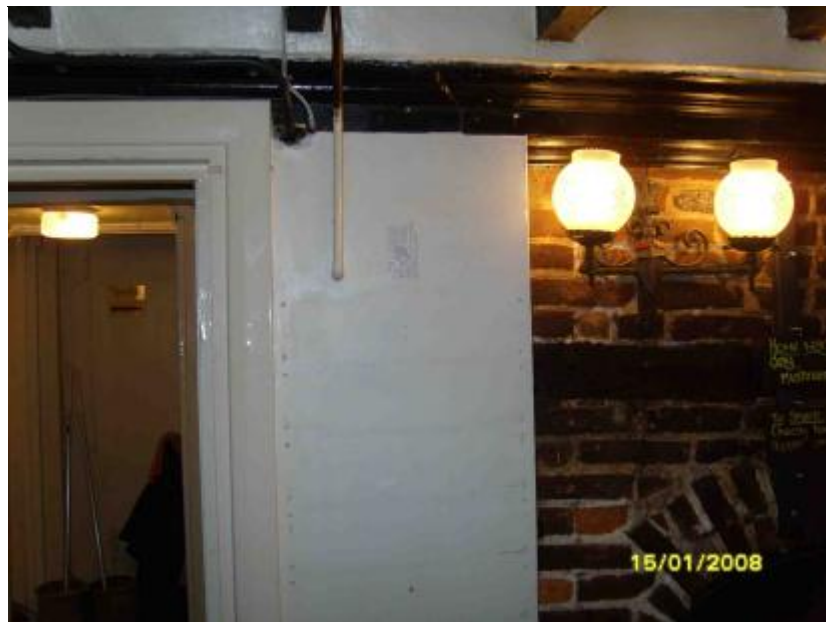
Location ID:	9707	Survey Type:	T 2
Location Ref:	5	Product Type:	Asbestos Insulating Board
Product:	Panel	Damage:	No visible damage
Area:	Not Applicable	Treatment:	AIB painted or encapsulated
Floor:	Ground floor	Asbestos Type:	Amosite
Room:	Bar area	Identification:	Identified
Surveyor Name:	J D Chilvers	Quantity:	
Drawing Ref:	5	Accessibility:	Easy Accessibility
Asbestos ?	Yes		
Date:	15 January 2008		
Next Inspection:	16 July 2008

Priority Risk Score: 6

Action: Apply Warning Labels

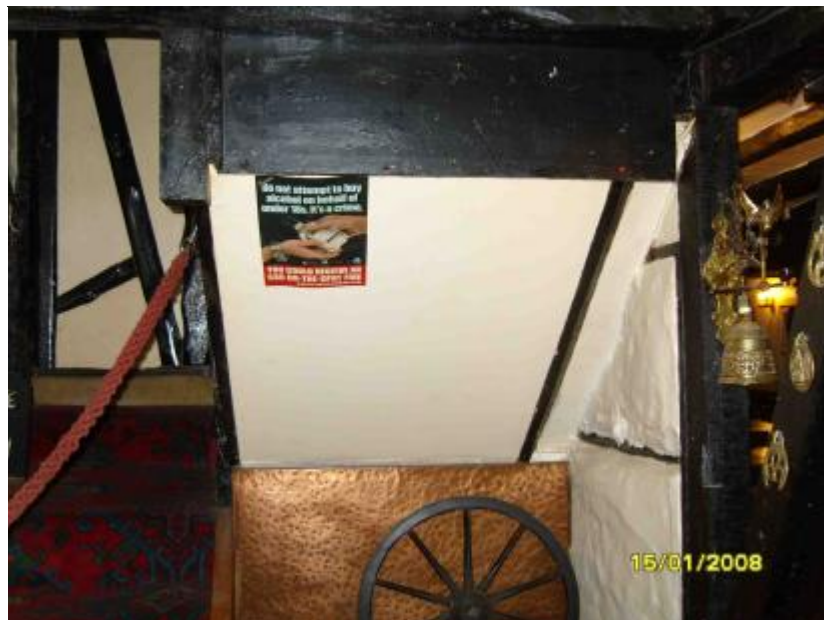
Location ID:	9708	Survey Type:	T 2
Location Ref:	6	Product Type:	Asbestos Insulating Board
Product:	Stair Backing / Cladding	Damage:	No visible damage
Area:	Not Applicable	Treatment:	AIB painted or encapsulated
Floor:	Ground floor	Asbestos Type:	Amosite
Room:	Bar area	Identification:	Identified
Surveyor Name:	J D Chilvers	Quantity:	
Drawing Ref:	6	Accessibility:	Easy Accessibility
Asbestos ?	Yes		
Date:	15 January 2008		
Next Inspection:	16 July 2008

Priority Risk Score: 6

Action: Apply Warning Labels

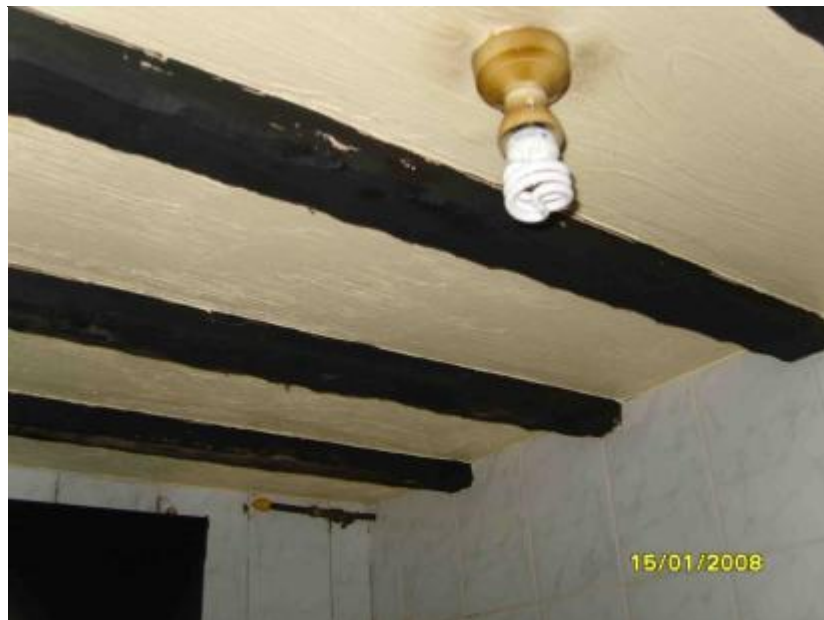
Location ID:	9709	Survey Type:	T 2
Location Ref:	7	Product Type:	NADIS
Product:	Textured coating	Damage:	NADIS
Area:	Not Applicable	Treatment:	NADIS
Floor:	Ground floor	Asbestos Type:	NADIS
Room:	WC - mens	Identification:	Identified
Surveyor Name:	J D Chilvers	Quantity:	
Drawing Ref:	7	Accessibility:	
Asbestos ?	No		
Date:	15 January 2008		
Next Inspection:	Not Applicable

Priority Risk Score: N/A

Action: No Action Required

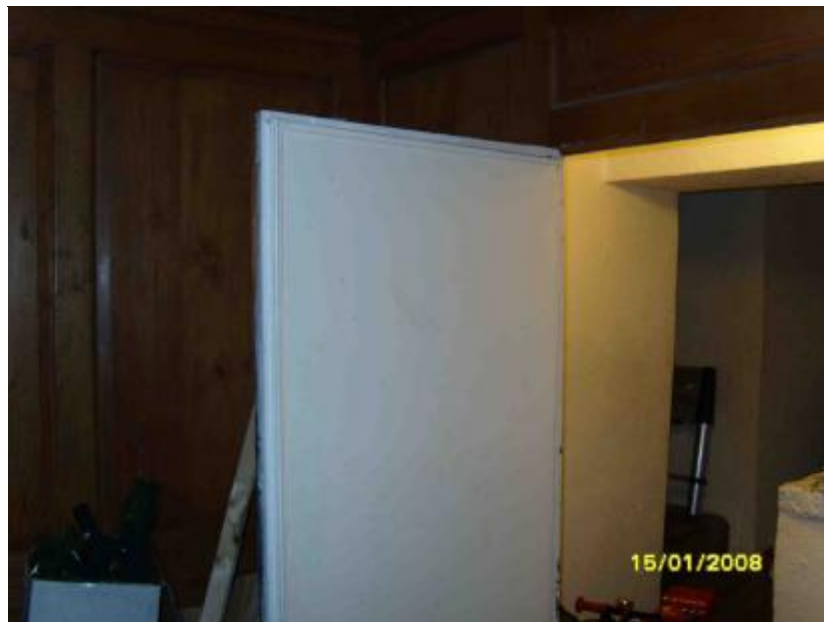
Location ID:	9710	Survey Type:	T 2
Location Ref:	8	Product Type:	Asbestos Insulating Board
Product:	Door panel	Damage:	No visible damage
Area:	Not Applicable	Treatment:	AIB painted or encapsulated
Floor:	First floor	Asbestos Type:	Amosite
Room:	Lounge	Identification:	Strongly Presumed
Surveyor Name:	J D Chilvers	Quantity:	
Drawing Ref:	8	Accessibility:	Easy Accessibility
Asbestos ?	Yes		
Date:	15 January 2008		
Next Inspection:	16 July 2008

Priority Risk Score: 5

Action: Encapsulate and Apply Warning Labels

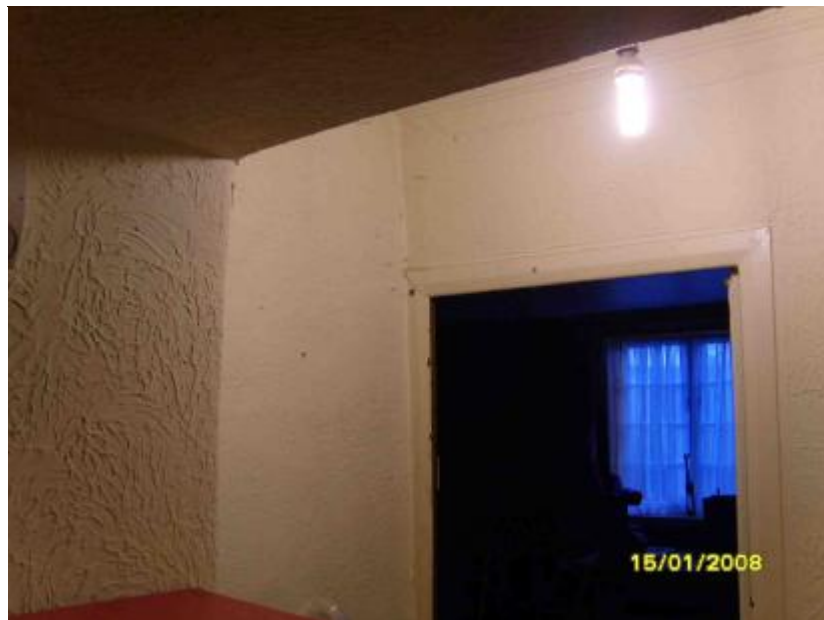
Location ID:	9711	Survey Type:	T 2
Location Ref:	9	Product Type:	Decorative finishes
Product:	Textured coating	Damage:	No visible damage
Area:	Not Applicable	Treatment:	Composite asbestos materials
Floor:	First floor	Asbestos Type:	Chrysotile
Room:	Passageway	Identification:	Presumed
Surveyor Name:	J D Chilvers	Quantity:	
Drawing Ref:	9	Accessibility:	Easy Accessibility
Asbestos ?	Yes		
Date:	15 January 2008		
Next Inspection:	14 January 2009

Material Risk Score	2
Material Risk Band:	Very Low Risk
Priority Risk Score:	4

Action: Apply Warning Labels

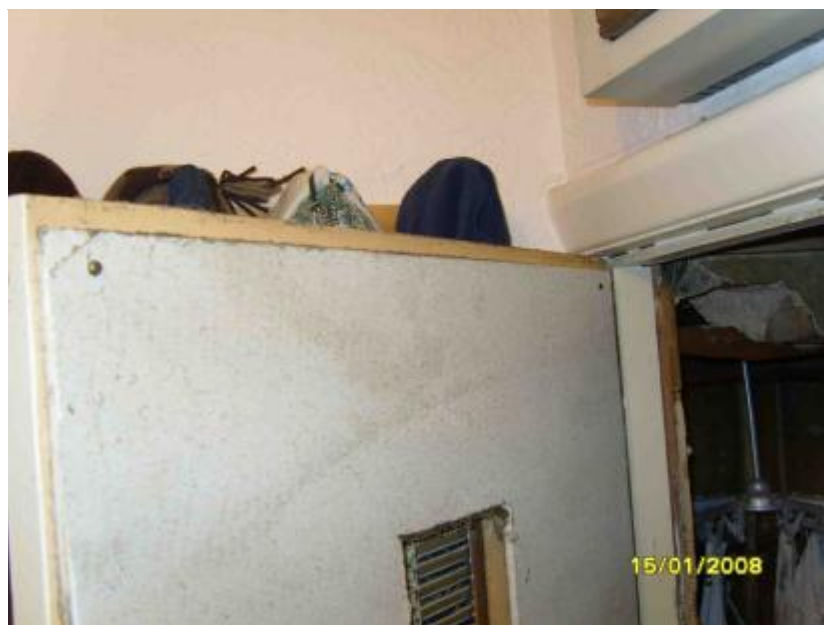
Location ID:	9712	Survey Type:	T 2
Location Ref:	10	Product Type:	Asbestos Insulating Board
Product:	Door panel	Damage:	No visible damage
Area:	Not Applicable	Treatment:	AIB painted or encapsulated
Floor:	First floor	Asbestos Type:	Amosite
Room:	Boiler cupboard	Identification:	Identified
Surveyor Name:	J D Chilvers	Quantity:	
Drawing Ref:	10	Accessibility:	Easy Accessibility
Asbestos ?	Yes		
Date:	15 January 2008		
Next Inspection:	16 July 2008

Priority Risk Score: 4

Action: Encapsulate and Apply Warning Labels

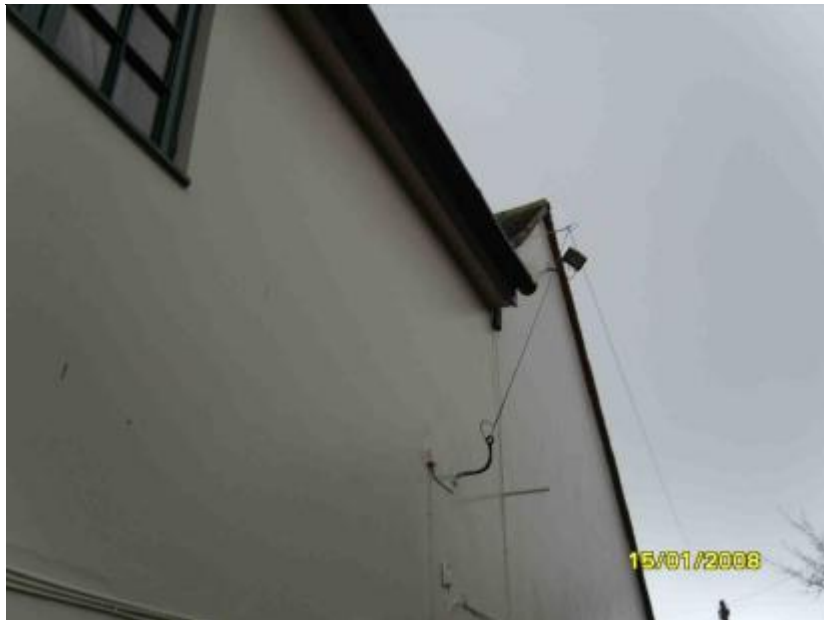
Location ID:	9713	Survey Type:	T 2
Location Ref:	11	Product Type:	Asbestos Insulating Board
Product:	Soffit	Damage:	No visible damage
Area:	Not Applicable	Treatment:	AIB painted or encapsulated
Floor:	Roof level	Asbestos Type:	Amosite
Room:	External	Identification:	Presumed
Surveyor Name:	J D Chilvers	Quantity:	
Drawing Ref:	11	Accessibility:	Difficult Accessibility
Asbestos ?	Yes		
Date:	15 January 2008		
Next Inspection:	16 July 2008

Priority Risk Score: 2

Action: Apply Warning Labels

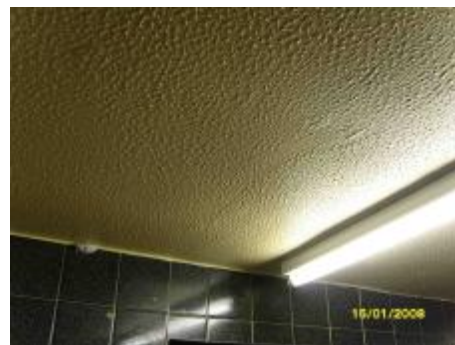
Location ID:	9704
Location Ref:	2
Product:	Textured coating
Area:	Not Applicable
Floor:	Ground floor
Room:	WC - mens
Surveyor Name:	J D Chilvers
Drawing Ref:	2
Asbestos ?	Yes
Date:	15 January 2008

Priority Assessment Algorithm			
Assessment factor	Variable(s) selected	Score for each	Overall score
Normal Occupant Activity:			
Main type of activity in area:	Low disturbance	1	average
Secondary activities for area:	Rare disturbance	0	1
Likelihood Of Disturbance:			
Location:	Rooms up to 100 m2	2	
Accessibility:	Usually inaccessible or unlikely to be disturbed	0	average
Extent/Amount:	<=10 m2 or <=10 m pipe run	1	1
Human Exposure Potential:			
Number of occupants:	1 to 3	1	
Frequency of use of area:	Daily	3	average
Average time area is in use:	<1 hour	0	1
Maintenance Activity:			
Type of maintenance activity:	Minor disturbance	0	average
Frequency of maintenance activity	<=1 per year	1	1

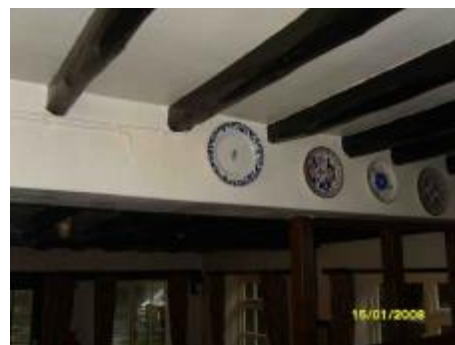
Location ID:	<div>9706</div>
Location Ref:	<div>4</div>
Product:	<div>Beam cladding</div>
Area:	<div>Not Applicable</div>
Floor:	<div>Ground floor</div>
Room:	<div>Restaurant</div>
Surveyor Name:	<div>J D Chilvers</div>
Drawing Ref:	<div>4</div>
Asbestos ?	<div>Yes</div>
Date:	<div>15 January 2008</div>

Priority Assessment Algorithm			
Assessment factor	Variable(s) selected	Score for each	Overall score
Normal Occupant Activity:			
Main type of activity in area:	Low disturbance	1	average
Secondary activities for area:	Low disturbance	1	1
Likelihood Of Disturbance:			
Location:	Large rooms or well-ventilated areas	1	average 1
Accessibility:	Usually inaccessible or unlikely to be disturbed	0	
Extent/Amount:	<=10 m2 or <=10 m pipe run	1	
Human Exposure Potential:			
Number of occupants:	>10	3	average 2
Frequency of use of area:	Daily	3	
Average time area is in use:	>1 to <3 hours	1	
Maintenance Activity:			
Type of maintenance activity:	Minor disturbance	0	average
Frequency of maintenance activity	<=1 per year	1	1

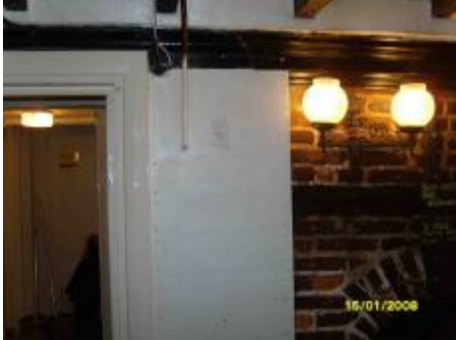
Location ID: <div style="border: 1px solid black; padding: 2px; display: inline-block;">9707</div> Location Ref: <div style="border: 1px solid black; padding: 2px; display: inline-block;">5</div> Product: <div style="border: 1px solid black; padding: 2px; display: inline-block;">Panel</div> Area: <div style="border: 1px solid black; padding: 2px; display: inline-block;">Not Applicable</div> Floor: <div style="border: 1px solid black; padding: 2px; display: inline-block;">Ground floor</div> Room: <div style="border: 1px solid black; padding: 2px; display: inline-block;">Bar area</div> Surveyor Name: <div style="border: 1px solid black; padding: 2px; display: inline-block;">J D Chilvers</div> Drawing Ref: <div style="border: 1px solid black; padding: 2px; display: inline-block;">5</div> Asbestos ? <div style="border: 1px solid black; padding: 2px; display: inline-block;">Yes</div> Date: <div style="border: 1px solid black; padding: 2px; display: inline-block;">15 January 2008</div>	<div style="border: 1px solid black; padding: 5px;">

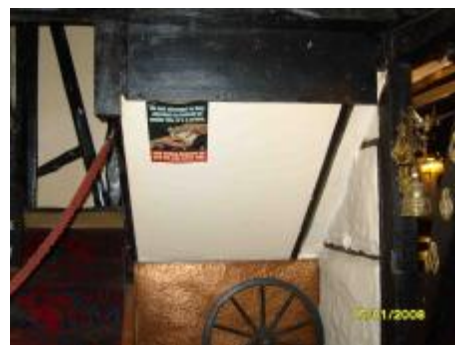
Location ID:	9708
Location Ref:	6
Product:	Stair Backing / Cladding
Area:	Not Applicable
Floor:	Ground floor
Room:	Bar area
Surveyor Name:	J D Chilvers
Drawing Ref:	6
Asbestos ?	Yes
Date:	15 January 2008

Priority Assessment Algorithm			
Assessment factor	Variable(s) selected	Score for each	Overall score
Normal Occupant Activity:			
Main type of activity in area:	Low disturbance	1	average
Secondary activities for area:	Low disturbance	1	1
Likelihood Of Disturbance:			
Location:	Large rooms or well-ventilated areas	1	
Accessibility:	Occasionally likely to be disturbed	1	average
Extent/Amount:	<=10 m2 or <=10 m pipe run	1	1
Human Exposure Potential:			
Number of occupants:	>10	3	
Frequency of use of area:	Daily	3	average
Average time area is in use:	>3 to <6 hours	2	3
Maintenance Activity:			
Type of maintenance activity:	Minor disturbance	0	average
Frequency of maintenance activity	<=1 per year	1	1

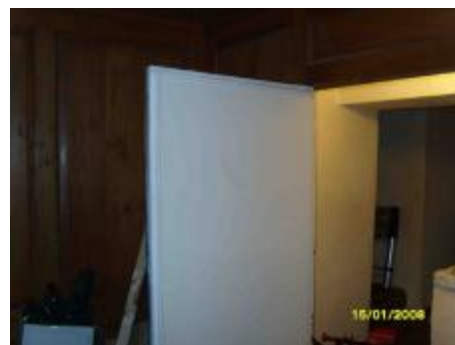
Location ID:	<div style="border: 1px solid black; padding: 2px; display: inline-block;">9710</div>
Location Ref:	<div style="border: 1px solid black; padding: 2px; display: inline-block;">8</div>
Product:	<div style="border: 1px solid black; padding: 2px; display: inline-block;">Door panel</div>
Area:	<div style="border: 1px solid black; padding: 2px; display: inline-block;">Not Applicable</div>
Floor:	<div style="border: 1px solid black; padding: 2px; display: inline-block;">First floor</div>
Room:	<div style="border: 1px solid black; padding: 2px; display: inline-block;">Lounge</div>
Surveyor Name:	<div style="border: 1px solid black; padding: 2px; display: inline-block;">J D Chilvers</div>

Priority Assessment Algorithm			
Assessment factor	Variable(s) selected	Score for each	Overall score
Normal Occupant Activity:			
Main type of activity in area:	Low disturbance	1	average 1
Secondary activities for area:	Rare disturbance	0	
Likelihood Of Disturbance:			
Location:	Rooms up to 100 m2	2	average 1
Accessibility:	Occasionally likely to be disturbed	1	
Extent/Amount:	<=10 m2 or <=10 m pipe run	1	
Human Exposure Potential:			
Number of occupants:	1 to 3	1	average 2
Frequency of use of area:	Daily	3	
Average time area is in use:	>3 to <6 hours	2	
Maintenance Activity:			
Type of maintenance activity:	Minor disturbance	0	average 1
Frequency of maintenance activity	<=1 per year	1

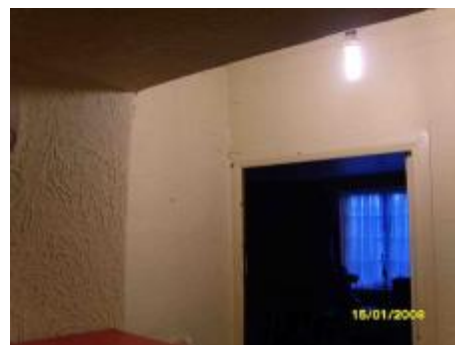
Location ID:	<div style="border: 1px solid black; padding: 2px;">9711</div>
Location Ref:	<div style="border: 1px solid black; padding: 2px;">9</div>
Product:	<div style="border: 1px solid black; padding: 2px;">Textured coating</div>
Area:	<div style="border: 1px solid black; padding: 2px;">Not Applicable</div>
Floor:	<div style="border: 1px solid black; padding: 2px;">First floor</div>
Room:	<div style="border: 1px solid black; padding: 2px;">Passageway</div>
Surveyor Name:	<div style="border: 1px solid black; padding: 2px;">J D Chilvers</div>
Drawing Ref:	<div style="border: 1px solid black; padding: 2px;">9</div>
Asbestos ?	<div style="border: 1px solid black; padding: 2px;">Yes</div>
Date:	<div style="border: 1px solid black; padding: 2px;">15 January 2008</div>

Priority Assessment Algorithm			
Assessment factor	Variable(s) selected	Score for each	Overall score
Normal Occupant Activity:			
Main type of activity in area:	Low disturbance	1	average 1
Secondary activities for area:	Rare disturbance	0	
Likelihood Of Disturbance:			
Location:	Rooms up to 100 m2	2	average 1
Accessibility:	Usually inaccessible or unlikely to be disturbed	0	
Extent/Amount:	<=10 m2 or <=10 m pipe run	1	
Human Exposure Potential:			
Number of occupants:	1 to 3	1	average 1
Frequency of use of area:	Daily	3	
Average time area is in use:	<1 hour	0	
Maintenance Activity:			
Type of maintenance activity:	Minor disturbance	0	average 1
Frequency of maintenance activity	<=1 per year	1

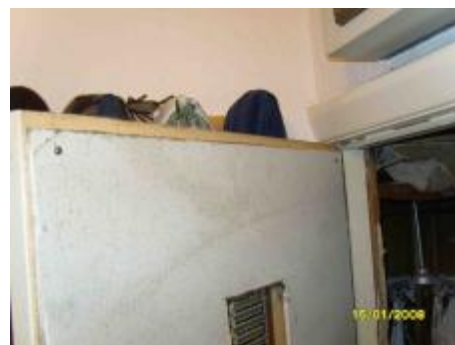
Location ID:	<div>9712</div>
Location Ref:	<div>10</div>
Product:	<div>Door panel</div>
Area:	<div>Not Applicable</div>
Floor:	<div>First floor</div>
Room:	<div>Boiler cupboard</div>
Surveyor Name:	<div>J D Chilvers</div>
Drawing Ref:	<div>10</div>
Asbestos ?	<div>Yes</div>
Date:	<div>15 January 2008</div>

Priority Assessment Algorithm			
Assessment factor	Variable(s) selected	Score for each	Overall score
Normal Occupant Activity:			
Main type of activity in area:	Low disturbance	1	average
Secondary activities for area:	Rare disturbance	0	1
Likelihood Of Disturbance:			
Location:	Rooms up to 100 m2	2	average 1
Accessibility:	Occasionally likely to be disturbed	1	
Extent/Amount:	<=10 m2 or <=10 m pipe run	1	
Human Exposure Potential:			
Number of occupants:	1 to 3	1	average 1
Frequency of use of area:	Daily	3	
Average time area is in use:	<1 hour	0	
Maintenance Activity:			
Type of maintenance activity:	Minor disturbance	0	average
Frequency of maintenance activity	<=1 per year	1	1

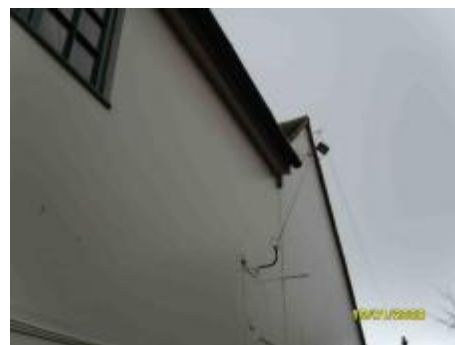
Location ID:	9713
Location Ref:	11
Product:	Soffit
Area:	Not Applicable
Floor:	Roof level
Room:	External
Surveyor Name:	J D Chilvers
Drawing Ref:	11
Asbestos ?	Yes
Date:	15 January 2008

Priority Assessment Algorithm			
Assessment factor	Variable(s) selected	Score for each	Overall score
Normal Occupant Activity:			
Main type of activity in area:	Rare disturbance	0	average
Secondary activities for area:	Rare disturbance	0	0
Likelihood Of Disturbance:			
Location:	Outdoors	0	average 1
Accessibility:	Usually inaccessible or unlikely to be disturbed	0	
Extent/Amount:	>10 to <=50 (m2 or pipe run)	2	
Human Exposure Potential:			
Number of occupants:	None	0	average 0
Frequency of use of area:	Infrequent	0	
Average time area is in use:	<1 hour	0	
Maintenance Activity:			
Type of maintenance activity:	Minor disturbance	0	average 1
Frequency of maintenance activity	<=1 per year	1
