Asbestos Survey for

Hall & Woodhouse Ltd

The Queens Head
North Street
Broadchalke
Salisbury
Wiltshire
SP5 5EN

Project Number: AS06181 - Queens Head Broadchalke

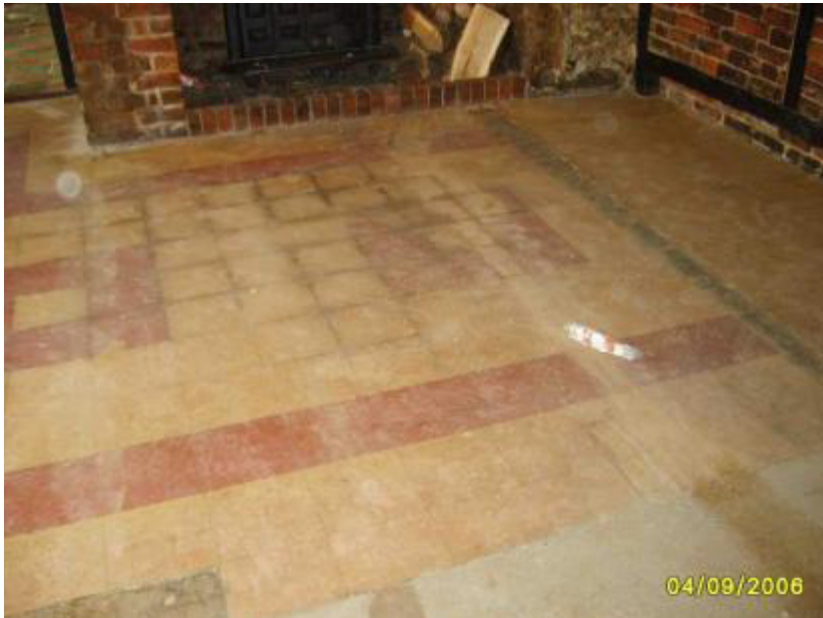
Location ID:	<input type="text" value="10899"/>	Survey Type:	<input type="text" value="T 2"/>
Location Ref:	<input type="text" value="1"/>	Product Type:	<input type="text" value="Vinyl floor tiles"/>
Product:	<input type="text" value="Floor tiles"/>	Damage:	<input type="text" value="Low damage: Broken edge Tiles"/>
Area:	<input type="text" value="Not Applicable"/>	Treatment:	<input type="text" value="Vinyl tiles"/>
Floor:	<input type="text" value="Ground floor"/>	Asbestos Type:	<input type="text" value="Chrysotile"/>
Room:	<input type="text" value="Bar area"/>	Identification:	<input type="text" value="Identified"/>
Surveyor Name:	<input type="text" value="J D Chilvers"/>	Quantity:	<input type="text"/>

Material Risk Score:	<input type="text" value="3"/>
Material Risk Band:	<input type="text" value="Very Low Risk"/>
Priority Risk Score:	<input type="text" value="5"/>

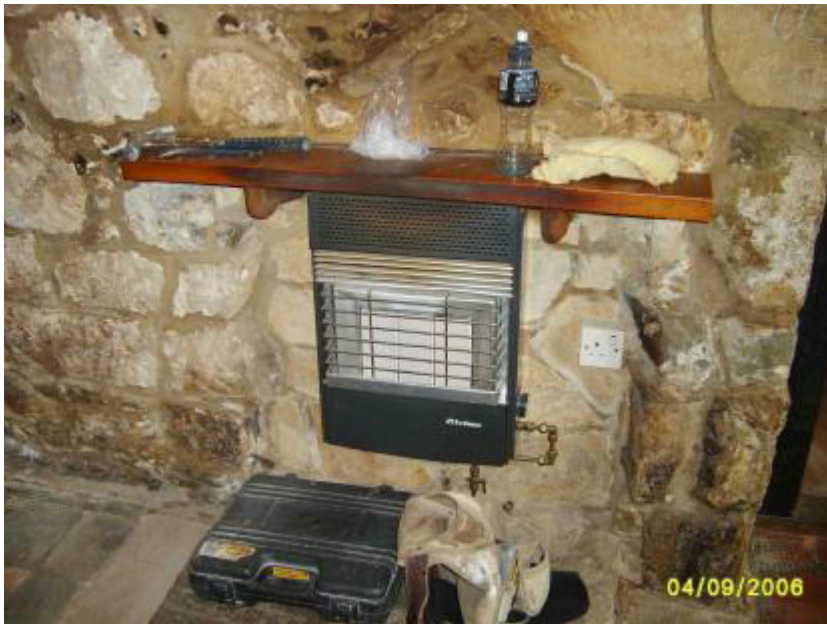
Location ID:	<input type="text" value="10900"/>	Survey Type:	<input type="text" value="T 2"/>
Location Ref:	<input type="text" value="2"/>	Product Type:	<input type="text" value="Gaskets"/>
Product:	<input type="text" value="Heater"/>	Damage:	<input type="text" value="No visible damage"/>
Area:	<input type="text" value="Not Applicable"/>	Treatment:	<input type="text" value="Composite asbestos materials"/>
Floor:	<input type="text" value="Ground floor"/>	Asbestos Type:	<input type="text" value="Chrysotile"/>
Room:	<input type="text" value="Bar area"/>	Identification:	<input type="text" value="Presumed"/>
Surveyor Name:	<input type="text" value="J D Chilvers"/>	Quantity:	<input type="text"/>

Material Risk Score:	<input type="text" value="3"/>
Material Risk Band:	<input type="text" value="Very Low Risk"/>
Priority Risk Score:	<input type="text" value="4"/>

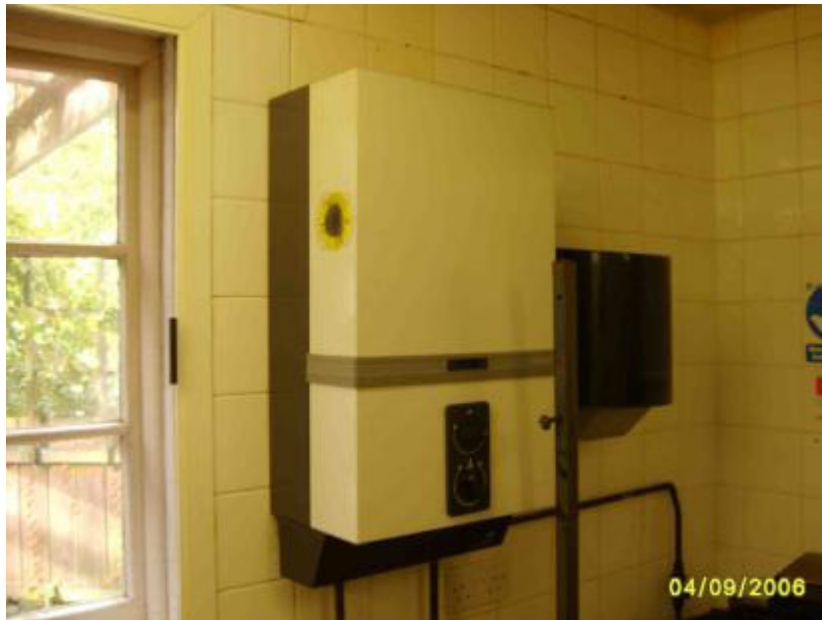
Location ID:	<input type="text" value="10901"/>	Survey Type:	<input type="text" value="T 2"/>
Location Ref:	<input type="text" value="3"/>	Product Type:	<input type="text" value="Gaskets"/>
Product:	<input type="text" value="Boiler"/>	Damage:	<input type="text" value="No visible damage"/>
Area:	<input type="text" value="Not Applicable"/>	Treatment:	<input type="text" value="Composite asbestos materials"/>
Floor:	<input type="text" value="Ground floor"/>	Asbestos Type:	<input type="text" value="Chrysotile"/>
Room:	<input type="text" value="Kitchen"/>	Identification:	<input type="text" value="Presumed"/>
Surveyor Name:	<input type="text" value="J D Chilvers"/>	Quantity:	<input type="text"/>

Material Risk Score:	<input type="text" value="3"/>
Material Risk Band:	<input type="text" value="Very Low Risk"/>
Priority Risk Score:	<input type="text" value="4"/>

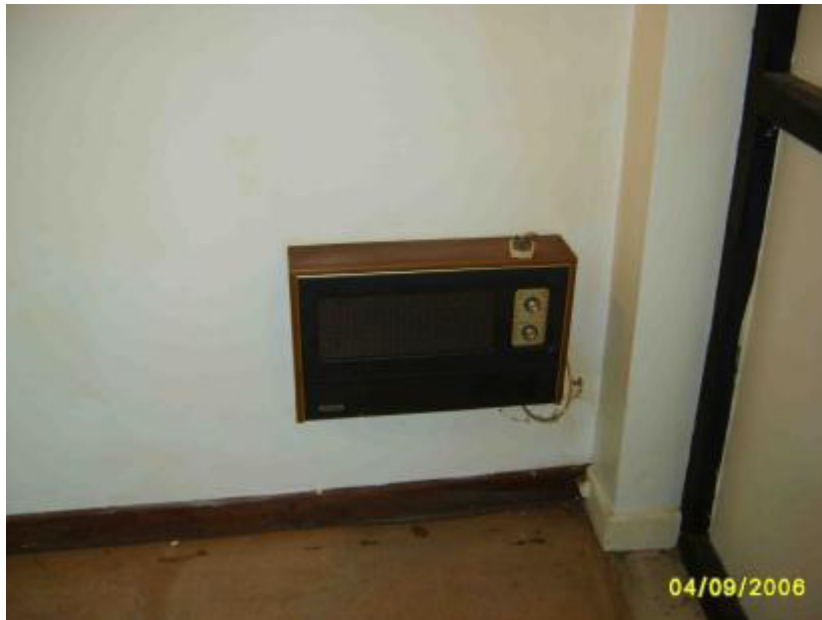
Location ID:	<input type="text" value="10902"/>	Survey Type:	<input type="text" value="T 2"/>
Location Ref:	<input type="text" value="4"/>	Product Type:	<input type="text" value="Gaskets"/>
Product:	<input type="text" value="Heater"/>	Damage:	<input type="text" value="No visible damage"/>
Area:	<input type="text" value="Not Applicable"/>	Treatment:	<input type="text" value="Composite asbestos materials"/>
Floor:	<input type="text" value="Ground floor"/>	Asbestos Type:	<input type="text" value="Chrysotile"/>
Room:	<input type="text" value="Bar area"/>	Identification:	<input type="text" value="Presumed"/>
Surveyor Name:	<input type="text" value="J D Chilvers"/>	Quantity:	<input type="text"/>

Material Risk Score:	<input type="text" value="3"/>
Material Risk Band:	<input type="text" value="Very Low Risk"/>
Priority Risk Score:	<input type="text" value="3"/>

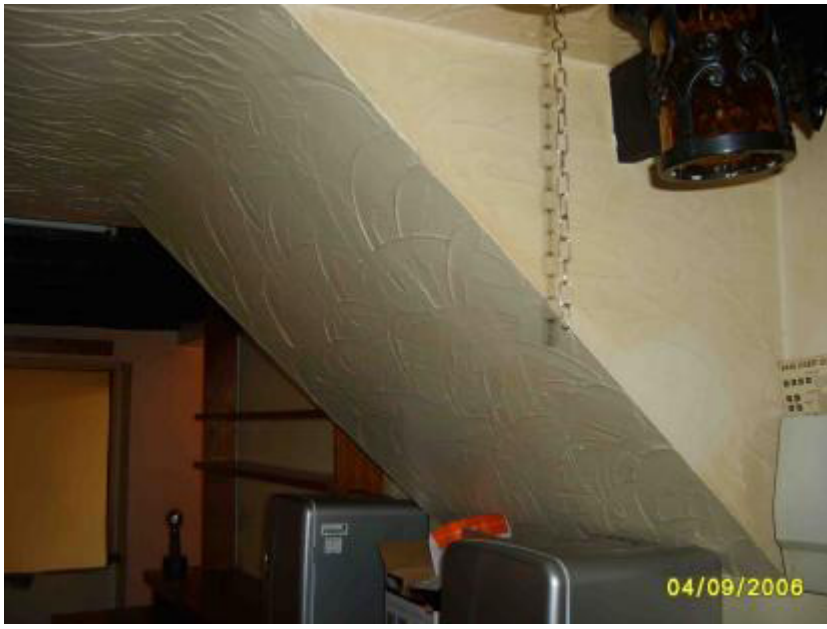
Location ID:	<input type="text" value="10903"/>	Survey Type:	<input type="text" value="T 2"/>
Location Ref:	<input type="text" value="5"/>	Product Type:	<input type="text" value="NADIS"/>
Product:	<input type="text" value="Textured coating"/>	Damage:	<input type="text" value="NADIS"/>
Area:	<input type="text" value="Not Applicable"/>	Treatment:	<input type="text" value="NADIS"/>
Floor:	<input type="text" value="Ground floor"/>	Asbestos Type:	<input type="text" value="NADIS"/>
Room:	<input type="text" value="Bar area"/>	Identification:	<input type="text" value="Identified"/>
Surveyor Name:	<input type="text" value="J D Chilvers"/>	Quantity:	<input type="text"/>

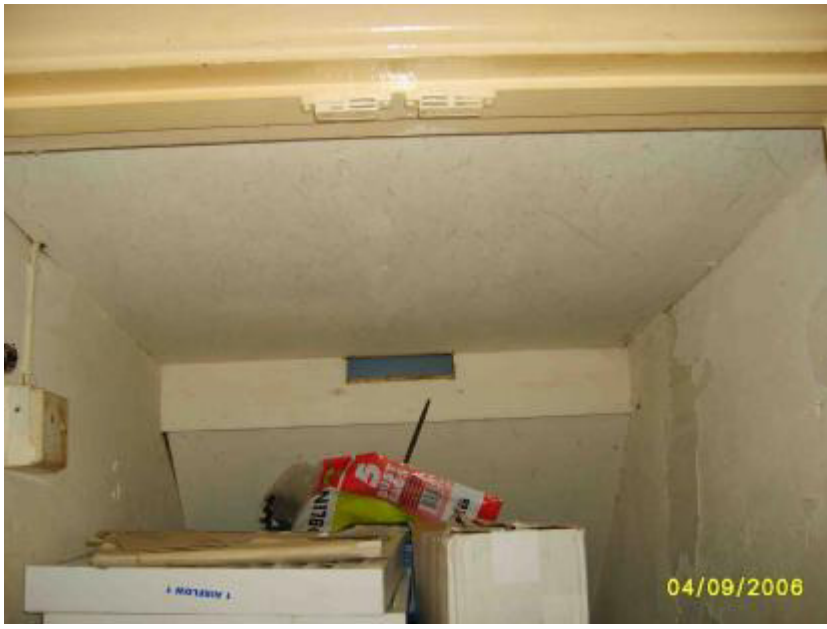
Location ID:	<input type="text" value="10904"/>	Survey Type:	<input type="text" value="T 2"/>
Location Ref:	<input type="text" value="6"/>	Product Type:	<input type="text" value="NADIS"/>
Product:	<input type="text" value="Stair Backing / Cladding"/>	Damage:	<input type="text" value="NADIS"/>
Area:	<input type="text" value="Not Applicable"/>	Treatment:	<input type="text" value="NADIS"/>
Floor:	<input type="text" value="Ground floor"/>	Asbestos Type:	<input type="text" value="NADIS"/>
Room:	<input type="text" value="Understair Cupboard"/>	Identification:	<input type="text" value="Identified"/>
Surveyor Name:	<input type="text" value="J D Chilvers"/>	Quantity:	<input type="text"/>

Material Risk Score:	<input type="text" value="0"/>
Material Risk Band:	<input type="text" value="NADIS"/>
Priority Risk Score:	<input type="text" value="N/A"/>

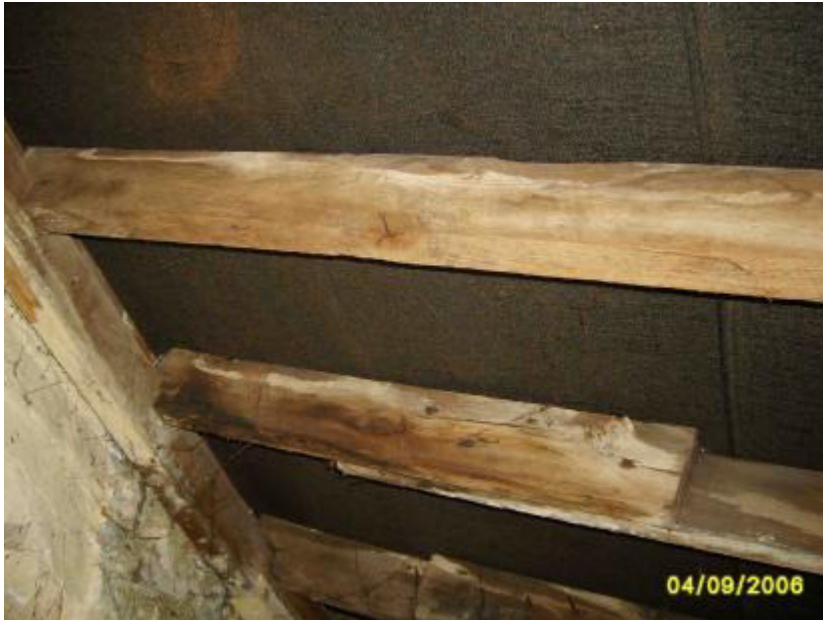
Location ID:	<input type="text" value="10905"/>	Survey Type:	<input type="text" value="T 2"/>
Location Ref:	<input type="text" value="7"/>	Product Type:	<input type="text" value="Roofing felts"/>
Product:	<input type="text" value="Roofing felt"/>	Damage:	<input type="text" value="No visible damage"/>
Area:	<input type="text" value="Not Applicable"/>	Treatment:	<input type="text" value="Composite asbestos materials"/>
Floor:	<input type="text" value="Ground floor"/>	Asbestos Type:	<input type="text" value="Chrysotile"/>
Room:	<input type="text" value="Loft space"/>	Identification:	<input type="text" value="Presumed"/>
Surveyor Name:	<input type="text" value="J D Chilvers"/>	Quantity:	<input type="text"/>

Material Risk Score:	<input type="text" value="2"/>
Material Risk Band:	<input type="text" value="Very Low Risk"/>
Priority Risk Score:	<input type="text" value="2"/>

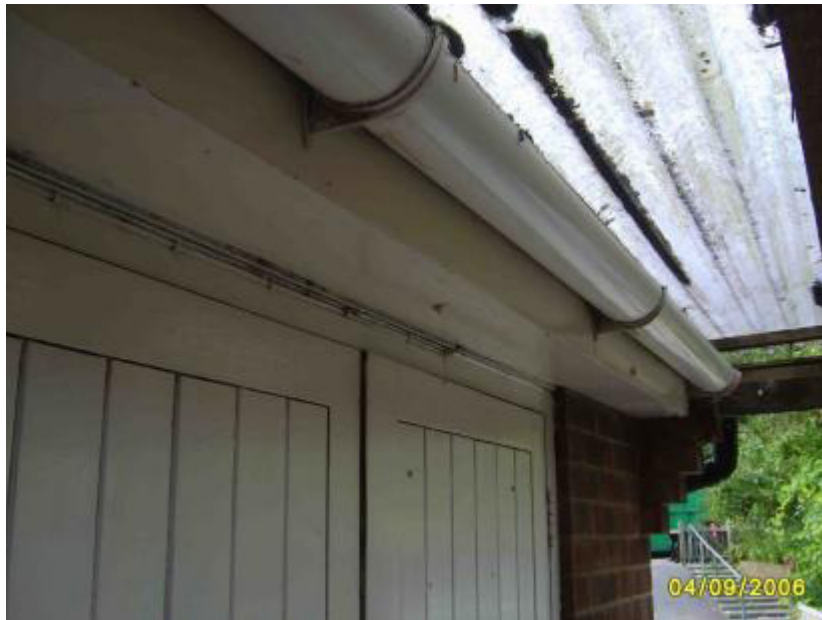
Location ID:	<input type="text" value="10906"/>	Survey Type:	<input type="text" value="T 2"/>
Location Ref:	<input type="text" value="8"/>	Product Type:	<input type="text" value="NADIS"/>
Product:	<input type="text" value="Soffit"/>	Damage:	<input type="text" value="NADIS"/>
Area:	<input type="text" value="Not Applicable"/>	Treatment:	<input type="text" value="NADIS"/>
Floor:	<input type="text" value="Ground floor"/>	Asbestos Type:	<input type="text" value="NADIS"/>
Room:	<input type="text" value="External"/>	Identification:	<input type="text" value="Identified"/>
Surveyor Name:	<input type="text" value="J D Chilvers"/>	Quantity:	<input type="text"/>

Material Risk Score:	<input type="text" value="0"/>
Material Risk Band:	<input type="text" value="NADIS"/>
Priority Risk Score:	<input type="text" value="N/A"/>

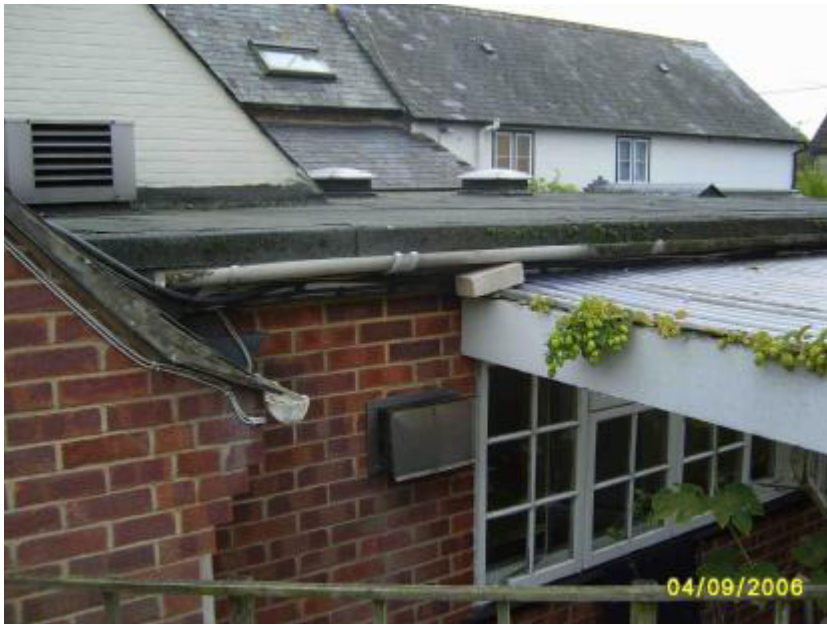
Location ID:	<input type="text" value="10907"/>	Survey Type:	<input type="text" value="T 2"/>
Location Ref:	<input type="text" value="9"/>	Product Type:	<input type="text" value="Roofing felts"/>
Product:	<input type="text" value="Roofing felt"/>	Damage:	<input type="text" value="No visible damage"/>
Area:	<input type="text" value="Not Applicable"/>	Treatment:	<input type="text" value="Composite asbestos materials"/>
Floor:	<input type="text" value="Roof level"/>	Asbestos Type:	<input type="text" value="Chrysotile"/>
Room:	<input type="text" value="Flat roof area"/>	Identification:	<input type="text" value="Presumed"/>
Surveyor Name:	<input type="text" value="J D Chilvers"/>	Quantity:	<input type="text"/>

Material Risk Score:	<input type="text" value="2"/>
Material Risk Band:	<input type="text" value="Very Low Risk"/>
Priority Risk Score:	<input type="text" value="2"/>

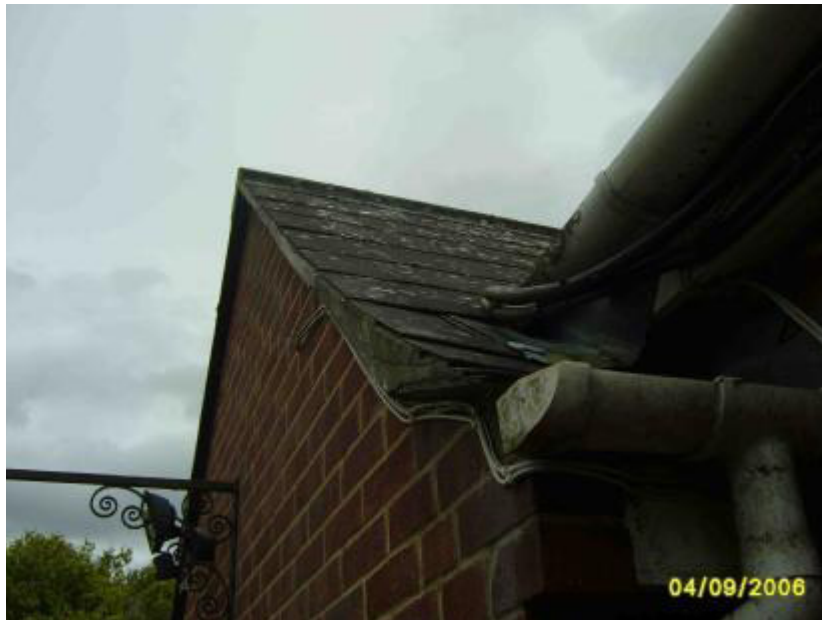
Location ID:	<input type="text" value="10908"/>	Survey Type:	<input type="text" value="T 2"/>
Location Ref:	<input type="text" value="10"/>	Product Type:	<input type="text" value="Asbestos cement"/>
Product:	<input type="text" value="Roof Tiles"/>	Damage:	<input type="text" value="Low damage: Scratches or marks"/>
Area:	<input type="text" value="Not Applicable"/>	Treatment:	<input type="text" value="Asbestos cement sheets etc"/>
Floor:	<input type="text" value="Roof level"/>	Asbestos Type:	<input type="text" value="Chrysotile"/>
Room:	<input type="text" value="External"/>	Identification:	<input type="text" value="Identified"/>
Surveyor Name:	<input type="text" value="J D Chilvers"/>	Quantity:	<input type="text"/>

Material Risk Score:	<input type="text" value="4"/>
Material Risk Band:	<input type="text" value="Very Low Risk"/>
Priority Risk Score:	<input type="text" value="2"/>

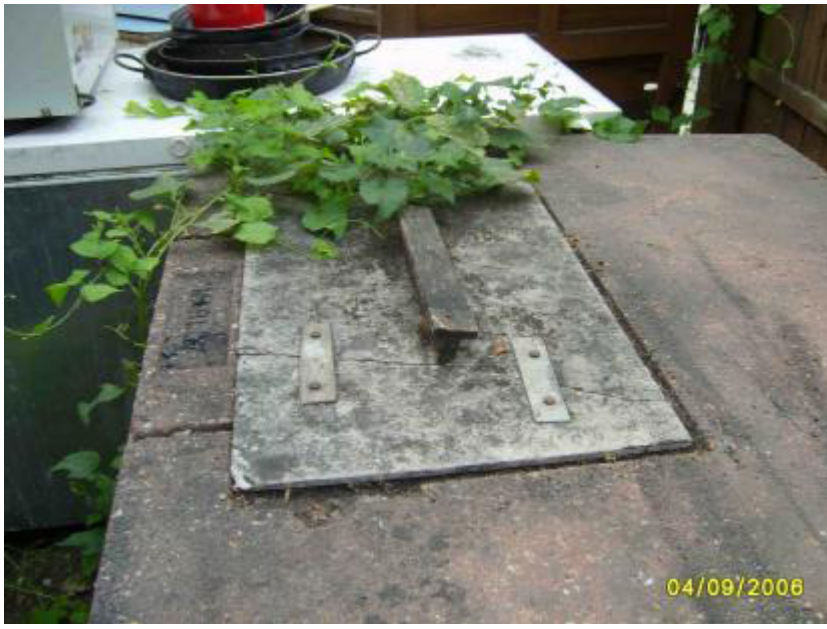
Location ID:	<input type="text" value="10909"/>	Survey Type:	<input type="text" value="T 2"/>
Location Ref:	<input type="text" value="11"/>	Product Type:	<input type="text" value="Asbestos cement"/>
Product:	<input type="text" value="Lid"/>	Damage:	<input type="text" value="Medium damage: Breakage"/>
Area:	<input type="text" value="Not Applicable"/>	Treatment:	<input type="text" value="Asbestos cement sheets etc"/>
Floor:	<input type="text" value="Ground floor"/>	Asbestos Type:	<input type="text" value="Chrysotile"/>
Room:	<input type="text" value="External"/>	Identification:	<input type="text" value="Identified"/>
Surveyor Name:	<input type="text" value="J D Chilvers"/>	Quantity:	<input type="text"/>

Material Risk Score:	<input type="text" value="5"/>
Material Risk Band:	<input type="text" value="Low Risk"/>
Priority Risk Score:	<input type="text" value="3"/>

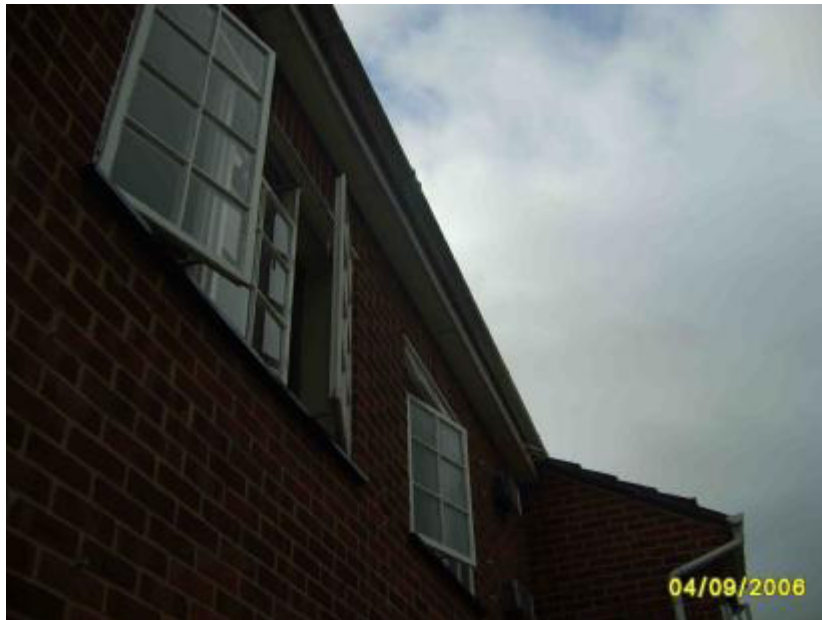
Location ID:	<input type="text" value="10910"/>	Survey Type:	<input type="text" value="T 2"/>
Location Ref:	<input type="text" value="12"/>	Product Type:	<input type="text" value="Asbestos Insulating Board"/>
Product:	<input type="text" value="Soffit"/>	Damage:	<input type="text" value="No visible damage"/>
Area:	<input type="text" value="Not Applicable"/>	Treatment:	<input type="text" value="AIB painted or encapsulated"/>
Floor:	<input type="text" value="Roof level"/>	Asbestos Type:	<input type="text" value="Amosite"/>
Room:	<input type="text" value="External"/>	Identification:	<input type="text" value="Presumed"/>
Surveyor Name:	<input type="text" value="J D Chilvers"/>	Quantity:	<input type="text"/>

Material Risk Score:	<input type="text" value="5"/>
Material Risk Band:	<input type="text" value="Low Risk"/>
Priority Risk Score:	<input type="text" value="1"/>

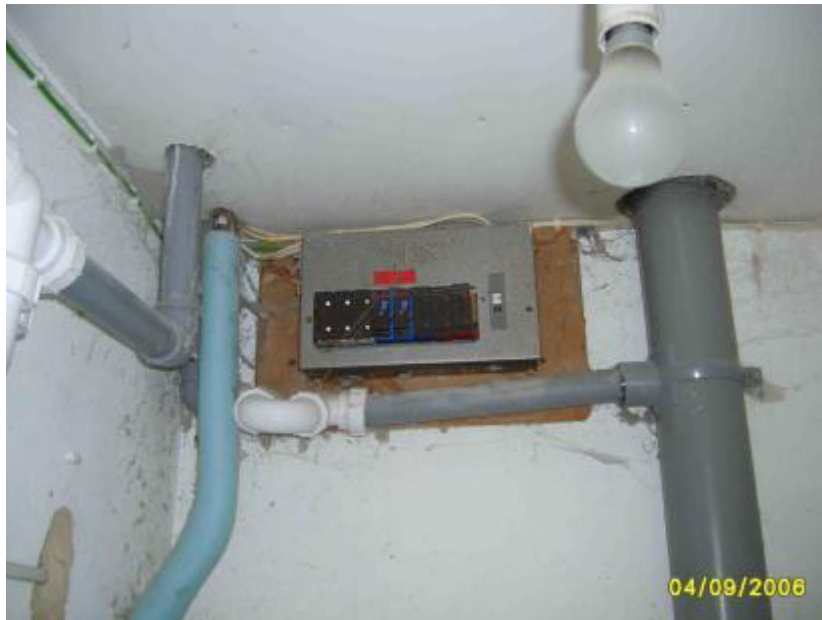
Location ID:	<input type="text" value="10912"/>	Survey Type:	<input type="text" value="T 2"/>
Location Ref:	<input type="text" value="14"/>	Product Type:	<input type="text" value="Ropes and woven textiles"/>
Product:	<input type="text" value="Fuse & Switchgear Flashguard"/>	Damage:	<input type="text" value="No visible damage"/>
Area:	<input type="text" value="Not Applicable"/>	Treatment:	<input type="text" value="Composite asbestos materials"/>
Floor:	<input type="text" value="Ground floor"/>	Asbestos Type:	<input type="text" value="Chrysotile"/>
Room:	<input type="text" value="Stockroom"/>	Identification:	<input type="text" value="Presumed"/>
Surveyor Name:	<input type="text" value="J D Chilvers"/>	Quantity:	<input type="text"/>

Material Risk Score:	<input type="text" value="3"/>
Material Risk Band:	<input type="text" value="Very Low Risk"/>
Priority Risk Score:	<input type="text" value="4"/>

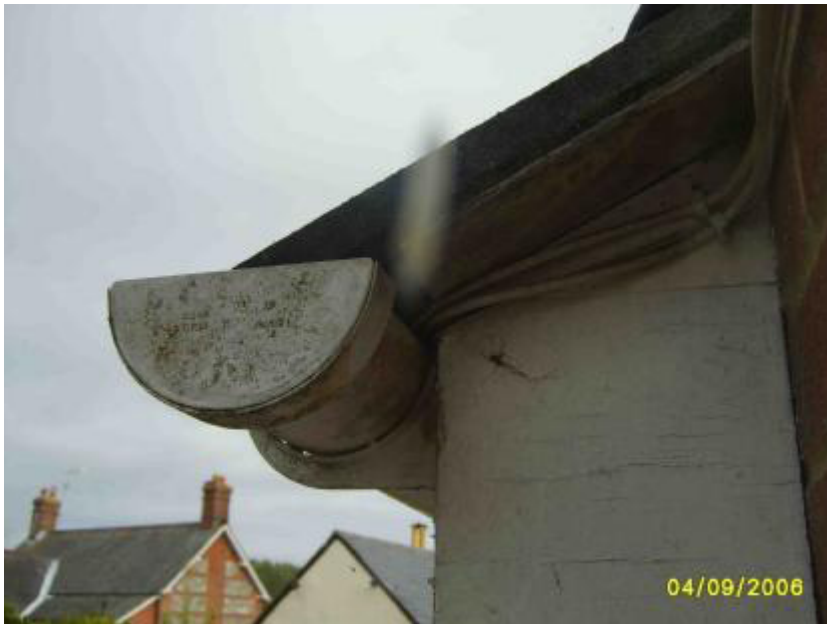
Location ID:	<input type="text" value="10913"/>	Survey Type:	<input type="text" value="T 2"/>
Location Ref:	<input type="text" value="15"/>	Product Type:	<input type="text" value="NADIS"/>
Product:	<input type="text" value="Verge Undercloak"/>	Damage:	<input type="text" value="NADIS"/>
Area:	<input type="text" value="Not Applicable"/>	Treatment:	<input type="text" value="NADIS"/>
Floor:	<input type="text" value="Roof level"/>	Asbestos Type:	<input type="text" value="NADIS"/>
Room:	<input type="text" value="External"/>	Identification:	<input type="text" value="Identified"/>
Surveyor Name:	<input type="text" value="J D Chilvers"/>	Quantity:	<input type="text"/>

Material Risk Score:	<input type="text" value="0"/>
Material Risk Band:	<input type="text" value="NADIS"/>
Priority Risk Score:	<input type="text" value="N/A"/>

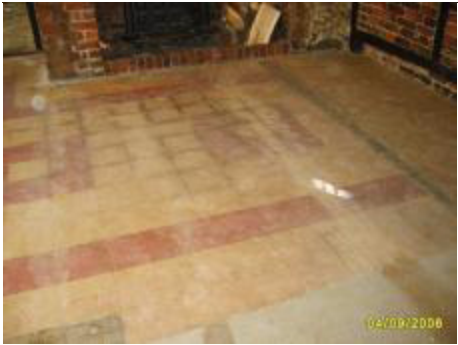
Location ID:	10899
Location Ref:	1
Product:	Floor tiles
Area:	Not Applicable
Floor:	Ground floor
Room:	Bar area
Surveyor Name:	J D Chilvers
Drawing Ref:	1
Asbestos ?	Yes
Date:	04 September 2006

Priority Assessment Algorithm			
Assessment factor	Variable(s) selected	Score for each variable	Overall score
Normal Occupant Activity:			
Main type of activity in area:	Low disturbance	1	average 1
Secondary activities for area:	Low disturbance	1	
Likelihood Of Disturbance:			
Location:	Large rooms or well-ventilated areas	1	average 1
Accessibility:	Occasionally likely to be disturbed	1	
Extent/Amount:	>10 to <=50 (m2 or pipe run)	2	
Human Exposure Potential:			
Number of occupants:	>10	3	average 2
Frequency of use of area:	Daily	3	
Average time area is in use:	>1 to <3 hours	1	
Maintenance Activity:			
Type of maintenance activity:	Minor disturbance	0	average 1
Frequency of maintenance activity:	<=1 per year	1

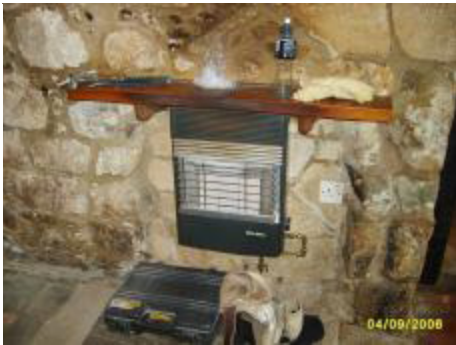
Location ID:	10900
Location Ref:	2
Product:	Heater
Area:	Not Applicable
Floor:	Ground floor
Room:	Bar area
Surveyor Name:	J D Chilvers
Drawing Ref:	2
Asbestos ?	Yes
Date:	04 September 2006

Priority Assessment Algorithm	Variable(s) selected	Score for each variable	Overall score
Normal Occupant Activity:			
Main type of activity in area:	Low disturbance	1	average 1
Secondary activities for area:	Rare disturbance	0	
Likelihood Of Disturbance:			
Location:	Large rooms or well-ventilated areas	1	average 0
Accessibility:	Usually inaccessible or unlikely to be disturbed	0	
Extent/Amount:	Small items strings gaskets	0	
Human Exposure Potential:			
Number of occupants:	>10	3	average 2
Frequency of use of area:	Daily	3	
Average time area is in use:	>1 to <3 hours	1	
Maintenance Activity:			
Type of maintenance activity:	Minor disturbance	0	average 1
Frequency of maintenance activity:	<=1 per year	1

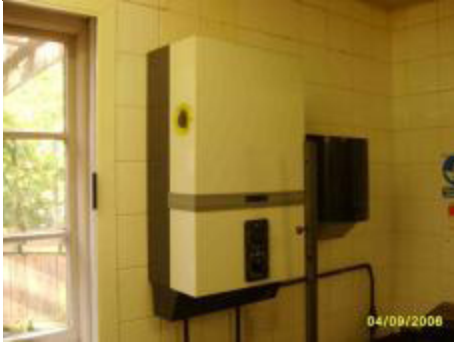
Location ID:	10901
Location Ref:	3
Product:	Boiler
Area:	Not Applicable
Floor:	Ground floor
Room:	Kitchen
Surveyor Name:	J D Chilvers
Drawing Ref:	3
Asbestos ?	Yes
Date:	04 September 2006

Priority Assessment Algorithm	Variable(s) selected	Score for each variable	Overall score
Normal Occupant Activity:			
Main type of activity in area:	Low disturbance	1	average 1
Secondary activities for area:	Rare disturbance	0	
Likelihood Of Disturbance:			
Location:	Large rooms or well-ventilated areas	1	average 0
Accessibility:	Usually inaccessible or unlikely to be disturbed	0	
Extent/Amount:	Small items strings gaskets	0	
Human Exposure Potential:			
Number of occupants:	1 to 3	1	average 2
Frequency of use of area:	Daily	3	
Average time area is in use:	>1 to <3 hours	1	
Maintenance Activity:			
Type of maintenance activity:	Minor disturbance	0	average 1
Frequency of maintenance activity:	<=1 per year	1

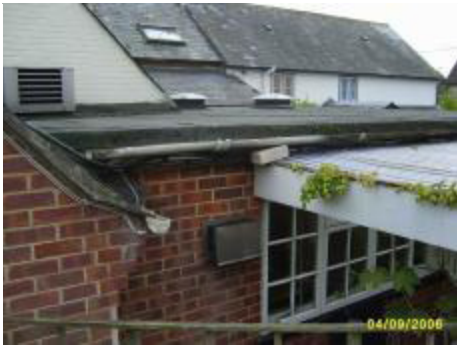
Location ID:	10907
Location Ref:	9
Product:	Roofing felt
Area:	Not Applicable
Floor:	Roof level
Room:	Flat roof area
Surveyor Name:	J D Chilvers
Drawing Ref:	9
Asbestos ?	Yes
Date:	04 September 2006

Priority Assessment Algorithm	Variable(s) selected	Score for each variable	Overall score
Normal Occupant Activity:			
Main type of activity in area:	Rare disturbance	0	average
Secondary activities for area:	Rare disturbance	0	0
Likelihood Of Disturbance:			
Location:	Outdoors	0	average 1
Accessibility:	Usually inaccessible or unlikely to be disturbed	0	
Extent/Amount:	>10 to <=50 (m2 or pipe run)	2	
Human Exposure Potential:			
Number of occupants:	1 to 3	1	average 0
Frequency of use of area:	Infrequent	0	
Average time area is in use:	<1 hour	0	
Maintenance Activity:			
Type of maintenance activity:	Minor disturbance	0	average 1
Frequency of maintenance activity:	<=1 per year	1

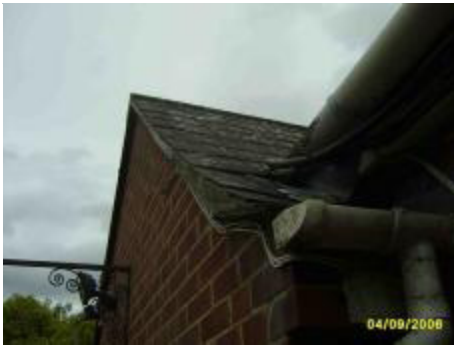
Location ID:	10908
Location Ref:	10
Product:	Roof Tiles
Area:	Not Applicable
Floor:	Roof level
Room:	External
Surveyor Name:	J D Chilvers
Drawing Ref:	10
Asbestos ?	Yes
Date:	04 September 2006

Priority Assessment Algorithm	Variable(s) selected	Score for each variable	Overall score
Normal Occupant Activity:			
Main type of activity in area:	Rare disturbance	0	average
Secondary activities for area:	Rare disturbance	0	0
Likelihood Of Disturbance:			
Location:	Outdoors	0	average 1
Accessibility:	Usually inaccessible or unlikely to be disturbed	0	
Extent/Amount:	>50 m2 or >50 m pipe run	3	
Human Exposure Potential:			
Number of occupants:	1 to 3	1	average 0
Frequency of use of area:	Infrequent	0	
Average time area is in use:	<1 hour	0	
Maintenance Activity:			
Type of maintenance activity:	Minor disturbance	0	average 1
Frequency of maintenance activity:	<=1 per year	1

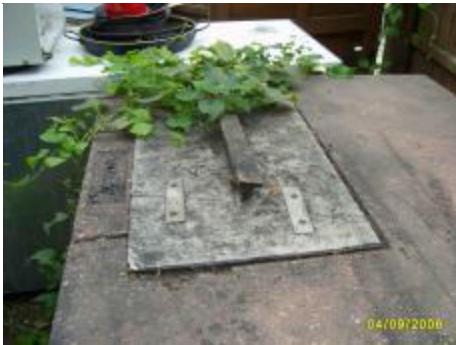
Location ID:	10909
Location Ref:	11
Product:	Lid
Area:	Not Applicable
Floor:	Ground floor
Room:	External
Surveyor Name:	J D Chilvers
Drawing Ref:	11
Asbestos ?	Yes
Date:	04 September 2006

Priority Assessment Algorithm	Variable(s) selected	Score for each variable	Overall score
Normal Occupant Activity:			
Main type of activity in area:	Rare disturbance	0	average
Secondary activities for area:	Rare disturbance	0	0
Likelihood Of Disturbance:			
Location:	Outdoors	0	average 1
Accessibility:	Occasionally likely to be disturbed	1	
Extent/Amount:	<=10 m2 or <=10 m pipe run	1	
Human Exposure Potential:			
Number of occupants:	1 to 3	1	average 1
Frequency of use of area:	Weekly	2	
Average time area is in use:	<1 hour	0	
Maintenance Activity:			
Type of maintenance activity:	Minor disturbance	0	average
Frequency of maintenance activity:	<=1 per year	1	1

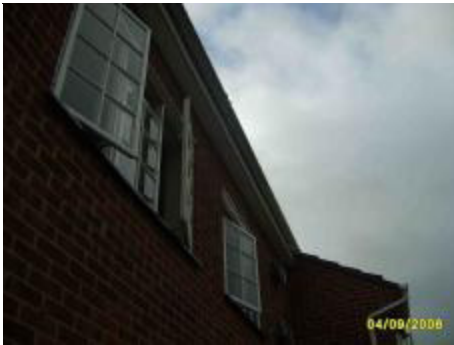
Location ID:	<input style="width: 95%;" type="text" value="10910"/>
Location Ref:	<input style="width: 95%;" type="text" value="12"/>
Product:	<input style="width: 95%;" type="text" value="Soffit"/>
Area:	<input style="width: 95%;" type="text" value="Not Applicable"/>
Floor:	<input style="width: 95%;" type="text" value="Roof level"/>
Room:	<input style="width: 95%;" type="text" value="External"/>
Surveyor Name:	<input style="width: 95%;" type="text" value="J D Chilvers"/>
Drawing Ref:	<input style="width: 95%;" type="text" value="12"/>
Asbestos ?	<input style="width: 95%;" type="text" value="Yes"/>
Date:	<input style="width: 95%;" type="text" value="04 September 2006"/>

Priority Assessment Algorithm			
Assessment factor	Variable(s) selected	Score for each variable	Overall score
Normal Occupant Activity:			
Main type of activity in area:	Rare disturbance	0	average
Secondary activities for area:	Rare disturbance	0	0
Likelihood Of Disturbance:			
Location:	Outdoors	0	
Accessibility:	Usually inaccessible or unlikely to be disturbed	0	average
Extent/Amount:	<=10 m2 or <=10 m pipe run	1	0
Human Exposure Potential:			
Number of occupants:	1 to 3	1	
Frequency of use of area:	Infrequent	0	average
Average time area is in use:	<1 hour	0	0
Maintenance Activity:			
Type of maintenance activity:	Minor disturbance	0	average
Frequency of maintenance activity:	<=1 per year	1	1

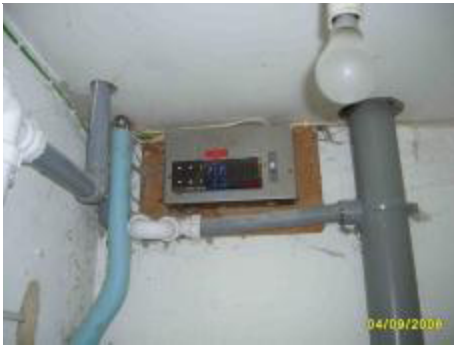
Location ID:	10912
Location Ref:	14
Product:	Fuse & Switchgear Flashguard
Area:	Not Applicable
Floor:	Ground floor
Room:	Stockroom
Surveyor Name:	J D Chilvers
Drawing Ref:	14
Asbestos ?	Yes
Date:	04 September 2008

Priority Assessment Algorithm	Variable(s) selected	Score for each variable	Overall score
Normal Occupant Activity:			
Main type of activity in area:	Low disturbance	1	average 1
Secondary activities for area:	Rare disturbance	0	
Likelihood Of Disturbance:			
Location:	Rooms up to 100 m2	2	average 1
Accessibility:	Usually inaccessible or unlikely to be disturbed	0	
Extent/Amount:	Small items strings gaskets	0	
Human Exposure Potential:			
Number of occupants:	1 to 3	1	average 1
Frequency of use of area:	Daily	3	
Average time area is in use:	<1 hour	0	
Maintenance Activity:			
Type of maintenance activity:	Minor disturbance	0	average 1
Frequency of maintenance activity:	<=1 per year	1

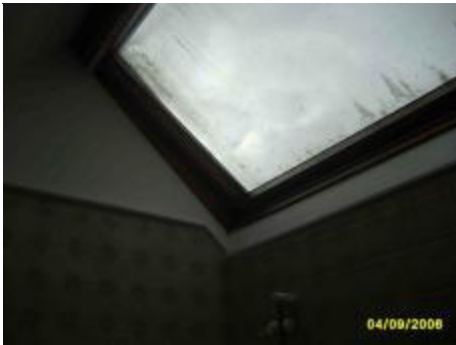
Location ID:	<input style="width: 95%;" type="text" value="10914"/>
Location Ref:	<input style="width: 95%;" type="text" value="16"/>
Product:	<input style="width: 95%;" type="text" value="Window panel"/>
Area:	<input style="width: 95%;" type="text" value="Not Applicable"/>
Floor:	<input style="width: 95%;" type="text" value="First floor"/>
Room:	<input style="width: 95%;" type="text" value="Bathroom"/>
Surveyor Name:	<input style="width: 95%;" type="text" value="J D Chilvers"/>
Drawing Ref:	<input style="width: 95%;" type="text" value="16"/>
Asbestos ?	<input style="width: 95%;" type="text" value="Yes"/>
Date:	<input style="width: 95%;" type="text" value="04 September 2006"/>

Priority Assessment Algorithm			
Assessment factor	Variable(s) selected	Score for each variable	Overall score
Normal Occupant Activity:			
Main type of activity in area:	Rare disturbance	0	average
Secondary activities for area:	Rare disturbance	0	0
Likelihood Of Disturbance:			
Location:	Outdoors	0	
Accessibility:	Usually inaccessible or unlikely to be disturbed	0	average
Extent/Amount:	Small items strings gaskets	0	0
Human Exposure Potential:			
Number of occupants:	1 to 3	1	
Frequency of use of area:	Infrequent	0	average
Average time area is in use:	<1 hour	0	0
Maintenance Activity:			
Type of maintenance activity:	Minor disturbance	0	average
Frequency of maintenance activity:	<=1 per year	1	1

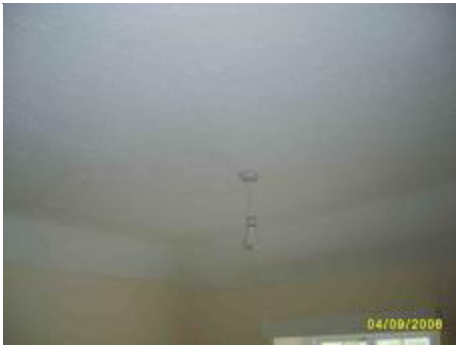
Location ID:	<input style="width: 95%;" type="text" value="10915"/>
Location Ref:	<input style="width: 95%;" type="text" value="17"/>
Product:	<input style="width: 95%;" type="text" value="Textured coating"/>
Area:	<input style="width: 95%;" type="text" value="Not Applicable"/>
Floor:	<input style="width: 95%;" type="text" value="First floor"/>
Room:	<input style="width: 95%;" type="text" value="Bedroom"/>
Surveyor Name:	<input style="width: 95%;" type="text" value="J D Chilvers"/>
Drawing Ref:	<input style="width: 95%;" type="text" value="17"/>
Asbestos ?	<input style="width: 95%;" type="text" value="Yes"/>
Date:	<input style="width: 95%;" type="text" value="04 September 2006"/>

Priority Assessment Algorithm	Variable(s) selected	Score for each variable	Overall score
Normal Occupant Activity:			
Main type of activity in area:	Low disturbance	1	average
Secondary activities for area:	Low disturbance	1	1
Likelihood Of Disturbance:			
Location:	Rooms up to 100 m2	2	average
Accessibility:	Usually inaccessible or unlikely to be disturbed	0	
Extent/Amount:	>10 to <=50 (m2 or pipe run)	2	
Human Exposure Potential:			
Number of occupants:	1 to 3	1	average
Frequency of use of area:	Daily	3	
Average time area is in use:	>6 hours	3	
Maintenance Activity:			
Type of maintenance activity:	Minor disturbance	0	average
Frequency of maintenance activity:	<=1 per year	1	1
