Asbestos Survey for

Hall & Woodhouse Ltd

The Bear
17 Market Square
Horsham
West Sussex
RH12 1EU

Project Number: AS07212- The Bear, Horsham

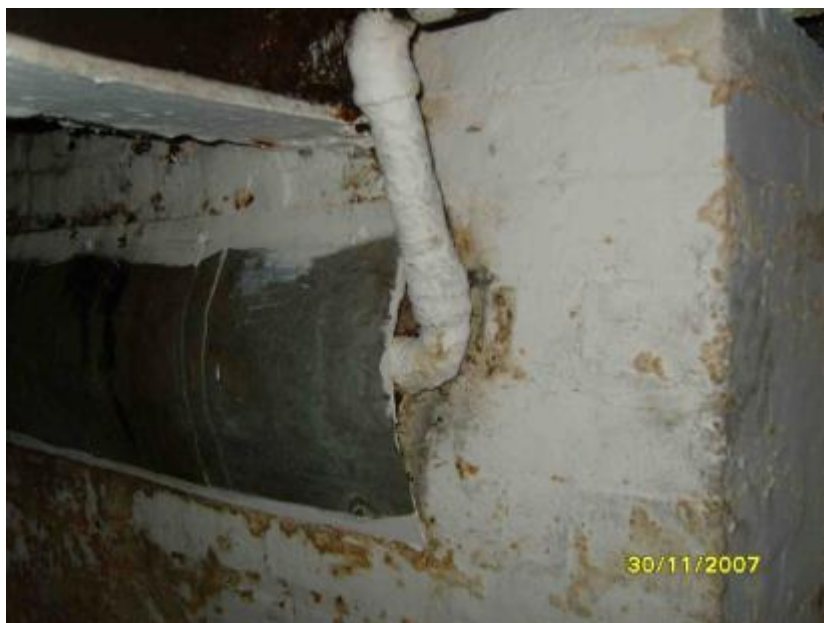
Location ID:	8856	Survey Type:	T 2
Location Ref:	1	Product Type:	NADIS
Product:	Cable sheathing	Damage:	NADIS
Area:	Not Applicable	Treatment:	NADIS
Floor:	Basement	Asbestos Type:	NADIS
Room:	Cellar	Identification:	Identified
Surveyor Name:	J D Chilvers	Quantity:	
Drawing Ref:	1	Accessibility:	
Asbestos ?	No		
Date:	30 November 2007		
Next Inspection:	Not Applicable

No Action Required

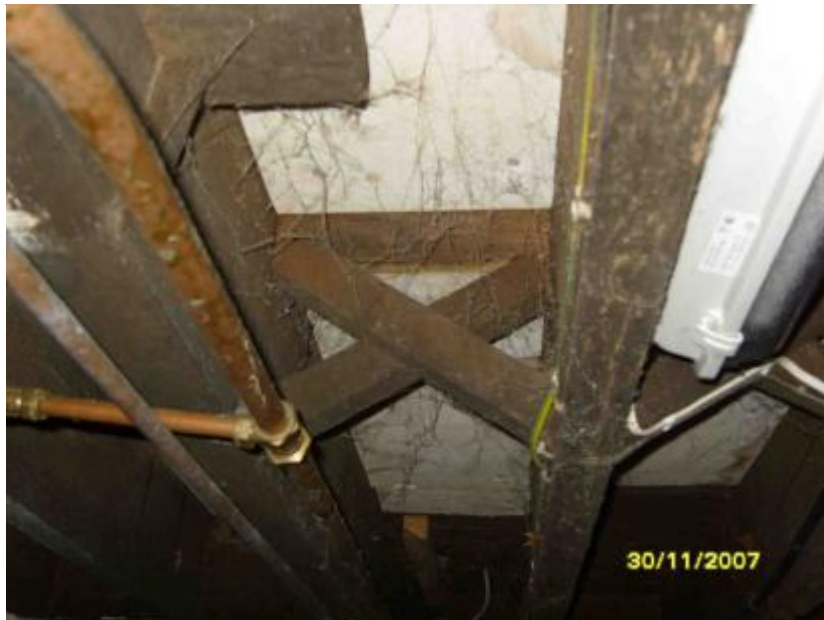
Location ID:	8857	Survey Type:	T 2
Location Ref:	2	Product Type:	NADIS
Product:	Ceiling panels	Damage:	NADIS
Area:	Not Applicable	Treatment:	NADIS
Floor:	Basement	Asbestos Type:	NADIS
Room:	Cellar	Identification:	Identified
Surveyor Name:	J D Chilvers	Quantity:	
Drawing Ref:	2	Accessibility:	
Asbestos ?	No		
Date:	30 November 2007		
Next Inspection:	Not Applicable

Action: No Action Required

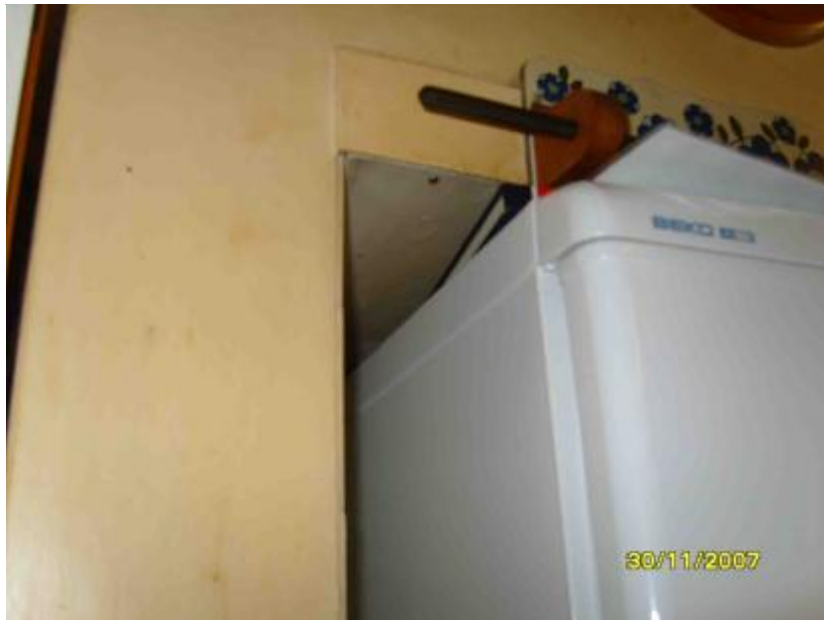
Location ID:	8858	Survey Type:	T 2
Location Ref:	3	Product Type:	Asbestos Insulating Board
Product:	Soffit	Damage:	No visible damage
Area:	Not Applicable	Treatment:	Unsealed AIB
Floor:	Ground floor	Asbestos Type:	Amosite
Room:	Kitchen	Identification:	Identified
Surveyor Name:	J D Chilvers	Quantity:	1m2
Drawing Ref:	3	Accessibility:	Easy Accessibility
Asbestos ?	Yes		
Date:	30 November 2007		
Next Inspection:	31 May 2008

Material Comments: Ex fireplace soffit

Action: Encapsulate and Apply Warning Labels

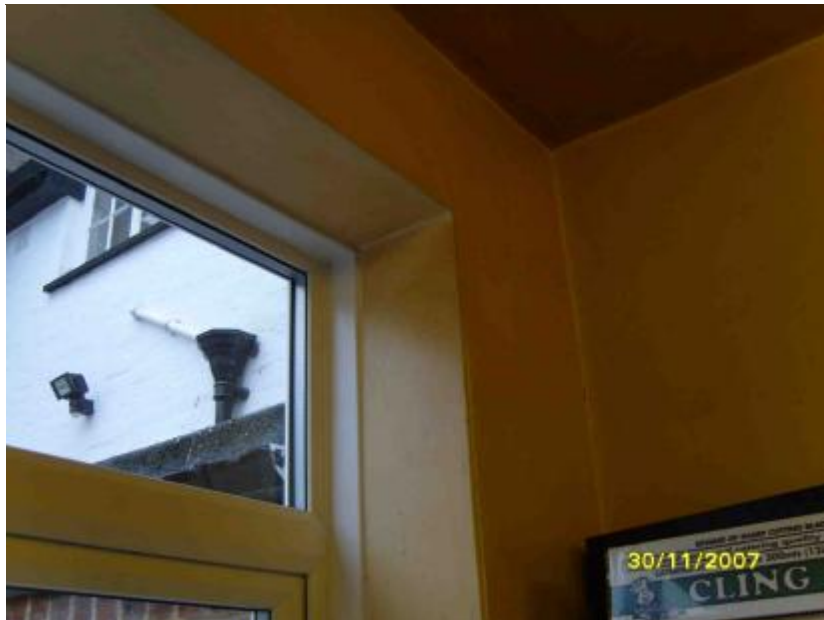
Location ID:	8859	Survey Type:	T 2
Location Ref:	4	Product Type:	Asbestos cement
Product:	Window panel	Damage:	No visible damage
Area:	Not Applicable	Treatment:	Asbestos cement sheets etc
Floor:	Ground floor	Asbestos Type:	Chrysotile
Room:	Kitchen	Identification:	Presumed
Surveyor Name:	J D Chilvers	Quantity:	<1m2
Drawing Ref:	4	Accessibility:	Medium Accessibility
Asbestos ?	Yes		
Date:	30 November 2007		
Next Inspection:	29 November 2008

Material Comments: Window reveals are thought to be AC

Action: Apply Warning Labels

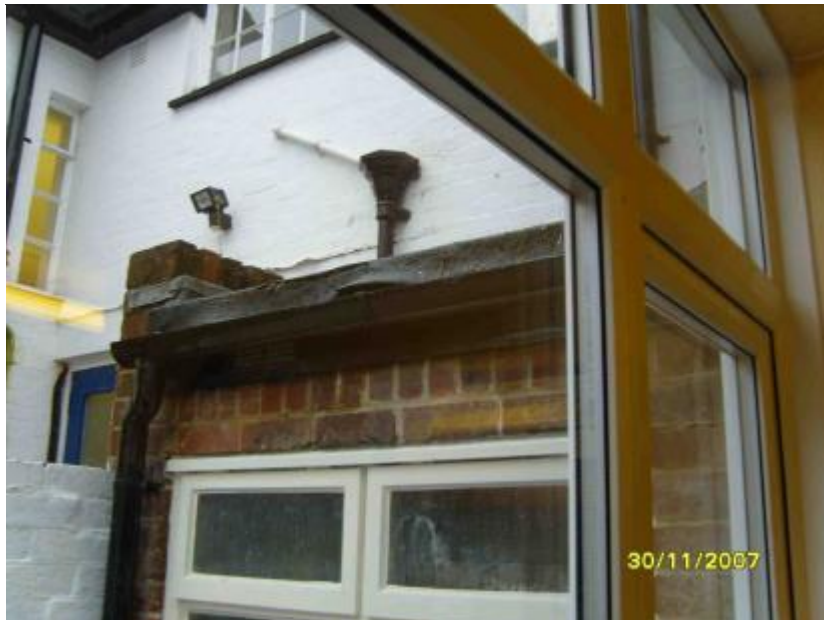
Location ID:	8860	Survey Type:	T 2
Location Ref:	5	Product Type:	Roofing felts
Product:	Roofing felt	Damage:	Low damage
Area:	Not Applicable	Treatment:	Resins
Floor:	Roof level	Asbestos Type:	Chrysotile
Room:	Flat roof area	Identification:	Presumed
Surveyor Name:	J D Chilvers	Quantity:	2m2
Drawing Ref:	5	Accessibility:	Medium Accessibility
Asbestos ?	Yes		
Date:	30 November 2007		
Next Inspection:	29 November 2008

Action: No Action Required

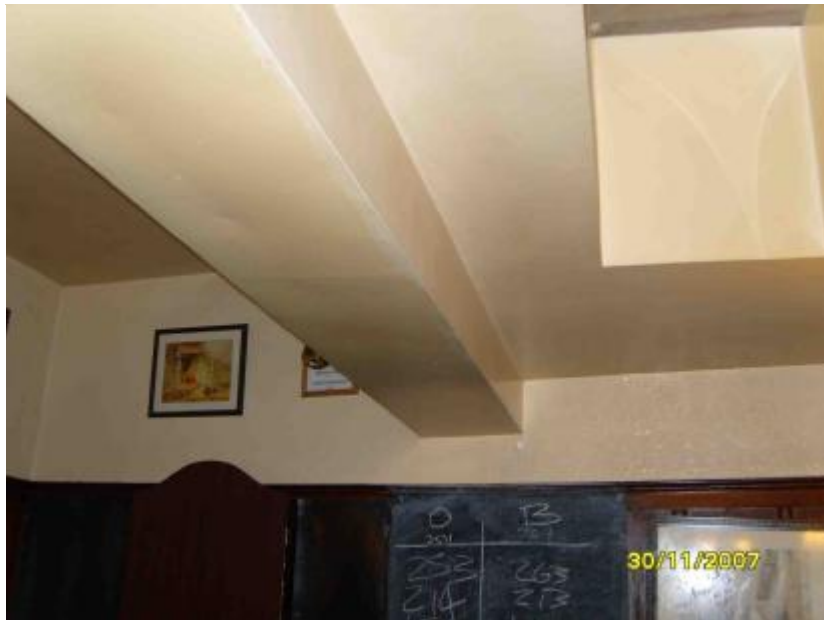
Location ID:	8861	Survey Type:	T 2
Location Ref:	6	Product Type:	Asbestos Insulating Board
Product:	Beam cladding	Damage:	No visible damage
Area:	Not Applicable	Treatment:	AIB painted or encapsulated
Floor:	Ground floor	Asbestos Type:	Amosite
Room:	Bar area	Identification:	Presumed
Surveyor Name:	J D Chilvers	Quantity:	
Drawing Ref:	6	Accessibility:	Medium Accessibility
Asbestos ?	Yes		
Date:	30 November 2007		
Next Inspection:	31 May 2008

Material Comments: All structural beams are presumed to be clad with AIB under plaster finish

Action: Apply Warning Labels

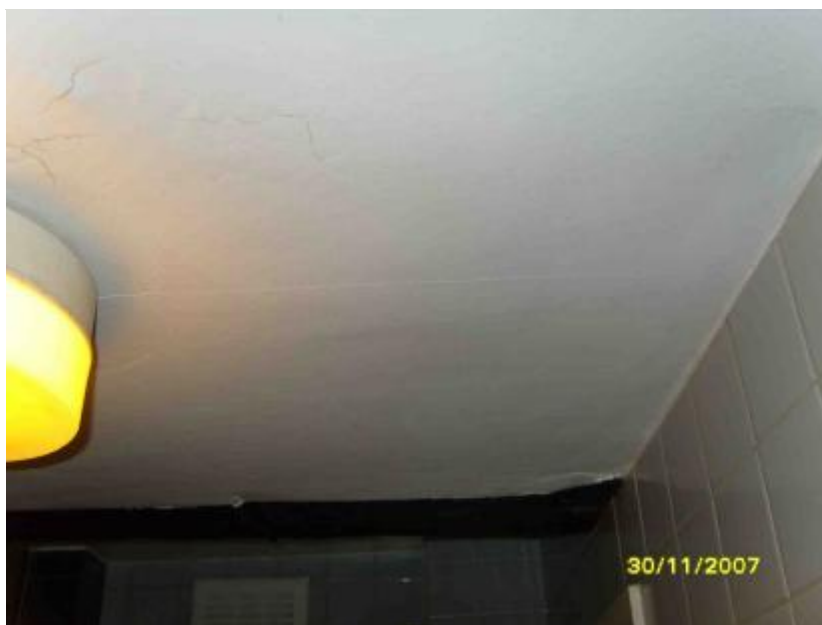
Location ID:	8862	Survey Type:	T 2
Location Ref:	7	Product Type:	Asbestos Insulating Board
Product:	Ceiling	Damage:	No visible damage
Area:	Not Applicable	Treatment:	AIB painted or encapsulated
Floor:	Ground floor	Asbestos Type:	Amosite
Room:	WC - mens	Identification:	Presumed
Surveyor Name:	J D Chilvers	Quantity:	6m2
Drawing Ref:	7	Accessibility:	Medium Accessibility
Asbestos ?	Yes		
Date:	30 November 2007		
Next Inspection:	31 May 2008

Material Comments: Ceiling panels presumed to be AIB above plaster finish

Action: Apply Warning Labels

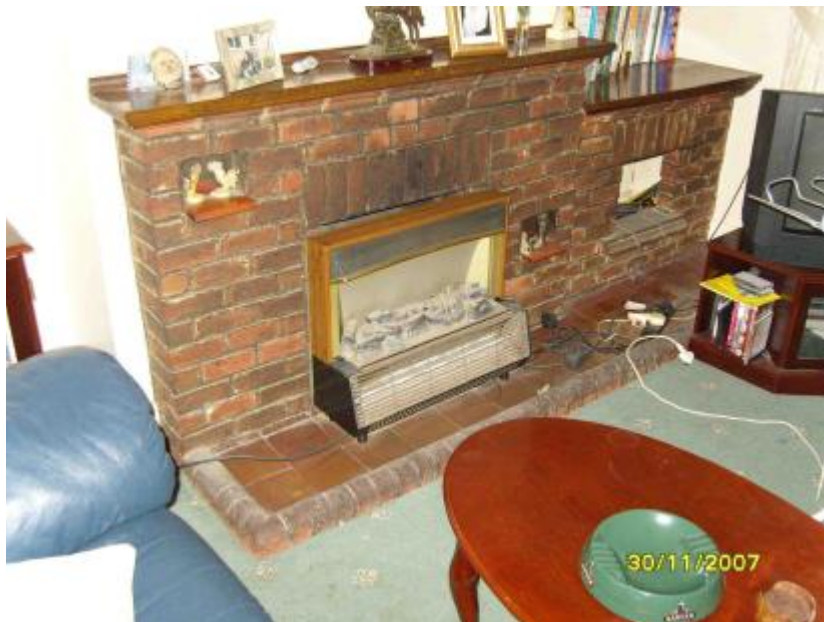
Location ID:	8863	Survey Type:	T 2
Location Ref:	8	Product Type:	Gaskets
Product:	Heater	Damage:	No visible damage
Area:	Not Applicable	Treatment:	Composite asbestos materials
Floor:	First floor	Asbestos Type:	Chrysotile
Room:	Lounge	Identification:	Presumed
Surveyor Name:	J D Chilvers	Quantity:	
Drawing Ref:	8	Accessibility:	Medium Accessibility
Asbestos ?	Yes		
Date:	30 November 2007		
Next Inspection:	29 November 2008

Action: Apply Warning Labels

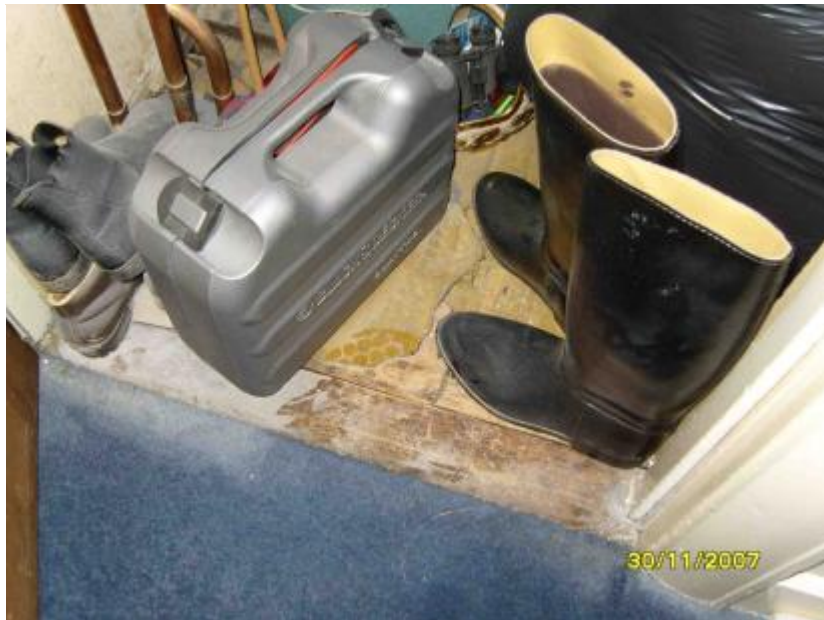
Location ID:	8864	Survey Type:	T 2
Location Ref:	9	Product Type:	NADIS
Product:	Floor covering	Damage:	NADIS
Area:	Not Applicable	Treatment:	NADIS
Floor:	First floor	Asbestos Type:	NADIS
Room:	Cupboard	Identification:	Identified
Surveyor Name:	J D Chilvers	Quantity:	
Drawing Ref:	9	Accessibility:	
Asbestos ?	No		
Date:	30 November 2007		
Next Inspection:	Not Applicable

Action: No Action Required

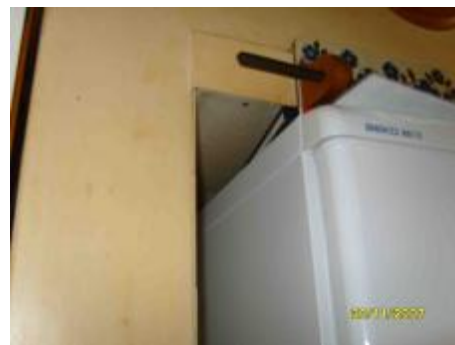
Location ID:	8858
Location Ref:	3
Product:	Soffit
Area:	Not Applicable
Floor:	Ground floor
Room:	Kitchen
Surveyor Name:	J D Chilvers
Drawing Ref:	3
Asbestos ?	Yes
Date:	30 November 2007

Priority Assessment Algorithm			
Assessment factor	Variable(s) selected	Score for each	Overall score
Normal Occupant Activity:			
Main type of activity in area:	Low disturbance	1	average
Secondary activities for area:	Low disturbance	1	1
Likelihood Of Disturbance:			
Location:	Rooms up to 100 m2	2	average 1
Accessibility:	Occasionally likely to be disturbed	1	
Extent/Amount:	<=10 m2 or <=10 m pipe run	1	
Human Exposure Potential:			
Number of occupants:	1 to 3	1	average 2
Frequency of use of area:	Daily	3	
Average time area is in use:	>3 to <6 hours	2	
Maintenance Activity:			
Type of maintenance activity:	Minor disturbance	0	average
Frequency of maintenance activity	<=1 per year	1	1

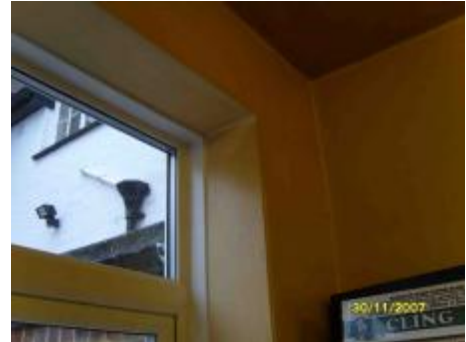
Location ID:	<div>8859</div>
Location Ref:	<div>4</div>
Product:	<div>Window panel</div>
Area:	<div>Not Applicable</div>
Floor:	<div>Ground floor</div>
Room:	<div>Kitchen</div>
Surveyor Name:	<div>J D Chilvers</div>
Drawing Ref:	<div>4</div>
Asbestos ?	<div>Yes</div>
Date:	<div>30 November 2007</div>

Priority Assessment Algorithm			
Assessment factor	Variable(s) selected	Score for each	Overall score
Normal Occupant Activity:			
Main type of activity in area:	Rare disturbance	0	average
Secondary activities for area:	Rare disturbance	0	0
Likelihood Of Disturbance:			
Location:	Rooms up to 100 m2	2	average 1
Accessibility:	Usually inaccessible or unlikely to be disturbed	0	
Extent/Amount:	<=10 m2 or <=10 m pipe run	1	
Human Exposure Potential:			
Number of occupants:	1 to 3	1	average 2
Frequency of use of area:	Daily	3	
Average time area is in use:	>3 to <6 hours	2	
Maintenance Activity:			
Type of maintenance activity:	Minor disturbance	0	average
Frequency of maintenance activity	Unlikely to be disturbed	0	0

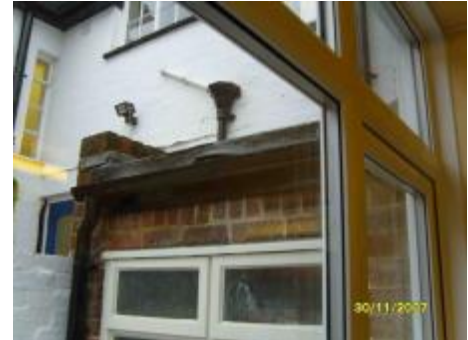
Location ID:	<div>8860</div>
Location Ref:	<div>5</div>
Product:	<div>Roofing felt</div>
Area:	<div>Not Applicable</div>
Floor:	<div>Roof level</div>
Room:	<div>Flat roof area</div>
Surveyor Name:	<div>J D Chilvers</div>
Drawing Ref:	<div>5</div>
Asbestos ?	<div>Yes</div>
Date:	<div>30 November 2007</div>

Priority Assessment Algorithm			
Assessment factor	Variable(s) selected	Score for each	Overall score
Normal Occupant Activity:			
Main type of activity in area:	Rare disturbance	0	average
Secondary activities for area:	Rare disturbance	0	0
Likelihood Of Disturbance:			
Location:	Outdoors	0	average 0
Accessibility:	Usually inaccessible or unlikely to be disturbed	0	
Extent/Amount:	<=10 m2 or <=10 m pipe run	1	
Human Exposure Potential:			
Number of occupants:	1 to 3	1	average 0
Frequency of use of area:	Infrequent	0	
Average time area is in use:	<1 hour	0	
Maintenance Activity:			
Type of maintenance activity:	Minor disturbance	0	average
Frequency of maintenance activity	<=1 per year	1	1

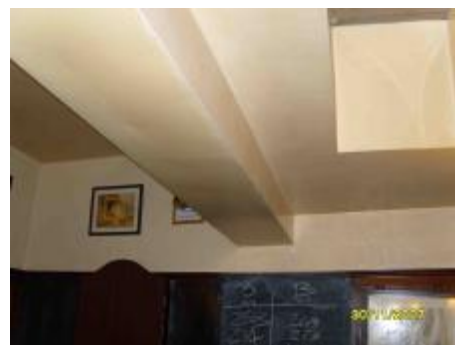
Location ID:	8861
Location Ref:	6
Product:	Beam cladding
Area:	Not Applicable
Floor:	Ground floor
Room:	Bar area
Surveyor Name:	J D Chilvers
Drawing Ref:	6
Asbestos ?	Yes
Date:	30 November 2007

Priority Assessment Algorithm			
Assessment factor	Variable(s) selected	Score for each	Overall score
Normal Occupant Activity:			
Main type of activity in area:	Low disturbance	1	average
Secondary activities for area:	Rare disturbance	0	1
Likelihood Of Disturbance:			
Location:	Rooms up to 100 m2	2	average 1
Accessibility:	Usually inaccessible or unlikely to be disturbed	0	
Extent/Amount:	<=10 m2 or <=10 m pipe run	1	
Human Exposure Potential:			
Number of occupants:	>10	3	average 2
Frequency of use of area:	Daily	3	
Average time area is in use:	>1 to <3 hours	1	
Maintenance Activity:			
Type of maintenance activity:	Minor disturbance	0	average
Frequency of maintenance activity	<=1 per year	1	1

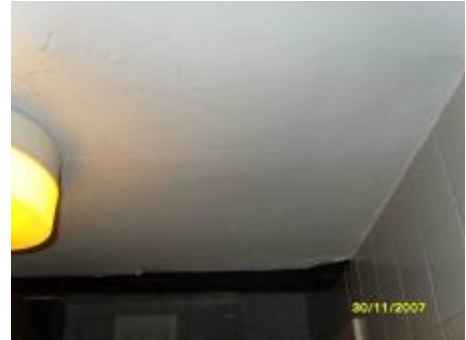
Location ID:	<div style="border: 1px solid black; padding: 2px;">8862</div>
Location Ref:	<div style="border: 1px solid black; padding: 2px;">7</div>
Product:	<div style="border: 1px solid black; padding: 2px;">Ceiling</div>
Area:	<div style="border: 1px solid black; padding: 2px;">Not Applicable</div>
Floor:	<div style="border: 1px solid black; padding: 2px;">Ground floor</div>
Room:	<div style="border: 1px solid black; padding: 2px;">WC - mens</div>
Surveyor Name:	<div style="border: 1px solid black; padding: 2px;">J D Chilvers</div>
Drawing Ref:	<div style="border: 1px solid black; padding: 2px;">7</div>
Asbestos ?	<div style="border: 1px solid black; padding: 2px;">Yes</div>
Date:	<div style="border: 1px solid black; padding: 2px;">30 November 2007</div>

Priority Assessment Algorithm			
Assessment factor	Variable(s) selected	Score for each	Overall score
Normal Occupant Activity:			
Main type of activity in area:	Low disturbance	1	average
Secondary activities for area:	Rare disturbance	0	1
Likelihood Of Disturbance:			
Location:	Rooms up to 100 m2	2	average 1
Accessibility:	Usually inaccessible or unlikely to be disturbed	0	
Extent/Amount:	<=10 m2 or <=10 m pipe run	1	
Human Exposure Potential:			
Number of occupants:	1 to 3	1	average 1
Frequency of use of area:	Daily	3	
Average time area is in use:	<1 hour	0	
Maintenance Activity:			
Type of maintenance activity:	Minor disturbance	0	average
Frequency of maintenance activity	<=1 per year	1	1

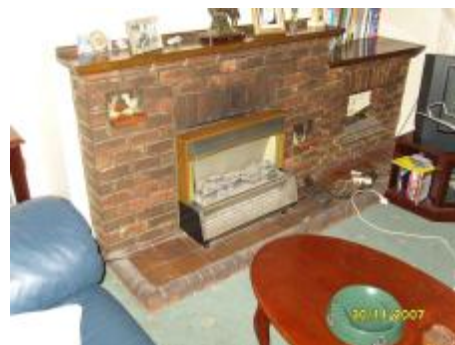
Location ID:	<div style="border: 1px solid black; padding: 2px;">8863</div>
Location Ref:	<div style="border: 1px solid black; padding: 2px;">8</div>
Product:	<div style="border: 1px solid black; padding: 2px;">Heater</div>
Area:	<div style="border: 1px solid black; padding: 2px;">Not Applicable</div>
Floor:	<div style="border: 1px solid black; padding: 2px;">First floor</div>
Room:	<div style="border: 1px solid black; padding: 2px;">Lounge</div>
Surveyor Name:	<div style="border: 1px solid black; padding: 2px;">J D Chilvers</div>
Drawing Ref:	<div style="border: 1px solid black; padding: 2px;">8</div>
Asbestos ?	<div style="border: 1px solid black; padding: 2px;">Yes</div>
Date:	<div style="border: 1px solid black; padding: 2px;">30 November 2007</div>

Priority Assessment Algorithm			
Assessment factor	Variable(s) selected	Score for each	Overall score
Normal Occupant Activity:			
Main type of activity in area:	Low disturbance	1	average
Secondary activities for area:	Rare disturbance	0	1
Likelihood Of Disturbance:			
Location:	Rooms up to 100 m2	2	average 1
Accessibility:	Usually inaccessible or unlikely to be disturbed	0	
Extent/Amount:	Small items strings gaskets	0	
Human Exposure Potential:			
Number of occupants:	1 to 3	1	average 2
Frequency of use of area:	Daily	3	
Average time area is in use:	>1 to <3 hours	1	
Maintenance Activity:			
Type of maintenance activity:	Minor disturbance	0	average
Frequency of maintenance activity	<=1 per year	1	1
