# **Asbestos Survey for**

Hall & Woodhouse Ltd

Silent Woman  
Coldharbour  
Wareham  
Dorset  
BH20 7PR

Project Number: AS04085 - Silent Woman

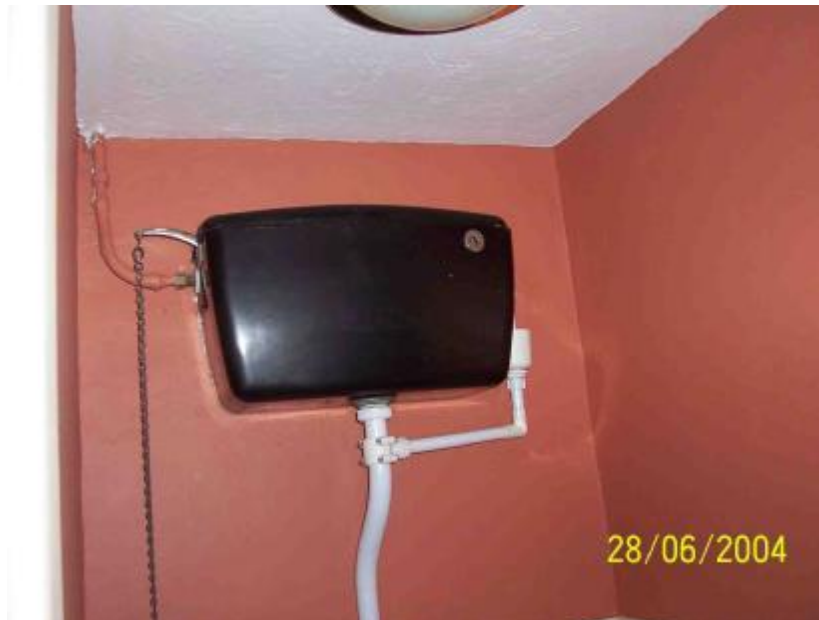
Location ID:	<input type="text" value="412"/>	Survey Type:	<input type="text" value="T 2"/>
Location Ref:	<input type="text" value="1"/>	Product Type:	<input type="text" value="Plastics"/>
Product:	<input type="text" value="Cistern"/>	Damage:	<input type="text" value="No visible damage"/>
Area:	<input type="text" value="Not Applicable"/>	Treatment:	<input type="text" value="Reinforced plastics"/>
Floor:	<input type="text" value="Ground floor"/>	Asbestos Type:	<input type="text" value="Chrysotile"/>
Room:	<input type="text" value="WC - mens"/>	Identification:	<input type="text" value="Presumed"/>
Surveyor Name:	<input type="text" value="J D Chilvers"/>	Quantity:	<input type="text"/>

Material Risk Score	<input type="text" value="2"/>
Material Risk Band:	<input type="text" value="Very Low Risk"/>
Priority Risk Score:	<input type="text" value="4"/>

Action:	<input type="text" value="Apply Warning Labels"/>
---------	---

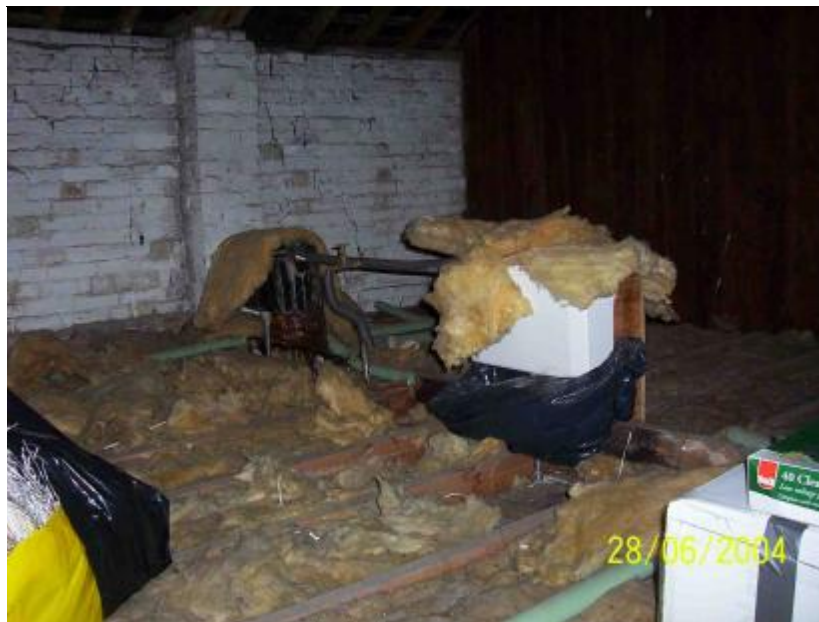
Location ID:	781	Survey Type:	T 2
Location Ref:	2	Product Type:	Plastics
Product:	Cistern	Damage:	No visible damage
Area:	Not Applicable	Treatment:	Reinforced plastics
Floor:	Roof level	Asbestos Type:	Chrysotile
Room:	Loft space	Identification:	Presumed
Surveyor Name:	J D Chilvers	Quantity:	
Drawing Ref:	2	Accessibility:	Medium Accessibility
Asbestos ?	Yes		
Date:	28 June 2004		
Next Inspection:	28 June 2005

Material Risk Score	2
Material Risk Band:	Very Low Risk
Priority Risk Score:	1

Action:	Apply Warning Labels
---------	----------------------

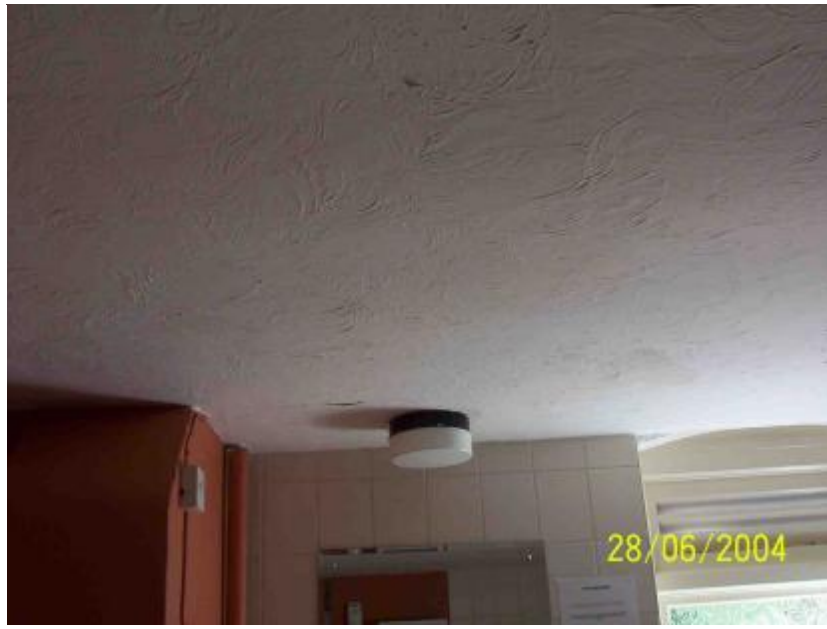
Location ID:	782	Survey Type:	T 2
Location Ref:	3	Product Type:	NADIS
Product:	Ceiling	Damage:	NADIS
Area:	Not Applicable	Treatment:	NADIS
Floor:	Ground floor	Asbestos Type:	NADIS
Room:	WC - mens	Identification:	Identified
Surveyor Name:	J D Chilvers	Quantity:	
Drawing Ref:	3	Accessibility:	
Asbestos ?	No		
Date:	28 June 2004		
Next Inspection:	Not Applicable

Material Risk Score	0
Material Risk Band:	NADIS
Priority Risk Score:	N/A

Action: No Action Required

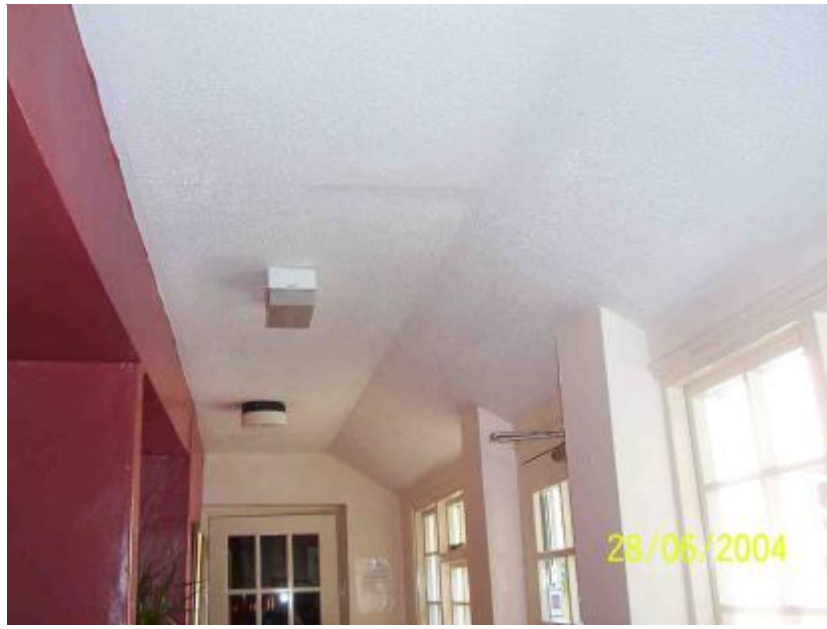
Location ID:	783	Survey Type:	T 2
Location Ref:	4	Product Type:	NADIS
Product:	Ceiling	Damage:	NADIS
Area:	Not Applicable	Treatment:	NADIS
Floor:	Ground floor	Asbestos Type:	NADIS
Room:	Corridor	Identification:	Presumed
Surveyor Name:	J D Chilvers	Quantity:	
Drawing Ref:	4	Accessibility:	
Asbestos ?	No		
Date:	28 June 2004		
Next Inspection:	Not Applicable

Material Risk Score	0
Material Risk Band:	NADIS
Priority Risk Score:	N/A

Material Comments:	Information obtained since the survey states that this material was replaced approximately 3 years ago.
--------------------	---

Action:	No Action Required
---------	--------------------

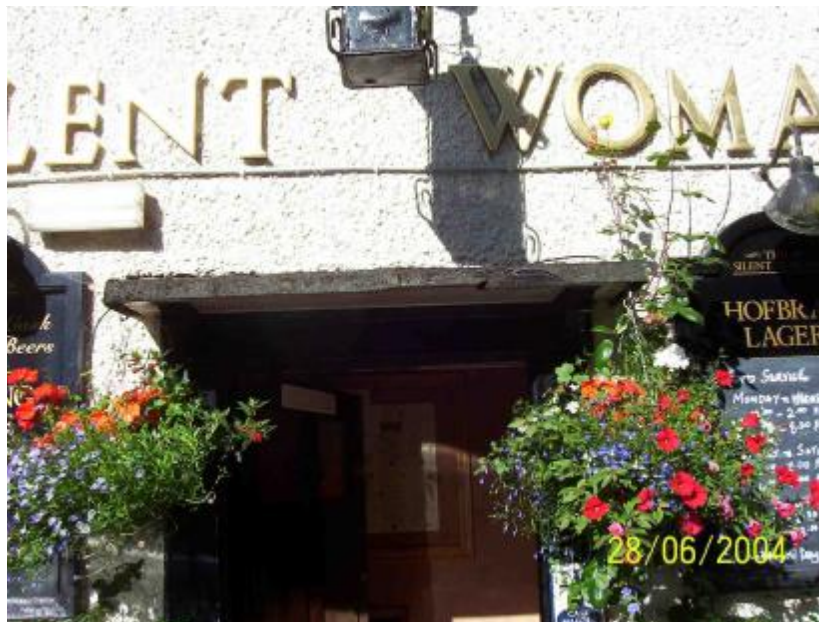
Location ID:	784	Survey Type:	T 2
Location Ref:	5	Product Type:	Roofing felts
Product:	Roofing felt	Damage:	Good condition
Area:	Not Applicable	Treatment:	Resins
Floor:	Ground floor	Asbestos Type:	Chrysotile
Room:	Porch	Identification:	Presumed
Surveyor Name:	J D Chilvers	Quantity:	
Drawing Ref:	5	Accessibility:	Easy Accessibility
Asbestos ?	Yes		
Date:	28 June 2004		
Next Inspection:	28 June 2005		
		Material Risk Score:	2
		Material Risk Band:	Very Low Risk
		Priority Risk Score:	2
Action:	No Action Required

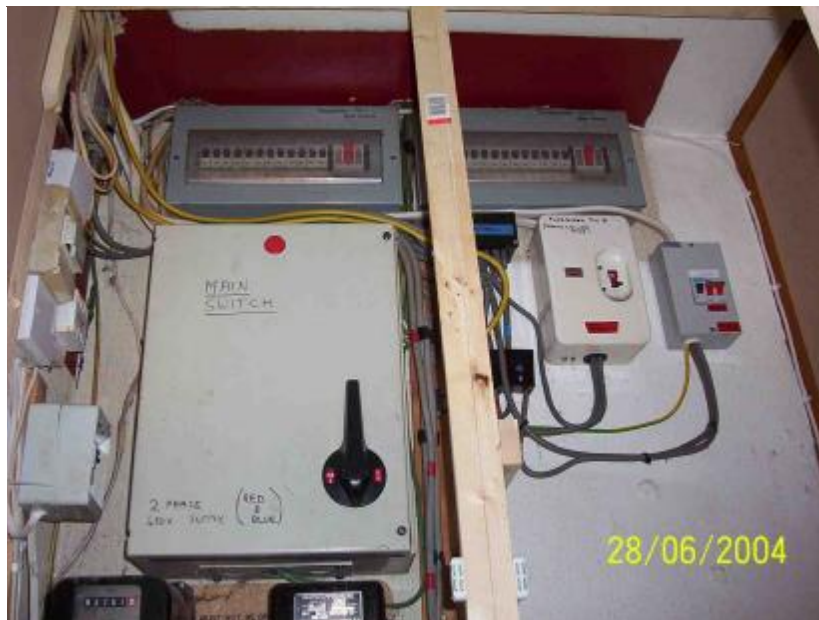
Location ID:	785	Survey Type:	T 2
Location Ref:	6	Product Type:	Ropes and woven textiles
Product:	Fuse & Switchgear Flashguard	Damage:	No visible damage
Area:	Not Applicable	Treatment:	Composite asbestos materials
Floor:	Ground floor	Asbestos Type:	Chrysotile
Room:	Lobby	Identification:	Presumed
Surveyor Name:	J D Chilvers	Quantity:	
Drawing Ref:	6	Accessibility:	Medium Accessibility
Asbestos ?	Yes		
Date:	28 June 2004		
Next Inspection:	28 June 2005		
		Material Risk Score:	3
		Material Risk Band:	Very Low Risk
		Priority Risk Score:	5

Action:	Apply Warning Labels
---------	----------------------

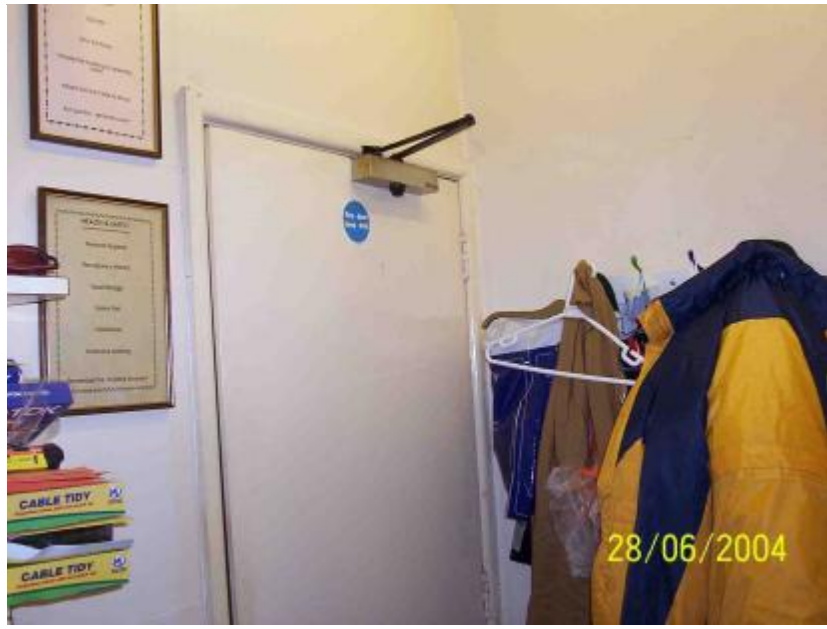
Location ID:	<input style="width: 95%;" type="text" value="786"/>	Survey Type:	<input style="width: 95%;" type="text" value="T 2"/>						
Location Ref:	<input style="width: 95%;" type="text" value="7"/>	Product Type:	<input style="width: 95%;" type="text" value="Asbestos cement"/>						
Product:	<input style="width: 95%;" type="text" value="Fire Door"/>	Damage:	<input style="width: 95%;" type="text" value="No visible damage"/>						
Area:	<input style="width: 95%;" type="text" value="Not Applicable"/>	Treatment:	<input style="width: 95%;" type="text" value="Asbestos cement sheets etc"/>						
Floor:	<input style="width: 95%;" type="text" value="Ground floor"/>	Asbestos Type:	<input style="width: 95%;" type="text" value="Chrysotile"/>						
Room:	<input style="width: 95%;" type="text" value="Stockroom"/>	Identification:	<input style="width: 95%;" type="text" value="Presumed"/>						
Surveyor Name:	<input style="width: 95%;" type="text" value="J D Chilvers"/>	Quantity:	<input style="width: 95%;" type="text"/>						
Drawing Ref:	<input style="width: 95%;" type="text" value="7 and others"/>	Accessibility:	<input style="width: 95%;" type="text" value="Medium Accessibility"/>						
Asbestos ?	<input style="width: 95%;" type="text" value="Yes"/>

Material Risk Score	<input style="width: 20%;" type="text" value="3"/>	Material Risk Band:	<input style="width: 20%;" type="text" value="Very Low Risk"/>	Priority Risk Score:	<input style="width: 20%;" type="text" value="4"/>
Material Risk Score	<input style="width: 20%;" type="text" value="3"/>								
Material Risk Band:	<input style="width: 20%;" type="text" value="Very Low Risk"/>								
Priority Risk Score:	<input style="width: 20%;" type="text" value="4"/>								
Date:	<input style="width: 95%;" type="text" value="28 June 2004"/>								
Next Inspection:	<input style="width: 95%;" type="text" value="28 June 2005"/>

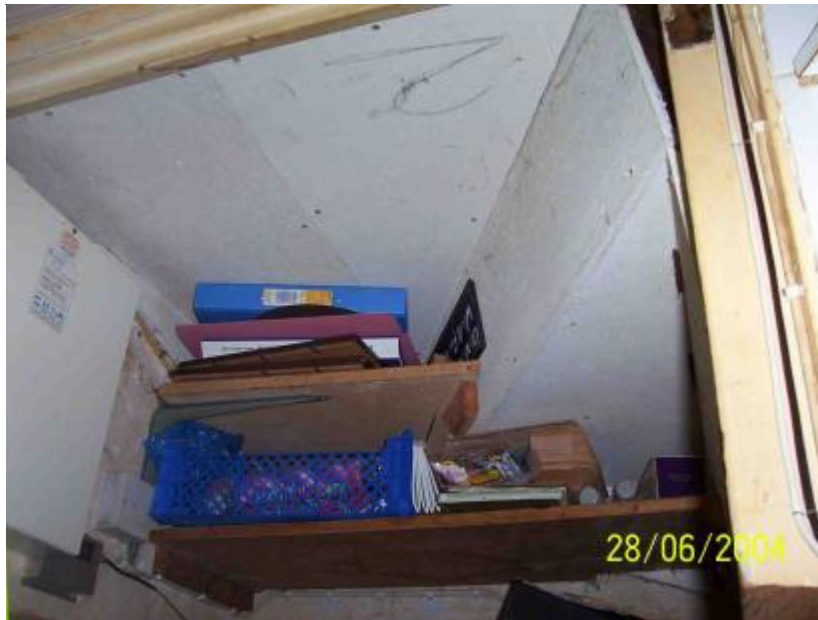
Location ID:	787	Survey Type:	T 2
Location Ref:	8	Product Type:	NADIS
Product:	Cladding	Damage:	NADIS
Area:	Not Applicable	Treatment:	NADIS
Floor:	Ground floor	Asbestos Type:	NADIS
Room:	Staircase	Identification:	Identified
Surveyor Name:	J D Chilvers	Quantity:	
Drawing Ref:	8	Accessibility:	
Asbestos ?	No		
Date:	28 June 2004		
Next Inspection:	Not Applicable

Material Risk Score	0
Material Risk Band:	NADIS
Priority Risk Score:	N/A

Action:	No Action Required
---------	--------------------

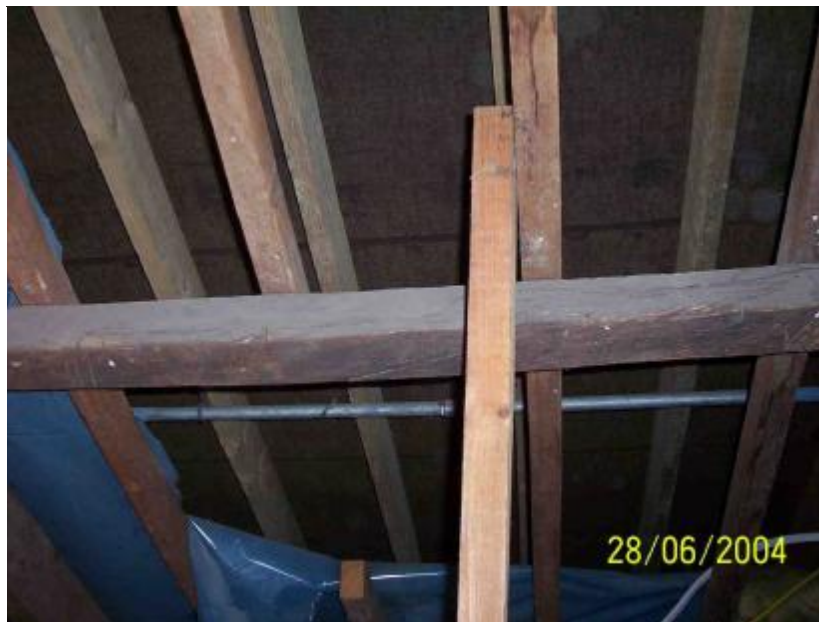
Location ID:	788	Survey Type:	T 2
Location Ref:	9	Product Type:	Roofing felts
Product:	Roofing felt	Damage:	No visible damage
Area:	Not Applicable	Treatment:	Resins
Floor:	Roof level	Asbestos Type:	Chrysotile
Room:	Loft space	Identification:	Presumed
Surveyor Name:	J D Chilvers	Quantity:	
Drawing Ref:	9	Accessibility:	Medium Accessibility
Asbestos ?	Yes		
Date:	28 June 2004		
Next Inspection:	28 June 2005		
		Material Risk Score:	2
		Material Risk Band:	Very Low Risk
		Priority Risk Score:	2
Action:	No Action Required

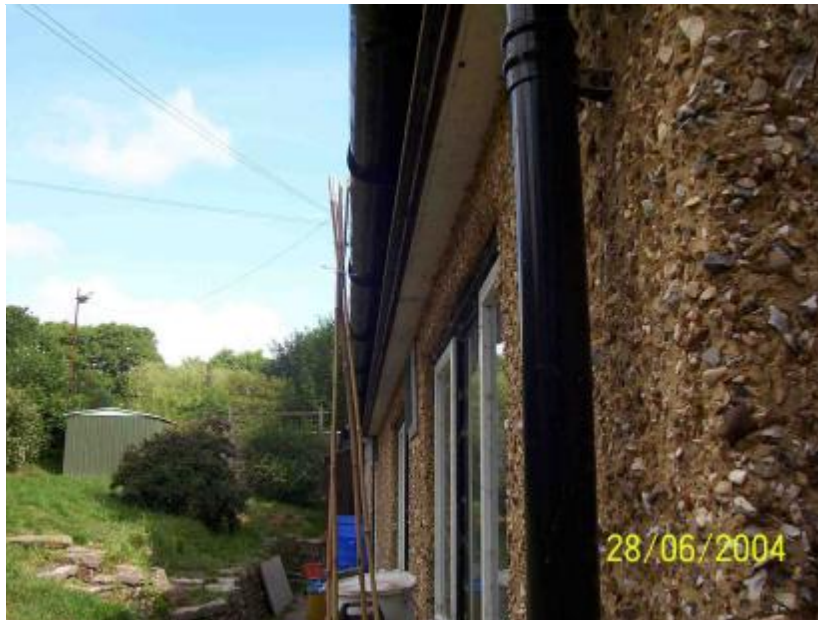
Location ID:	789	Survey Type:	T 2
Location Ref:	10	Product Type:	NADIS
Product:	Soffit	Damage:	NADIS
Area:	Not Applicable	Treatment:	NADIS
Floor:	External	Asbestos Type:	NADIS
Room:	External	Identification:	Identified
Surveyor Name:	J D Chilvers	Quantity:	
Drawing Ref:	10 and others	Accessibility:	
Asbestos ?	No		
Date:	28 June 2004		
Next Inspection:	Not Applicable

Material Risk Score	0
Material Risk Band:	NADIS
Priority Risk Score:	N/A

Action:	No Action Required
---------	--------------------

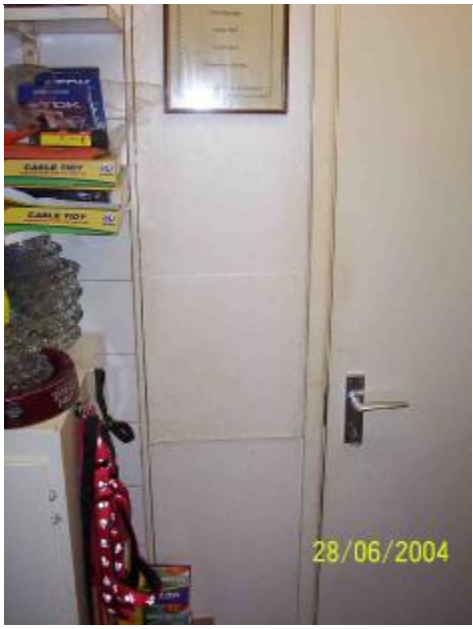
Location ID:	<input type="text" value="790"/>	Survey Type:	<input type="text" value="T 2"/>						
Location Ref:	<input type="text" value="11"/>	Product Type:	<input type="text" value="NADIS"/>						
Product:	<input type="text" value="Wall cladding"/>	Damage:	<input type="text" value="NADIS"/>						
Area:	<input type="text" value="Not Applicable"/>	Treatment:	<input type="text" value="NADIS"/>						
Floor:	<input type="text" value="Ground floor"/>	Asbestos Type:	<input type="text" value="NADIS"/>						
Room:	<input type="text" value="Stockroom"/>	Identification:	<input type="text" value="Presumed"/>						
Surveyor Name:	<input type="text" value="J D Chilvers"/>	Quantity:	<input type="text"/>						
Drawing Ref:	<input type="text" value="11"/>	Accessibility:	<input type="text"/>						
Asbestos ?	<input type="text" value="No"/>

Material Risk Score	<input type="text" value="0"/>	Material Risk Band:	<input type="text" value="NADIS"/>	Priority Risk Score:	<input type="text" value="N/A"/>
Material Risk Score	<input type="text" value="0"/>								
Material Risk Band:	<input type="text" value="NADIS"/>								
Priority Risk Score:	<input type="text" value="N/A"/>								
Date:	<input type="text" value="28 June 2004"/>								
Next Inspection:	<input type="text" value="Not Applicable"/>

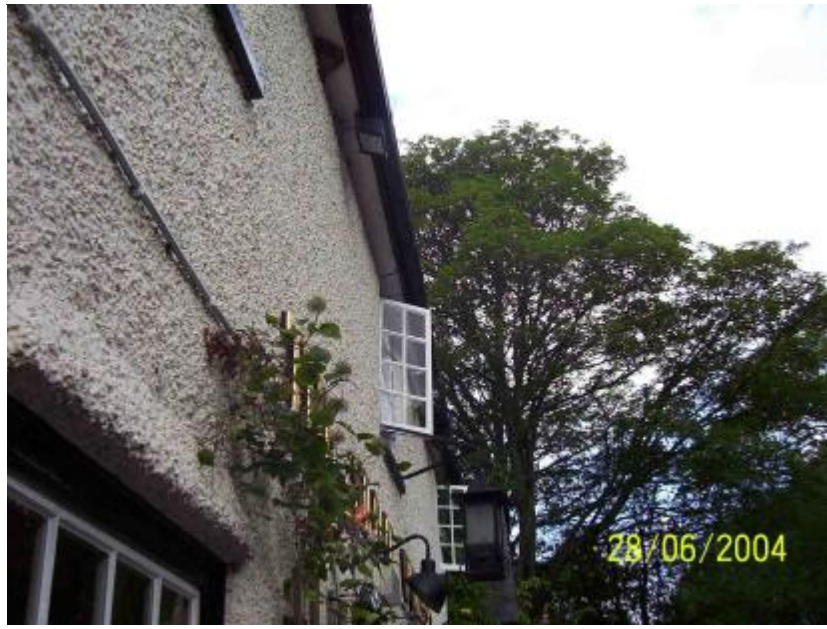
Location ID:	791	Survey Type:	T 2
Location Ref:	12	Product Type:	Asbestos cement
Product:	Soffit	Damage:	No visible damage
Area:	Not Applicable	Treatment:	Asbestos cement sheets etc
Floor:	Roof level	Asbestos Type:	Chrysotile
Room:	External	Identification:	Presumed
Surveyor Name:	J D Chilvers	Quantity:	
Drawing Ref:	12	Accessibility:	Difficult Accessibility
Asbestos ?	Yes		
Date:	28 June 2004		
Next Inspection:	28 June 2005

Material Risk Score	3
Material Risk Band:	Very Low Risk
Priority Risk Score:	2

Action:	No Action Required
---------	--------------------

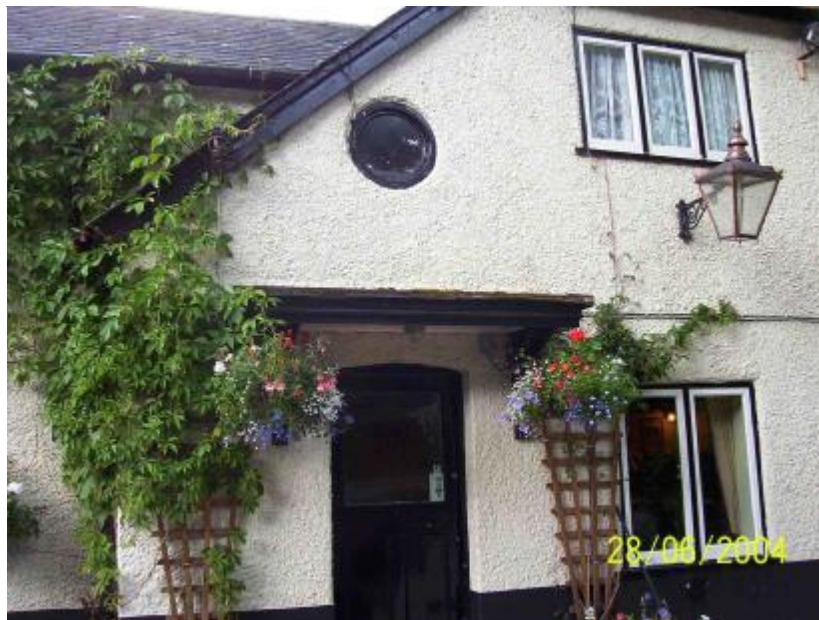
Location ID:	792	Survey Type:	T 2
Location Ref:	13	Product Type:	Roofing felts
Product:	Roofing felt	Damage:	No visible damage
Area:	Not Applicable	Treatment:	Resins
Floor:	External grd floor	Asbestos Type:	Chrysotile
Room:	Porch	Identification:	Presumed
Surveyor Name:	J D Chilvers	Quantity:	
Drawing Ref:	13	Accessibility:	Medium Accessibility
Asbestos ?	Yes		
Date:	28 June 2004		
Next Inspection:	28 June 2005

Material Risk Score	2
Material Risk Band:	Very Low Risk
Priority Risk Score:	1

Action:	No Action Required
---------	--------------------

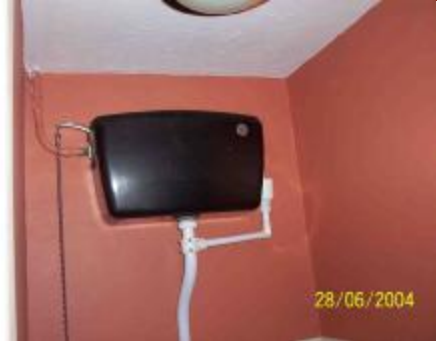
Priority Assessment Algorithm			
Assessment factor	Variable(s) selected	Score for each	Overall score
<b>Normal Occupant Activity:</b>			
Main type of activity in area:	Low disturbance	1	average
Secondary activities for area:	Low disturbance	1	1
<b>Likelihood Of Disturbance:</b>			
Location:	Rooms up to 100 m2	2	
Accessibility:	Usually inaccessible or unlikely to be disturbed	0	average
Extent/Amount:	Small items strings gaskets	0	1
<b>Human Exposure Potential:</b>			
Number of occupants:	1 to 3	1	
Frequency of use of area:	Daily	3	average
Average time area is in use:	<1 hour	0	1
<b>Maintenance Activity:</b>			
Type of maintenance activity:	Low disturbance	1	average
Frequency of maintenance activity	<=1 per year	1	1

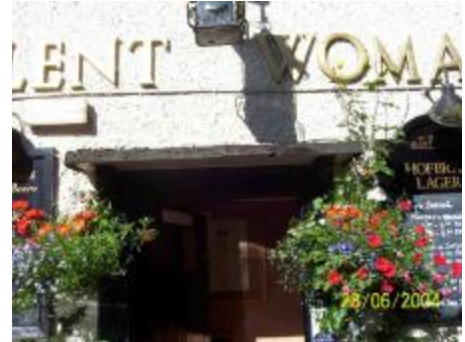
Location ID:	784
Location Ref:	5
Product:	Roofing felt
Area:	Not Applicable
Floor:	Ground floor
Room:	Porch
Surveyor Name:	J D Chilvers
Drawing Ref:	5
Asbestos ?	Yes
Date:	28 June 2004

Priority Assessment Algorithm	Variable(s) selected	Score for each	Overall score
<b>Normal Occupant Activity:</b>			
Main type of activity in area:	Rare disturbance	0	average
Secondary activities for area:	Rare disturbance	0	0
<b>Likelihood Of Disturbance:</b>			
Location:	Outdoors	0	
Accessibility:	Usually inaccessible or unlikely to be disturbed	0	average
Extent/Amount:	<=10 m2 or <=10 m pipe run	1	0
<b>Human Exposure Potential:</b>			
Number of occupants:	None	0	
Frequency of use of area:	Daily	3	average
Average time area is in use:	<1 hour	0	1
<b>Maintenance Activity:</b>			
Type of maintenance activity:	Minor disturbance	0	average
Frequency of maintenance activity	<=1 per year	1	1

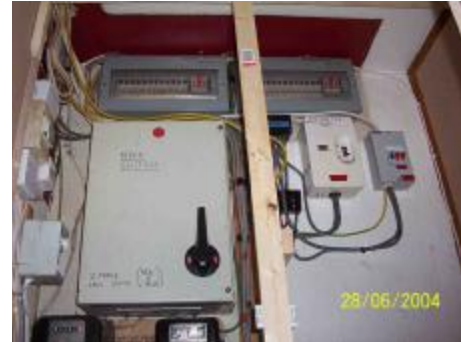
Location ID:	785
Location Ref:	6
Product:	Fuse & Switchgear Flashguard
Area:	Not Applicable
Floor:	Ground floor
Room:	Lobby
Surveyor Name:	J D Chilvers
Drawing Ref:	6
Asbestos ?	Yes
Date:	28 June 2004

Priority Assessment Algorithm	Variable(s) selected	Score for each	Overall score
<b>Normal Occupant Activity:</b>			
Main type of activity in area:	Low disturbance	1	average
Secondary activities for area:	Low disturbance	1	1
<b>Likelihood Of Disturbance:</b>			
Location:	Rooms up to 100 m2	2	average
Accessibility:	Occasionally likely to be disturbed	1	
Extent/Amount:	Small items strings gaskets	0	
<b>Human Exposure Potential:</b>			
Number of occupants:	>10	3	average
Frequency of use of area:	Daily	3	
Average time area is in use:	<1 hour	0	
<b>Maintenance Activity:</b>			
Type of maintenance activity:	Low disturbance	1	average
Frequency of maintenance activity	<=1 per year	1	1

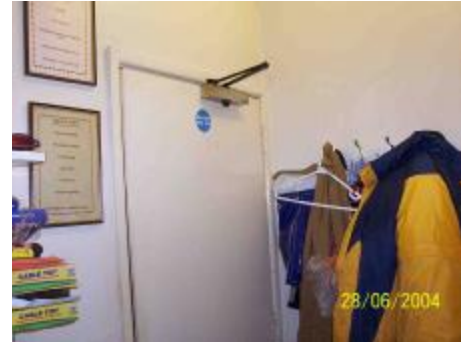
Location ID:	786
Location Ref:	7
Product:	Fire Door
Area:	Not Applicable
Floor:	Ground floor
Room:	Stockroom
Surveyor Name:	J D Chilvers
Drawing Ref:	7 and others
Asbestos ?	Yes
Date:	28 June 2004

Priority Assessment Algorithm	Variable(s) selected	Score for each	Overall score
<b>Normal Occupant Activity:</b>			
Main type of activity in area:	Low disturbance	1	average
Secondary activities for area:	Low disturbance	1	1
<b>Likelihood Of Disturbance:</b>			
Location:	Rooms up to 100 m2	2	average
Accessibility:	Usually inaccessible or unlikely to be disturbed	0	
Extent/Amount:	<=10 m2 or <=10 m pipe run	1	
<b>Human Exposure Potential:</b>			
Number of occupants:	1 to 3	1	average
Frequency of use of area:	Daily	3	
Average time area is in use:	<1 hour	0	
<b>Maintenance Activity:</b>			
Type of maintenance activity:	Minor disturbance	0	average
Frequency of maintenance activity	<=1 per year	1	1

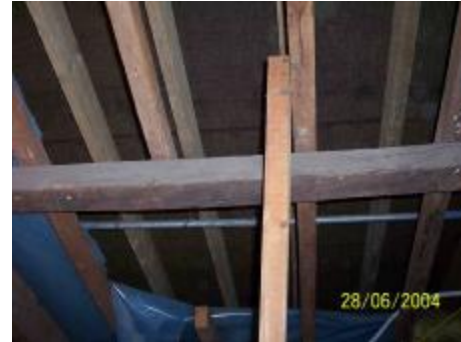
Priority Assessment Algorithm			
Assessment factor	Variable(s) selected	Score for each	Overall score
<b>Normal Occupant Activity:</b>			
Main type of activity in area:	Rare disturbance	0	average
Secondary activities for area:	Rare disturbance	0	0
<b>Likelihood Of Disturbance:</b>			
Location:	Large rooms or well-ventilated areas	1	
Accessibility:	Usually inaccessible or unlikely to be disturbed	0	average
Extent/Amount:	>50 m2 or >50 m pipe run	3	1
<b>Human Exposure Potential:</b>			
Number of occupants:	None	0	
Frequency of use of area:	Infrequent	0	average
Average time area is in use:	<1 hour	0	0
<b>Maintenance Activity:</b>			
Type of maintenance activity:	Minor disturbance	0	average
Frequency of maintenance activity	<=1 per year	1	1

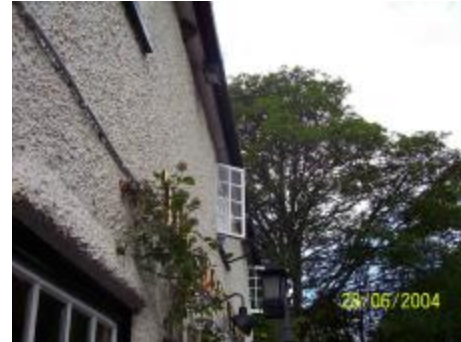
Location ID:	791
Location Ref:	12
Product:	Soffit
Area:	Not Applicable
Floor:	Roof level
Room:	External
Surveyor Name:	J D Chilvers
Drawing Ref:	12
Asbestos ?	Yes
Date:	28 June 2004

Priority Assessment Algorithm	Variable(s) selected	Score for each	Overall score
<b>Normal Occupant Activity:</b>			
Main type of activity in area:	Rare disturbance	0	average
Secondary activities for area:	Rare disturbance	0	0
<b>Likelihood Of Disturbance:</b>			
Location:	Outdoors	0	average 1
Accessibility:	Usually inaccessible or unlikely to be disturbed	0	
Extent/Amount:	>10 to <=50 (m2 or pipe run)	2	
<b>Human Exposure Potential:</b>			
Number of occupants:	None	0	average 0
Frequency of use of area:	Infrequent	0	
Average time area is in use:	<1 hour	0	
<b>Maintenance Activity:</b>			
Type of maintenance activity:	Minor disturbance	0	average 1
Frequency of maintenance activity	<=1 per year	1

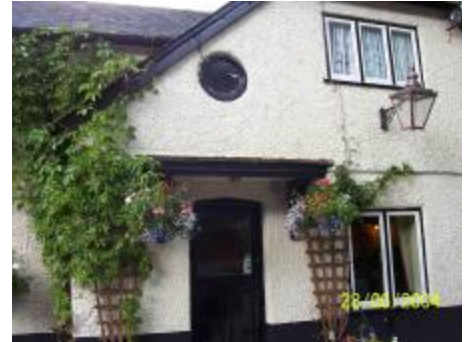
Priority Assessment Algorithm			
Assessment factor	Variable(s) selected	Score for each	Overall score
<b>Normal Occupant Activity:</b>			
Main type of activity in area:	Rare disturbance	0	average
Secondary activities for area:	Rare disturbance	0	0
<b>Likelihood Of Disturbance:</b>			
Location:	Outdoors	0	
Accessibility:	Usually inaccessible or unlikely to be disturbed	0	average
Extent/Amount:	<=10 m2 or <=10 m pipe run	1	0
<b>Human Exposure Potential:</b>			
Number of occupants:	None	0	
Frequency of use of area:	Infrequent	0	average
Average time area is in use:	<1 hour	0	0
<b>Maintenance Activity:</b>			
Type of maintenance activity:	Minor disturbance	0	average
Frequency of maintenance activity	<=1 per year	1	1
