Asbestos Survey for

Hall & Woodhouse Ltd

Cherry Tree
Cophorne Bank
Cophorne
Crawley
West Sussex
RH10 3JD

Project Number: AS07028 - Cherry Tree Cophorne

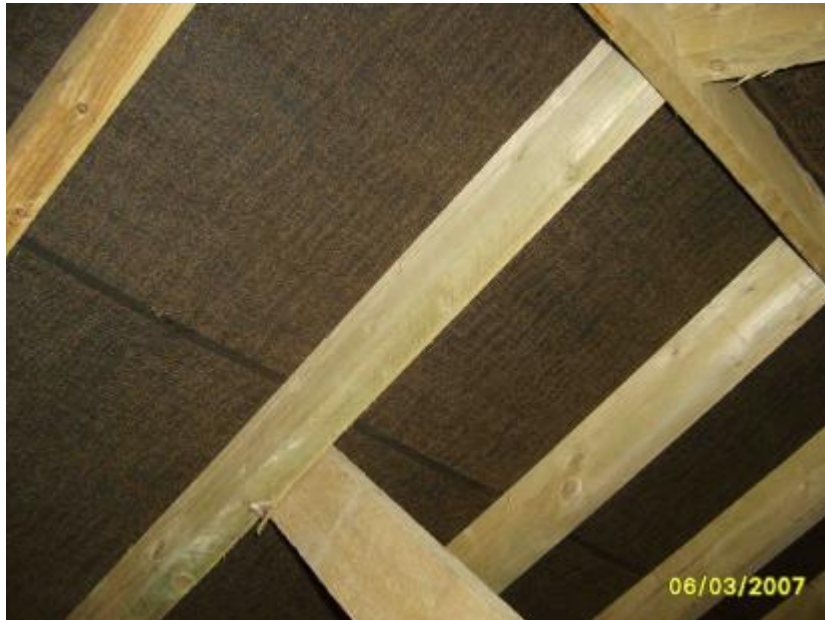
| Sample Date | Location Ref | Location ID | Drawing Reference | Floor | Room | Asbestos Type | Product Name | Material Risk Score | Material Risk Band | Priority Risk Score | Comments | Action | Survey Type |
|---|---|---|---|---|---|---|---|---|---|---|---|---|---|
| 06/03/07 | 1 | 7466 | 1 | Ground floor | Loft space | Chrysotile | Roofing felt | 2 | Very Low Risk | 2 | | No Action Required | T 2 |

| Product: | Roofing felt | Damage: | No visible damage |
| Floor: | Ground floor | Asbestos Type: | Chrysotile |
| Room: | Loft space | Identification: | Presumed |

Material Risk Score: 2

Material Risk Band: Very Low Risk

Action: No Action Required

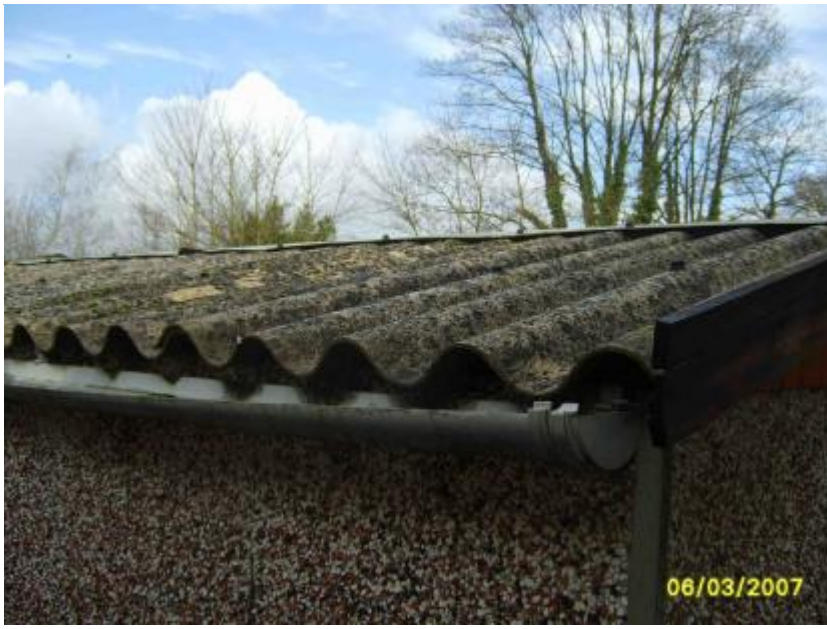
| Sample Date | Location Ref | Location ID | Drawing Reference | Floor | Room | Asbestos Type | Product Name | Material Risk Score | Material Risk Band | Priority Risk Score | Comments | Action | Survey Type |
|---|---|---|---|---|---|---|---|---|---|---|---|---|---|
| 06/03/07 | 2 | 7467 | 2 | Roof level | Sheds / Outbuildings | NADIS | Roof sheets | 0 | NADIS | N/A | | No Action Required | T 2 |

| Product: | Roof sheets | Damage: | NADIS |
| Asbestos ? | No | | |

| Material Risk Band: | NADIS |

Action: No Action Required

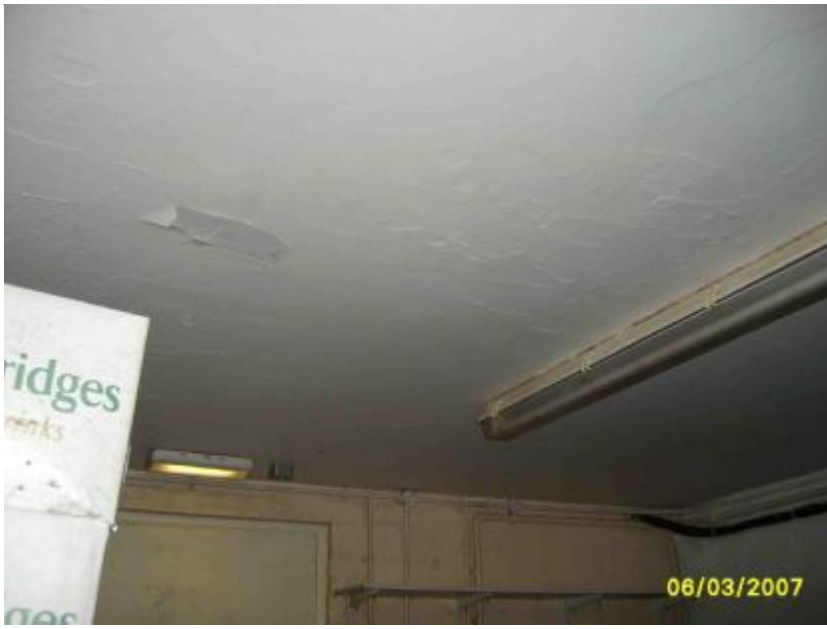
| Sample Date | Location Ref | Location ID | Drawing Reference | Floor | Room | Asbestos Type | Product Name | Material Risk Score | Material Risk Band | Priority Risk Score | Comments | Action | Survey Type |
|---|---|---|---|---|---|---|---|---|---|---|---|---|---|
| 06/03/07 | 3 | 7468 | 3 | Ground floor | Cellar | NADIS | Ceiling | 0 | NADIS | N/A | | No Action Required | T 2 |

| Product: | Ceiling | Damage: | NADIS |

Action: No Action Required

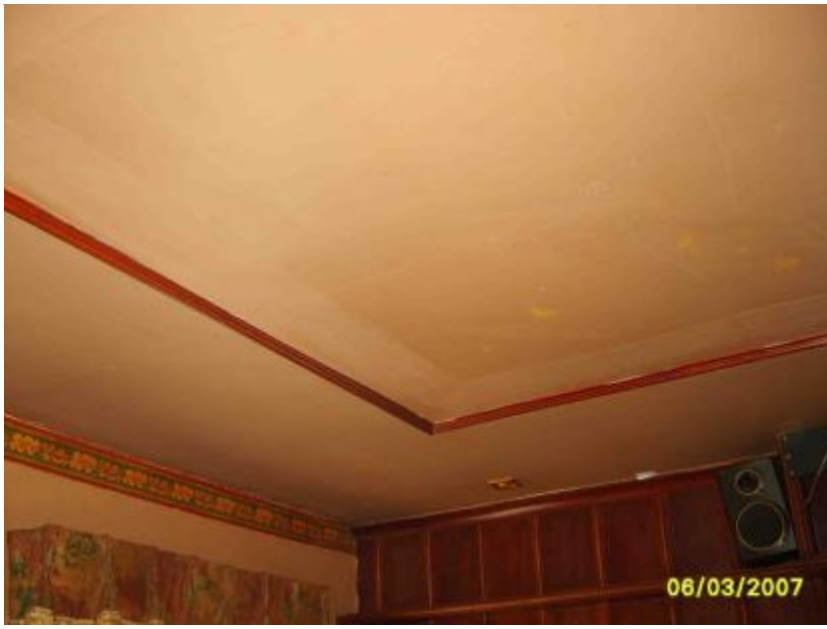
| Sample Date | Location Ref | Location ID | Drawing Reference | Floor | Room | Asbestos Type | Product Name | Material Risk Score | Material Risk Band | Priority Risk Score | Comments | Action | Survey Type |
|---|---|---|---|---|---|---|---|---|---|---|---|---|---|
| 06/03/07 | 4 | 7469 | 4 | Ground floor | Bar area | NADIS | Ceiling | 0 | NADIS | N/A | | No Action Required | T 2 |

| Product: | Ceiling | Damage: | NADIS |

Action: No Action Required

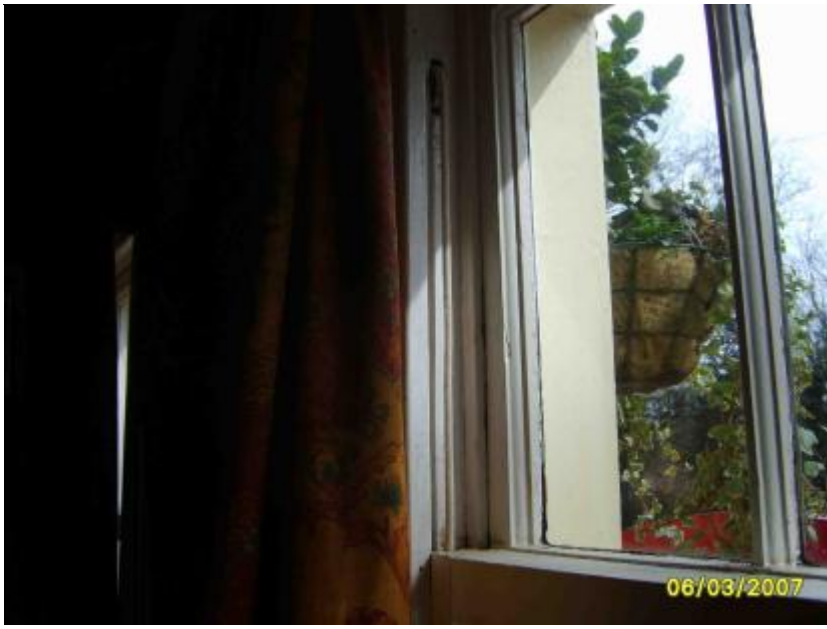
| Sample Date | Location Ref | Location ID | Drawing Reference | Floor | Room | Asbestos Type | Product Name | Material Risk Score | Material Risk Band | Priority Risk Score | Comments | Action | Survey Type |
|---|---|---|---|---|---|---|---|---|---|---|---|---|---|
| 06/03/07 | 5 | 7470 | 5 | Ground floor | Bar area | Chrysotile | Sash Cord | 3 | Very Low Risk | 5 | | Apply Warning Labels | T 2 |

| Product: | Sash Cord | Damage: | No visible damage |

Action: Apply Warning Labels

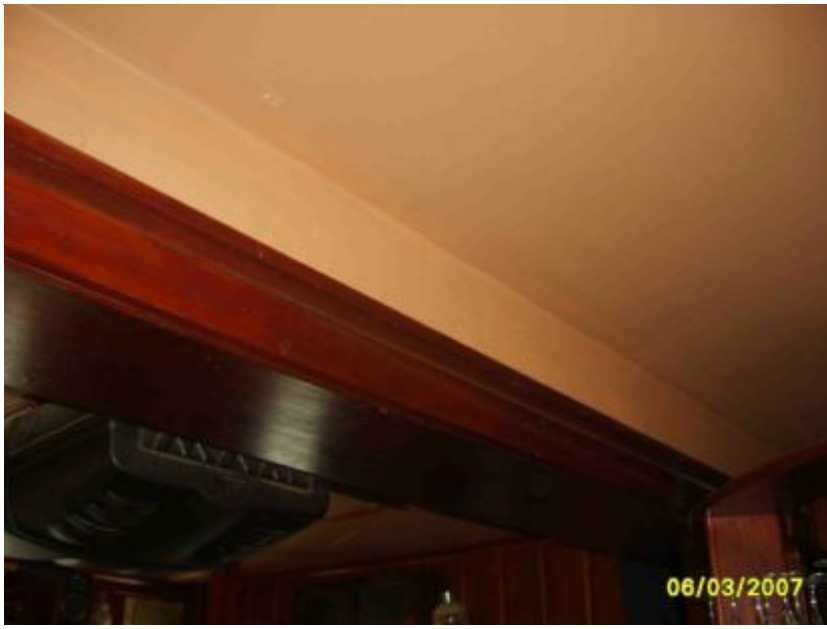
| Sample Date | Location Ref | Location ID | Drawing Reference | Floor | Room | Asbestos Type | Product Name | Material Risk Score | Material Risk Band | Priority Risk Score | Comments | Action | Survey Type |
|---|---|---|---|---|---|---|---|---|---|---|---|---|---|
| 06/03/07 | 6 | 7471 | 6 | Ground floor | Bar area | Amosite | Beam cladding | 5 | Low Risk | 4 | All structural beams may have AIB cladding underneath external finishes. | Apply Warning Labels | T 2 |

| Product: | Beam cladding | Damage: | No visible damage |

Material Comments: All structural beams may have AIB cladding underneath external finishes.

Action: Apply Warning Labels

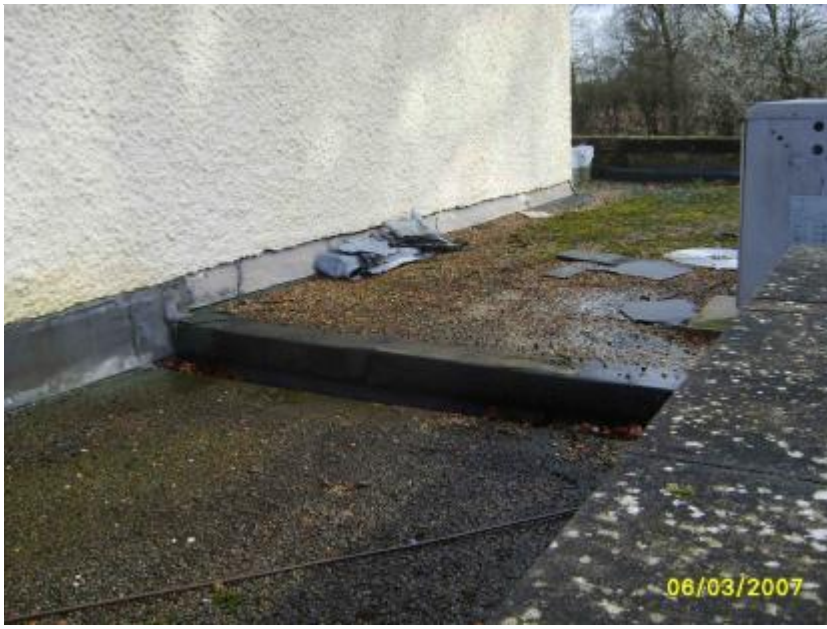
| Sample Date | Location Ref | Location ID | Drawing Reference | Floor | Room | Asbestos Type | Product Name | Material Risk Score | Material Risk Band | Priority Risk Score | Comments | Action | Survey Type |
|---|---|---|---|---|---|---|---|---|---|---|---|---|---|
| 06/03/07 | 7 | 7472 | 7 | Roof level | Flat roof area | NADIS | Roofing felt | 0 | NADIS | N/A | | No Action Required | T 2 |

| Product: | Roofing felt | Damage: | NADIS |

Action: No Action Required

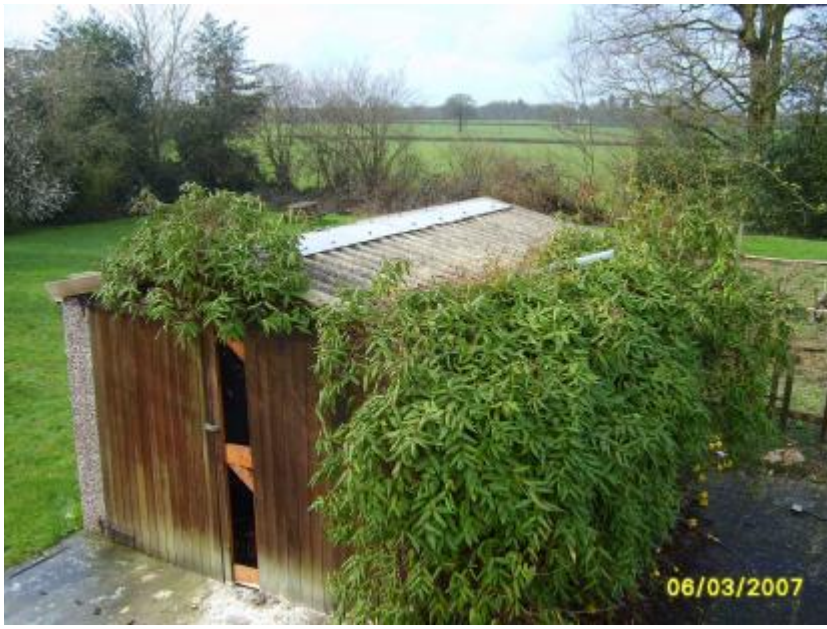
| Sample Date | Location Ref | Location ID | Drawing Reference | Floor | Room | Asbestos Type | Product Name | Material Risk Score | Material Risk Band | Priority Risk Score | Comments | Action | Survey Type |
|---|---|---|---|---|---|---|---|---|---|---|---|---|---|
| 06/03/07 | 8 | 7473 | 8 | Roof level | Sheds / Outbuildings | NADIS | Roof sheets | 0 | NADIS | N/A | | No Action Required | T 2 |

| Product: | Roof sheets | Damage: | NADIS |

Action: No Action Required

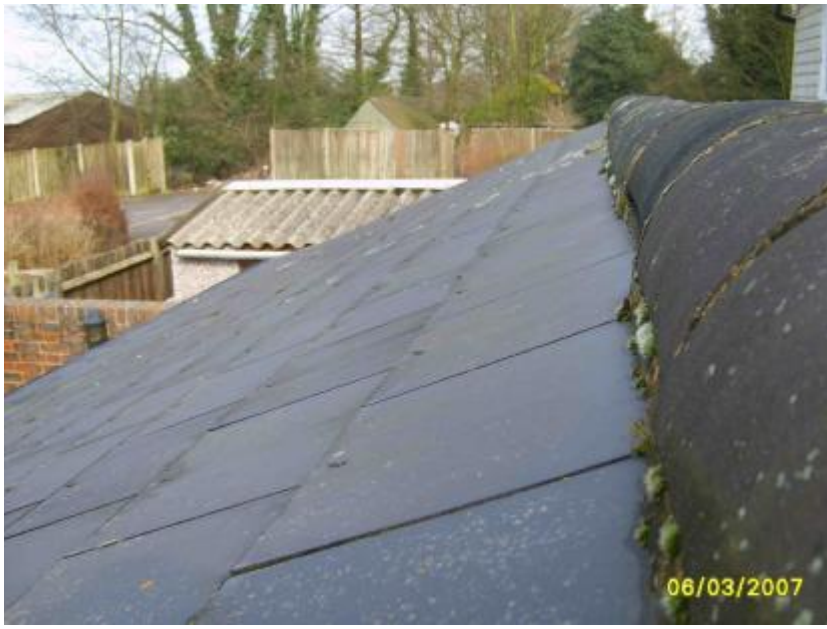
| Sample Date | Location Ref | Location ID | Drawing Reference | Floor | Room | Asbestos Type | Product Name | Material Risk Score | Material Risk Band | Priority Risk Score | Comments | Action | Survey Type |
|---|---|---|---|---|---|---|---|---|---|---|---|---|---|
| 06/03/07 | 9 | 7474 | 9 | Roof level | External | NADIS | Roof Tiles | 0 | NADIS | N/A | | No Action Required | T 2 |

| Product: | Roof Tiles | Damage: | NADIS |

Action: No Action Required

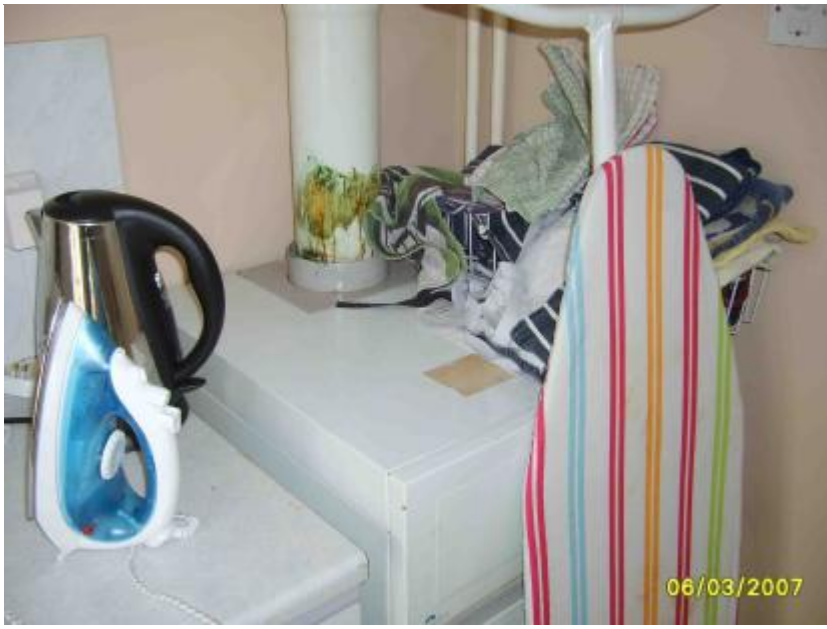
| Sample Date | Location Ref | Location ID | Drawing Reference | Floor | Room | Asbestos Type | Product Name | Material Risk Score | Material Risk Band | Priority Risk Score | Comments | Action | Survey Type |
|---|---|---|---|---|---|---|---|---|---|---|---|---|---|
| 06/03/07 | 10 | 7475 | 10 | First floor | Kitchen | Chrysotile | Boiler | 3 | Very Low Risk | 3 | | Apply Warning Labels | T 2 |

| Product: | Boiler | Damage: | No visible damage |

Action: Apply Warning Labels

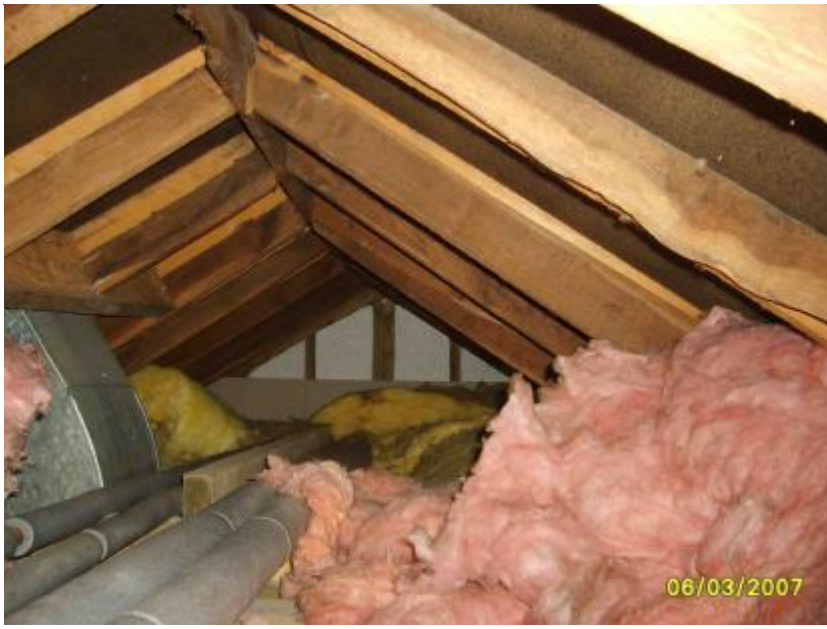
| Sample Date | Location Ref | Location ID | Drawing Reference | Floor | Room | Asbestos Type | Product Name | Material Risk Score | Material Risk Band | Priority Risk Score | Comments | Action | Survey Type |
|---|---|---|---|---|---|---|---|---|---|---|---|---|---|
| 06/03/07 | 11 | 7476 | 11 | Roof level | Loft space | Amosite | Fire break | 6 | Low Risk | 2 | Firebreak presumed to contain ACMs - not possible to get sufficient access to sample. | Encapsulate and Apply Warning Labels | T 2 |

| Product: | Fire break | Damage: | No visible damage |

Material Comments: Firebreak presumed to contain ACMs - not possible to get sufficient access to sample.

Action: Encapsulate and Apply Warning Labels

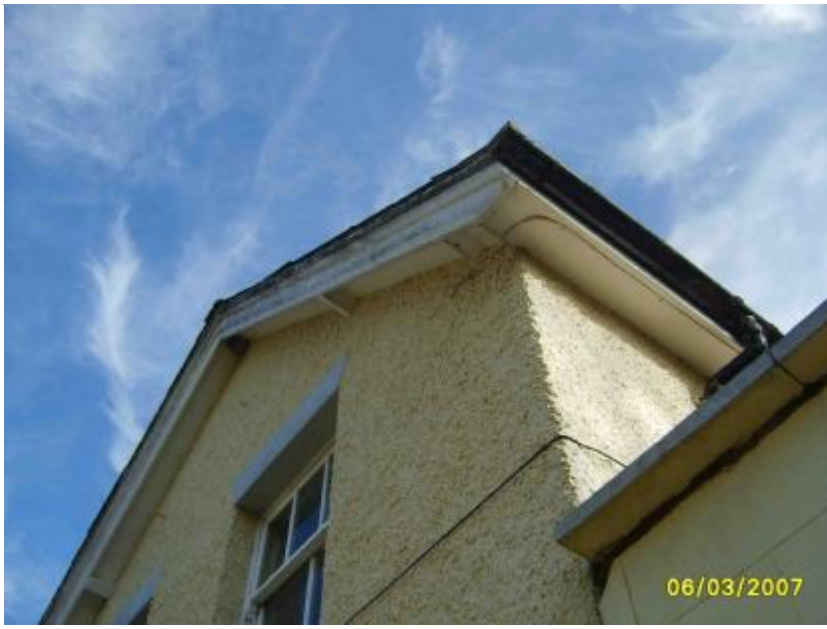
| Sample Date | Location Ref | Location ID | Drawing Reference | Floor | Room | Asbestos Type | Product Name | Material Risk Score | Material Risk Band | Priority Risk Score | Comments | Action | Survey Type |
|---|---|---|---|---|---|---|---|---|---|---|---|---|---|
| 06/03/07 | 12 | 7477 | 12 | Roof level | External | Chrysotile | Verge Undercloak | 3 | Very Low Risk | 1 | | No Action Required | T 2 |

| Product: | Verge Undercloak | Damage: | No visible damage |

Action: No Action Required
