JTEC Environmental Ltd.

Asbestos Survey for

The Stout House
29 Carfax
Horsham
West Sussex
RH12 1EE

Project Number: AS08006 - Stout House

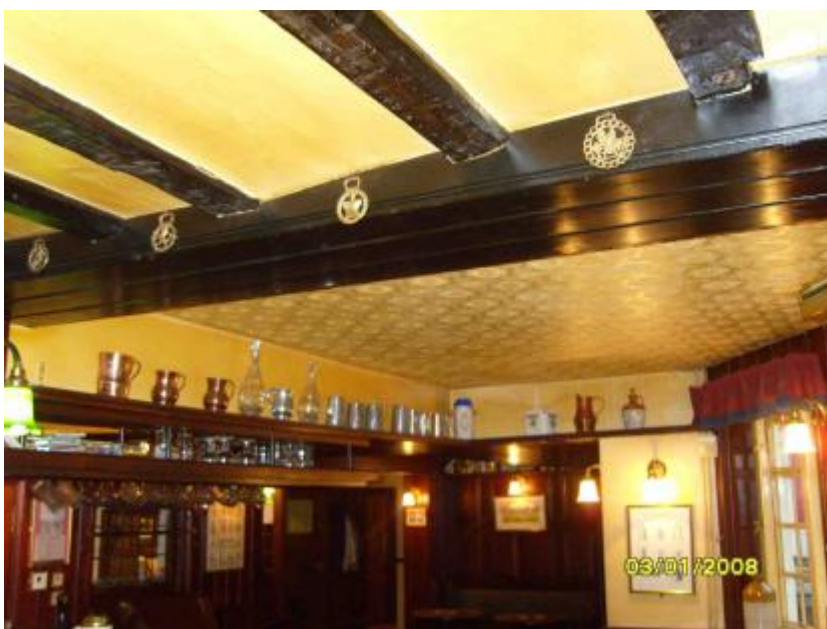
Location ID:	<input type="text" value="9417"/>	Survey Type:	<input type="text" value="T 2"/>
Location Ref:	<input type="text" value="1"/>	Product Type:	<input type="text" value="Asbestos Insulating Board"/>
Product:	<input type="text" value="Beam cladding"/>	Damage:	<input type="text" value="No visible damage"/>
Area:	<input type="text" value="Not Applicable"/>	Treatment:	<input type="text" value="AIB painted or encapsulated"/>
Floor:	<input type="text" value="Ground floor"/>	Asbestos Type:	<input type="text" value="Amosite"/>
Room:	<input type="text" value="Bar area"/>	Identification:	<input type="text" value="Presumed"/>
Surveyor Name:	<input type="text" value="J D Chilvers"/>	Quantity:	<input type="text"/>

Drawing Ref:	<input type="text" value="1"/>	Accessibility:	<input type="text" value="Medium Accessibility"/>
Asbestos ?	<input type="text" value="Yes"/>		
Date:	<input type="text" value="03 January 2008"/>		
Next Inspection:	<input type="text" value="04 July 2008"/>

Material Risk Score	<input type="text" value="5"/>
Material Risk Band:	<input type="text" value="Low Risk"/>
Priority Risk Score:	<input type="text" value="5"/>

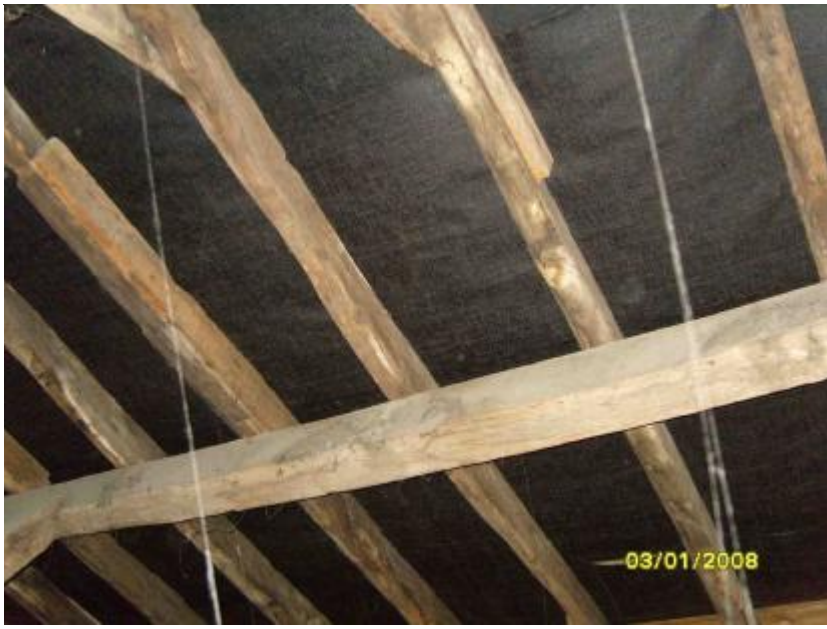
Location ID:	9418	Survey Type:	T 2
Location Ref:	2	Product Type:	Roofing felts
Product:	Roofing felt	Damage:	No visible damage
Area:	Not Applicable	Treatment:	Resins
Floor:	Roof level	Asbestos Type:	Chrysotile
Room:	Loft space	Identification:	Presumed
Surveyor Name:	J D Chilvers	Quantity:	
Drawing Ref:	2	Accessibility:	Medium Accessibility
Asbestos ?	Yes		
Date:	03 January 2008		
Next Inspection:	02 January 2009		
		Material Risk Score:	2
		Material Risk Band:	Very Low Risk
		Priority Risk Score:	2

Action:	No Action Required
---------	--------------------

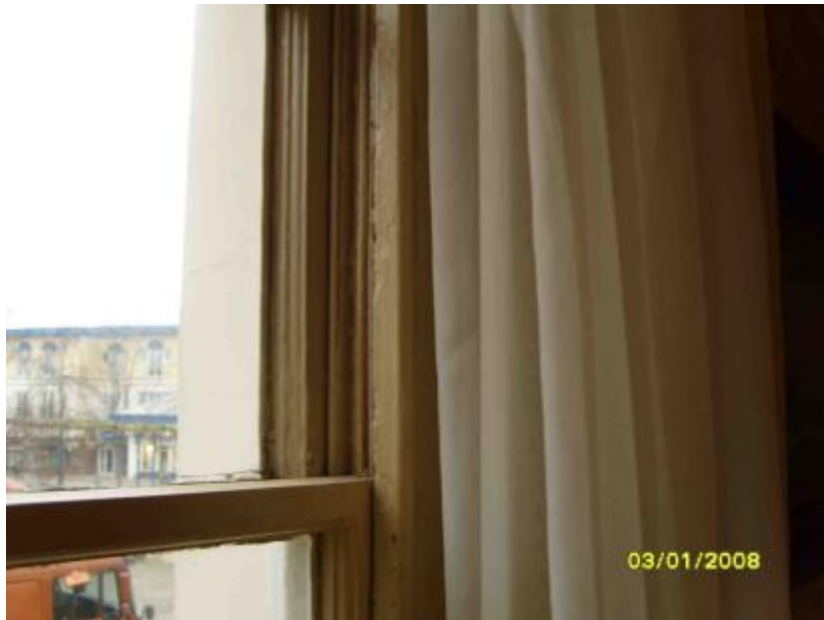
Location ID:	9419	Survey Type:	T 2
Location Ref:	3	Product Type:	Ropes and woven textiles
Product:	Sash Cord	Damage:	Low damage
Area:	Not Applicable	Treatment:	Composite asbestos materials
Floor:	First floor	Asbestos Type:	Chrysotile
Room:	All	Identification:	Presumed
Surveyor Name:	J D Chilvers	Quantity:	
Drawing Ref:	3	Accessibility:	Easy Accessibility
Asbestos ?	Yes		
Date:	03 January 2008		
Next Inspection:	02 January 2009		
		Material Risk Score:	4
		Material Risk Band:	Very Low Risk
		Priority Risk Score:	5
Action:	Apply Warning Labels

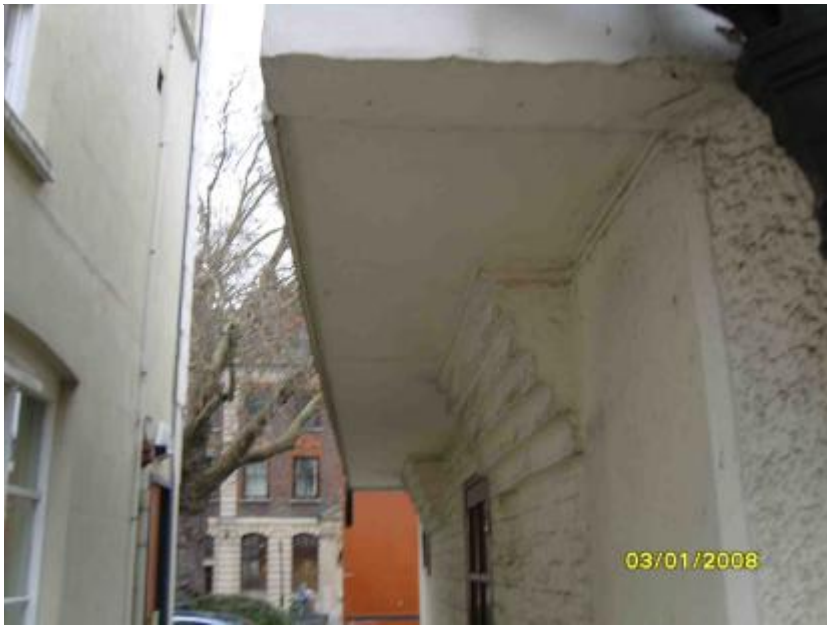
Location ID:	9421	Survey Type:	T 2
Location Ref:	5	Product Type:	Asbestos Insulating Board
Product:	Soffit	Damage:	Low damage: Scratches or marks
Area:	Not Applicable	Treatment:	AIB painted or encapsulated
Floor:	Ground floor	Asbestos Type:	Amosite
Room:	External	Identification:	Identified
Surveyor Name:	J D Chilvers	Quantity:	
Drawing Ref:	5	Accessibility:	Medium Accessibility
Asbestos ?	Yes		
Date:	03 January 2008		
Next Inspection:	04 July 2008

Material Risk Score	6
Material Risk Band:	Low Risk
Priority Risk Score:	3

Action:	Apply Warning Labels
---------	----------------------

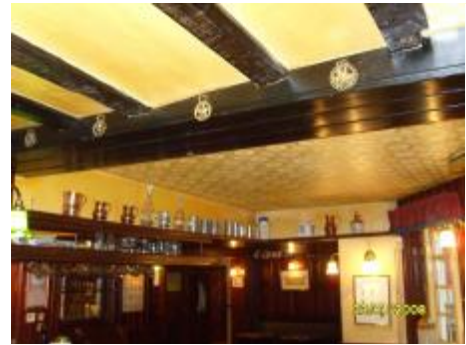
Location ID:	9417
Location Ref:	1
Product:	Beam cladding
Area:	Not Applicable
Floor:	Ground floor
Room:	Bar area
Surveyor Name:	J D Chilvers
Drawing Ref:	1
Asbestos ?	Yes
Date:	03 January 2008

Priority Assessment Algorithm	Variable(s) selected	Score for each	Overall score
Normal Occupant Activity:			
Main type of activity in area:	Low disturbance	1	average
Secondary activities for area:	Low disturbance	1	1
Likelihood Of Disturbance:			
Location:	Large rooms or well-ventilated areas	1	average
Accessibility:	Usually inaccessible or unlikely to be disturbed	0	
Extent/Amount:	<=10 m2 or <=10 m pipe run	1	
Human Exposure Potential:			
Number of occupants:	>10	3	average
Frequency of use of area:	Daily	3	
Average time area is in use:	>1 to <3 hours	1	
Maintenance Activity:			
Type of maintenance activity:	Minor disturbance	0	average
Frequency of maintenance activity	<=1 per year	1	1

Total Priority Assessment Score:		5
Material Assessment Score (supplied by surveyor):	Low Risk	5
Total of Material and Priority Assessment Scores:		10

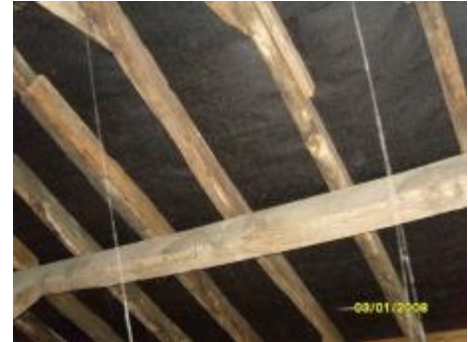
Location ID:	<input style="width: 95%;" type="text" value="9418"/>
Location Ref:	<input style="width: 95%;" type="text" value="2"/>
Product:	<input style="width: 95%;" type="text" value="Roofing felt"/>
Area:	<input style="width: 95%;" type="text" value="Not Applicable"/>
Floor:	<input style="width: 95%;" type="text" value="Roof level"/>
Room:	<input style="width: 95%;" type="text" value="Loft space"/>
Surveyor Name:	<input style="width: 95%;" type="text" value="J D Chilvers"/>
Drawing Ref:	<input style="width: 95%;" type="text" value="2"/>
Asbestos ?	<input style="width: 95%;" type="text" value="Yes"/>
Date:	<input style="width: 95%;" type="text" value="03 January 2008"/>

Priority Assessment Algorithm			
Assessment factor	Variable(s) selected	Score for each	Overall score
Normal Occupant Activity:			
Main type of activity in area:	Rare disturbance	0	average
Secondary activities for area:	Rare disturbance	0	0
Likelihood Of Disturbance:			
Location:	Large rooms or well-ventilated areas	1	
Accessibility:	Usually inaccessible or unlikely to be disturbed	0	average
Extent/Amount:	>50 m2 or >50 m pipe run	3	1
Human Exposure Potential:			
Number of occupants:	1 to 3	1	
Frequency of use of area:	Infrequent	0	average
Average time area is in use:	<1 hour	0	0
Maintenance Activity:			
Type of maintenance activity:	Minor disturbance	0	average
Frequency of maintenance activity	<=1 per year	1	1

Total Priority Assessment Score:	2
Material Assessment Score (supplied by surveyor):	Very Low Risk 2
Total of Material and Priority Assessment Scores:	4

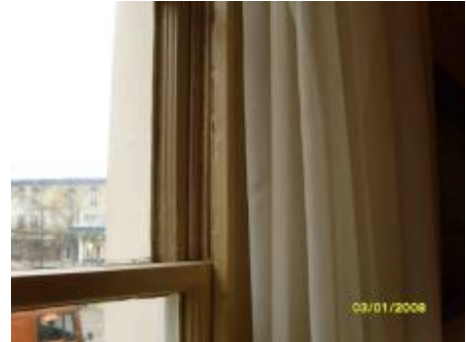
Location ID:	9419
Location Ref:	3
Product:	Sash Cord
Area:	Not Applicable
Floor:	First floor
Room:	All
Surveyor Name:	J D Chilvers
Drawing Ref:	3
Asbestos ?	Yes
Date:	03 January 2008

Priority Assessment Algorithm			
Assessment factor	Variable(s) selected	Score for each	Overall score
Normal Occupant Activity:			
Main type of activity in area:	Low disturbance	1	average 1
Secondary activities for area:	Rare disturbance	0	
Likelihood Of Disturbance:			
Location:	Rooms up to 100 m2	2	average 1
Accessibility:	Occasionally likely to be disturbed	1	
Extent/Amount:	Small items strings gaskets	0	
Human Exposure Potential:			
Number of occupants:	1 to 3	1	average 2
Frequency of use of area:	Daily	3	
Average time area is in use:	>3 to <6 hours	2	
Maintenance Activity:			
Type of maintenance activity:	Minor disturbance	0	average 1
Frequency of maintenance activity	<=1 per year	1

Total Priority Assessment Score:		5
Material Assessment Score (supplied by surveyor):	Very Low Risk	4
Total of Material and Priority Assessment Scores:		9

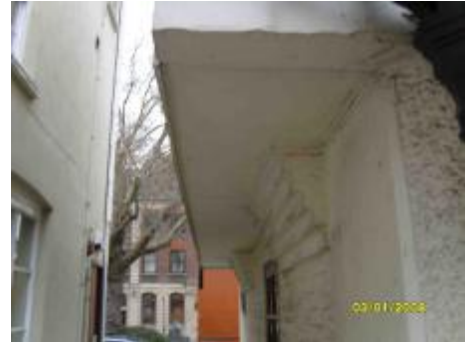
Location ID:	<input style="width: 90%;" type="text" value="9421"/>
Location Ref:	<input style="width: 90%;" type="text" value="5"/>
Product:	<input style="width: 90%;" type="text" value="Soffit"/>
Area:	<input style="width: 90%;" type="text" value="Not Applicable"/>
Floor:	<input style="width: 90%;" type="text" value="Ground floor"/>
Room:	<input style="width: 90%;" type="text" value="External"/>
Surveyor Name:	<input style="width: 90%;" type="text" value="J D Chilvers"/>
Drawing Ref:	<input style="width: 90%;" type="text" value="5"/>
Asbestos ?	<input style="width: 90%;" type="text" value="Yes"/>
Date:	<input style="width: 90%;" type="text" value="03 January 2008"/>

Priority Assessment Algorithm			
Assessment factor	Variable(s) selected	Score for each	Overall score
Normal Occupant Activity:			
Main type of activity in area:	Rare disturbance	0	average
Secondary activities for area:	Rare disturbance	0	0
Likelihood Of Disturbance:			
Location:	Outdoors	0	
Accessibility:	Occasionally likely to be disturbed	1	average
Extent/Amount:	<=10 m2 or <=10 m pipe run	1	1
Human Exposure Potential:			
Number of occupants:	1 to 3	1	
Frequency of use of area:	Daily	3	average
Average time area is in use:	<1 hour	0	1
Maintenance Activity:			
Type of maintenance activity:	Minor disturbance	0	average
Frequency of maintenance activity	<=1 per year	1	1

Total Priority Assessment Score:		3
Material Assessment Score (supplied by surveyor):	Low Risk	6
Total of Material and Priority Assessment Scores:		9
