Asbestos Survey for

Hall & Woodhouse Ltd

George Inn St Mary Bourne Andover Hampshire SP11 6BG

Project Number: AS07069 - George Inn St Mary Bourne Printed: 22/10/2008 By: JTEC Environmental Ltd.. Using Multibase software.

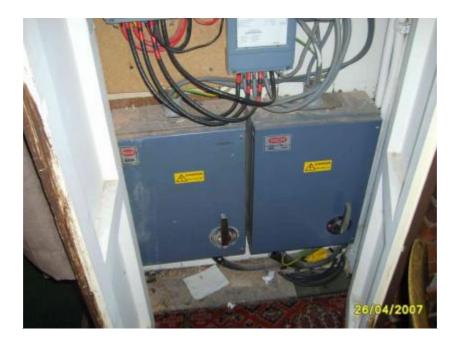
Site Address: Geo	rge Inn, St Mary Bourne, Andover, Hampshi		ent Name:	Hall & Wo	odhouse Ltd
		Pro	oject Number:	AS07069 - George	Inn St Mary Bourne
Location ID:	10497	Survey Type:		T 2	
Location Ref:	1	Product Type:	I	Ropes and woven te	xtiles
Product:	Fuse & Switchgear Flashguard	Damage:		No visible damag	e
Area:	Not Applicable	Treatment:	Co	mposite asbestos m	aterials
Floor:	Ground floor	Asbestos Type:		Chrysotile	
Room:	Electrical cupboard	Identification:		Presumed	
Surveyor Name:	J D Chilvers	Quantity:			
Drawing Ref:	1	Accessibility:		Difficult Accessibi	lity
Asbestos ?	Yes				
Date:	26 April 2007			ial Risk Score	3
Next Inspection:	25 April 2008		Mater	rial Risk Band:	Very Low Risk
			Priori	ty Risk Score:	2

Apply Warning Labels

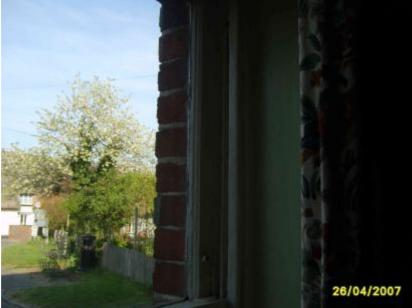
Site Address:	George Inn, St Mary Bourne, Andover, Hampshir		lient Name:	Hall & Wo	oodhouse Ltd
		P	roject Number:	AS07069 - George	e Inn St Mary Bourne
Location ID:	10498	Survey Type:		T 2	
Location Ref:	2	Product Type:		Ropes and woven te	xtiles
Product:	Sash Cord	Damage:		No visible damag	je
Area:	Not Applicable	Treatment:	Co	mposite asbestos m	aterials
Floor:	Ground floor	Asbestos Type	э:	Chrysotile	
Room:	Bar area	Identification:		Presumed	
Surveyor Name	e: J D Chilvers	Quantity:			
Drawing Ref:	2	Accessibility:		Easy Accessibili	ty
Asbestos ?	Yes				
Date:	26 April 2007		Mater	rial Risk Score	3
Next Inspection	n: 25 April 2008		Mate	rial Risk Band:	Very Low Risk
			Priori	ty Risk Score:	5
Action:		Apply Warnin	ig Labels

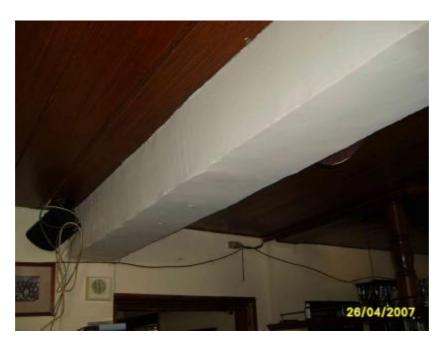
Site Address	George Inn, St Mary Bourne, Andover, Hampshire		ient Name:	Hall & Wo	odhouse Ltd
Site Address:	George Init, St Mary Bourne, Andover, Hampshire		oject Number:	AS07069 - George	Inn St Mary Bourne
Location ID:	10499	Survey Type:		Т 2	
Location Ref:	3	Product Type:	A	sbestos Insulating E	Board
Product:	Beam cladding	Damage:		No visible damage	9
Area:	Not Applicable	Treatment:	AI	B painted or encaps	ulated
Floor:	Ground floor	Asbestos Type	:	Amosite	
Room:	Bar area	Identification:		Presumed	
Surveyor Nam	e: J D Chilvers	Quantity:			
Drawing Ref:	3	Accessibility:		Medium Accessibil	ity
Asbestos ?	Yes				[]
Date:	26 April 2007			ial Risk Score	5
Next Inspection	n: 26 October 2007	7	Mater	ial Risk Band:	Low Risk
-		<u> </u>	Priorit	ty Risk Score:	5
Action:		Apply Warning	J Labels

Material Comments: Structural beams may be clad with ACMs under surface finish

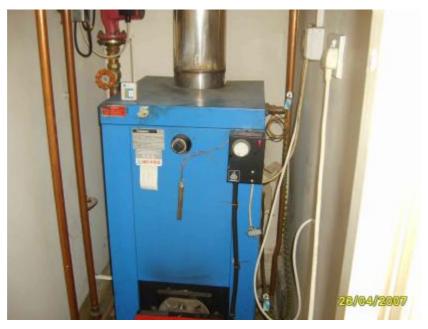
Site Address:	George Inn, St Mary Bourne, Andover, Hampshire,		ent Name:	Hall & Wo	odhouse Ltd
		Pro	oject Number:	AS07069 - George	Inn St Mary Bourne
Location ID:	10500	Survey Type:		Τ 2	
Location Ref:	4	Product Type:		Gaskets	
Product:	Boiler	Damage:		No visible damag	e
Area:	Not Applicable	Treatment:	Co	mposite asbestos m	aterials
Floor:	Ground floor	Asbestos Type:		Chrysotile	
Room:	Boiler room	Identification:		Presumed	
Surveyor Name	e: J D Chilvers	Quantity:			
Drawing Ref:	4	Accessibility:		Medium Accessibi	lity
Asbestos ?	Yes				
Date:	26 April 2007			rial Risk Score	3
Next Inspection	1: 25 April 2008			rial Risk Band: ty Risk Score:	Very Low Risk
Action:		Apply Warning	Labels

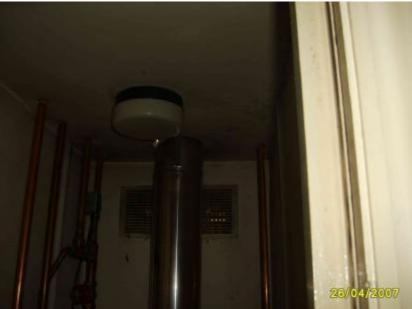
Site Address:	George Inn, St Mary Bourne, Andover, Hampsh		ient Name:	Hall & Wo	odhouse Ltd
			oject Number:	AS07069 - George	e Inn St Mary Bourne
Location ID:	10501	Survey Type:		T 2	
Location Ref:	5	Product Type:		Ropes and woven te	xtiles
Product:	Flue pipe	Damage:		No visible damag	e
Area:	Not Applicable	Treatment:	Co	mposite asbestos m	aterials
Floor:	Ground floor	Asbestos Type:		Chrysotile	
Room:	Boiler room	Identification:		Presumed	
Surveyor Nam	e: J D Chilvers	Quantity:			
Drawing Ref:	5	Accessibility:		Medium Accessibi	lity
Asbestos ?	Yes				[]
Date:	26 April 2007		Mater	rial Risk Score	3
Next Inspectio	n: 25 April 2008		Mate	rial Risk Band:	Very Low Risk
			Priori	ty Risk Score:	3
Action:		Apply Warning	Labels

Material Comments: Seals around flue and in ceiling void.

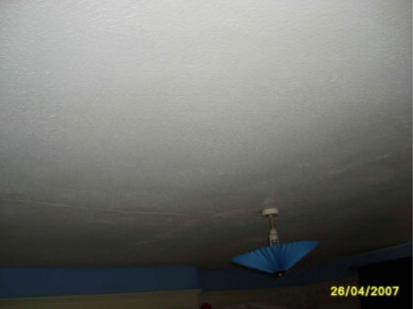
Site Address:	George Inn, St Mary Bourne, Andover, Hampshire,		ient Name:	Hall & Woodhouse Ltd	
		Pr	oject Number:	AS07069 - George	e Inn St Mary Bourne
Location ID:	10503	Survey Type:		T 2	
Location Ref:	7	Product Type:		Decorative finishe	es
Product:	Textured coating	Damage:		No visible damag	e
Area:	Not Applicable	Treatment:	Co	omposite asbestos m	aterials
Floor:	First floor	Asbestos Type	:	Chrysotile	
Room:	Bedroom	Identification:		Presumed	
Surveyor Name	e: J D Chilvers	Quantity:			
Drawing Ref:	7	Accessibility:		Easy Accessibili	ty
Asbestos ?	Yes				
Date:	26 April 2007		Mate	rial Risk Score	2
Next Inspectior	25 April 2008		Mate	rial Risk Band:	Very Low Risk
			Priori	ty Risk Score:	5
Action:		Apply Warning	Labels

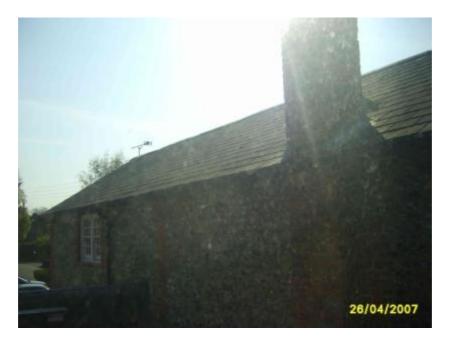
Site Address:	George Inn, St Mary Bourne, Andover, Hampshire, S		ent Name:	Hall & Wo	oodhouse Ltd
One Address.			oject Number:	AS07069 - George	e Inn St Mary Bourne
Location ID:	10504	Survey Type:		T 2	
Location Ref:	8	Product Type:		Asbestos cemer	nt
Product:	Roof Tiles	Damage:	Low	damage: Scratches	or marks
Area:	Not Applicable	Treatment:	As	sbestos cement she	ets etc
Floor:	Roof level	Asbestos Type:		Chrysotile	
Room:	External	Identification:		Strongly Presume	ed
Surveyor Name	e: J D Chilvers	Quantity:			
Drawing Ref:	8	Accessibility:		Difficult Accessibi	lity
Asbestos ?	Yes				
Date:	26 April 2007			ial Risk Score	4
Next Inspectior	1: 25 April 2008			ial Risk Band:	Very Low Risk
			Priori	ty Risk Score:	2
Action:		No Action Req	juired

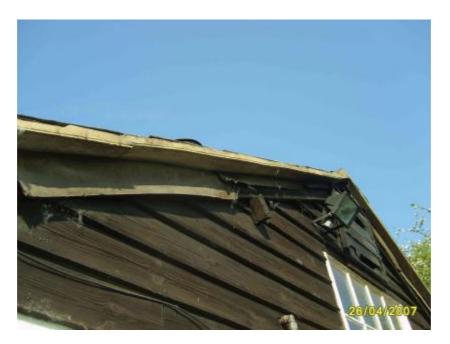
Site Address:	George Inn, St Mary Bourne, Andover, Hampshire,		ent Name:	Hall & Wo	oodhouse Ltd
		Pro	oject Number:	AS07069 - George	e Inn St Mary Bourne
Location ID:	10505	Survey Type:		T 2	
Location Ref:	9	Product Type:		Asbestos cemen	t
Product:	Verge Undercloak	Damage:	Low	damage: Scratches	or marks
Area:	Not Applicable	Treatment:	As	sbestos cement she	ets etc
Floor:	Roof level	Asbestos Type:		Chrysotile	
Room:	External	Identification:		Identified	
Surveyor Name	e: J D Chilvers	Quantity:			
Drawing Ref:	9	Accessibility:		Easy Accessibilit	y
Asbestos ?	Yes				
Date:	26 April 2007		Mater	ial Risk Score	4
Next Inspectior	25 April 2008		Mater	rial Risk Band:	Very Low Risk
			Priori	ty Risk Score:	1
Action:		No Action Req	juired

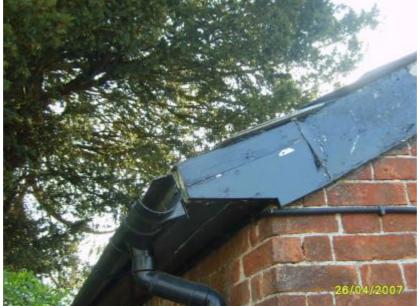
ient Name:	Hall & Woo	dhouse Ltd
Site Address: Ge	orge Inn, St Mary Bourne, Andover, Hamp	snire, SP11 6BG			
		Pr	oject Number:	AS07069 - George I	nn St Mary Bourne
Location ID:	10506	Survey Type:		T 2	
Location Ref:	10	Product Type:		NADIS	
Product:	Roof Tiles	Damage:		NADIS	
Area:	Not Applicable	Treatment:		NADIS	
Floor:	Roof level	Asbestos Type:	:	NADIS	
Room:	External	Identification:		Identified	
Surveyor Name:	J D Chilvers	Quantity:			
Drawing Ref:	1-	Accessibility:			
Asbestos ?	No				
Date:	26 April 2007		Mater	rial Risk Score	0
Next Inspection:	Not Applicable		Mater	rial Risk Band:	NADIS
			Priori	ty Risk Score:	N/A
Action:		No Action Re	quired		
L
