Asbestos Refurbishment Report

Cowdray Arms
London Road
Balcombe
RH17 6QD

Hall & Woodhouse

Reference: C-04582

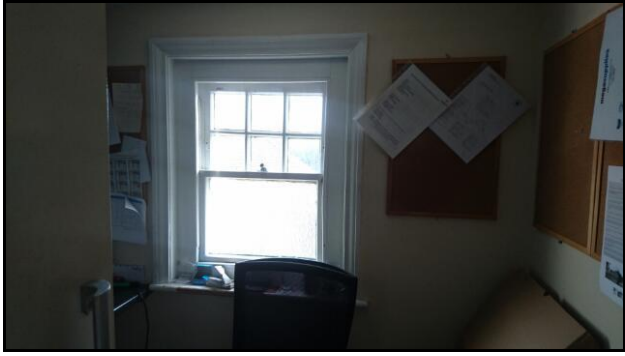
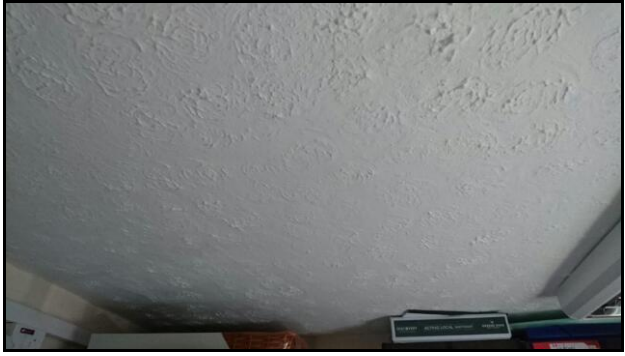
Building:	Cowdray Arms	Floor	1st Floor
Location ID	029	Location	Office
Sample Number	S003	Extent	<4 m ²
Item / Position	Ceiling	Material	Textured Coating
Product Type	Asbestos reinforced composites etc.	Scores	1
Condition	Good Condition		0
Surface Treatment	Sealed		1
Asbestos Type	Chrysotile		1
Material Assessment	Very Low		3
Substrate	Bonded to plasterboard	Accessibility	Medium
Main Photo		Close Up Photo

Recommendation	<p>Label & manage (NON-LICENSED) Manage by the way of regular visual inspections to form part of your management plan. Avoid drilling or cutting into the material. This material is not licensed however may still be notifiable to the HSE prior to removal works taking place. All works must conform to the Control of Asbestos Regulations 2012.</p>		
Comments	Bonded to plasterboard

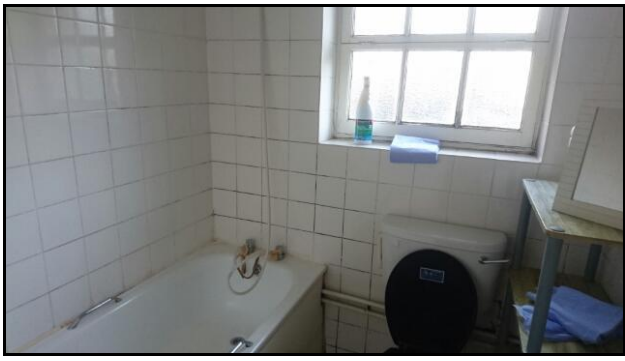
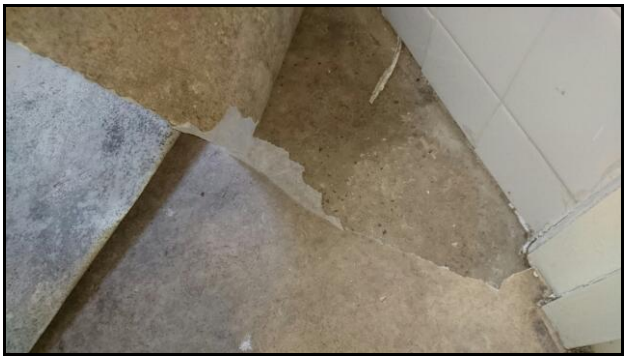
Building:	Cowdray Arms	Floor	Ground Floor
Location ID	003	Location	Bathroom
Sample Number	S001	Extent	<6 m ²
Item / Position	Floor Covering	Material	Paper Product
Product Type		Scores	-
Condition			-
Surface Treatment			-
Asbestos Type	No asbestos detected		-
Material Assessment	N/A		
Substrate	Bonded to concrete	Accessibility	-
Main Photo		Close Up Photo

Recommendation	No action required		
Comments	Modern ceramic cistern with a plastic soil-pipe Bonded to concrete

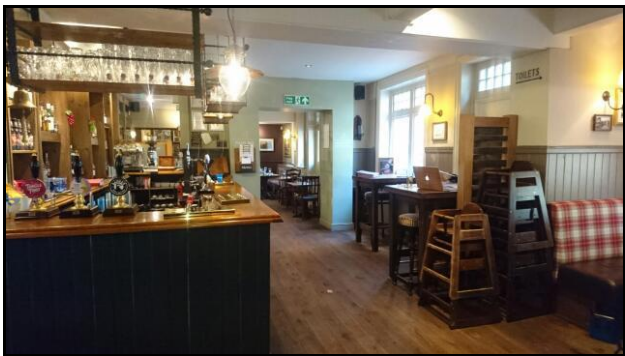
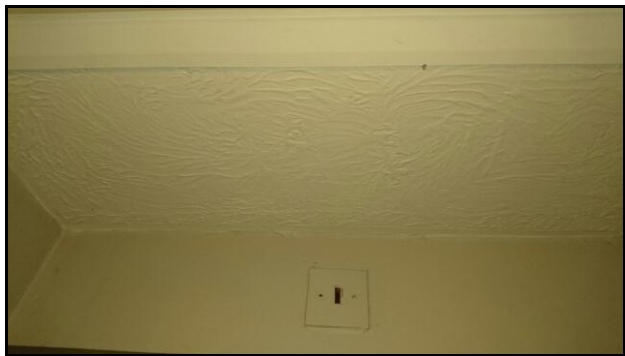
Building:	Cowdray Arms	Floor	Ground Floor
Location ID	012	Location	Bar Area
Sample Number	S002	Extent	<1 m ²
Item / Position	Ceiling	Material	Textured Coating
Product Type	Asbestos reinforced composites etc.	Scores	1
Condition	Good Condition		0
Surface Treatment	Sealed		1
Asbestos Type	Chrysotile		1
Material Assessment	Very Low		3
Substrate	Bonded to plasterboard	Accessibility	
Main Photo		Close Up Photo

Recommendation	<p>Label & manage (NON-LICENSED) Manage by the way of regular visual inspections to form part of your management plan. Avoid drilling or cutting into the material. This material is not licensed however may still be notifiable to the HSE prior to removal works taking place. All works must conform to the Control of Asbestos Regulations 2012.</p>		
Comments	<p>Modern built bar area, unlagged pipe-work, Timber beam cladding, Timber cladding, modern linoleum flooring to bar area Bonded to plasterboard</p>
