Asbestos Survey for

Hall & Woodhouse Ltd

The Swan
Market Place
Sturminster Newton
Dorset
DT10 1AR

Project Number: AS05030 - Swan Sturminster Newton

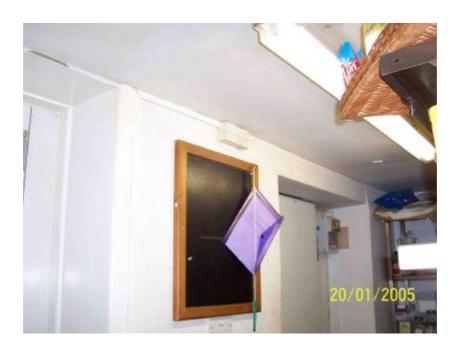
Hall & Woodhouse Ltd Client Name: The Swan, Market Place, Sturminster Newton, Dorset, DT10 Site Address: AS05030 - Swan Sturminster Newton Project Number: Location ID: 2651 Survey Type: T 2 Location Ref: 1 **Product Type:** Asbestos Insulating Board Beam cladding Product: No visible damage Damage: Not Applicable Treatment: AIB painted or encapsulated Area: Ground floor Amosite Floor: Asbestos Type: Cold Room Identification: Presumed Room: Surveyor Name: Richard Jeffery Quantity: Drawing Ref: Medium Accessibility Accessibility: Yes Asbestos? Material Risk Score 5 20 January 2005 Date: Material Risk Band: Low Risk 22 July 2005 **Next Inspection:** Priority Risk Score: 5

All beam cladding is presumed to contain ACM's until proven otherwise.

Apply Warning Labels

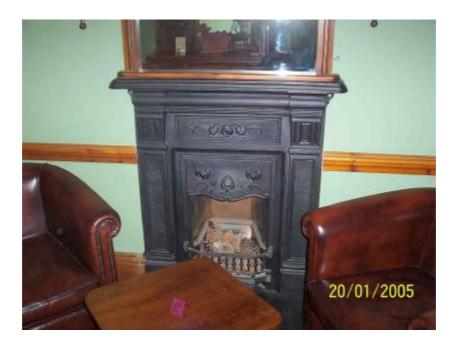
Location ID:	2652	Survey Type:	T 2
Location Ref:	2	Product Type:	Ropes and woven textiles
Product:	Fireplace cladding	Damage:	No visible damage
Area:	Not Applicable	Treatment:	Composite asbestos materials
Floor:	Ground floor	Asbestos Type:	Chrysotile
Room:	Bar area	Identification:	Presumed
Surveyor Name:	Richard Jeffery	Quantity:	
Drawing Ref:	2	Accessibility:	Difficult Accessibility
Asbestos ?	Yes

Material Risk Score Material Risk Band: Very Low Risk

Action: Apply Warning Labels

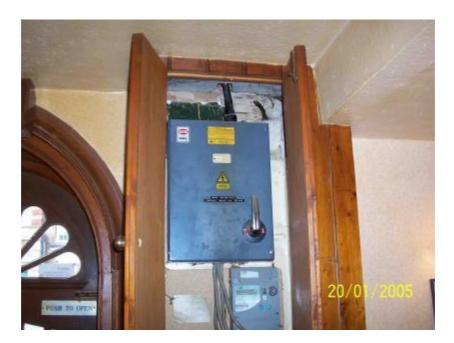
Location ID:	2653	Survey Type:	T 2
Location Ref:	3	Product Type:	Ropes and woven textiles
Product:	Fuse & Switchgear Flashguard	Damage:	No visible damage
Area:	Not Applicable	Treatment:	Composite asbestos materials
Floor:	Ground floor	Asbestos Type:	Chrysotile
Room:	Bar area	Identification:	Presumed
Surveyor Name:	Richard Jeffery	Quantity:	
Drawing Ref:	3	Accessibility:	Medium Accessibility
Asbestos ?	Yes

Material Risk Score Very Low Risk Material Risk Band: Priority Risk Score:

Action: Apply Warning Labels

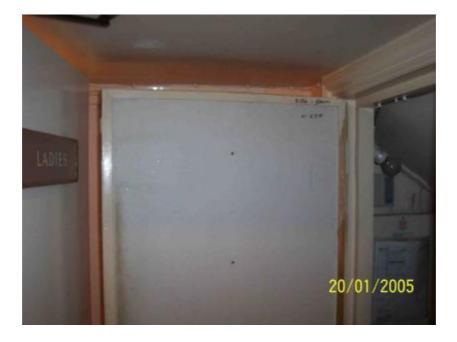
Location ID:	2654	Survey Type:	T 2	
Location Ref:	4	Product Type:	Asbestos Insulating Board	
Product:	Door panel	Damage:	Low damage: Scratches or marks	
Area:	Not Applicable	Treatment:	AIB painted or encapsulated	
Floor:	Ground floor	Asbestos Type:	Amosite	
Room:	Cupboard	Identification:	Strongly Presumed	
Surveyor Name:	Richard Jeffery	Quantity:		
Drawing Ref:	4	Accessibility:	Medium Accessibility	
Asbestos ?	Yes		Motorial Diak Coara

Material Risk Score Material Risk Band: Low Risk Priority Risk Score:

Re-encapsulate and Apply Warning Labels

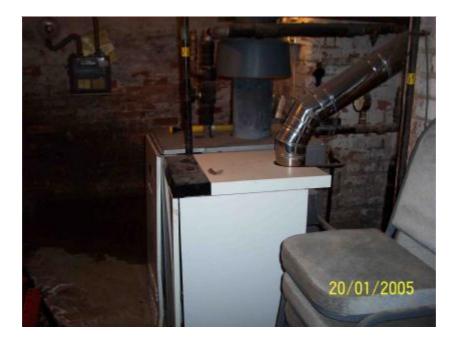
T 2 Location ID: 2655 Survey Type: Location Ref: 5 **Product Type:** Gaskets Product: Boiler Damage: No visible damage Not Applicable Treatment: Composite asbestos materials Area: Basement Chrysotile Floor: Asbestos Type: Cellar Presumed Identification: Room: Richard Jeffery Surveyor Name: Quantity: Medium Accessibility Drawing Ref: Accessibility: Asbestos? Yes Material Risk Score 3 20 January 2005 Date:

Very Low Risk

Action: **Apply Warning Labels**

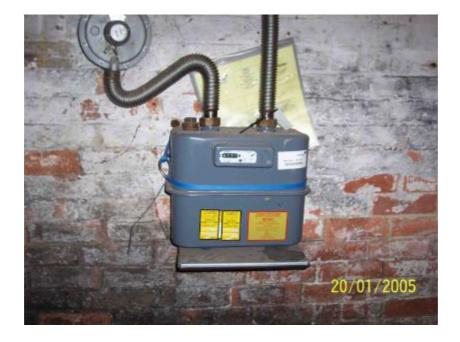
Client Name: Hall & Woodhouse Ltd Site Address: The Swan, Market Place, Sturminster Newton, Dorset, DT10 Project Number: AS05030 - Swan Sturminster Newton 2656 Survey Type: T 2 Location ID: Location Ref: 6 **Product Type:** Gaskets Product: Gas meter Damage: No visible damage Area: Not Applicable Treatment: Composite asbestos materials Basement Chrysotile Floor: Asbestos Type: Cellar Presumed Identification: Room: Richard Jeffery Surveyor Name: Quantity: Medium Accessibility Drawing Ref: Accessibility: Yes Asbestos? Material Risk Score 3 20 January 2005 Date: Material Risk Band: Very Low Risk Next Inspection: 20 January 2006

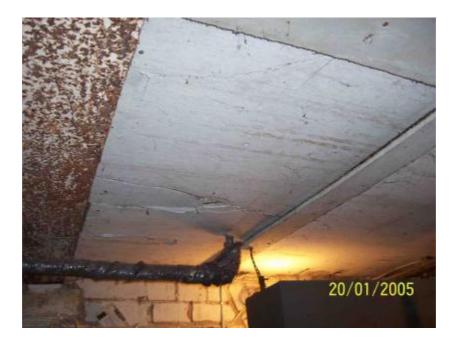
Location ID:	2657	Survey Type:	T 2	
Location Ref:	7	Product Type:	Asbestos Insulating Board	
Product:	Ceiling panels	Damage:	Low damage: Broken edge boards	
Area:	Not Applicable	Treatment:	Unsealed AIB	
Floor:	Basement	Asbestos Type:	Amosite	
Room:	Cellar	Identification:	Identified	
Surveyor Name:	Richard Jeffery	Quantity:		
Drawing Ref:	7	Accessibility:	Medium Accessibility	
Asbestos ?	Yes			
Date:	20 January 2005		Material Risk Score 7	
	•		Material Risk Band: Medium Risk

Location ID	Sample Location	Fibre Type
7	2657	Basement, Cellar, Ceiling panels	Amosite
8	2658	Basement, Cellar, Ceiling panels	Amosite

Action: **Encapsulate and Apply Warning Labels**

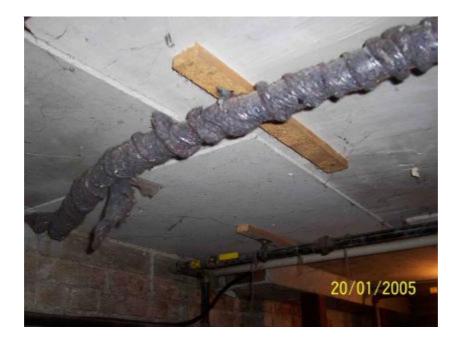
Medium Risk

Location ID:	2658	Survey Type:	T 2	
Location Ref:	8	Product Type:	Asbestos Insulating Board	
Product:	Ceiling panels	Damage:	Low damage: Broken edge boards	
Area:	Not Applicable	Treatment:	Unsealed AIB	
Floor:	Basement	Asbestos Type:	Amosite	
Room:	Cellar	Identification:	Identified	
Surveyor Name:	Richard Jeffery	Quantity:		
Drawing Ref:	8	Accessibility:	Medium Accessibility	
Asbestos ?	Yes			
Date:	20 January 2005		Material Risk Score 7

Action: **Encapsulate and Apply Warning Labels**

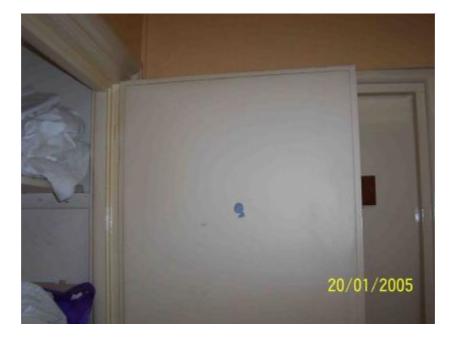
Location ID:	2659	Survey Type:	T 2
Location Ref:	9	Product Type:	Asbestos Insulating Board
Product:	Door panel	Damage:	Low damage: Scratches or marks
Area:	Not Applicable	Treatment:	Unsealed AIB
Floor:	First floor	Asbestos Type:	Amosite
Room:	Linen Cupboard / Store	Identification:	Strongly Presumed
Surveyor Name:	Richard Jeffery	Quantity:	
Drawing Ref:	9	Accessibility:	Easy Accessibility
Asbestos ?	Yes

Material Risk Score Material Risk Band: Medium Risk Priority Risk Score:

Action: **Encapsulate and Apply Warning Labels**

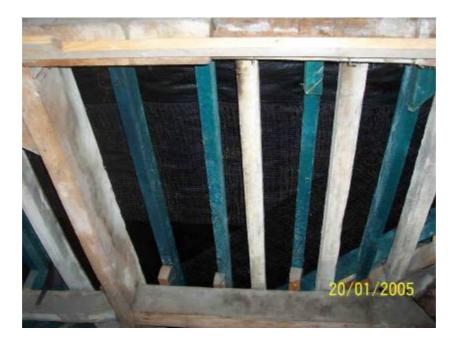
Client Name: Hall & Woodhouse Ltd Site Address: The Swan, Market Place, Sturminster Newton, Dorset, DT10 Project Number: AS05030 - Swan Sturminster Newton 2660 Survey Type: T 2 Location ID: Location Ref: 10 **Product Type:** Roofing felts Product: Roofing felt Damage: No visible damage Area: Not Applicable Treatment: Resins Roof level Chrysotile Floor: Asbestos Type: Presumed Loft space Identification: Room: Richard Jeffery Surveyor Name: Quantity: 10 Difficult Accessibility Drawing Ref: Accessibility: Asbestos? Yes

Very Low Risk

Action: No Action Required
