Asbestos Survey for

Hall & Woodhouse Ltd

The Huntsman
Eridge Road
Eridge Green
Tunbridge Wells
Kent
TN3 9LE

Project Number: AS08054 - Huntsman

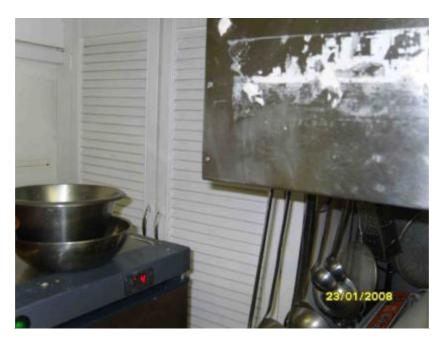
_			Client Name:	Hall & Wo	odhouse Ltd	
	The Huntsman, Eridge Road, Eridge Green, Tunbri Wells, Kent, TN3 9LE	een, Tunbridge				
		F	Project Number:	AS08054	- Huntsman	
Location ID:	9370	Survey Type:		T 2		
Location Ref:	1	Product Type	:	Gaskets		
Product:	Boiler	Damage:		No visible damage		
Area:	Not Applicable	Treatment:	Cor	Composite asbestos materials		
Floor:	Ground floor	Asbestos Typ	e:	Chrysotile		
Room:	Kitchen	Identification:		Presumed		
Surveyor Nam	e: J D Chilvers	Quantity:				
Drawing Ref:	1	Accessibility:		Medium Accessib	ility	
Asbestos ?	Yes					
Date:	23 January 2008		Materi	al Risk Score	3	
Next Inspection	n: 22 January 2009		Materi	al Risk Band:	Very Low Risk	
. text mopeout			Priorit	y Risk Score:	4

Location ID: 9370 Location Ref: Boiler Product: Not Applicable Area: Ground floor Floor: Kitchen Room: J D Chilvers Surveyor Name: 1 Drawing Ref: Asbestos? Yes Date: 23 January 2008 and the same

Priority Assessment Algorithm			
Assessment factor	Variable(s) selected	Score for each	Overall score
Normal Occupant Activity:			
Main type of activity in area:	Rare disturbance	0	average
Secondary activities for area:	Rare disturbance	0	0
Likelihood Of Disturbance:			
Location:	Rooms up to 100 m2	2	
Accessibility:	Usually inaccessible or unlikely to be disturbed	0	average
Extent/Amount:	Small items strings gaskets	0	1
Human Exposure Potential:			
Number of occupants:	1 to 3	1	
Frequency of use of area:	Daily	3	average
Average time area is in use:	>1 to <3 hours	1	2
Maintenance Activity:			
Type of maintenance activity:	Minor disturbance	0	average
Frequency of maintenance activity	<=1 per year	1	1

Total Priority Assessment Score:		4
Material Assessment Score (supplied by surveyor):	Very Low Risk	3
Total of Material and Priority Assessment Scores:		7

Apply Warning Labels

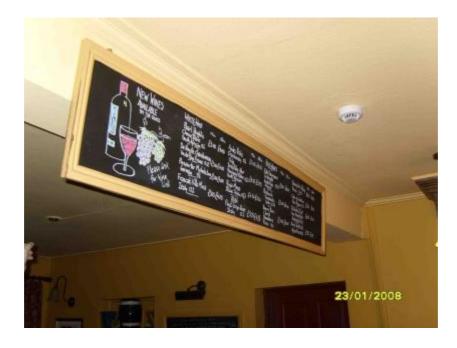
9371 T 2 Location ID: Survey Type: Location Ref: 2 **Product Type:** Asbestos Insulating Board Product: Beam cladding Damage: No visible damage Not Applicable Treatment: AIB painted or encapsulated Area: Ground floor Amosite Floor: Asbestos Type: Presumed Bar area Identification: Room: J D Chilvers Surveyor Name: Quantity: Easy Accessibility Drawing Ref: Accessibility: Asbestos? Yes

Material Risk Score 5 Material Risk Band: Low Risk Priority Risk Score: 5

Location ID: 9371 2 Location Ref: Beam cladding Product: Not Applicable Area: Ground floor Floor: Room: Bar area J D Chilvers Surveyor Name: 2 Drawing Ref: Asbestos? Yes Date: 23 January 2008

Priority Assessment Algorithm			
Assessment factor	Variable(s) selected	Score for each	Overall score
Normal Occupant Activity:			
Main type of activity in area:	Low disturbance	1	average
Secondary activities for area:	Low disturbance	1	1
Likelihood Of Disturbance:			
Location:	Large rooms or well-ventilated areas	1	
Accessibility:	Usually inaccessible or unlikely to be disturbed	0	average
Extent/Amount:	<=10 m2 or <=10 m pipe run	1	1
Human Exposure Potential:			
Number of occupants:	>10	3	
Frequency of use of area:	Daily	3	average
Average time area is in use:	>1 to <3 hours	1	2
Maintenance Activity:			
Type of maintenance activity:	Minor disturbance	0	average
Frequency of maintenance activity	<=1 per year	1	1

Total Priority Assessment Score:		5
Material Assessment Score (supplied by surveyor):	Low Risk	5
Total of Material and Priority Assessment Scores:		10

Action: **Apply Warning Labels**

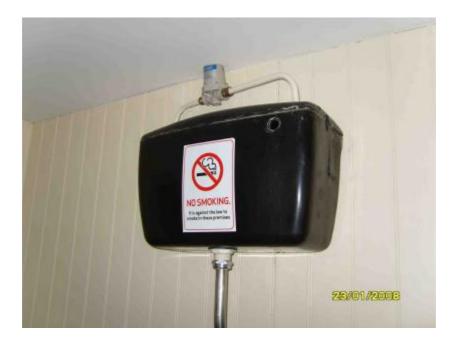
Hall & Woodhouse Ltd Client Name: Site Address: The Huntsman, Eridge Road, Eridge Green, Tunbridge Wells, Kent, TN3 9LE Project Number: AS08054 - Huntsman 9372 T 2 Location ID: Survey Type: Location Ref: 3 **Product Type: Plastics** Product: Cistern / Toilet seat Damage: Low damage: Scratches or marks Not Applicable Treatment: Reinforced plastics Area: Ground floor Amosite Floor: Asbestos Type: WC - mens Strongly Presumed Identification: Room: J D Chilvers Surveyor Name: Quantity: 3 Easy Accessibility Drawing Ref: Accessibility: Asbestos? Yes

Location ID: 9372 3 Location Ref: Cistern / Toilet seat Product: Not Applicable Area: Ground floor Floor: WC - mens Room: J D Chilvers Surveyor Name: 3 Drawing Ref: Asbestos? Yes 23 January 2008 Date:

Total Priority Assessment Score:	4
Material Assessment Score (supplied by surveyor): Very Low F	Risk 4
Total of Material and Priority Assessment Scores:	8

Action: Apply Warning Labels

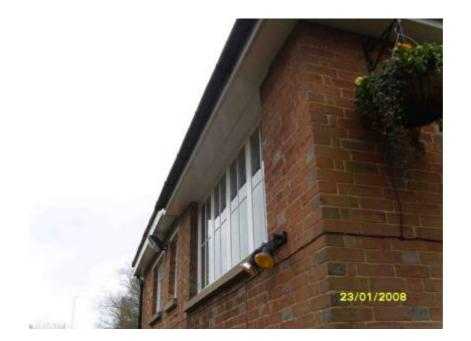
Hall & Woodhouse Ltd Client Name: Site Address: The Huntsman, Eridge Road, Eridge Green, Tunbridge Wells, Kent, TN3 9LE **Project Number:** AS08054 - Huntsman 9373 T 2 Location ID: Survey Type: Location Ref: 4 **Product Type:** Asbestos Insulating Board Product: Soffit Damage: No visible damage Not Applicable Treatment: AIB painted or encapsulated Area: Roof level Amosite Floor: Asbestos Type: External Presumed Identification: Room: J D Chilvers Surveyor Name: Quantity: 4 Difficult Accessibility Drawing Ref: Accessibility: Asbestos? Yes Material Risk Score 5 23 January 2008 Date: Material Risk Band: Low Risk 24 July 2008 Next Inspection: Priority Risk Score:

Location ID: 9373 4 Location Ref: Soffit Product: Not Applicable Area: Roof level Floor: External Room: J D Chilvers Surveyor Name: 4 Drawing Ref: Asbestos? Yes Date: 23 January 2008 23/01/2008

Total Priority Assessment Score:		
Material Assessment Score (supplied by surveyor):	Low Risk	5
Total of Material and Priority Assessment Scores:		6

Apply Warning Labels
