Asbestos Survey for

Hall & Woodhouse Ltd

White Hart
High Street
Henfield
West Sussex
BN5 9HP

Project Number: AS05161 - White Hart Henfield

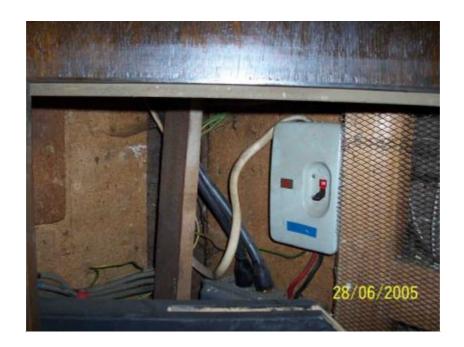
Site Address: Wh	nite Hart, High Street, Henfield, West Sussex	k, BN5 9HP	Client Name:	Hall & W	boanouse Lta
			Project Number	: AS05161 - W	hite Hart Henfield
Location ID:	3993	Survey Typ	e:	T 2	
Location Ref:	1	Product Typ	oe:	Ropes and woven to	extiles
Product:	Fuse & Switchgear Flashguard	Damage:		No visible damaç	је
Area:	Not Applicable	Treatment:	С	omposite asbestos m	naterials
Floor:	Ground floor	Asbestos Ty	/pe:	Chrysotile	
Room:	Electrical cupboard	Identificatio	n:	Presumed	
Surveyor Name:	J D Chilvers	Quantity:			
Drawing Ref:	1	Accessibility	/ :	Medium Accessib	ility
Asbestos ?	Yes				
Date:	28 June 2005		Mate	erial Risk Score	3
Next Inspection:	28 June 2006		Mate	erial Risk Band:	Very Low Risk
•			Prior	rity Risk Score:	2
Action:		Apply War	ning Labels

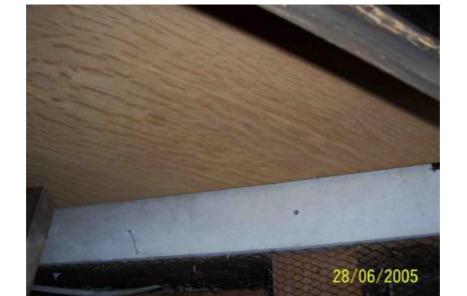
Hall & Woodhouse Ltd Client Name: Site Address: White Hart, High Street, Henfield, West Sussex, BN5 9HP Project Number: AS05161 - White Hart Henfield 3994 T 2 Location ID: Survey Type: Location Ref: 2 **Product Type:** Asbestos Insulating Board Product: Panel Damage: No visible damage Not Applicable Treatment: Unsealed AIB Area: Ground floor Amosite Floor: Asbestos Type: Electrical cupboard Identified Identification: Room: J D Chilvers Surveyor Name: Quantity: Medium Accessibility Drawing Ref: Accessibility: Asbestos? Yes Material Risk Score 6 28 June 2005 Date: Material Risk Band: Low Risk Next Inspection: 28 December 2005 Priority Risk Score: 4

Full extent of this material unknown without destructive intrusion.

Location ID: 3994 2 Location Ref: Panel Product: Not Applicable Area: Ground floor Floor: Room: Electrical cupboard J D Chilvers Surveyor Name: 2 Drawing Ref: Asbestos? Yes Date: 28 June 2005

Total Priority Assessment Score:		4
Material Assessment Score (supplied by surveyor):	Low Risk	6
Total of Material and Priority Assessment Scores:		10

Encapsulate and Apply Warning Labels

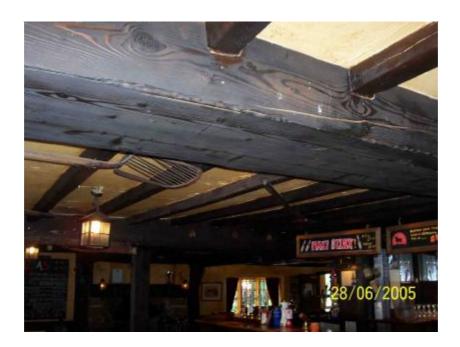
Client Name: Hall & Woodhouse Ltd White Hart, High Street, Henfield, West Sussex, BN5 9HP Site Address: Project Number: AS05161 - White Hart Henfield 3995 Survey Type: T 2 Location ID: Location Ref: 3 **Product Type:** Asbestos Insulating Board Product: Beam cladding Damage: No visible damage Not Applicable Treatment: AIB painted or encapsulated Area:

28 June 2005 Date: Material Risk Band: Low Risk Next Inspection: 28 December 2005

AIB presumed under external wood panels cladding structural beams

Amosite

Location ID: 3995 3 Location Ref: Beam cladding Product: Not Applicable Area: Ground floor Floor: Bar area Room: J D Chilvers Surveyor Name: 3 Drawing Ref: Asbestos? Yes Date: 28 June 2005

Apply Warning Labels

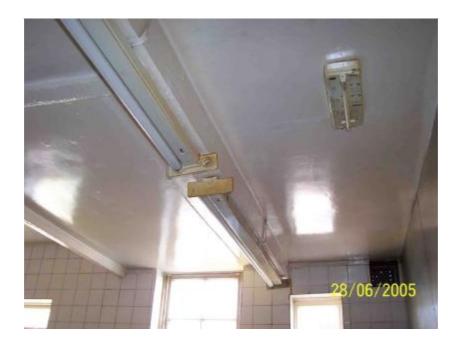
Client Name: Hall & Woodhouse Ltd White Hart, High Street, Henfield, West Sussex, BN5 9HP Site Address: Project Number: AS05161 - White Hart Henfield 3997 Survey Type: T 2 Location ID: Location Ref: 5 **Product Type:** Asbestos Insulating Board Product: Ceiling Damage: No visible damage Area: Not Applicable Treatment: AIB painted or encapsulated Ground floor Amosite Floor: Asbestos Type: Kitchen Presumed Identification: Room: J D Chilvers Surveyor Name: Quantity: Medium Accessibility Drawing Ref: Accessibility: Asbestos? Yes Material Risk Score 5 28 June 2005 Date: Material Risk Band: Low Risk 28 December 2005 Next Inspection: Priority Risk Score: 5

Apply Warning Labels

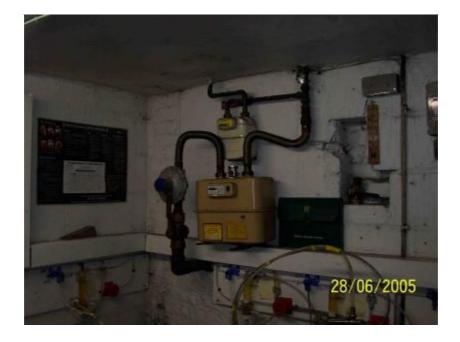
Client Name: Hall & Woodhouse Ltd White Hart, High Street, Henfield, West Sussex, BN5 9HP Site Address: Project Number: AS05161 - White Hart Henfield 3998 Survey Type: T 2 Location ID: Location Ref: 6 **Product Type:** Gaskets Product: Gas meter Damage: No visible damage Area: Not Applicable Treatment: Composite asbestos materials Ground floor Chrysotile Floor: Asbestos Type: Cellar Presumed Identification: Room: J D Chilvers Surveyor Name: Quantity: Medium Accessibility Drawing Ref: Accessibility: Yes Asbestos? Material Risk Score 3 28 June 2005 Date: Material Risk Band: Very Low Risk 28 June 2006 Next Inspection: Priority Risk Score:

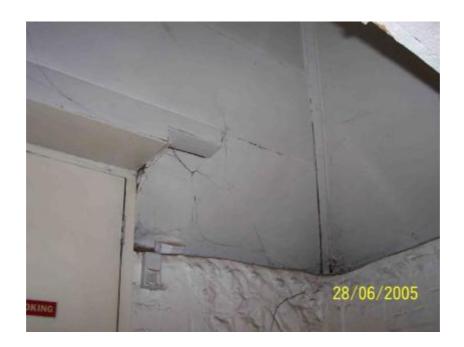
Site Address:	White Hart, High Street, Henfield, West Suss	1	it ivaille.	Tiali & WOO	anouse Eta
		Proje	ect Number:	AS05161 - Whit	e Hart Henfield
Location ID:	3999	Survey Type:		T 2	
Location Ref:	7	Product Type:	As	bestos Insulating Bo	ard
Product:	Cladding	Damage:		No visible damage	
Area:	Not Applicable	Treatment:	AIB	painted or encapsul	ated
Floor:	Ground floor	Asbestos Type:		Amosite	
Room:	Bottle Store	Identification:		Identified	
Surveyor Nam	e: J D Chilvers	Quantity:			
Drawing Ref:	7	Accessibility:		Easy Accessibility	
Asbestos ?	Yes				
Date:	28 June 2005		Materia	al Risk Score	5
Next Inspection	n· 28 December 2005		Materia	al Risk Band:	Low Risk
Trone moposito			Priority	Risk Score:	4
Action:		Re-encapsulate and Apply V	Varning Labels

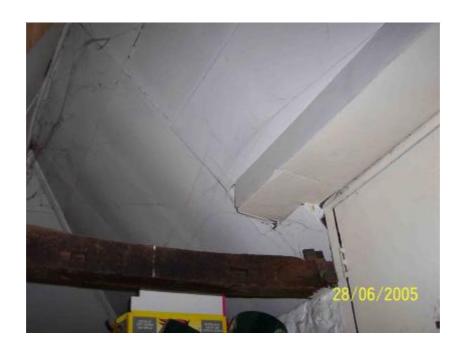
Site Address: V	Vhite Hart, High Street, Henfield, West Suss		it Name.	Tiali & WOC	unouse Liu
		Proje	ect Number:	AS05161 - Whi	te Hart Henfield
Location ID:	4000	Survey Type:		T 2	
Location Ref:	8	Product Type:	Ast	bestos Insulating B	oard
Product:	Cladding	Damage:	Low da	amage: Scratches o	r marks
Area:	Not Applicable	Treatment:	AIB	painted or encapsu	lated
Floor:	Ground floor	Asbestos Type:		Amosite	
Room:	Bottle Store	Identification:		Identified	
Surveyor Name	J D Chilvers	Quantity:			
Drawing Ref:	8	Accessibility:		Easy Accessibility	
Asbestos ?	Yes			Г	
Date:	28 June 2005		Materia	al Risk Score	6
Next Inspection	28 December 2005		Materia	al Risk Band:	Low Risk
			Priority	Risk Score:	4
Action:		Re-encapsulate and Apply V	Varning Labels

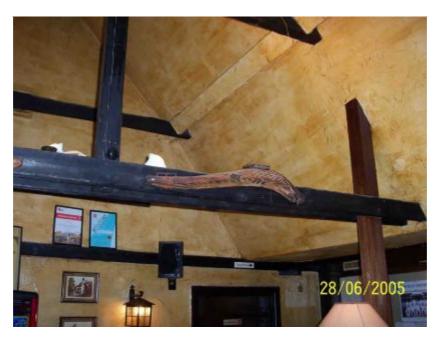
Client Name: Hall & Woodhouse Ltd White Hart, High Street, Henfield, West Sussex, BN5 9HP Site Address: Project Number: AS05161 - White Hart Henfield 4001 Survey Type: T 2 Location ID: Location Ref: 9 **Product Type:** Asbestos Insulating Board Product: Ceiling panels Damage: No visible damage Area: Not Applicable Treatment: AIB painted or encapsulated Ground floor Amosite Floor: Asbestos Type: Bar area Presumed Identification: Room: J D Chilvers Surveyor Name: Quantity: Medium Accessibility Drawing Ref: Accessibility: Asbestos? Yes Material Risk Score 5 28 June 2005 Date: Material Risk Band: Low Risk Next Inspection: 28 December 2005 Priority Risk Score: 5

Apply Warning Labels

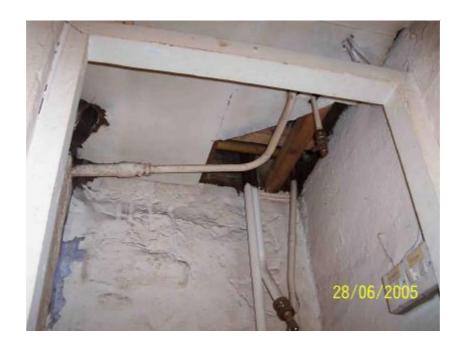
Site Address:	White Hart, High Street, Henfield, West Sussex, E		lient Name:	Hall & Wo	odnouse Ltd
		P	roject Number:	AS05161 - Wh	ite Hart Henfield
Location ID:	4002	Survey Type:		T 2	
Location Ref:	10	Product Type:	A	sbestos Insulating B	oard
Product:	Ceiling	Damage:	Me	edium damage: Brea	akage
Area:	Not Applicable	Treatment:		Unsealed AIB	
Floor:	Ground floor	Asbestos Type):	Amosite	
Room:	Cupboard	Identification:		Identified	
Surveyor Nam	ne: J D Chilvers	Quantity:			
Drawing Ref:	10	Accessibility:		Medium Accessibil	ity
Asbestos ?	Yes				
Date:	28 June 2005			ial Risk Score	8
Next Inspectio	on: 26 September 2005		Mater	ial Risk Band:	Medium Risk
-		_	Priorit	y Risk Score:	4

Requires Removal by Licenced Contractor

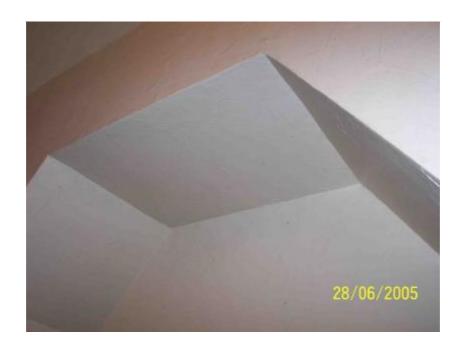
Site Address:	White Hart, High Street, Henfield, West Suss	ex, BN5 9HP	Client	Name:	Hall & WOO	anouse Lta
			Project	Number:	AS05161 - Whi	te Hart Henfield
Location ID:	4003	Survey T	ype:		T 2	
Location Ref:	11	Product ⁻	Гуре:	Asb	estos Insulating Bo	pard
Product:	Ceiling panel	Damage	:		No visible damage	
Area:	Not Applicable	Treatme	nt:	AIB	painted or encapsu	lated
Floor:	Ground floor	Asbestos	туре:		Amosite	
Room:	Passageway	Identifica	ition:		Strongly Presumed	
Surveyor Nam	e: J D Chilvers	Quantity				
Drawing Ref:	11	Accessib	ility:	N	Medium Accessibili	ty
Asbestos ?	Yes				Г	
Date:	28 June 2005			Materia	I Risk Score	5
Next Inspection	n: 28 December 2005			Materia	I Risk Band:	Low Risk
,	L			Priority	Risk Score:	4
Action:		Apply \	Warning Labe	ls

AIB present in adjacent cupboard.

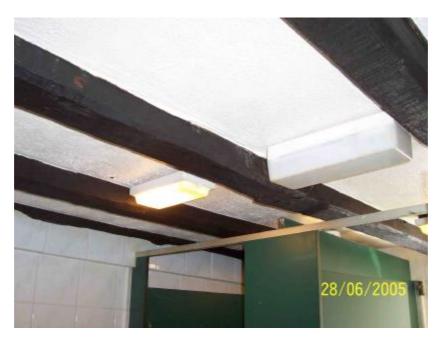
Site Address: V	Vhite Hart, High Street, Henfield, West Sussex, BN		ient Name:	Hall & Wood	lhouse Ltd
		Pr	oject Number:	AS05161 - White	e Hart Henfield
Location ID:	4004	Survey Type:		T 2	
Location Ref:	12	Product Type:		NADIS	
Product:	Textured coating	Damage:		NADIS	
Area:	Not Applicable	Treatment:		NADIS	
Floor:	Ground floor	Asbestos Type	:	NADIS	
Room:	WC - mens	Identification:		Identified	
Surveyor Name	J D Chilvers	Quantity:			
Drawing Ref:	12	Accessibility:			
Asbestos ?	No				
Date:	28 June 2005		Materia	Il Risk Score	0
Next Inspection	: Not Applicable		Materia	al Risk Band:	NADIS
			Priority	Risk Score:	N/A
Action:		No Action Re	quired

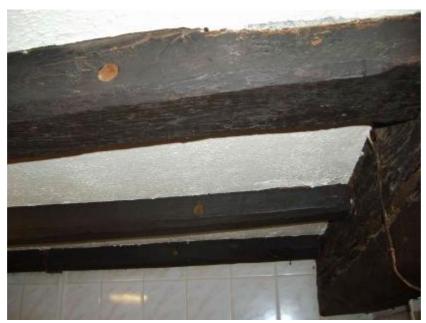
Site Address: White	e Hart, High Street, Henfield, West Sus	ssex, BN5 9HP	Name.	Trail & VVOOd	House Eld
		Project	Number:	AS05161 - White	Hart Henfield
Location ID:	4005	Survey Type:		T 2	
Location Ref:	13	Product Type:		NADIS	
Product:	Textured coating	Damage:		NADIS	
Area:	Not Applicable	Treatment:		NADIS	
Floor:	Ground floor	Asbestos Type:	NADIS		
Room:	WC - ladies	Identification:		Identified	
Surveyor Name:	J D Chilvers	Quantity:			
Drawing Ref:	12	Accessibility:			
Asbestos ?	No				
Date:	28 June 2005		Materia	I Risk Score	0
Next Inspection:	Not Applicable		Materia	I Risk Band:	NADIS
Next mopeoution.			Priority	Risk Score:	N/A
Action:		No Action Required	<u> </u>

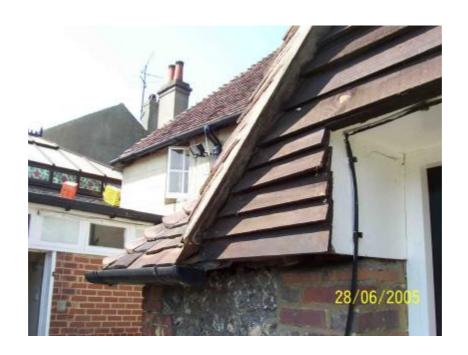
Site Address: Wh	nite Hart, High Street, Henfield, West Sussex, BN		ient Name:	Hall & Wood	lhouse Ltd
		Pr	oject Number:	AS05161 - White	e Hart Henfield
Location ID:	4006	Survey Type:		T 2	
Location Ref:	14	Product Type:		NADIS	
Product:	Verge Undercloak	Damage:		NADIS	
Area:	Not Applicable	Treatment:		NADIS	
Floor:	External ground floor	Asbestos Type		NADIS	
Room:	Roof	Identification:		Identified	
Surveyor Name:	J D Chilvers	Quantity:			
Drawing Ref:	14	Accessibility:			
Asbestos ?	No				
Date:	28 June 2005		Materia	I Risk Score	0
Next Inspection:	Not Applicable		Materia	I Risk Band:	NADIS
			Priority	Risk Score:	N/A
Action:		No Action Re	quired
