Asbestos Survey for

Hall & Woodhouse Ltd

The Botany Bay
Winterborne Zelstone
Blandford
Dorset
DT11 9ET

Project Number: AS07224 - Botany Bay

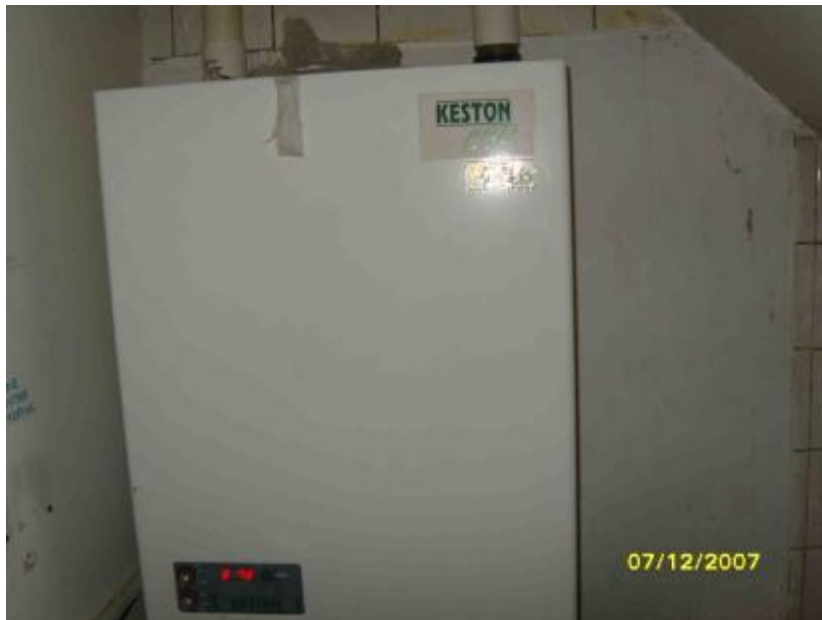
Location ID:	<input type="text" value="8915"/>	Survey Type:	<input type="text" value="T 2"/>
Location Ref:	<input type="text" value="1"/>	Product Type:	<input type="text" value="Gaskets"/>
Product:	<input type="text" value="Boiler"/>	Damage:	<input type="text" value="No visible damage"/>
Area:	<input type="text" value="Not Applicable"/>	Treatment:	<input type="text" value="Composite asbestos materials"/>
Floor:	<input type="text" value="Ground floor"/>	Asbestos Type:	<input type="text" value="Chrysotile"/>
Room:	<input type="text" value="Boiler cupboard"/>	Identification:	<input type="text" value="Presumed"/>
Surveyor Name:	<input type="text" value="J D Chilvers"/>	Quantity:	<input type="text"/>

Drawing Ref:	<input type="text" value="1"/>	Accessibility:	<input type="text" value="Medium Accessibility"/>
Asbestos ?	<input type="text" value="Yes"/>		
Date:	<input type="text" value="06 December 2007"/>		
Next Inspection:	<input type="text" value="05 December 2008"/>

Material Risk Score	<input type="text" value="3"/>
Material Risk Band:	<input type="text" value="Very Low Risk"/>
Priority Risk Score:	<input type="text" value="3"/>

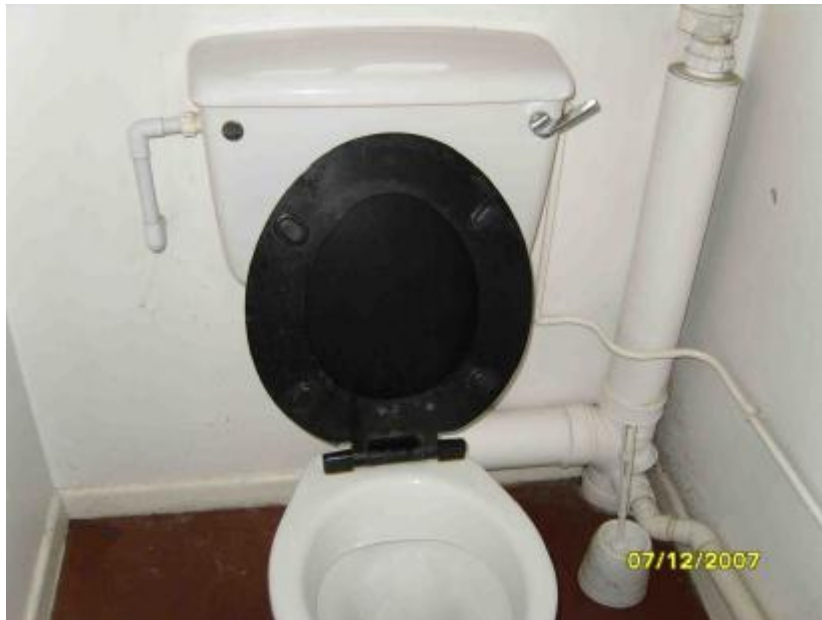
Location ID:	8916	Survey Type:	T 2
Location Ref:	2	Product Type:	Plastics
Product:	Cistern / Toilet seat	Damage:	No visible damage
Area:	Not Applicable	Treatment:	Reinforced plastics
Floor:	Ground floor	Asbestos Type:	Amosite
Room:	WC	Identification:	Presumed
Surveyor Name:	J D Chilvers	Quantity:	
Drawing Ref:	2	Accessibility:	Easy Accessibility
Asbestos ?	Yes		
Date:	06 December 2007		
Next Inspection:	05 December 2008

Material Risk Score	3
Material Risk Band:	Very Low Risk
Priority Risk Score:	3

Action:	Apply Warning Labels
---------	----------------------

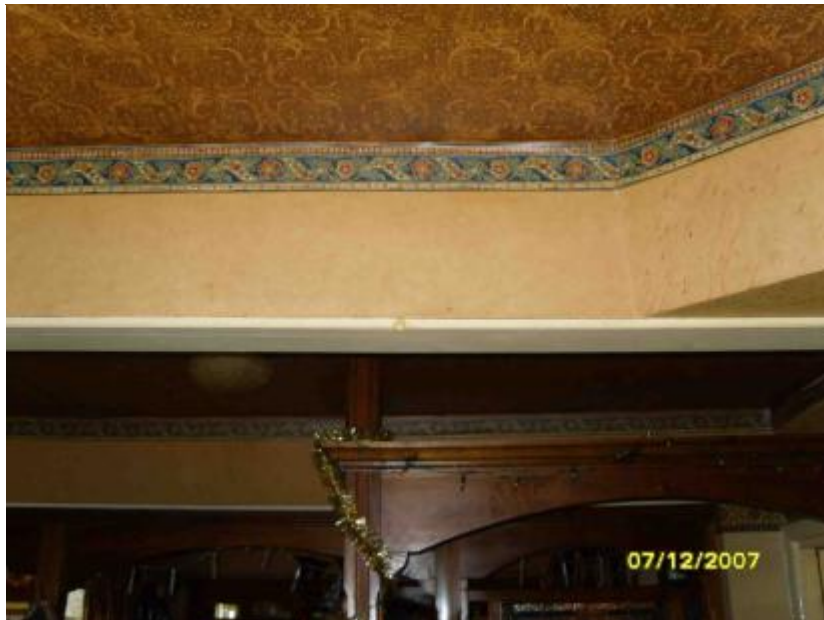
Location ID:	8917	Survey Type:	T 2
Location Ref:	3	Product Type:	Asbestos Insulating Board
Product:	Beam cladding	Damage:	No visible damage
Area:	Not Applicable	Treatment:	AIB painted or encapsulated
Floor:	Ground floor	Asbestos Type:	Amosite
Room:	Bar area	Identification:	Presumed
Surveyor Name:	J D Chilvers	Quantity:	15m2
Drawing Ref:	3	Accessibility:	Medium Accessibility
Asbestos ?	Yes		
Date:	06 December 2007		
Next Inspection:	06 June 2008		
		Material Risk Score:	5
		Material Risk Band:	Low Risk
		Priority Risk Score:	5
Action:	Apply Warning Labels

Material Comments:	All structural beams may have AIB cladding beneath plasterboard exterior finish.
--------------------	--

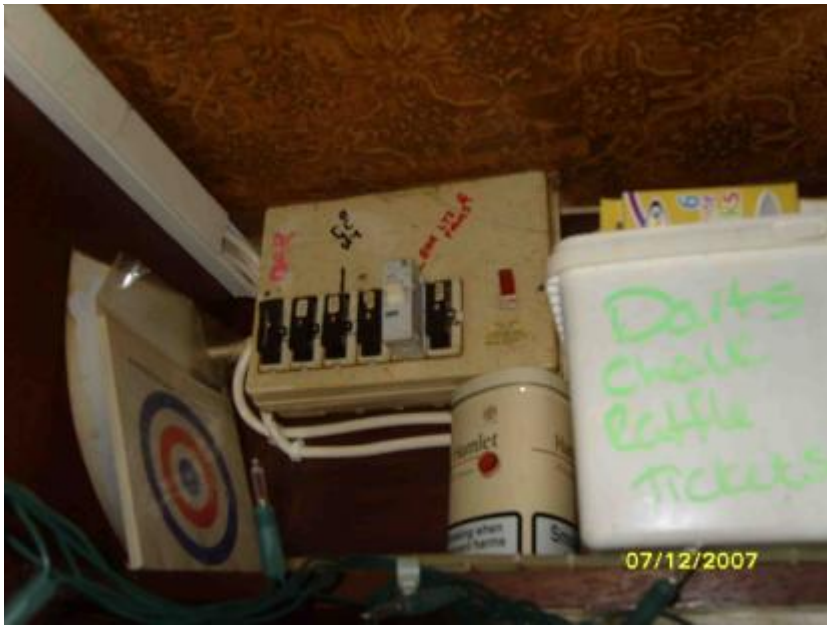
Location ID:	<input type="text" value="8918"/>	Survey Type:	<input type="text" value="T 2"/>
Location Ref:	<input type="text" value="4"/>	Product Type:	<input type="text" value="Ropes and woven textiles"/>
Product:	<input type="text" value="Fuse & Switchgear Flashguard"/>	Damage:	<input type="text" value="No visible damage"/>
Area:	<input type="text" value="Not Applicable"/>	Treatment:	<input type="text" value="Composite asbestos materials"/>
Floor:	<input type="text" value="Ground floor"/>	Asbestos Type:	<input type="text" value="Chrysotile"/>
Room:	<input type="text" value="Servery"/>	Identification:	<input type="text" value="Presumed"/>
Surveyor Name:	<input type="text" value="J D Chilvers"/>	Quantity:	<input type="text"/>

Drawing Ref:	<input type="text" value="4"/>	Accessibility:	<input type="text" value="Medium Accessibility"/>
Asbestos ?	<input type="text" value="Yes"/>	Material Risk Score <input type="text" value="3"/> Material Risk Band: <input type="text" value="Very Low Risk"/> Priority Risk Score: <input type="text" value="2"/>	
Date:	<input type="text" value="06 December 2007"/>		
Next Inspection:	<input type="text" value="05 December 2008"/>

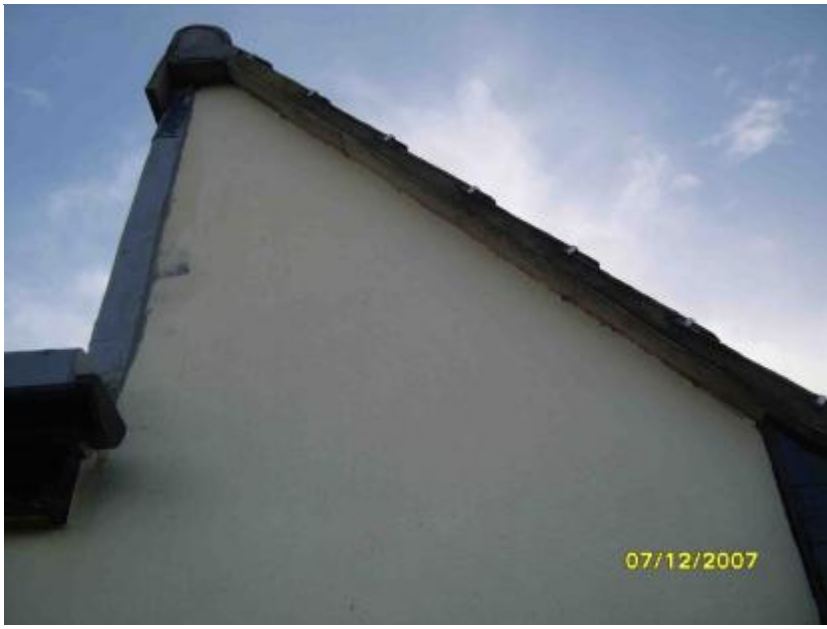
Location ID:	8919	Survey Type:	T 2
Location Ref:	5	Product Type:	NADIS
Product:	Verge Undercloak	Damage:	NADIS
Area:	Not Applicable	Treatment:	NADIS
Floor:	Roof level	Asbestos Type:	NADIS
Room:	External	Identification:	Identified
Surveyor Name:	J D Chilvers	Quantity:	
Drawing Ref:	5	Accessibility:	
Asbestos ?	No		
Date:	06 December 2007		
Next Inspection:	Not Applicable

Material Risk Score	0
Material Risk Band:	NADIS
Priority Risk Score:	N/A

Action: No Action Required

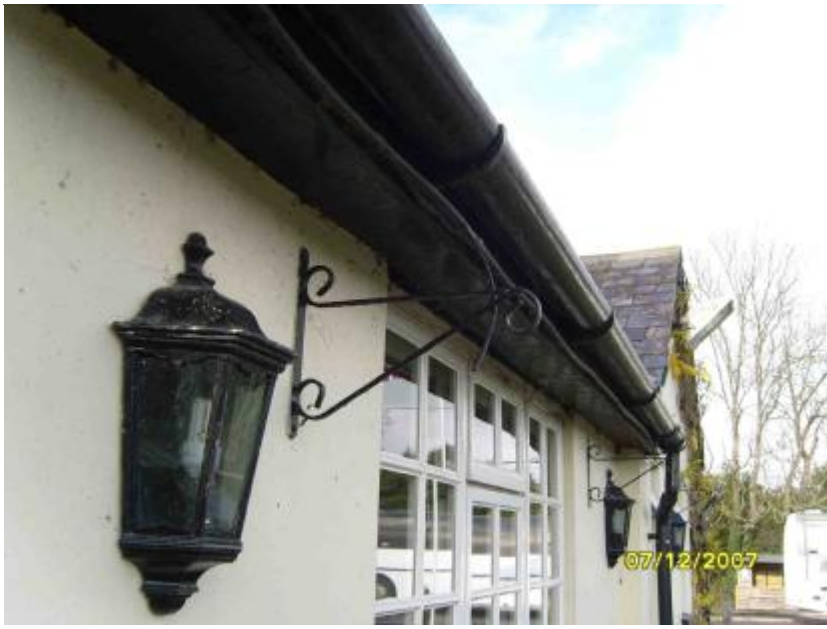
Location ID:	8920	Survey Type:	T 2
Location Ref:	6	Product Type:	NADIS
Product:	Soffit	Damage:	NADIS
Area:	Not Applicable	Treatment:	NADIS
Floor:	Roof level	Asbestos Type:	NADIS
Room:	External	Identification:	Identified
Surveyor Name:	J D Chilvers	Quantity:	
Drawing Ref:	6	Accessibility:	
Asbestos ?	No		
Date:	06 December 2007		
Next Inspection:	Not Applicable

Material Risk Score	0
Material Risk Band:	NADIS
Priority Risk Score:	N/A

Action:	No Action Required
---------	--------------------

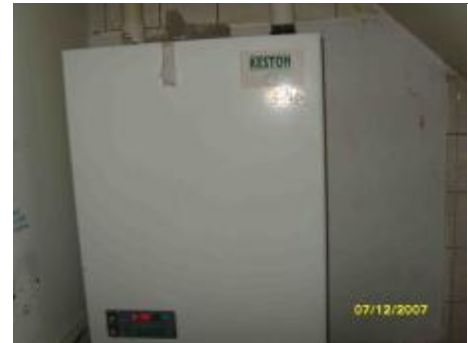
Location ID:	8915
Location Ref:	1
Product:	Boiler
Area:	Not Applicable
Floor:	Ground floor
Room:	Boiler cupboard
Surveyor Name:	J D Chilvers
Drawing Ref:	1
Asbestos ?	Yes
Date:	06 December 2007

Priority Assessment Algorithm			
Assessment factor	Variable(s) selected	Score for each	Overall score
Normal Occupant Activity:			
Main type of activity in area:	Rare disturbance	0	average
Secondary activities for area:	Rare disturbance	0	0
Likelihood Of Disturbance:			
Location:	Rooms up to 100 m2	2	
Accessibility:	Usually inaccessible or unlikely to be disturbed	0	average
Extent/Amount:	Small items strings gaskets	0	1
Human Exposure Potential:			
Number of occupants:	1 to 3	1	
Frequency of use of area:	Weekly	2	average
Average time area is in use:	<1 hour	0	1
Maintenance Activity:			
Type of maintenance activity:	Minor disturbance	0	average
Frequency of maintenance activity	<=1 per year	1	1

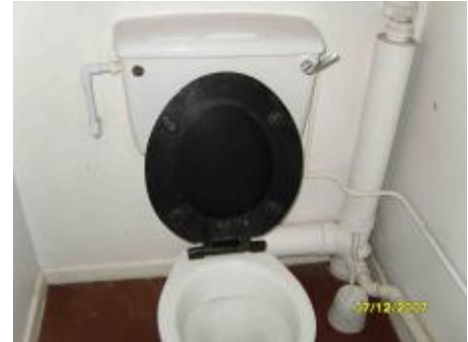
Location ID:	8916
Location Ref:	2
Product:	Cistern / Toilet seat
Area:	Not Applicable
Floor:	Ground floor
Room:	WC
Surveyor Name:	J D Chilvers
Drawing Ref:	2
Asbestos ?	Yes
Date:	06 December 2007

Priority Assessment Algorithm	Variable(s) selected	Score for each	Overall score
Normal Occupant Activity:			
Main type of activity in area:	Rare disturbance	0	average
Secondary activities for area:	Rare disturbance	0	0
Likelihood Of Disturbance:			
Location:	Rooms up to 100 m2	2	
Accessibility:	Usually inaccessible or unlikely to be disturbed	0	average
Extent/Amount:	Small items strings gaskets	0	1
Human Exposure Potential:			
Number of occupants:	1 to 3	1	
Frequency of use of area:	Daily	3	average
Average time area is in use:	<1 hour	0	1
Maintenance Activity:			
Type of maintenance activity:	Minor disturbance	0	average
Frequency of maintenance activity	<=1 per year	1	1

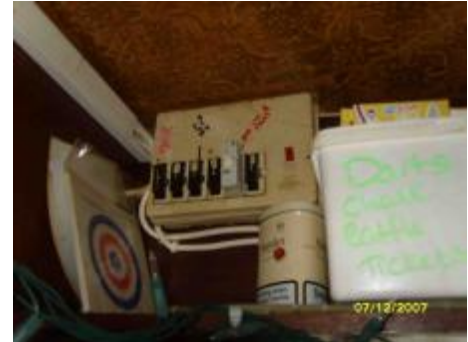
Location ID:	8918
Location Ref:	4
Product:	Fuse & Switchgear Flashguard
Area:	Not Applicable
Floor:	Ground floor
Room:	Servery
Surveyor Name:	J D Chilvers
Drawing Ref:	4
Asbestos ?	Yes
Date:	06 December 2007

Priority Assessment Algorithm	Variable(s) selected	Score for each	Overall score
Normal Occupant Activity:			
Main type of activity in area:	Rare disturbance	0	average
Secondary activities for area:	Rare disturbance	0	0
Likelihood Of Disturbance:			
Location:	Large rooms or well-ventilated areas	1	
Accessibility:	Usually inaccessible or unlikely to be disturbed	0	average
Extent/Amount:	Small items strings gaskets	0	0
Human Exposure Potential:			
Number of occupants:	1 to 3	1	
Frequency of use of area:	Daily	3	average
Average time area is in use:	<1 hour	0	1
Maintenance Activity:			
Type of maintenance activity:	Minor disturbance	0	average
Frequency of maintenance activity	<=1 per year	1	1
