JTEC Environmental Ltd.

Asbestos Survey for

Hall & Woodhouse Ltd

White Hart
2 Cheap Street
Sherborne
Dorset
DT9 3PX

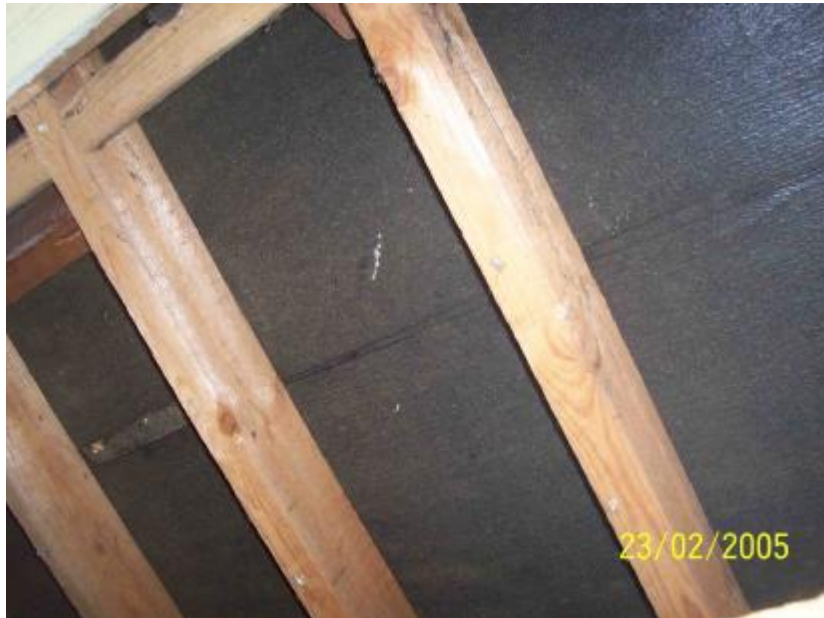
Location ID:	2693	Survey Type:	T 2
Location Ref:	1	Product Type:	Roofing felts
Product:	Roofing felt	Damage:	No visible damage
Area:	Not Applicable	Treatment:	Resins
Floor:	Roof level	Asbestos Type:	Chrysotile
Room:	Loft space	Identification:	Presumed
Surveyor Name:	J D Chilvers	Quantity:	
Drawing Ref:	1	Accessibility:	Difficult Accessibility
Asbestos ?	Yes		
Date:	23 February 2005		
Next Inspection:	23 February 2006

Action: No Action Required

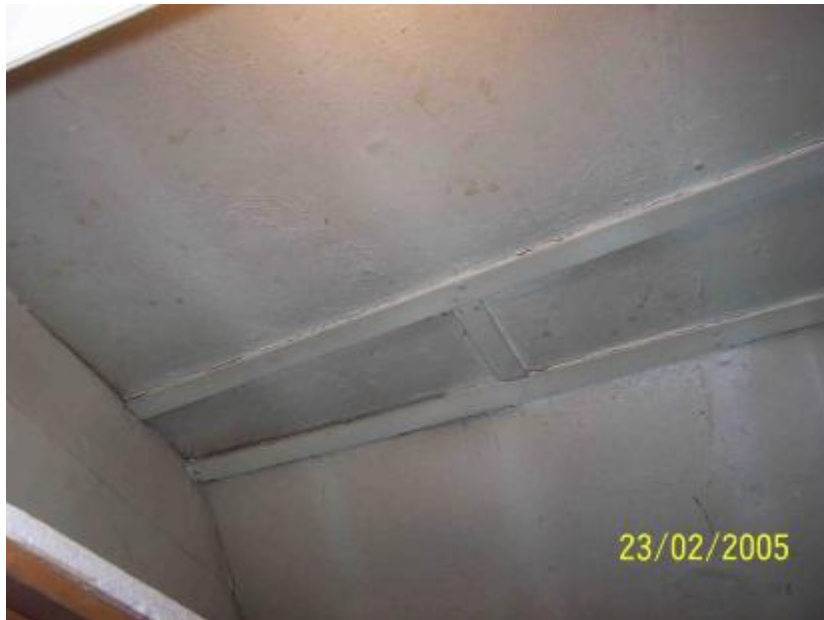
Location ID:	2694	Survey Type:	T 2
Location Ref:	2	Product Type:	Asbestos cement
Product:	Ceiling	Damage:	Low damage: Scratches or marks
Area:	Not Applicable	Treatment:	Asbestos cement sheets etc
Floor:	First floor	Asbestos Type:	Chrysotile
Room:	Boiler room	Identification:	Strongly Presumed
Surveyor Name:	J D Chilvers	Quantity:	
Drawing Ref:	2	Accessibility:	Medium Accessibility
Asbestos ?	Yes		
Date:	23 February 2005		
Next Inspection:	23 February 2006

Material Comments: Sample not possible without causing major damage.

Action: Apply Warning Labels

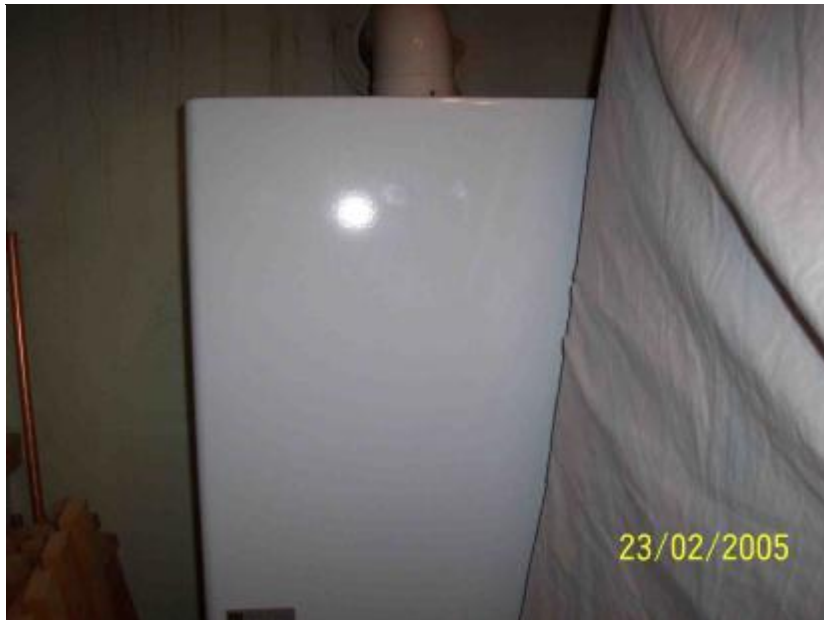
Location ID:	2695	Survey Type:	T 2
Location Ref:	3	Product Type:	Gaskets
Product:	Boiler	Damage:	No visible damage
Area:	Not Applicable	Treatment:	Composite asbestos materials
Floor:	First floor	Asbestos Type:	Chrysotile
Room:	Boiler room	Identification:	Presumed
Surveyor Name:	J D Chilvers	Quantity:	
Drawing Ref:	3	Accessibility:	Difficult Accessibility
Asbestos ?	Yes		
Date:	23 February 2005		
Next Inspection:	23 February 2006

Action: Apply Warning Labels

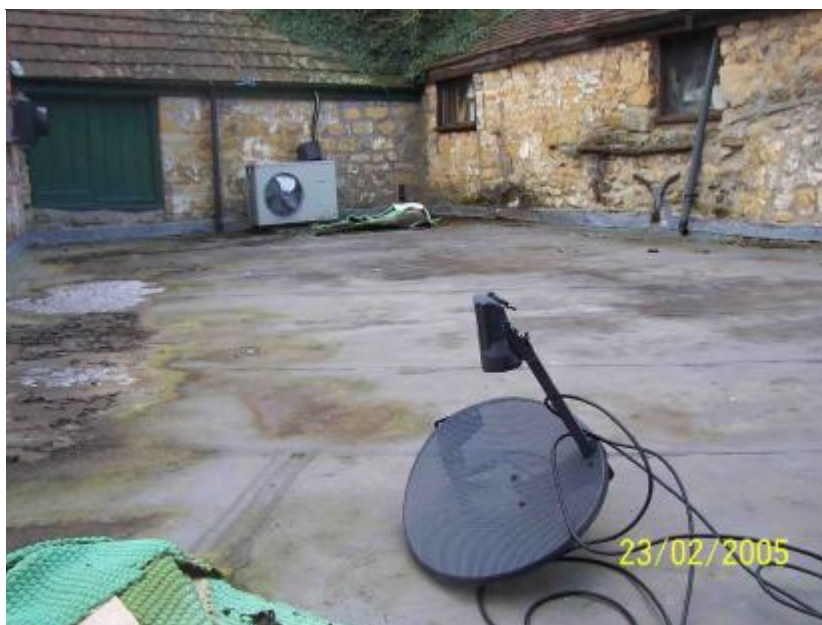
Location ID:	2696	Survey Type:	T 2
Location Ref:	4	Product Type:	Roofing felts
Product:	Roofing felt	Damage:	No visible damage
Area:	Not Applicable	Treatment:	Resins
Floor:	Roof level	Asbestos Type:	Chrysotile
Room:	Flat roof area	Identification:	Presumed
Surveyor Name:	J D Chilvers	Quantity:	
Drawing Ref:	4	Accessibility:	Difficult Accessibility
Asbestos ?	Yes		
Date:	23 February 2005		
Next Inspection:	23 February 2006

Action: No Action Required

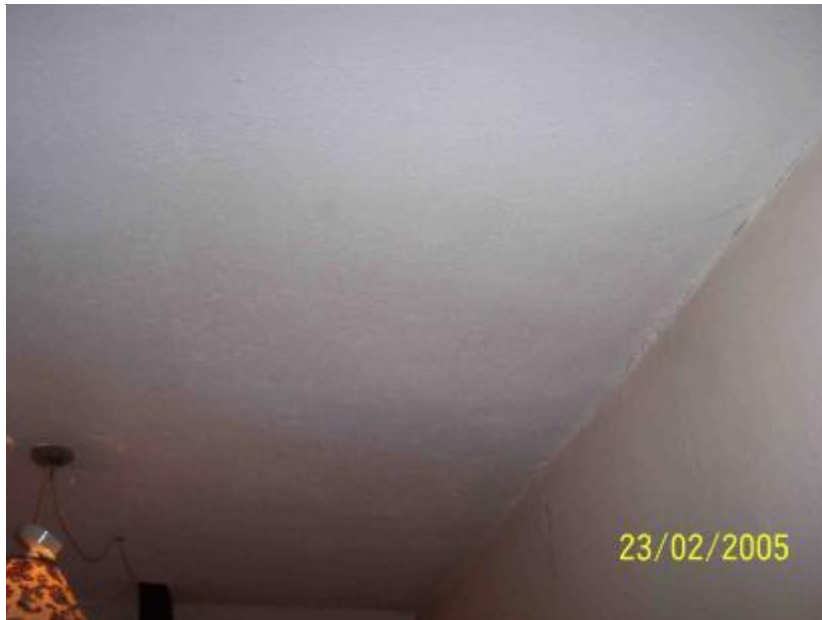
Location ID:	2697	Survey Type:	T 2
Location Ref:	5	Product Type:	Decorative finishes
Product:	Textured coating	Damage:	No visible damage
Area:	Not Applicable	Treatment:	Composite asbestos materials
Floor:	First floor	Asbestos Type:	Chrysotile
Room:	Office	Identification:	Presumed
Surveyor Name:	J D Chilvers	Quantity:	
Drawing Ref:	5	Accessibility:	Easy Accessibility
Asbestos ?	Yes		
Date:	23 February 2005		
Next Inspection:	23 February 2006

Action: Apply Warning Labels

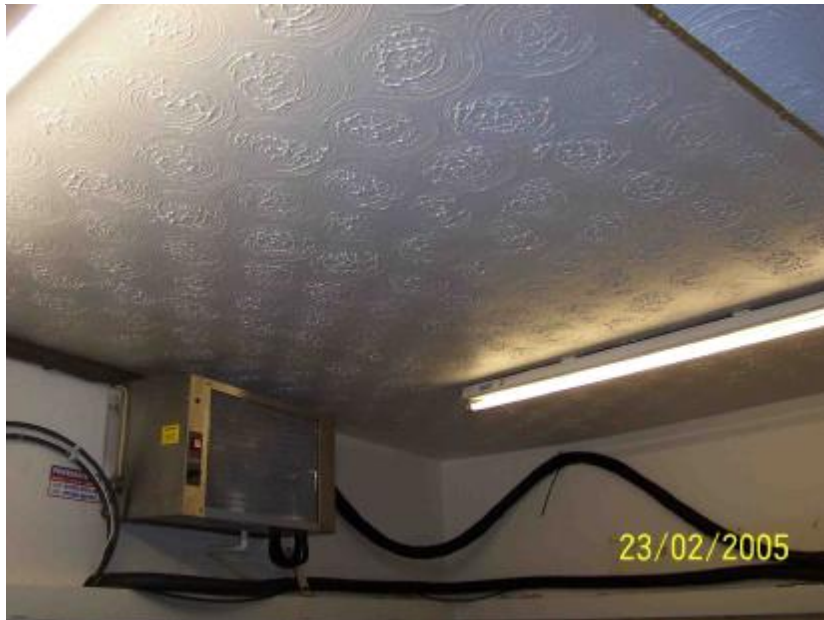
Location ID:	2698	Survey Type:	T 2
Location Ref:	6	Product Type:	Decorative finishes
Product:	Textured coating	Damage:	No visible damage
Area:	Not Applicable	Treatment:	Composite asbestos materials
Floor:	Ground floor	Asbestos Type:	Chrysotile
Room:	Cellar	Identification:	Presumed
Surveyor Name:	J D Chilvers	Quantity:	
Drawing Ref:	6	Accessibility:	Medium Accessibility
Asbestos ?	Yes		
Date:	23 February 2005		
Next Inspection:	23 February 2006

Action: Apply Warning Labels

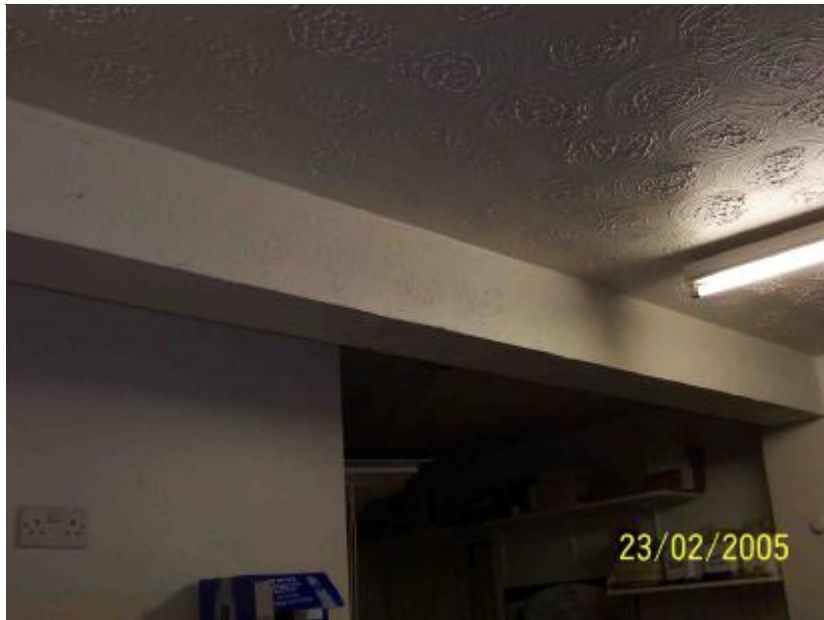
Location ID:	2699	Survey Type:	T 2
Location Ref:	7	Product Type:	Asbestos Insulating Board
Product:	Beam cladding	Damage:	No visible damage
Area:	Not Applicable	Treatment:	AIB painted or encapsulated
Floor:	Ground floor	Asbestos Type:	Amosite
Room:	Cellar	Identification:	Presumed
Surveyor Name:	J D Chilvers	Quantity:	
Drawing Ref:	7	Accessibility:	Medium Accessibility
Asbestos ?	Yes		
Date:	23 February 2005		
Next Inspection:	25 August 2005

Action: Apply Warning Labels

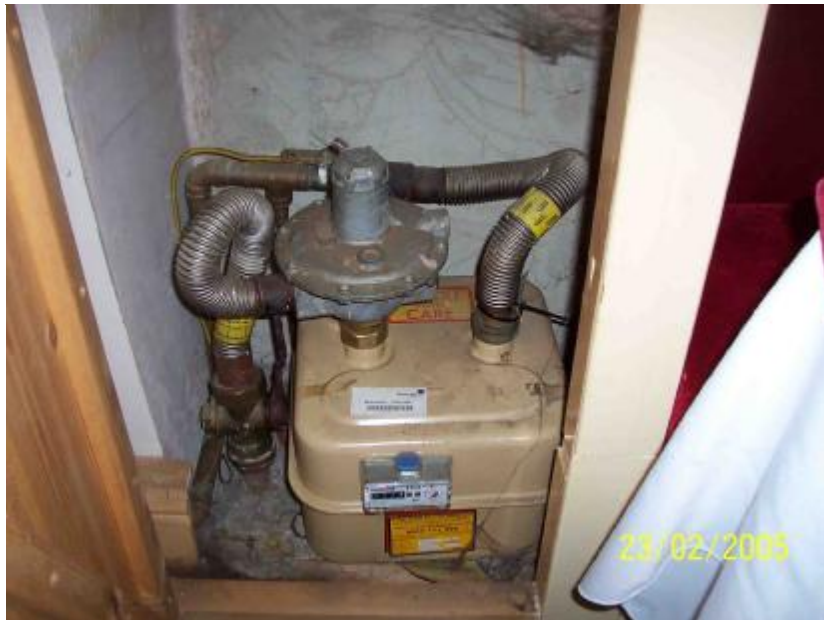
Location ID:	2700	Survey Type:	T 2
Location Ref:	8	Product Type:	Gaskets
Product:	Gas meter	Damage:	No visible damage
Area:	Not Applicable	Treatment:	Composite asbestos materials
Floor:	Ground floor	Asbestos Type:	Chrysotile
Room:	Bar area	Identification:	Presumed
Surveyor Name:	J D Chilvers	Quantity:	
Drawing Ref:	8	Accessibility:	Difficult Accessibility
Asbestos ?	Yes		
Date:	23 February 2005		
Next Inspection:	23 February 2006

Action: Apply Warning Labels

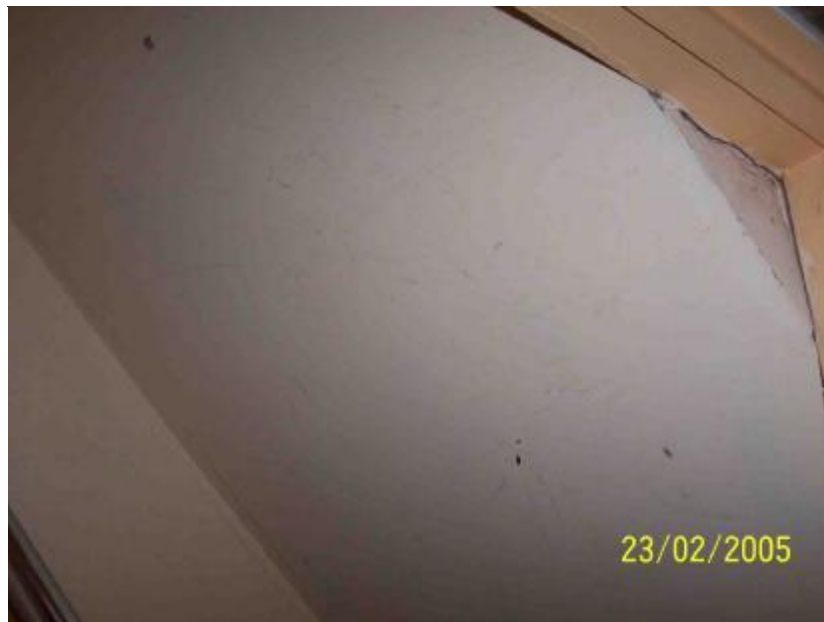
Location ID:	2701	Survey Type:	T 2
Location Ref:	9	Product Type:	Asbestos Insulating Board
Product:	Stair Backing / Cladding	Damage:	No visible damage
Area:	Not Applicable	Treatment:	AIB painted or encapsulated
Floor:	Ground floor	Asbestos Type:	Amosite
Room:	Understair Cupboard	Identification:	Presumed
Surveyor Name:	J D Chilvers	Quantity:	
Drawing Ref:	9	Accessibility:	Medium Accessibility
Asbestos ?	Yes		
Date:	23 February 2005		
Next Inspection:	25 August 2005

Action: Apply Warning Labels

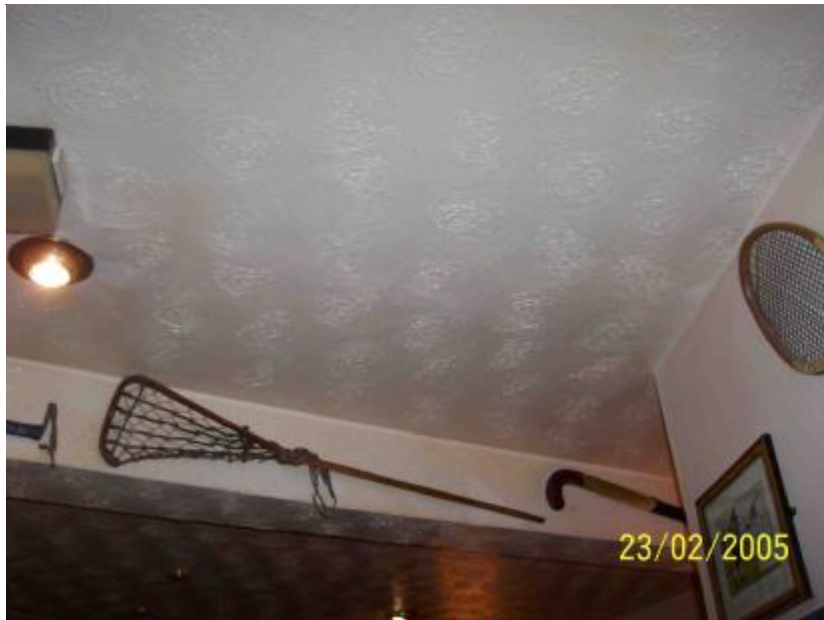
Location ID:	2702	Survey Type:	T 2
Location Ref:	10	Product Type:	NADIS
Product:	Textured coating	Damage:	NADIS
Area:	Not Applicable	Treatment:	NADIS
Floor:	Ground floor	Asbestos Type:	NADIS
Room:	Bar area	Identification:	Identified
Surveyor Name:	J D Chilvers	Quantity:	
Drawing Ref:	10	Accessibility:	
Asbestos ?	No		
Date:	23 February 2005		
Next Inspection:	Not Applicable

Action: No Action Required

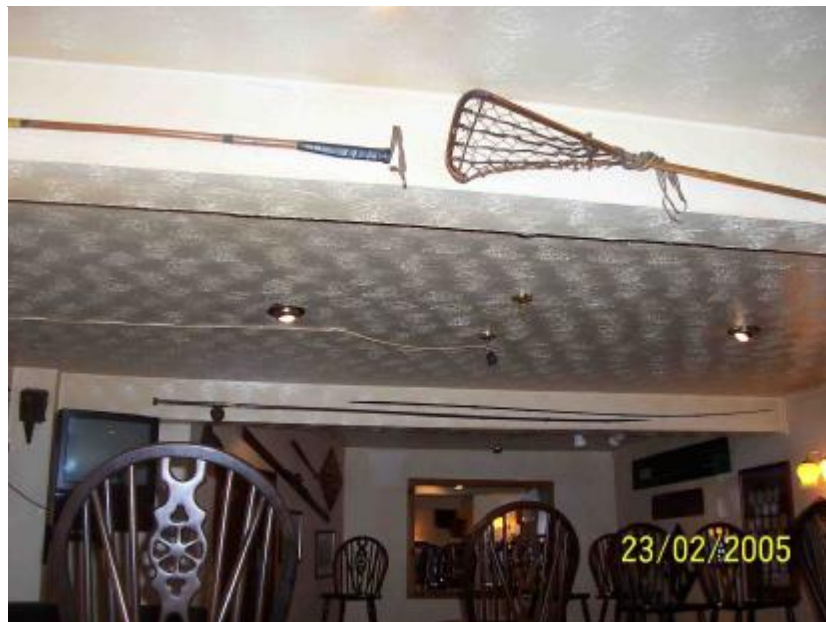
Location ID:	2703	Survey Type:	T 2
Location Ref:	11	Product Type:	Asbestos Insulating Board
Product:	Beam cladding	Damage:	No visible damage
Area:	Not Applicable	Treatment:	AIB painted or encapsulated
Floor:	Ground floor	Asbestos Type:	Amosite
Room:	Bar area	Identification:	Presumed
Surveyor Name:	J D Chilvers	Quantity:	
Drawing Ref:	11	Accessibility:	Medium Accessibility
Asbestos ?	Yes		
Date:	23 February 2005		
Next Inspection:	25 August 2005

Action: Apply Warning Labels

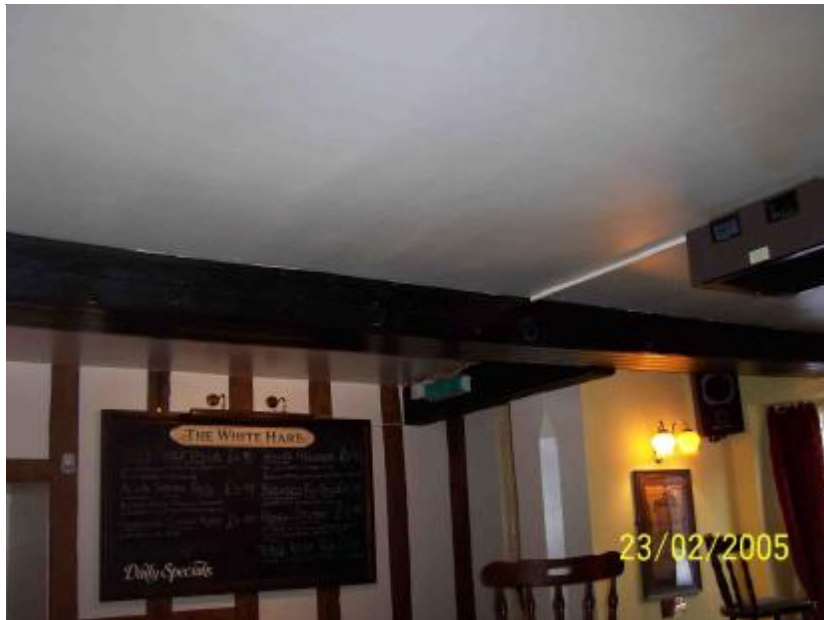
Location ID:	2704	Survey Type:	T 2
Location Ref:	12	Product Type:	Asbestos Insulating Board
Product:	Beam cladding	Damage:	No visible damage
Area:	Not Applicable	Treatment:	AIB painted or encapsulated
Floor:	Ground floor	Asbestos Type:	Amosite
Room:	Bar area	Identification:	Presumed
Surveyor Name:	J D Chilvers	Quantity:	
Drawing Ref:	12	Accessibility:	Medium Accessibility
Asbestos ?	Yes		
Date:	23 February 2005		
Next Inspection:	25 August 2005

Action: Apply Warning Labels

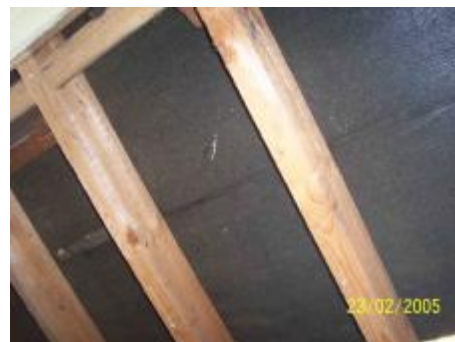
Location ID:	2693
Location Ref:	1
Product:	Roofing felt
Area:	Not Applicable
Floor:	Roof level
Room:	Loft space
Surveyor Name:	J D Chilvers
Drawing Ref:	1
Asbestos ?	Yes
Date:	23 February 2005

Priority Assessment Algorithm			
Assessment factor	Variable(s) selected	Score for each	Overall score
Normal Occupant Activity:			
Main type of activity in area:	Rare disturbance	0	average
Secondary activities for area:	Rare disturbance	0	0
Likelihood Of Disturbance:			
Location:	Rooms up to 100 m2	2	average 2
Accessibility:	Usually inaccessible or unlikely to be disturbed	0	
Extent/Amount:	>50 m2 or >50 m pipe run	3	
Human Exposure Potential:			
Number of occupants:	1 to 3	1	average 0
Frequency of use of area:	Infrequent	0	
Average time area is in use:	<1 hour	0	
Maintenance Activity:			
Type of maintenance activity:	Minor disturbance	0	average
Frequency of maintenance activity	Unlikely to be disturbed	0	0

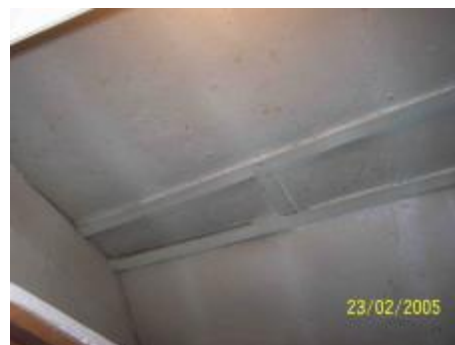
Location ID:	<div style="border: 1px solid black; padding: 2px;">2694</div>
Location Ref:	<div style="border: 1px solid black; padding: 2px;">2</div>
Product:	<div style="border: 1px solid black; padding: 2px;">Ceiling</div>
Area:	<div style="border: 1px solid black; padding: 2px;">Not Applicable</div>
Floor:	<div style="border: 1px solid black; padding: 2px;">First floor</div>
Room:	<div style="border: 1px solid black; padding: 2px;">Boiler room</div>
Surveyor Name:	<div style="border: 1px solid black; padding: 2px;">J D Chilvers</div>
Drawing Ref:	<div style="border: 1px solid black; padding: 2px;">2</div>
Asbestos ?	<div style="border: 1px solid black; padding: 2px;">Yes</div>
Date:	<div style="border: 1px solid black; padding: 2px;">23 February 2005</div>

Priority Assessment Algorithm			
Assessment factor	Variable(s) selected	Score for each	Overall score
Normal Occupant Activity:			
Main type of activity in area:	Low disturbance	1	average
Secondary activities for area:	Low disturbance	1	1
Likelihood Of Disturbance:			
Location:	Rooms up to 100 m2	2	average 1
Accessibility:	Usually inaccessible or unlikely to be disturbed	0	
Extent/Amount:	<=10 m2 or <=10 m pipe run	1	
Human Exposure Potential:			
Number of occupants:	1 to 3	1	average 1
Frequency of use of area:	Weekly	2	
Average time area is in use:	<1 hour	0	
Maintenance Activity:			
Type of maintenance activity:	Minor disturbance	0	average
Frequency of maintenance activity	<=1 per year	1	1

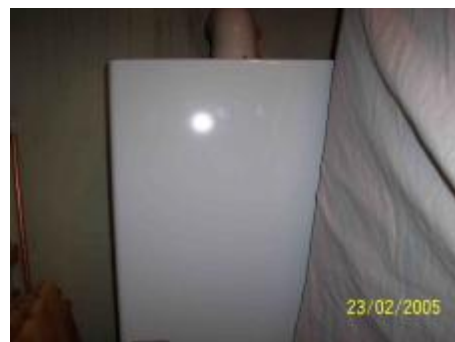
Location ID:	<div style="border: 1px solid black; padding: 2px; display: inline-block;">2695</div>
Location Ref:	<div style="border: 1px solid black; padding: 2px; display: inline-block;">3</div>
Product:	<div style="border: 1px solid black; padding: 2px; display: inline-block;">Boiler</div>
Area:	<div style="border: 1px solid black; padding: 2px; display: inline-block;">Not Applicable</div>
Floor:	<div style="border: 1px solid black; padding: 2px; display: inline-block;">First floor</div>
Room:	<div style="border: 1px solid black; padding: 2px; display: inline-block;">Boiler room</div>
Surveyor Name:	<div style="border: 1px solid black; padding: 2px; display: inline-block;">J D Chilvers</div>

Priority Assessment Algorithm			
Assessment factor	Variable(s) selected	Score for each	Overall score
Normal Occupant Activity:			
Main type of activity in area:	Rare disturbance	0	average
Secondary activities for area:	Rare disturbance	0	0
Likelihood Of Disturbance:			
Location:	Rooms up to 100 m2	2	average 1
Accessibility:	Usually inaccessible or unlikely to be disturbed	0	
Extent/Amount:	Small items strings gaskets	0	
Human Exposure Potential:			
Number of occupants:	1 to 3	1	average 1
Frequency of use of area:	Weekly	2	
Average time area is in use:	<1 hour	0	
Maintenance Activity:			
Type of maintenance activity:	Minor disturbance	0	average
Frequency of maintenance activity	Unlikely to be disturbed	0	0

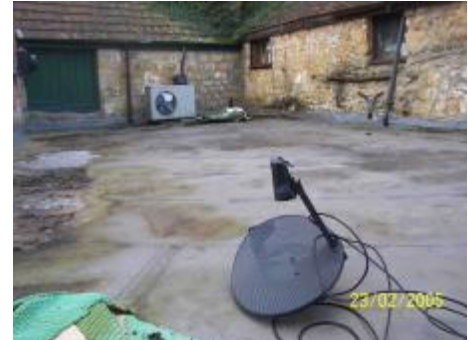
Location ID:	<div style="border: 1px solid black; padding: 2px; display: inline-block;">2696</div>
Location Ref:	<div style="border: 1px solid black; padding: 2px; display: inline-block;">4</div>
Product:	<div style="border: 1px solid black; padding: 2px; display: inline-block;">Roofing felt</div>
Area:	<div style="border: 1px solid black; padding: 2px; display: inline-block;">Not Applicable</div>
Floor:	<div style="border: 1px solid black; padding: 2px; display: inline-block;">Roof level</div>
Room:	<div style="border: 1px solid black; padding: 2px; display: inline-block;">Flat roof area</div>
Surveyor Name:	<div style="border: 1px solid black; padding: 2px; display: inline-block;">J D Chilvers</div>

Priority Assessment Algorithm			
Assessment factor	Variable(s) selected	Score for each	Overall score
Normal Occupant Activity:			
Main type of activity in area:	Rare disturbance	0	average
Secondary activities for area:	Rare disturbance	0	0
Likelihood Of Disturbance:			
Location:	Outdoors	0	average 1
Accessibility:	Usually inaccessible or unlikely to be disturbed	0	
Extent/Amount:	>50 m2 or >50 m pipe run	3	
Human Exposure Potential:			
Number of occupants:	1 to 3	1	average 0
Frequency of use of area:	Infrequent	0	
Average time area is in use:	<1 hour	0	
Maintenance Activity:			
Type of maintenance activity:	Minor disturbance	0	average
Frequency of maintenance activity	Unlikely to be disturbed	0	0

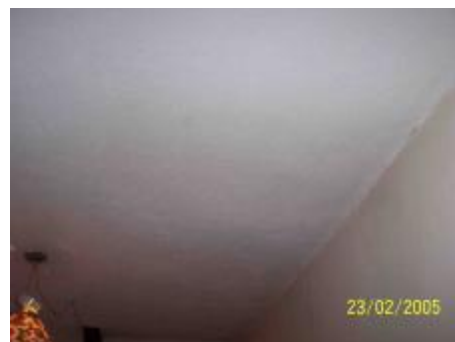
Location ID:	2697
Location Ref:	5
Product:	Textured coating
Area:	Not Applicable
Floor:	First floor
Room:	Office
Surveyor Name:	J D Chilvers
Drawing Ref:	5
Asbestos ?	Yes
Date:	23 February 2005

Priority Assessment Algorithm			
Assessment factor	Variable(s) selected	Score for each	Overall score
Normal Occupant Activity:			
Main type of activity in area:	Low disturbance	1	average
Secondary activities for area:	Low disturbance	1	1
Likelihood Of Disturbance:			
Location:	Rooms up to 100 m2	2	average 1
Accessibility:	Usually inaccessible or unlikely to be disturbed	0	
Extent/Amount:	<=10 m2 or <=10 m pipe run	1	
Human Exposure Potential:			
Number of occupants:	1 to 3	1	average 2
Frequency of use of area:	Daily	3	
Average time area is in use:	>1 to <3 hours	1	
Maintenance Activity:			
Type of maintenance activity:	Minor disturbance	0	average
Frequency of maintenance activity	Unlikely to be disturbed	0	0

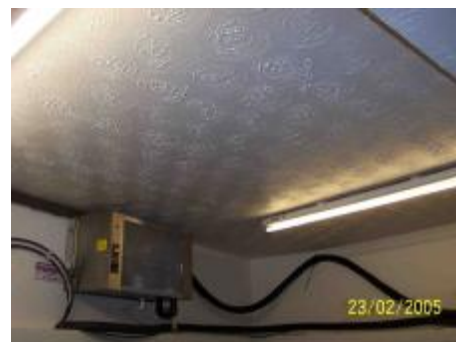
Location ID:	2698
Location Ref:	6
Product:	Textured coating
Area:	Not Applicable
Floor:	Ground floor
Room:	Cellar
Surveyor Name:	J D Chilvers
Drawing Ref:	6
Asbestos ?	Yes
Date:	23 February 2005

Priority Assessment Algorithm			
Assessment factor	Variable(s) selected	Score for each	Overall score
Normal Occupant Activity:			
Main type of activity in area:	Rare disturbance	0	average
Secondary activities for area:	Rare disturbance	0	0
Likelihood Of Disturbance:			
Location:	Rooms up to 100 m2	2	average 1
Accessibility:	Usually inaccessible or unlikely to be disturbed	0	
Extent/Amount:	>10 to <=50 (m2 or pipe run)	2	
Human Exposure Potential:			
Number of occupants:	1 to 3	1	average 1
Frequency of use of area:	Daily	3	
Average time area is in use:	<1 hour	0	
Maintenance Activity:			
Type of maintenance activity:	Minor disturbance	0	average
Frequency of maintenance activity	Unlikely to be disturbed	0	0

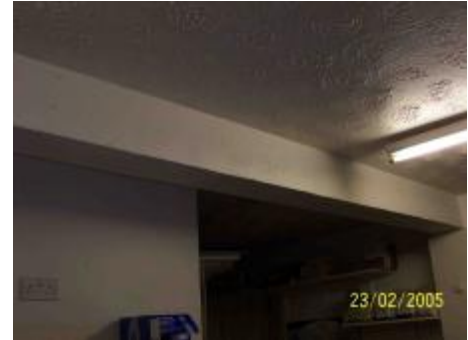
Location ID:	<div>2699</div>
Location Ref:	<div>7</div>
Product:	<div>Beam cladding</div>
Area:	<div>Not Applicable</div>
Floor:	<div>Ground floor</div>
Room:	<div>Cellar</div>
Surveyor Name:	<div>J D Chilvers</div>
Drawing Ref:	<div>7</div>
Asbestos ?	<div>Yes</div>
Date:	<div>23 February 2005</div>

Priority Assessment Algorithm			
Assessment factor	Variable(s) selected	Score for each	Overall score
Normal Occupant Activity:			
Main type of activity in area:	Rare disturbance	0	average
Secondary activities for area:	Rare disturbance	0	0
Likelihood Of Disturbance:			
Location:	Rooms up to 100 m2	2	average 1
Accessibility:	Usually inaccessible or unlikely to be disturbed	0	
Extent/Amount:	<=10 m2 or <=10 m pipe run	1	
Human Exposure Potential:			
Number of occupants:	1 to 3	1	average 1
Frequency of use of area:	Daily	3	
Average time area is in use:	<1 hour	0	
Maintenance Activity:			
Type of maintenance activity:	Minor disturbance	0	average
Frequency of maintenance activity	Unlikely to be disturbed	0	0

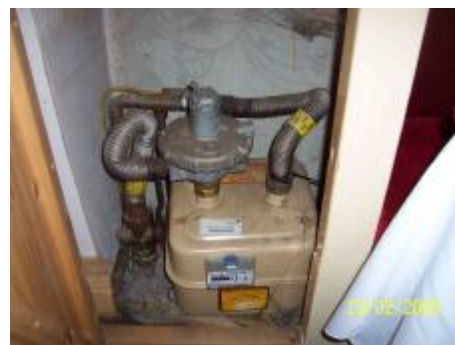
Location ID:	2700
Location Ref:	8
Product:	Gas meter
Area:	Not Applicable
Floor:	Ground floor
Room:	Bar area
Surveyor Name:	J D Chilvers
Drawing Ref:	8
Asbestos ?	Yes
Date:	23 February 2005

Priority Assessment Algorithm			
Assessment factor	Variable(s) selected	Score for each	Overall score
Normal Occupant Activity:			
Main type of activity in area:	Rare disturbance	0	average
Secondary activities for area:	Rare disturbance	0	0
Likelihood Of Disturbance:			
Location:	Rooms up to 100 m2	2	average 1
Accessibility:	Usually inaccessible or unlikely to be disturbed	0	
Extent/Amount:	Small items strings gaskets	0	
Human Exposure Potential:			
Number of occupants:	1 to 3	1	average 1
Frequency of use of area:	Monthly	1	
Average time area is in use:	<1 hour	0	
Maintenance Activity:			
Type of maintenance activity:	Minor disturbance	0	average
Frequency of maintenance activity	Unlikely to be disturbed	0	0

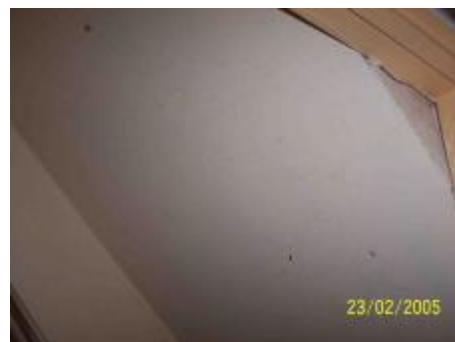
Location ID:	<div style="border: 1px solid black; padding: 2px; display: inline-block;">2701</div>
Location Ref:	<div style="border: 1px solid black; padding: 2px; display: inline-block;">9</div>
Product:	<div style="border: 1px solid black; padding: 2px; display: inline-block;">Stair Backing / Cladding</div>
Area:	<div style="border: 1px solid black; padding: 2px; display: inline-block;">Not Applicable</div>
Floor:	<div style="border: 1px solid black; padding: 2px; display: inline-block;">Ground floor</div>
Room:	<div style="border: 1px solid black; padding: 2px; display: inline-block;">Understair Cupboard</div>
Surveyor Name:	<div style="border: 1px solid black; padding: 2px; display: inline-block;">J D Chilvers</div>

Priority Assessment Algorithm			
Assessment factor	Variable(s) selected	Score for each	Overall score
Normal Occupant Activity:			
Main type of activity in area:	Rare disturbance	0	average
Secondary activities for area:	Rare disturbance	0	0
Likelihood Of Disturbance:			
Location:	Confined spaces	3	average 1
Accessibility:	Usually inaccessible or unlikely to be disturbed	0	
Extent/Amount:	<=10 m2 or <=10 m pipe run	1	
Human Exposure Potential:			
Number of occupants:	1 to 3	1	average 1
Frequency of use of area:	Daily	3	
Average time area is in use:	<1 hour	0	
Maintenance Activity:			
Type of maintenance activity:	Minor disturbance	0	average
Frequency of maintenance activity	Unlikely to be disturbed	0	0

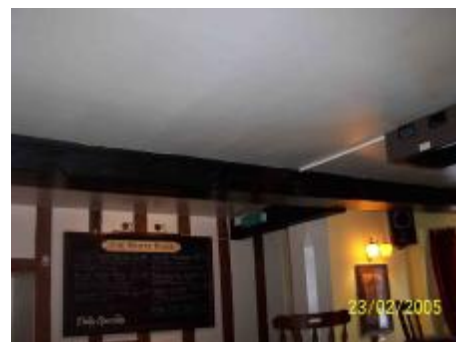
Location ID:	2704
Location Ref:	12
Product:	Beam cladding
Area:	Not Applicable
Floor:	Ground floor
Room:	Bar area
Surveyor Name:	J D Chilvers
Drawing Ref:	12
Asbestos ?	Yes
Date:	23 February 2005

Priority Assessment Algorithm			
Assessment factor	Variable(s) selected	Score for each	Overall score
Normal Occupant Activity:			
Main type of activity in area:	Low disturbance	1	average
Secondary activities for area:	Low disturbance	1	1
Likelihood Of Disturbance:			
Location:	Large rooms or well-ventilated areas	1	
Accessibility:	Usually inaccessible or unlikely to be disturbed	0	average
Extent/Amount:	>10 to <=50 (m2 or pipe run)	2	1
Human Exposure Potential:			
Number of occupants:	>10	3	
Frequency of use of area:	Daily	3	average
Average time area is in use:	>1 to <3 hours	1	2
Maintenance Activity:			
Type of maintenance activity:	Minor disturbance	0	average
Frequency of maintenance activity	Unlikely to be disturbed	0	0
