Asbestos Survey for

Hall & Woodhouse Ltd

Amberwood
Ringwood Road
Walkford
Christchurch
Dorset

Project Number: AS07112 - Amberwood

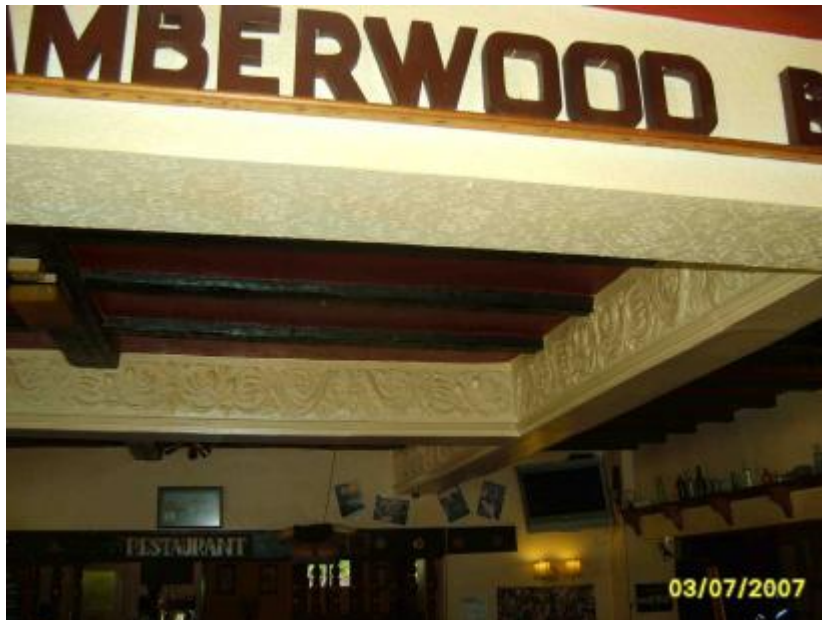
Location ID:	8011	Survey Type:	T 2
Location Ref:	1	Product Type:	Asbestos Insulating Board
Product:	Beam cladding	Damage:	No visible damage
Area:	Not Applicable	Treatment:	AIB painted or encapsulated
Floor:	Ground floor	Asbestos Type:	Amosite
Room:	Bar area	Identification:	Presumed
Surveyor Name:	J D Chilvers	Quantity:	
Drawing Ref:	1	Accessibility:	Medium Accessibility
Asbestos ?	Yes		
Date:	03 July 2007		
Next Inspection:	02 January 2008

Material Risk Score	5
Material Risk Band:	Low Risk
Priority Risk Score:	5

Material Comments:	All structural beams within the building may be encased with AIB
--------------------	--

Action:	Apply Warning Labels
---------	----------------------

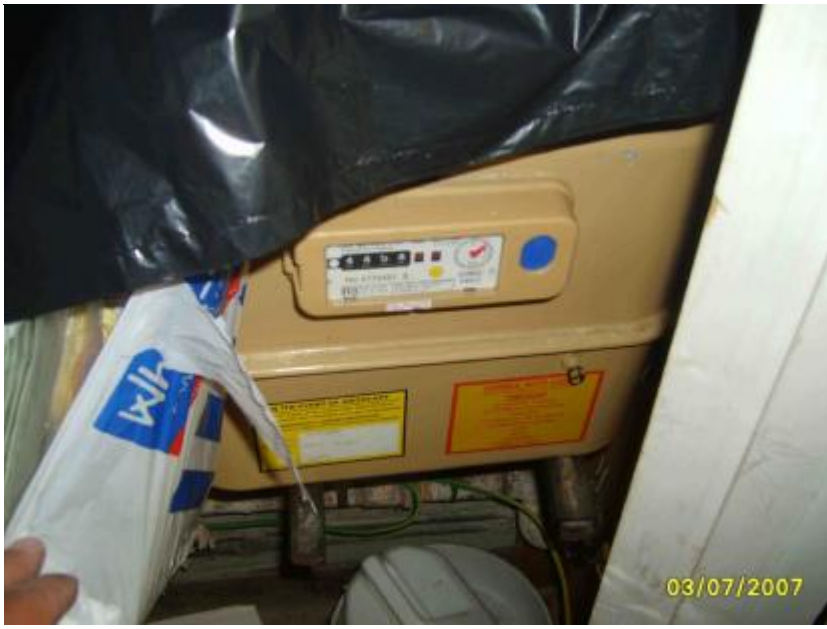
Location ID:	8012	Survey Type:	T 2
Location Ref:	2	Product Type:	Gaskets
Product:	Gas meter	Damage:	No visible damage
Area:	Not Applicable	Treatment:	Composite asbestos materials
Floor:	Ground floor	Asbestos Type:	Chrysotile
Room:	Cellar	Identification:	Presumed
Surveyor Name:	J D Chilvers	Quantity:	
Drawing Ref:	2	Accessibility:	Medium Accessibility
Asbestos ?	Yes		
Date:	03 July 2007		
Next Inspection:	02 July 2008		
		Material Risk Score:	3
		Material Risk Band:	Very Low Risk
		Priority Risk Score:	3

Action:	Apply Warning Labels
---------	----------------------

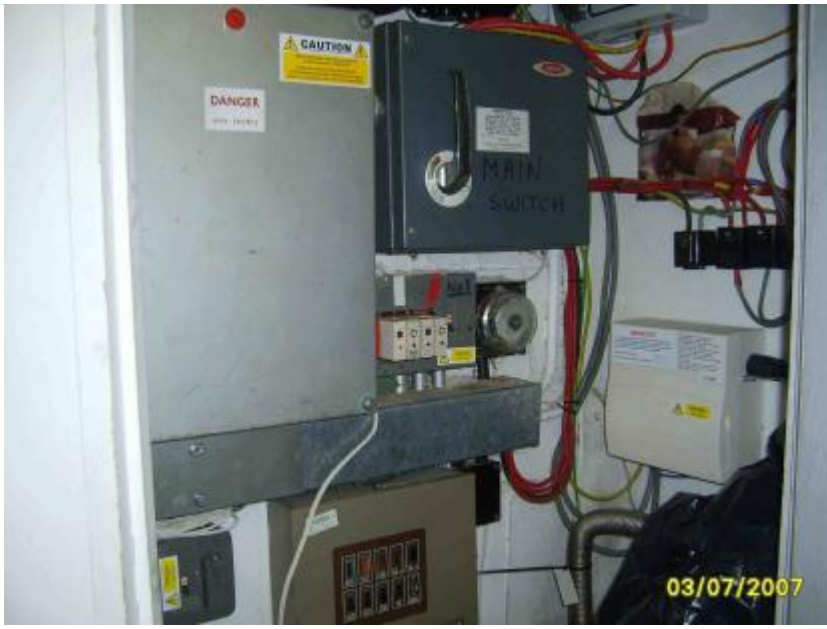
Location ID:	8013	Survey Type:	T 2
Location Ref:	3	Product Type:	Ropes and woven textiles
Product:	Fuse & Switchgear Flashguard	Damage:	No visible damage
Area:	Not Applicable	Treatment:	Composite asbestos materials
Floor:	Ground floor	Asbestos Type:	Chrysotile
Room:	Cellar	Identification:	Presumed
Surveyor Name:	J D Chilvers	Quantity:	
Drawing Ref:	3	Accessibility:	Medium Accessibility
Asbestos ?	Yes		
Date:	03 July 2007		
Next Inspection:	02 July 2008		
		Material Risk Score:	3
		Material Risk Band:	Very Low Risk
		Priority Risk Score:	2

Action:	Apply Warning Labels
---------	----------------------

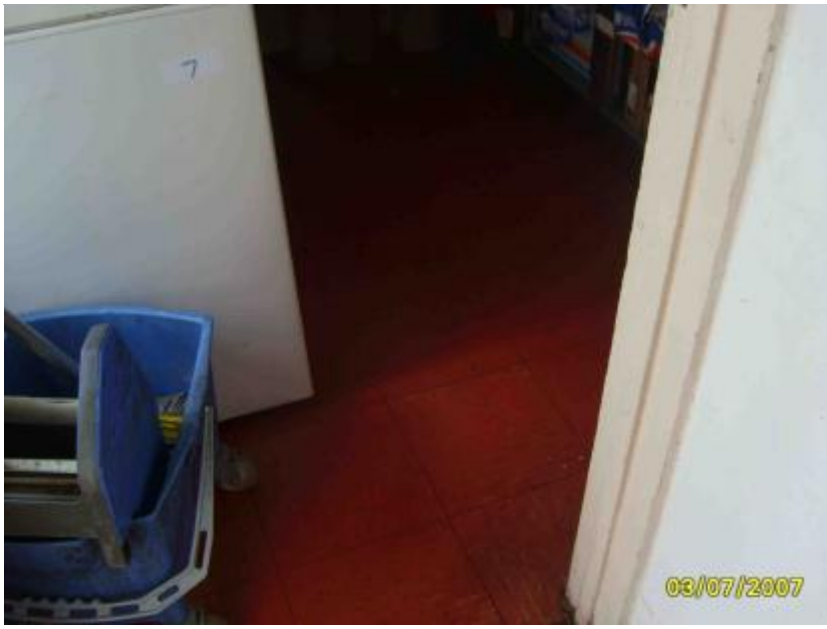
Location ID:	<input type="text" value="8014"/>	Survey Type:	<input type="text" value="T 2"/>
Location Ref:	<input type="text" value="4"/>	Product Type:	<input type="text" value="NADIS"/>
Product:	<input type="text" value="Floor tiles"/>	Damage:	<input type="text" value="NADIS"/>
Area:	<input type="text" value="Not Applicable"/>	Treatment:	<input type="text" value="NADIS"/>
Floor:	<input type="text" value="Ground floor"/>	Asbestos Type:	<input type="text" value="NADIS"/>
Room:	<input type="text" value="Dry Store"/>	Identification:	<input type="text" value="Identified"/>
Surveyor Name:	<input type="text" value="J D Chilvers"/>	Quantity:	<input type="text"/>

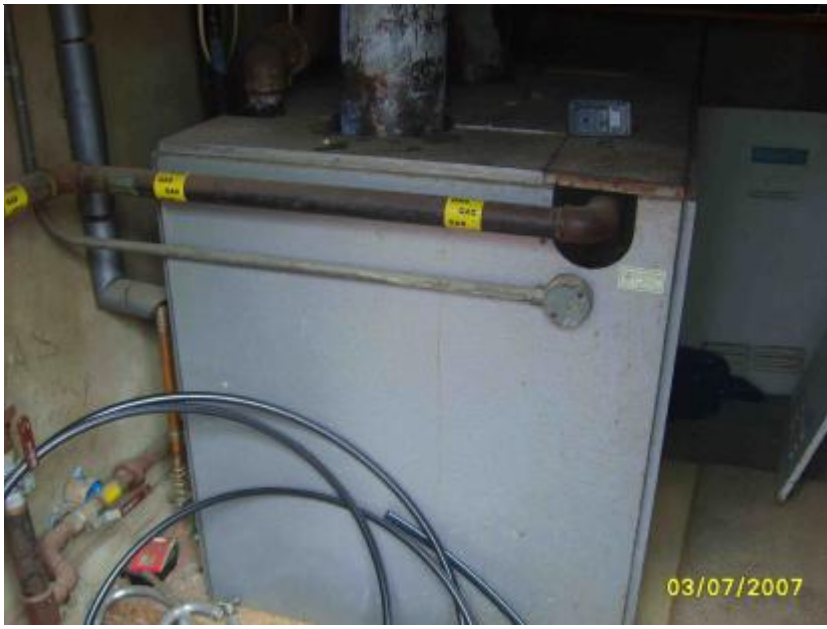
Location ID:	8015	Survey Type:	T 2
Location Ref:	5	Product Type:	Gaskets
Product:	Boiler	Damage:	No visible damage
Area:	Not Applicable	Treatment:	Composite asbestos materials
Floor:	Ground floor	Asbestos Type:	Chrysotile
Room:	Boiler room	Identification:	Presumed
Surveyor Name:	J D Chilvers	Quantity:	
Drawing Ref:	5	Accessibility:	Medium Accessibility
Asbestos ?	Yes		
Date:	03 July 2007		
Next Inspection:	02 July 2008

Material Risk Score	3
Material Risk Band:	Very Low Risk
Priority Risk Score:	3

Action:	Apply Warning Labels
---------	----------------------

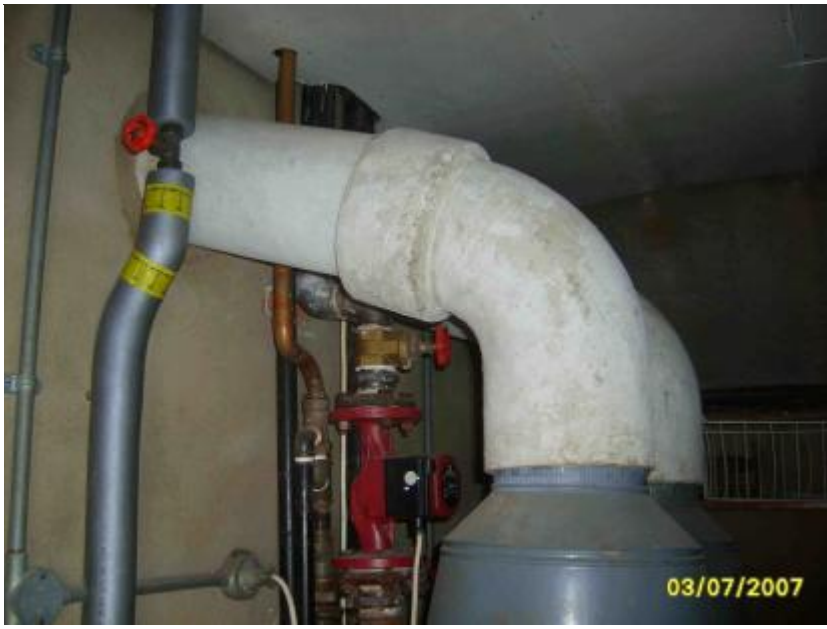
Location ID:	8016	Survey Type:	T 2
Location Ref:	6	Product Type:	Asbestos cement
Product:	Flue pipe	Damage:	Low damage: Scratches or marks
Area:	Not Applicable	Treatment:	Asbestos cement sheets etc
Floor:	Ground floor	Asbestos Type:	Chrysotile
Room:	Boiler room	Identification:	Strongly Presumed
Surveyor Name:	J D Chilvers	Quantity:	
Drawing Ref:	6	Accessibility:	Easy Accessibility
Asbestos ?	Yes		
Date:	03 July 2007		
Next Inspection:	02 July 2008

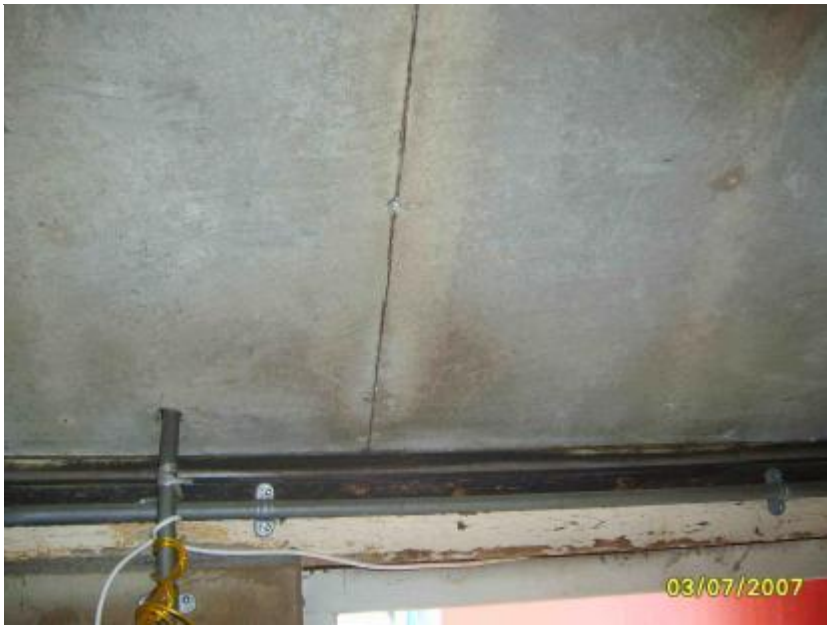
Location ID:	<input type="text" value="8017"/>	Survey Type:	<input type="text" value="T 2"/>
Location Ref:	<input type="text" value="7"/>	Product Type:	<input type="text" value="Asbestos cement"/>
Product:	<input type="text" value="Ceiling panel"/>	Damage:	<input type="text" value="Low damage: Scratches or marks"/>
Area:	<input type="text" value="Not Applicable"/>	Treatment:	<input type="text" value="Asbestos cement sheets etc"/>
Floor:	<input type="text" value="Ground floor"/>	Asbestos Type:	<input type="text" value="Chrysotile"/>
Room:	<input type="text" value="Boiler room"/>	Identification:	<input type="text" value="Identified"/>
Surveyor Name:	<input type="text" value="J D Chilvers"/>	Quantity:	<input type="text"/>

Material Risk Score	<input type="text" value="4"/>
Material Risk Band:	<input type="text" value="Very Low Risk"/>
Priority Risk Score:	<input type="text" value="4"/>

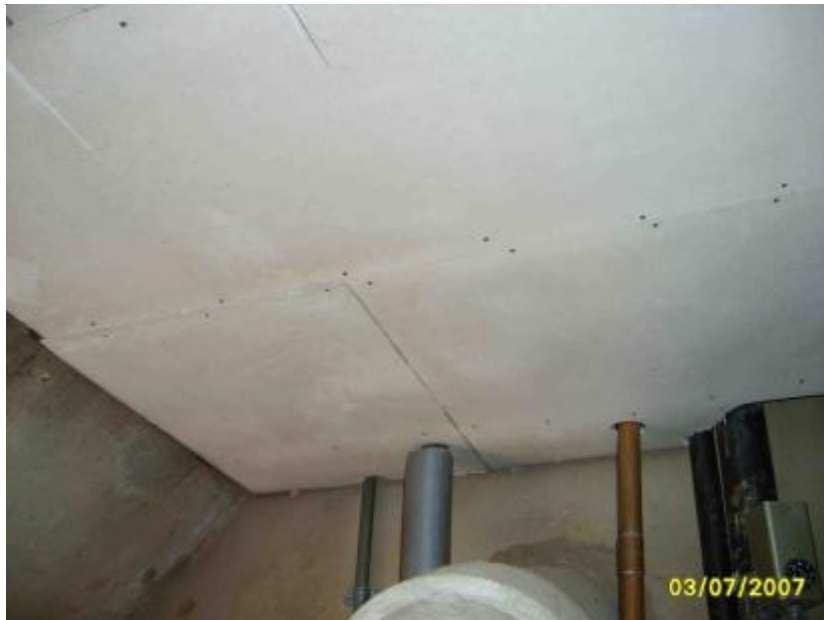
Location ID:	<input type="text" value="8021"/>	Survey Type:	<input type="text" value="T 2"/>
Location Ref:	<input type="text" value="8"/>	Product Type:	<input type="text" value="Asbestos Insulating Board"/>
Product:	<input type="text" value="Ceiling panel"/>	Damage:	<input type="text" value="Low damage: Scratches or marks"/>
Area:	<input type="text" value="Not Applicable"/>	Treatment:	<input type="text" value="Unsealed AIB"/>
Floor:	<input type="text" value="Ground floor"/>	Asbestos Type:	<input type="text" value="Amosite"/>
Room:	<input type="text" value="Boiler room"/>	Identification:	<input type="text" value="Identified"/>
Surveyor Name:	<input type="text" value="J D Chilvers"/>	Quantity:	<input type="text"/>

Material Risk Score	<input type="text" value="7"/>
Material Risk Band:	<input type="text" value="Medium Risk"/>
Priority Risk Score:	<input type="text" value="4"/>

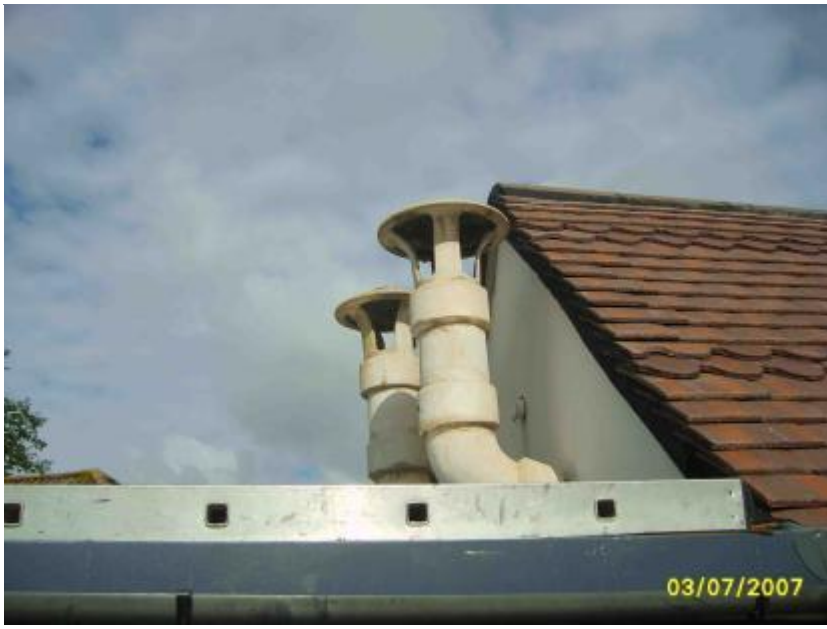
Location ID:	<input type="text" value="8022"/>	Survey Type:	<input type="text" value="T 2"/>						
Location Ref:	<input type="text" value="9"/>	Product Type:	<input type="text" value="Asbestos cement"/>						
Product:	<input type="text" value="Flue pipe"/>	Damage:	<input type="text" value="Low damage: Scratches or marks"/>						
Area:	<input type="text" value="Not Applicable"/>	Treatment:	<input type="text" value="Asbestos cement sheets etc"/>						
Floor:	<input type="text" value="Roof level"/>	Asbestos Type:	<input type="text" value="Chrysotile"/>						
Room:	<input type="text" value="External"/>	Identification:	<input type="text" value="Strongly Presumed"/>						
Surveyor Name:	<input type="text" value="J D Chilvers"/>	Quantity:	<input type="text"/>						
Drawing Ref:	<input type="text" value="9"/>	Accessibility:	<input type="text" value="Medium Accessibility"/>						
Asbestos ?	<input type="text" value="Yes"/>

Material Risk Score	<input type="text" value="4"/>	Material Risk Band:	<input type="text" value="Very Low Risk"/>	Priority Risk Score:	<input type="text" value="2"/>
Material Risk Score	<input type="text" value="4"/>								
Material Risk Band:	<input type="text" value="Very Low Risk"/>								
Priority Risk Score:	<input type="text" value="2"/>								
Date:	<input type="text" value="03 July 2007"/>								
Next Inspection:	<input type="text" value="02 July 2008"/>

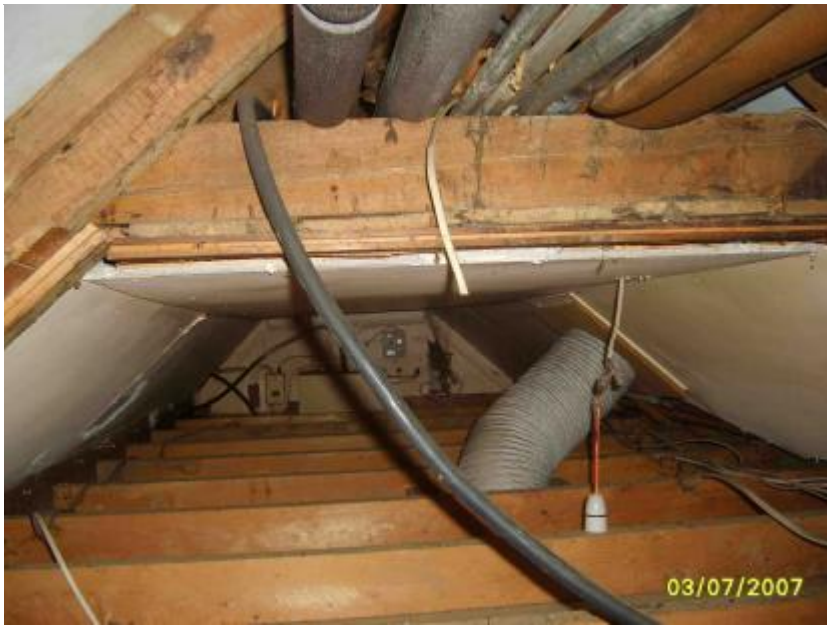
Location ID:	8023	Survey Type:	T 2
Location Ref:	10	Product Type:	Asbestos Insulating Board
Product:	Ceiling panels	Damage:	Low damage: Scratches or marks
Area:	Not Applicable	Treatment:	Unsealed AIB
Floor:	Roof level	Asbestos Type:	Amosite
Room:	Loft space	Identification:	Identified
Surveyor Name:	J D Chilvers	Quantity:	
Drawing Ref:	10	Accessibility:	Medium Accessibility
Asbestos ?	Yes		
Date:	03 July 2007		
Next Inspection:	01 October 2007

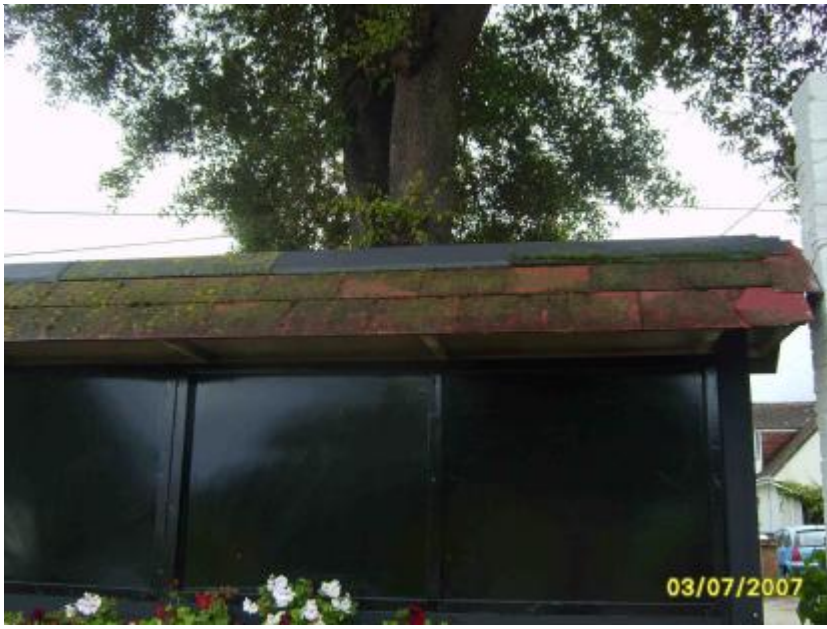
Location ID:	8024	Survey Type:	T 2
Location Ref:	11	Product Type:	Asbestos cement
Product:	Tiles	Damage:	Low damage: Scratches or marks
Area:	Not Applicable	Treatment:	Asbestos cement sheets etc
Floor:	External	Asbestos Type:	Chrysotile
Room:	External	Identification:	Identified
Surveyor Name:	J D Chilvers	Quantity:	
Drawing Ref:	11	Accessibility:	Easy Accessibility
Asbestos ?	Yes		
Date:	03 July 2007		
Next Inspection:	02 July 2008

Material Risk Score	4
Material Risk Band:	Very Low Risk
Priority Risk Score:	2

Action:	No Action Required
---------	--------------------

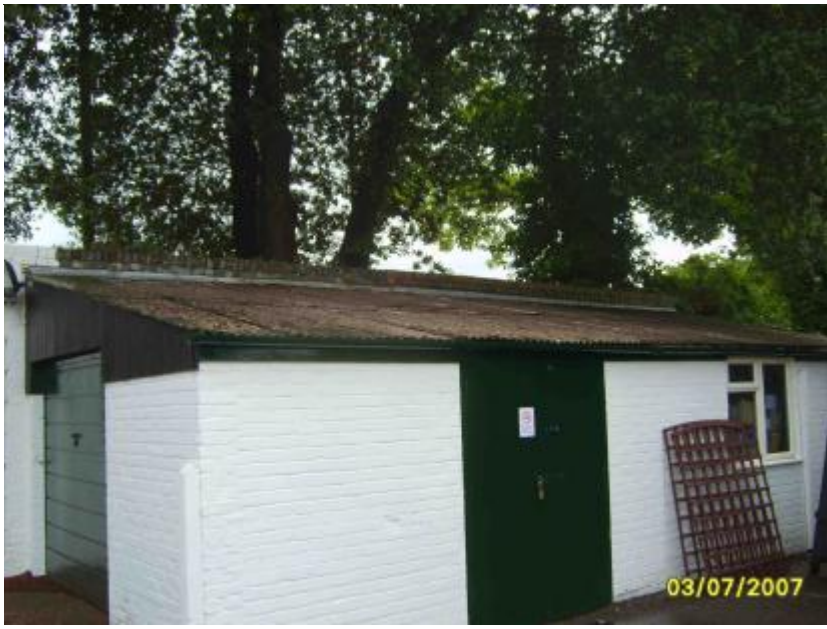
Location ID:	<input type="text" value="8025"/>	Survey Type:	<input type="text" value="T 2"/>						
Location Ref:	<input type="text" value="12"/>	Product Type:	<input type="text" value="Asbestos cement"/>						
Product:	<input type="text" value="Tiles"/>	Damage:	<input type="text" value="Low damage: Scratches or marks"/>						
Area:	<input type="text" value="Not Applicable"/>	Treatment:	<input type="text" value="Asbestos cement sheets etc"/>						
Floor:	<input type="text" value="External"/>	Asbestos Type:	<input type="text" value="Chrysotile"/>						
Room:	<input type="text" value="External"/>	Identification:	<input type="text" value="Identified"/>						
Surveyor Name:	<input type="text" value="J D Chilvers"/>	Quantity:	<input type="text"/>						
Drawing Ref:	<input type="text" value="12"/>	Accessibility:	<input type="text" value="Easy Accessibility"/>						
Asbestos ?	<input type="text" value="Yes"/>

Material Risk Score	<input type="text" value="4"/>	Material Risk Band:	<input type="text" value="Very Low Risk"/>	Priority Risk Score:	<input type="text" value="2"/>
Material Risk Score	<input type="text" value="4"/>								
Material Risk Band:	<input type="text" value="Very Low Risk"/>								
Priority Risk Score:	<input type="text" value="2"/>								
Date:	<input type="text" value="03 July 2007"/>								
Next Inspection:	<input type="text" value="02 July 2008"/>

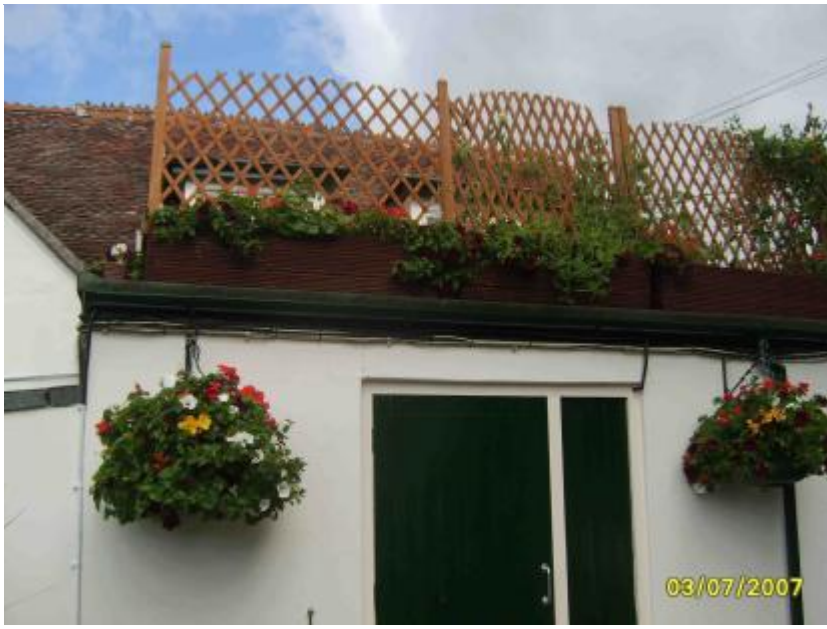
Location ID:	8026	Survey Type:	T 2
Location Ref:	13	Product Type:	Roofing felts
Product:	Roofing felt	Damage:	Low damage: Scratches or marks
Area:	Not Applicable	Treatment:	Resins
Floor:	Roof level	Asbestos Type:	Chrysotile
Room:	Flat roof area	Identification:	Presumed
Surveyor Name:	J D Chilvers	Quantity:	
Drawing Ref:	13	Accessibility:	Easy Accessibility
Asbestos ?	Yes		
Date:	03 July 2007		
Next Inspection:	02 July 2008

Material Risk Score	3
Material Risk Band:	Very Low Risk
Priority Risk Score:	4

Action:	No Action Required
---------	--------------------

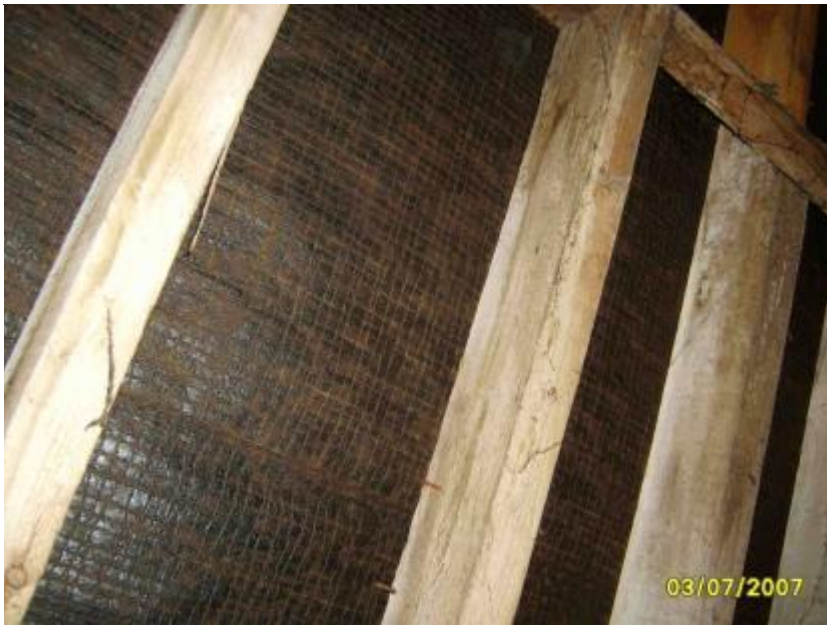
Location ID:	8027	Survey Type:	T 2
Location Ref:	14	Product Type:	Roofing felts
Product:	Roofing felt	Damage:	No visible damage
Area:	Not Applicable	Treatment:	Resins
Floor:	Roof level	Asbestos Type:	Chrysotile
Room:	Loft space	Identification:	Presumed
Surveyor Name:	J D Chilvers	Quantity:	
Drawing Ref:	14	Accessibility:	Medium Accessibility
Asbestos ?	Yes		
Date:	03 July 2007		
Next Inspection:	02 July 2008

Material Risk Score	2
Material Risk Band:	Very Low Risk
Priority Risk Score:	4

Action:	No Action Required
---------	--------------------

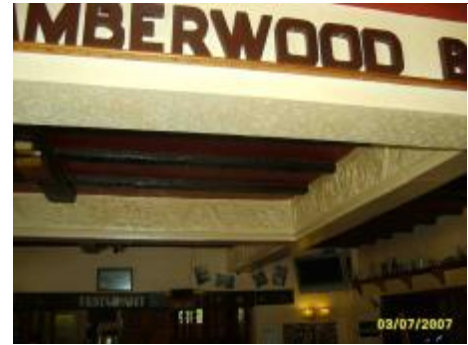
Location ID:	8011
Location Ref:	1
Product:	Beam cladding
Area:	Not Applicable
Floor:	Ground floor
Room:	Bar area
Surveyor Name:	J D Chilvers
Drawing Ref:	1
Asbestos ?	Yes
Date:	03 July 2007

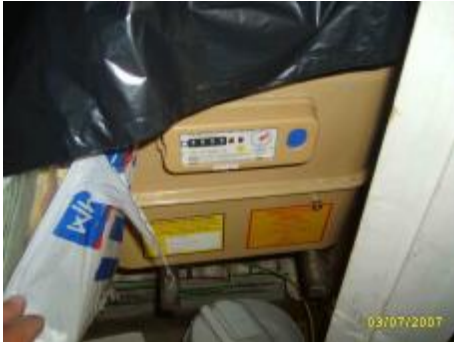
Location ID:	8012
Location Ref:	2
Product:	Gas meter
Area:	Not Applicable
Floor:	Ground floor
Room:	Cellar
Surveyor Name:	J D Chilvers
Drawing Ref:	2
Asbestos ?	Yes
Date:	03 July 2007

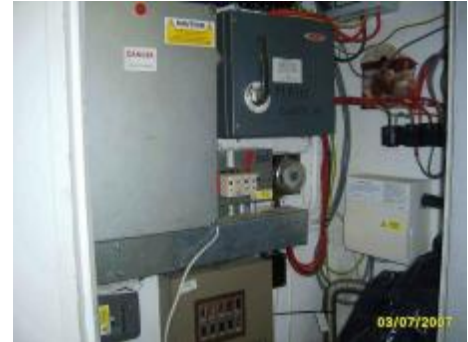
Location ID:	8013
Location Ref:	3
Product:	Fuse & Switchgear Flashguard
Area:	Not Applicable
Floor:	Ground floor
Room:	Cellar
Surveyor Name:	J D Chilvers
Drawing Ref:	3
Asbestos ?	Yes
Date:	03 July 2007

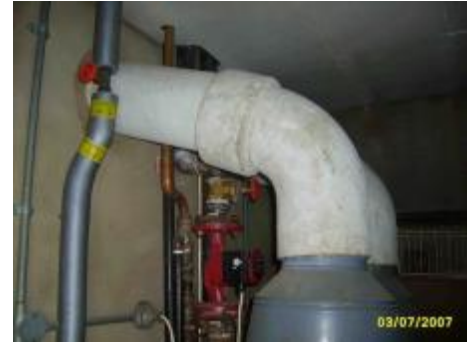
Location ID:	8016
Location Ref:	6
Product:	Flue pipe
Area:	Not Applicable
Floor:	Ground floor
Room:	Boiler room
Surveyor Name:	J D Chilvers
Drawing Ref:	6
Asbestos ?	Yes
Date:	03 July 2007

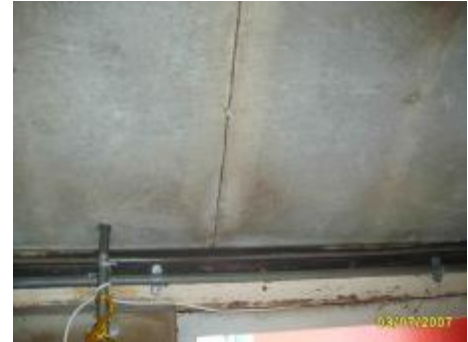
Location ID:	8017
Location Ref:	7
Product:	Ceiling panel
Area:	Not Applicable
Floor:	Ground floor
Room:	Boiler room
Surveyor Name:	J D Chilvers
Drawing Ref:	7
Asbestos ?	Yes
Date:	03 July 2007

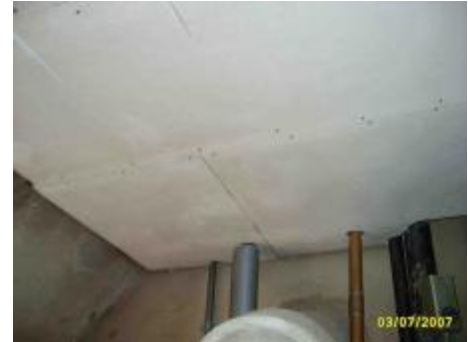
Location ID:	8021
Location Ref:	8
Product:	Ceiling panel
Area:	Not Applicable
Floor:	Ground floor
Room:	Boiler room
Surveyor Name:	J D Chilvers
Drawing Ref:	8
Asbestos ?	Yes
Date:	03 July 2007

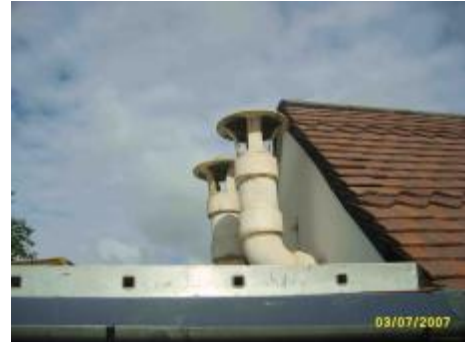
Location ID:	8022
Location Ref:	9
Product:	Flue pipe
Area:	Not Applicable
Floor:	Roof level
Room:	External
Surveyor Name:	J D Chilvers
Drawing Ref:	9
Asbestos ?	Yes
Date:	03 July 2007

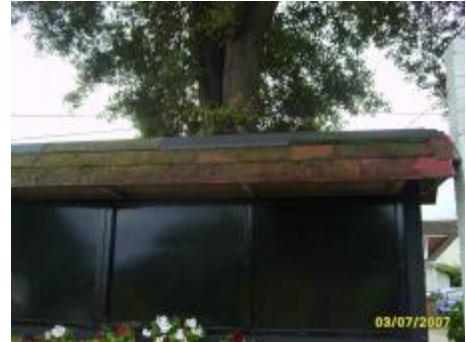
Location ID:	8024
Location Ref:	11
Product:	Tiles
Area:	Not Applicable
Floor:	External
Room:	External
Surveyor Name:	J D Chilvers
Drawing Ref:	11
Asbestos ?	Yes
Date:	03 July 2007

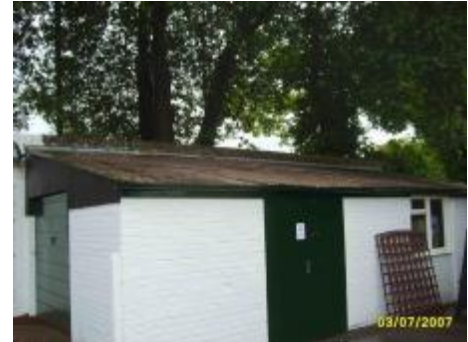
Location ID:	8025
Location Ref:	12
Product:	Tiles
Area:	Not Applicable
Floor:	External
Room:	External
Surveyor Name:	J D Chilvers
Drawing Ref:	12
Asbestos ?	Yes
Date:	03 July 2007

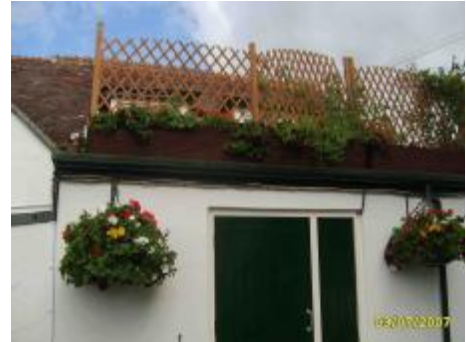
Location ID:	8026
Location Ref:	13
Product:	Roofing felt
Area:	Not Applicable
Floor:	Roof level
Room:	Flat roof area
Surveyor Name:	J D Chilvers
Drawing Ref:	13
Asbestos ?	Yes
Date:	03 July 2007
