Asbestos Survey for

Hall & Woodhouse Ltd

The Jekyll & Hyde
Turgis Green
Basingstoke
Hampshire
RG27 0AX

Project Number: AS09135 - Jekyll & Hyde

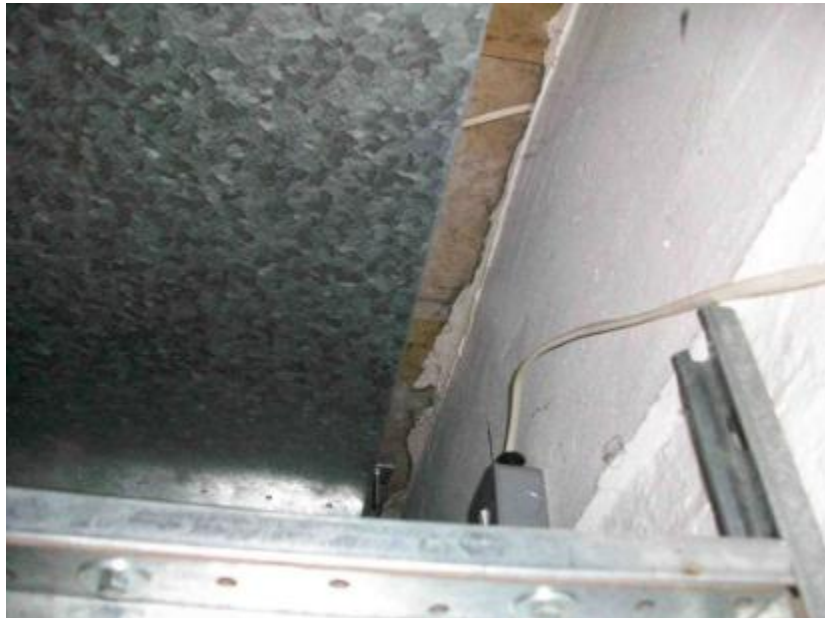
| Location ID: | <input type="text" value="12383"/> | Survey Type: | <input type="text" value="T 2"/> |

| Sample Date | Location Ref | Location ID | Drawing Reference | Floor | Room | Asbestos Type | Product Name | Material Risk Score | Material Risk Band | Priority Risk Score | Comments | Action | Survey Type |
|---|---|---|---|---|---|---|---|---|---|---|---|---|---|
| 29/10/09 | 1 | 12383 | 1 | Ground floor | Ceiling void | Amosite | Beam cladding | 5 | Low Risk | 4 | AIB presumed behind plasterboard finish | Apply Warning Labels | T 2 |

| Location Ref: | <input type="text" value="1"/> | Product Type: | <input type="text" value="Asbestos Insulating Board"/> |
| Product: | <input type="text" value="Beam cladding"/> | Damage: | <input type="text" value="No visible damage"/> |
| Area: | <input type="text" value="Not Applicable"/> | Treatment: | <input type="text" value="AIB painted or encapsulated"/> |
| Floor: | <input type="text" value="Ground floor"/> | Asbestos Type: | <input type="text" value="Amosite"/> |
| Room: | <input type="text" value="Ceiling void"/> | Identification: | <input type="text" value="Presumed"/> |

| Material Risk Score: | <input type="text" value="5"/> |
| Material Risk Band: | <input type="text" value="Low Risk"/> |

Action:

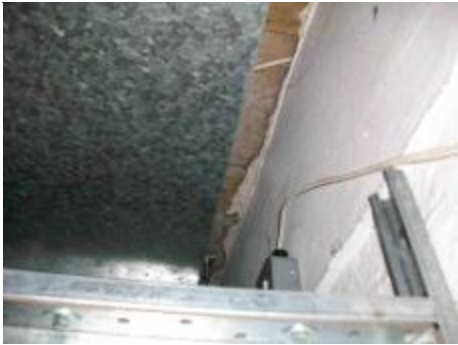
| Location ID: | 12383 |

| Product: | Beam cladding |
| Floor: | Ground floor |
| Room: | Ceiling void |

| Total Priority Assessment Score: | 4 |
| Material Assessment Score (supplied by surveyor): | Low Risk 5 |
| Total of Material and Priority Assessment Scores: | 9 |
