Asbestos Survey for

Hall & Woodhouse Ltd

Scarlett Arms

Project Number: AS07032 - Scarlett Arms

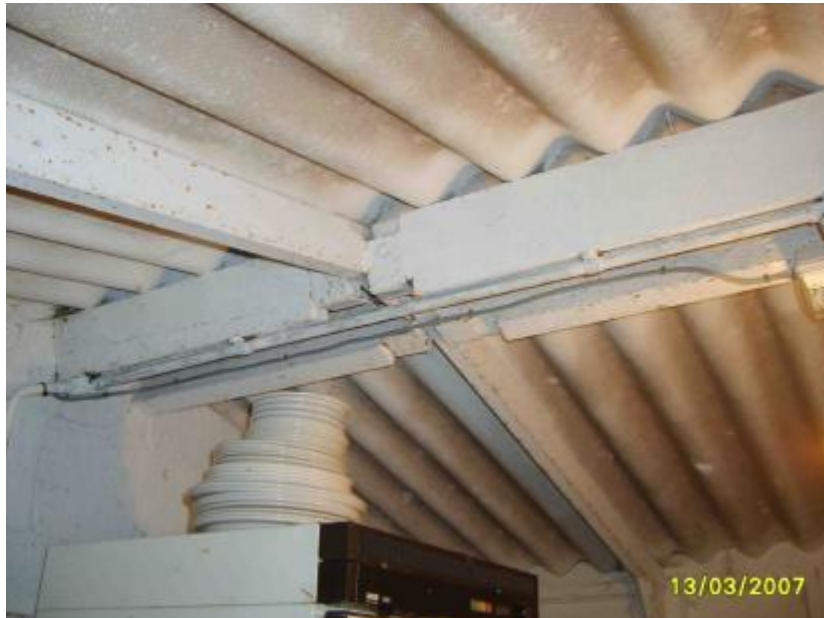
Location ID:	7478	Survey Type:	T 2
Location Ref:	1	Product Type:	Asbestos cement
Product:	Roofing Sheets	Damage:	Low damage: Scratches or marks
Area:	Not Applicable	Treatment:	Asbestos cement sheets etc
Floor:	Roof	Asbestos Type:	Chrysotile
Room:	Sheds / Outbuildings	Identification:	Identified
Surveyor Name:	J D Chilvers	Quantity:	
Drawing Ref:	1	Accessibility:	Easy Accessibility
Asbestos ?	Yes		
Date:	13 March 2007		
Next Inspection:	12 March 2008

Material Risk Score	4
Material Risk Band:	Very Low Risk
Priority Risk Score:	4

Action:	Apply Warning Labels
---------	----------------------

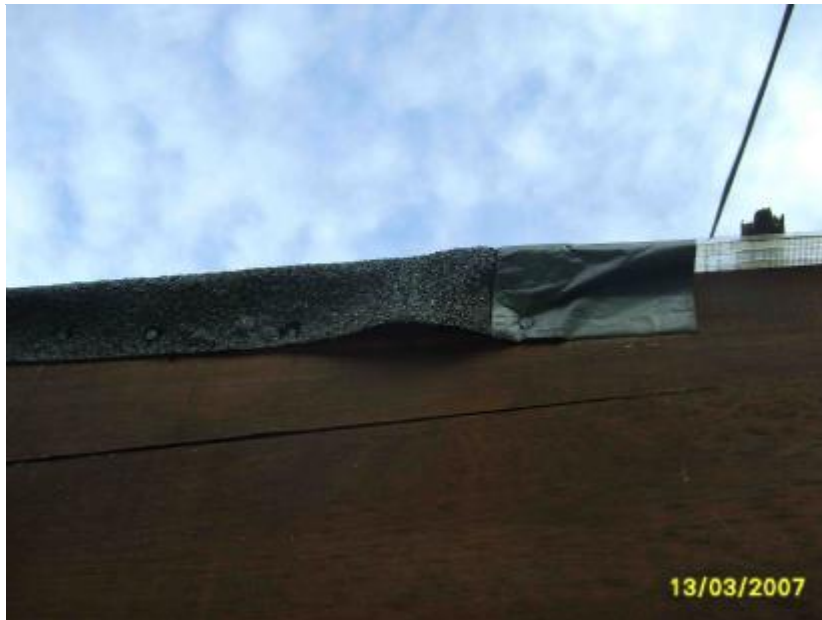
Location ID:	7479	Survey Type:	T 2
Location Ref:	2	Product Type:	NADIS
Product:	Roofing felt	Damage:	NADIS
Area:	Not Applicable	Treatment:	NADIS
Floor:	Roof	Asbestos Type:	NADIS
Room:	Sheds / Outbuildings	Identification:	Identified
Surveyor Name:	J D Chilvers	Quantity:	
Drawing Ref:	2	Accessibility:	
Asbestos ?	No		
Date:	13 March 2007		
Next Inspection:	Not Applicable

Material Risk Score	0
Material Risk Band:	NADIS
Priority Risk Score:	N/A

Action:	No Action Required
---------	--------------------

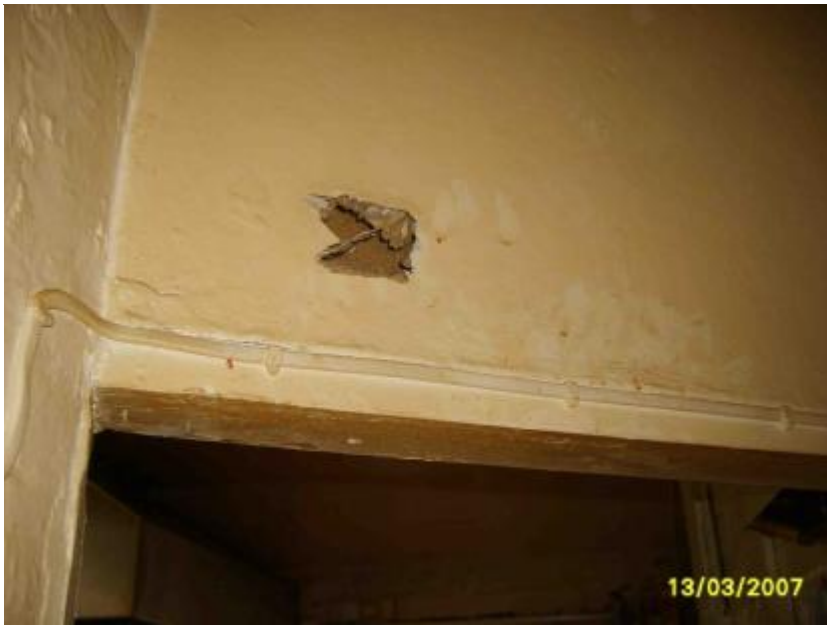
Location ID:	7481	Survey Type:	T 2
Location Ref:	4	Product Type:	NADIS
Product:	Panel	Damage:	NADIS
Area:	Not Applicable	Treatment:	NADIS
Floor:	Ground floor	Asbestos Type:	NADIS
Room:	Store Room	Identification:	Identified
Surveyor Name:	J D Chilvers	Quantity:	
Drawing Ref:	4	Accessibility:	
Asbestos ?	No		
Date:	13 March 2007		
Next Inspection:	Not Applicable

Material Risk Score	0
Material Risk Band:	NADIS
Priority Risk Score:	N/A

Action: No Action Required

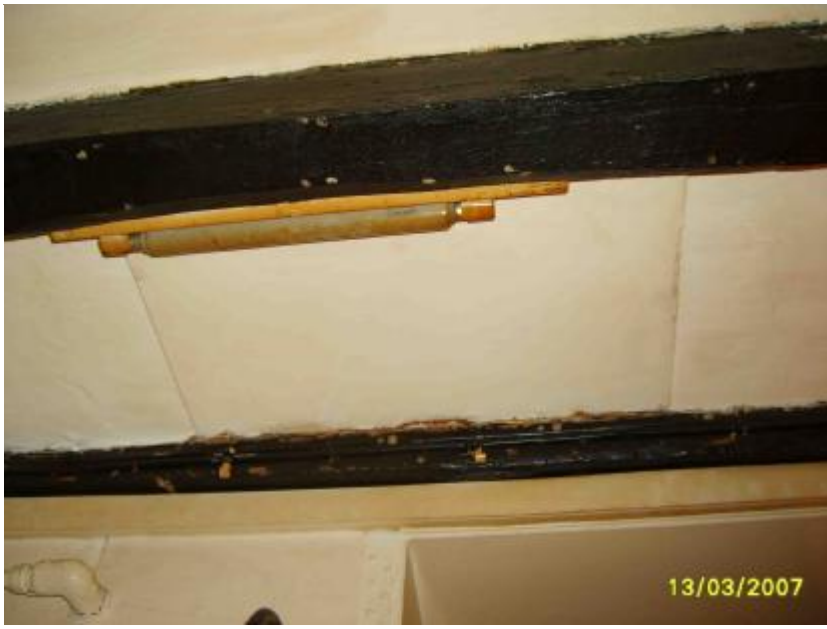
Location ID:	7483	Survey Type:	T 2
Location Ref:	6	Product Type:	NADIS
Product:	Panel	Damage:	NADIS
Area:	Not Applicable	Treatment:	NADIS
Floor:	Ground floor	Asbestos Type:	NADIS
Room:	Bar area	Identification:	Identified
Surveyor Name:	J D Chilvers	Quantity:	
Drawing Ref:	6	Accessibility:	
Asbestos ?	No		
Date:	13 March 2007		
Next Inspection:	Not Applicable

Material Risk Score	0
Material Risk Band:	NADIS
Priority Risk Score:	N/A

Action: No Action Required

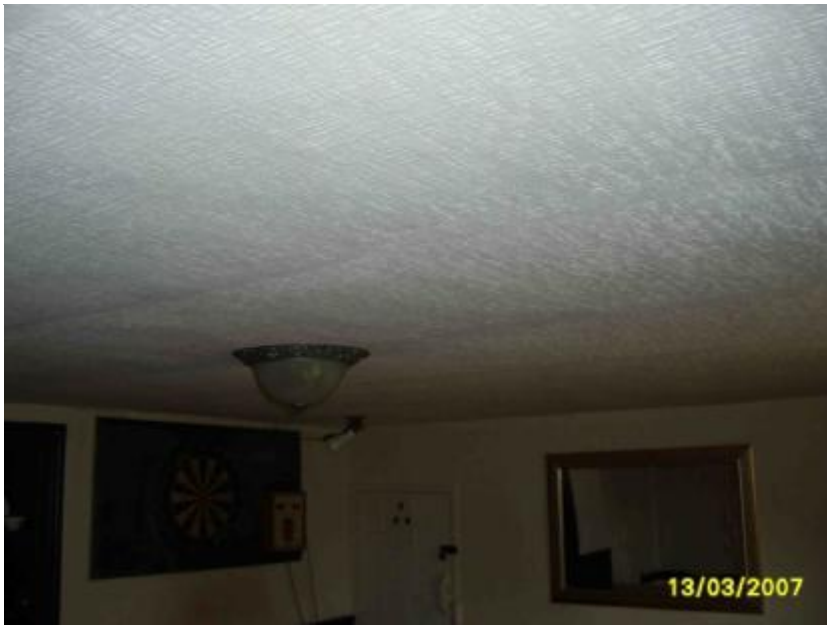
Location ID:	7484	Survey Type:	T 2
Location Ref:	7	Product Type:	NADIS
Product:	Ceiling	Damage:	NADIS
Area:	Not Applicable	Treatment:	NADIS
Floor:	Ground floor	Asbestos Type:	NADIS
Room:	Restaurant	Identification:	Identified
Surveyor Name:	J D Chilvers	Quantity:	
Drawing Ref:	7	Accessibility:	
Asbestos ?	No		
Date:	13 March 2007		
Next Inspection:	Not Applicable

Material Risk Score	0
Material Risk Band:	NADIS
Priority Risk Score:	N/A

Action:	No Action Required
---------	--------------------

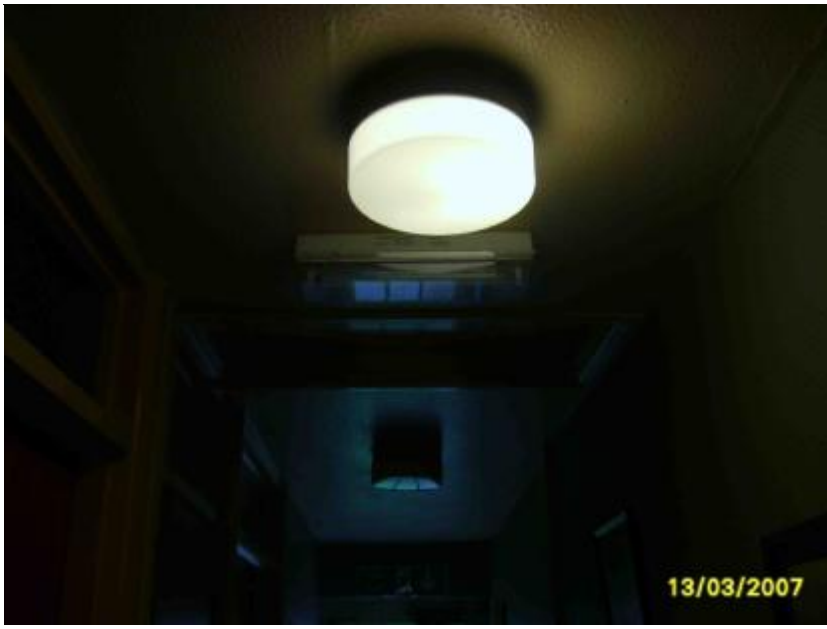
Location ID:	7485	Survey Type:	T 2
Location Ref:	8	Product Type:	NADIS
Product:	Textured coating	Damage:	NADIS
Area:	Not Applicable	Treatment:	NADIS
Floor:	Ground floor	Asbestos Type:	NADIS
Room:	Passageway	Identification:	Identified
Surveyor Name:	J D Chilvers	Quantity:	
Drawing Ref:	8	Accessibility:	
Asbestos ?	No		
Date:	13 March 2007		
Next Inspection:	Not Applicable

Material Risk Score	0
Material Risk Band:	NADIS
Priority Risk Score:	N/A

Action:	No Action Required
---------	--------------------

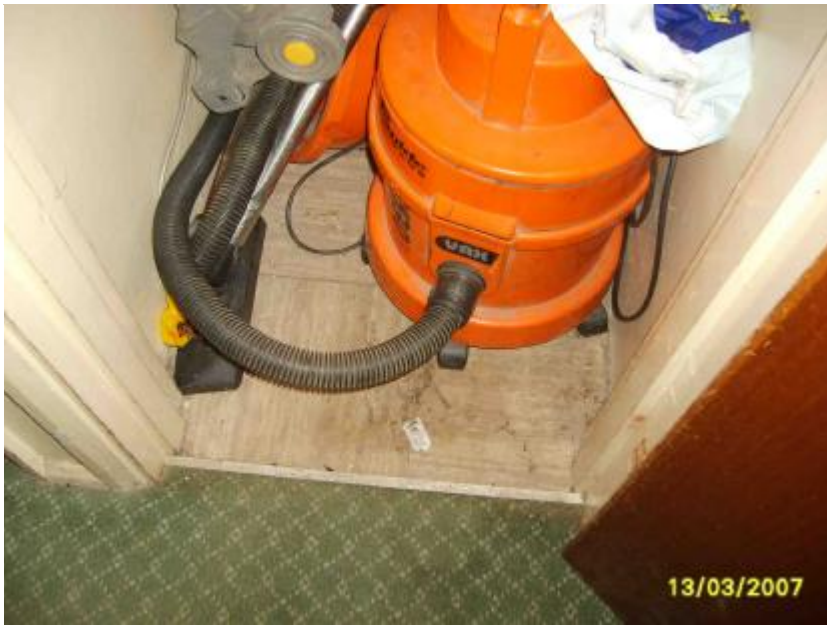
Location ID:	7487	Survey Type:	T 2
Location Ref:	10	Product Type:	Vinyl floor tiles
Product:	Floor tiles	Damage:	Low damage: Scratches or marks
Area:	Not Applicable	Treatment:	Vinyl tiles
Floor:	Ground floor	Asbestos Type:	Chrysotile
Room:	Cupboard	Identification:	Presumed
Surveyor Name:	J D Chilvers	Quantity:	
Drawing Ref:	10	Accessibility:	Medium Accessibility
Asbestos ?	Yes		
Date:	13 March 2007	Material Risk Score:	3
Next Inspection:	12 March 2008	Material Risk Band:	Very Low Risk
		Priority Risk Score:	3

Action:	No Action Required
---------	--------------------

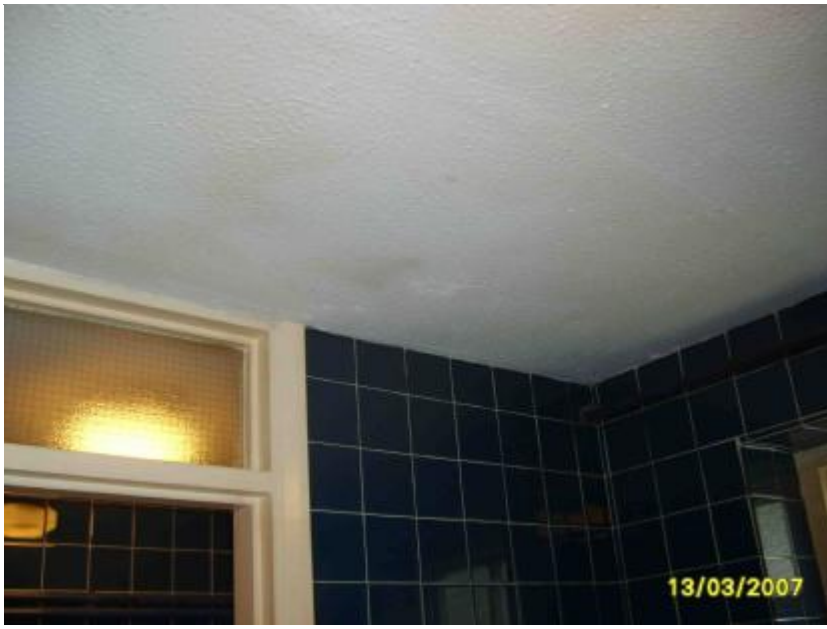
Location ID:	7488	Survey Type:	T 2
Location Ref:	11	Product Type:	NADIS
Product:	Textured coating	Damage:	NADIS
Area:	Not Applicable	Treatment:	NADIS
Floor:	Ground floor	Asbestos Type:	NADIS
Room:	WC - mens	Identification:	Identified
Surveyor Name:	J D Chilvers	Quantity:	
Drawing Ref:	11	Accessibility:	
Asbestos ?	No		
Date:	13 March 2007		
Next Inspection:	Not Applicable

Material Risk Score	0
Material Risk Band:	NADIS
Priority Risk Score:	N/A

Action: No Action Required

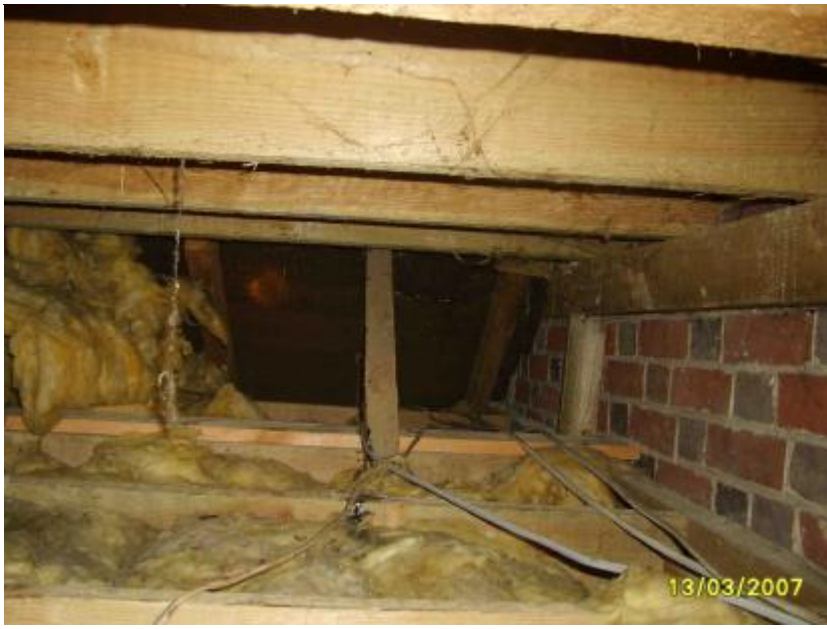
Location ID:	7489	Survey Type:	T 2
Location Ref:	12	Product Type:	Roofing felts
Product:	Roofing felt	Damage:	No visible damage
Area:	Not Applicable	Treatment:	Resins
Floor:	Roof	Asbestos Type:	Chrysotile
Room:	Loft space	Identification:	Presumed
Surveyor Name:	J D Chilvers	Quantity:	
Drawing Ref:	12	Accessibility:	Difficult Accessibility
Asbestos ?	Yes		
Date:	13 March 2007		
Next Inspection:	12 March 2008

Material Risk Score	2
Material Risk Band:	Very Low Risk
Priority Risk Score:	2

Action: No Action Required

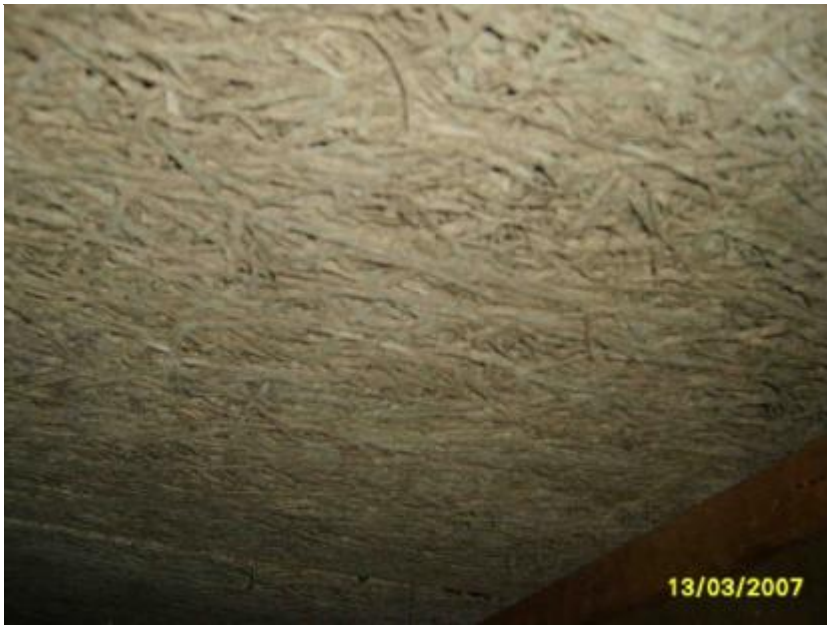
Location ID:	7490	Survey Type:	T 2
Location Ref:	13	Product Type:	NADIS
Product:	Ceiling panel	Damage:	NADIS
Area:	Not Applicable	Treatment:	NADIS
Floor:	Ground floor	Asbestos Type:	NADIS
Room:	Loft space	Identification:	Identified
Surveyor Name:	J D Chilvers	Quantity:	
Drawing Ref:	13	Accessibility:	
Asbestos ?	No		
Date:	13 March 2007		
Next Inspection:	Not Applicable

Material Risk Score	0
Material Risk Band:	NADIS
Priority Risk Score:	N/A

Material Comments: 'Stramet' in loft space

Action: No Action Required

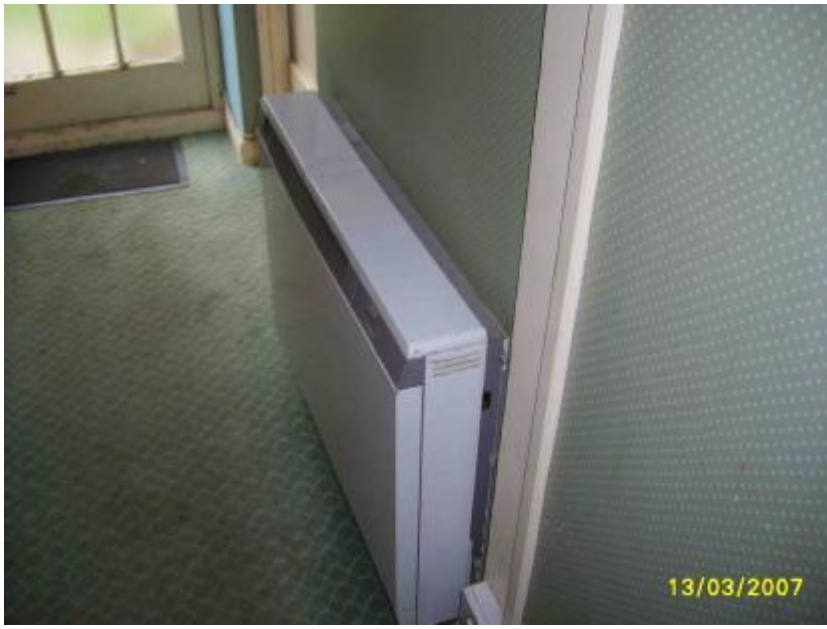
Location ID:	7491	Survey Type:	T 2
Location Ref:	14	Product Type:	Ropes and woven textiles
Product:	Heater	Damage:	No visible damage
Area:	Not Applicable	Treatment:	Composite asbestos materials
Floor:	Ground floor	Asbestos Type:	Chrysotile
Room:	Passageway	Identification:	Presumed
Surveyor Name:	J D Chilvers	Quantity:	
Drawing Ref:	14	Accessibility:	Medium Accessibility
Asbestos ?	Yes		
Date:	13 March 2007		
Next Inspection:	12 March 2008

Material Risk Score	3
Material Risk Band:	Very Low Risk
Priority Risk Score:	3

Material Comments: All heaters may contain ACMs

Action: Apply Warning Labels

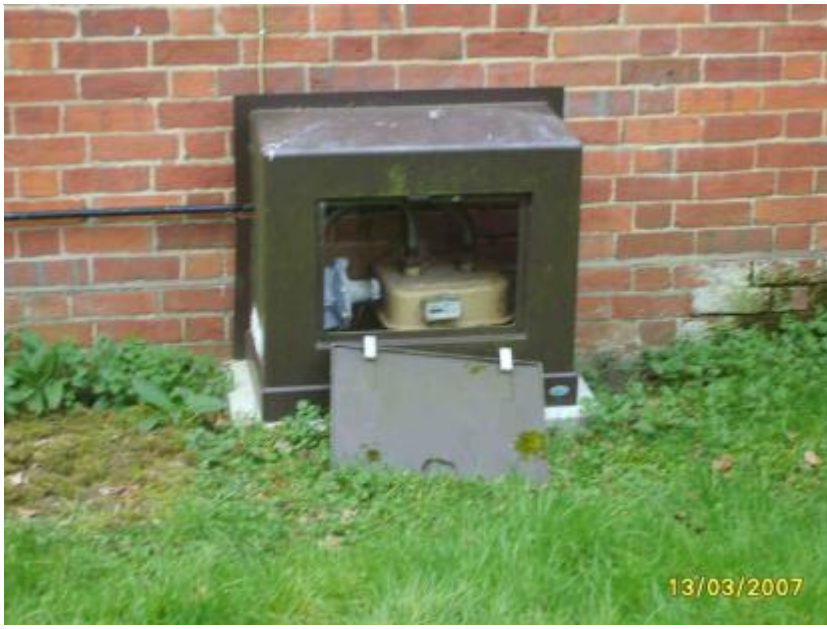
Location ID:	7492	Survey Type:	T 2
Location Ref:	15	Product Type:	Gaskets
Product:	Gas meter	Damage:	No visible damage
Area:	Not Applicable	Treatment:	Composite asbestos materials
Floor:	Ground floor	Asbestos Type:	Chrysotile
Room:	Gas cupboard	Identification:	Presumed
Surveyor Name:	J D Chilvers	Quantity:	
Drawing Ref:	15	Accessibility:	Medium Accessibility
Asbestos ?	Yes		
Date:	13 March 2007		
Next Inspection:	12 March 2008

Material Risk Score	3
Material Risk Band:	Very Low Risk
Priority Risk Score:	2

Action:	Apply Warning Labels
---------	----------------------

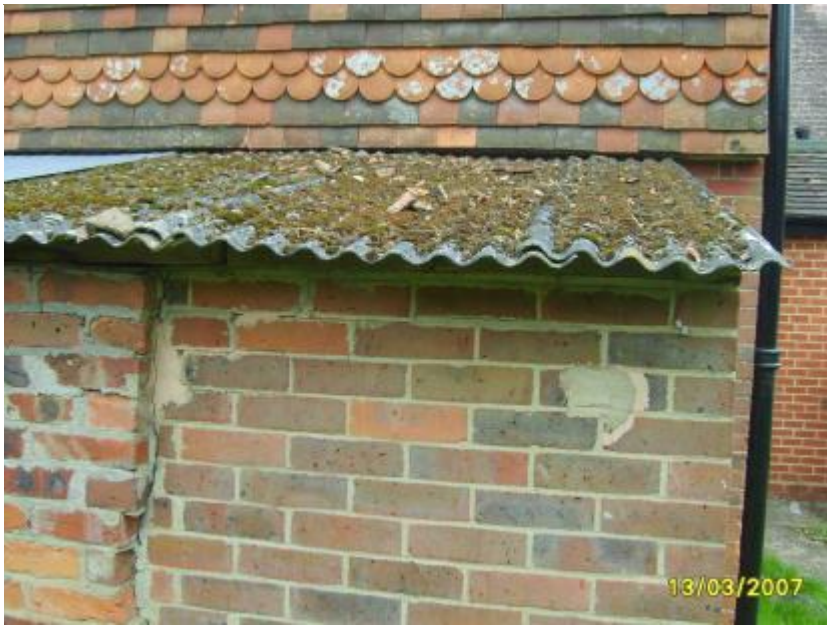
Location ID:	<input type="text" value="7493"/>	Survey Type:	<input type="text" value="T 2"/>
Location Ref:	<input type="text" value="16"/>	Product Type:	<input type="text" value="Asbestos cement"/>
Product:	<input type="text" value="Roofing Sheets"/>	Damage:	<input type="text" value="Low damage: Scratches or marks"/>
Area:	<input type="text" value="Not Applicable"/>	Treatment:	<input type="text" value="Asbestos cement sheets etc"/>
Floor:	<input type="text" value="Roof"/>	Asbestos Type:	<input type="text" value="Chrysotile"/>
Room:	<input type="text" value="Sheds / Outbuildings"/>	Identification:	<input type="text" value="Identified"/>
Surveyor Name:	<input type="text" value="J D Chilvers"/>	Quantity:	<input type="text"/>

Drawing Ref:	<input type="text" value="16"/>	Accessibility:	<input type="text" value="Easy Accessibility"/>
Asbestos ?	<input type="text" value="Yes"/>	Material Risk Score <input type="text" value="4"/> Material Risk Band: <input type="text" value="Very Low Risk"/> Priority Risk Score: <input type="text" value="4"/>	
Date:	<input type="text" value="13 March 2007"/>		
Next Inspection:	<input type="text" value="12 March 2008"/>

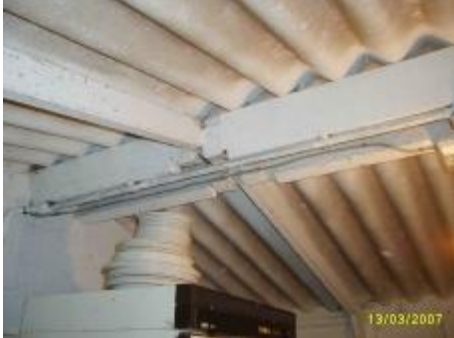
Location ID:	7478

Priority Comments:
Location Ref:	1		
Product:	Roofing Sheets		
Area:	Not Applicable		
Floor:	Roof		
Room:	Sheds / Outbuildings		
Surveyor Name:	J D Chilvers		
Drawing Ref:	1		
Asbestos ?	Yes		
Date:	13 March 2007

Priority Assessment Algorithm	Variable(s) selected	Score for each	Overall score
Normal Occupant Activity:			
Main type of activity in area:	Low disturbance	1	average
Secondary activities for area:	Rare disturbance	0	1
Likelihood Of Disturbance:			
Location:	Outdoors	0	average
Accessibility:	Occasionally likely to be disturbed	1	
Extent/Amount:	<=10 m2 or <=10 m pipe run	1	
Human Exposure Potential:			
Number of occupants:	1 to 3	1	average
Frequency of use of area:	Daily	3	
Average time area is in use:	<1 hour	0	
Maintenance Activity:			
Type of maintenance activity:	Minor disturbance	0	average
Frequency of maintenance activity	<=1 per year	1	1

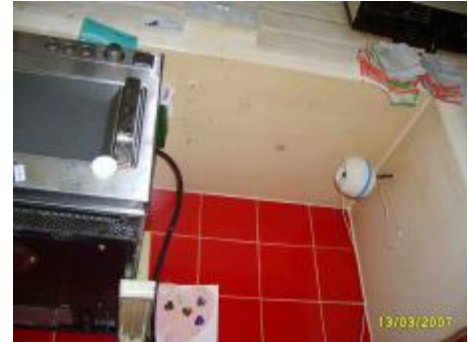
Location ID:	7480
Location Ref:	3
Product:	Soffit
Area:	Not Applicable
Floor:	Ground floor
Room:	Kitchen
Surveyor Name:	J D Chilvers
Drawing Ref:	3
Asbestos ?	Yes
Date:	13 March 2007

Priority Assessment Algorithm	Variable(s) selected	Score for each	Overall score
Normal Occupant Activity:			
Main type of activity in area:	Rare disturbance	0	average
Secondary activities for area:	Rare disturbance	0	0
Likelihood Of Disturbance:			
Location:	Rooms up to 100 m2	2	average
Accessibility:	Usually inaccessible or unlikely to be disturbed	0	
Extent/Amount:	<=10 m2 or <=10 m pipe run	1	
Human Exposure Potential:			
Number of occupants:	1 to 3	1	average
Frequency of use of area:	Daily	3	
Average time area is in use:	>1 to <3 hours	1	
Maintenance Activity:			
Type of maintenance activity:	Minor disturbance	0	average
Frequency of maintenance activity	<=1 per year	1	1

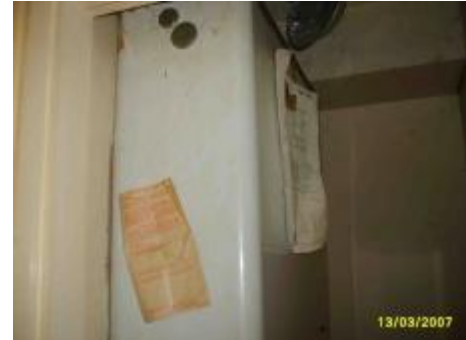
Location ID:	7486
Location Ref:	9
Product:	Water heater
Area:	Not Applicable
Floor:	Ground floor
Room:	Cupboard
Surveyor Name:	J D Chilvers
Drawing Ref:	9
Asbestos ?	Yes
Date:	13 March 2007

Priority Assessment Algorithm	Variable(s) selected	Score for each	Overall score
Normal Occupant Activity:			
Main type of activity in area:	Rare disturbance	0	average
Secondary activities for area:	Rare disturbance	0	0
Likelihood Of Disturbance:			
Location:	Rooms up to 100 m2	2	average
Accessibility:	Usually inaccessible or unlikely to be disturbed	0	
Extent/Amount:	Small items strings gaskets	0	
Human Exposure Potential:			
Number of occupants:	1 to 3	1	average
Frequency of use of area:	Daily	3	
Average time area is in use:	<1 hour	0	
Maintenance Activity:			
Type of maintenance activity:	Minor disturbance	0	average
Frequency of maintenance activity	<=1 per year	1	1

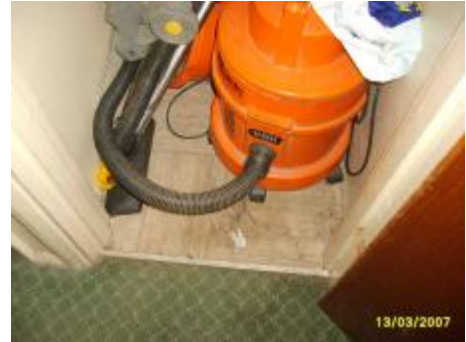
Location ID:	7487
Location Ref:	10
Product:	Floor tiles
Area:	Not Applicable
Floor:	Ground floor
Room:	Cupboard
Surveyor Name:	J D Chilvers
Drawing Ref:	10
Asbestos ?	Yes
Date:	13 March 2007

Priority Assessment Algorithm			
Assessment factor	Variable(s) selected	Score for each	Overall score
Normal Occupant Activity:			
Main type of activity in area:	Rare disturbance	0	average
Secondary activities for area:	Rare disturbance	0	0
Likelihood Of Disturbance:			
Location:	Rooms up to 100 m2	2	
Accessibility:	Occasionally likely to be disturbed	1	average
Extent/Amount:	<=10 m2 or <=10 m pipe run	1	1
Human Exposure Potential:			
Number of occupants:	1 to 3	1	
Frequency of use of area:	Daily	3	average
Average time area is in use:	<1 hour	0	1
Maintenance Activity:			
Type of maintenance activity:	Minor disturbance	0	average
Frequency of maintenance activity	<=1 per year	1	1

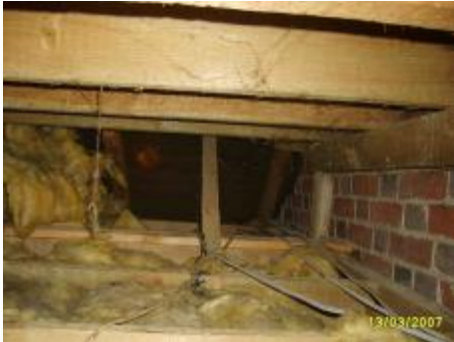
Location ID:	7489
Location Ref:	12
Product:	Roofing felt
Area:	Not Applicable
Floor:	Roof
Room:	Loft space
Surveyor Name:	J D Chilvers
Drawing Ref:	12
Asbestos ?	Yes
Date:	13 March 2007

Priority Assessment Algorithm	Variable(s) selected	Score for each	Overall score
Normal Occupant Activity:			
Main type of activity in area:	Rare disturbance	0	average
Secondary activities for area:	Rare disturbance	0	0
Likelihood Of Disturbance:			
Location:	Large rooms or well-ventilated areas	1	average 1
Accessibility:	Usually inaccessible or unlikely to be disturbed	0	
Extent/Amount:	>10 to <=50 (m2 or pipe run)	2	
Human Exposure Potential:			
Number of occupants:	1 to 3	1	average 0
Frequency of use of area:	Infrequent	0	
Average time area is in use:	<1 hour	0	
Maintenance Activity:			
Type of maintenance activity:	Minor disturbance	0	average 1
Frequency of maintenance activity	<=1 per year	1

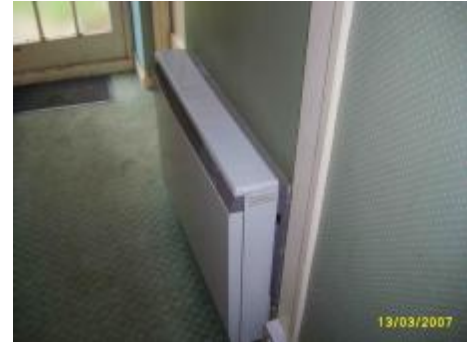
Location ID:	<input style="width: 95%;" type="text" value="7491"/>
Location Ref:	<input style="width: 95%;" type="text" value="14"/>
Product:	<input style="width: 95%;" type="text" value="Heater"/>
Area:	<input style="width: 95%;" type="text" value="Not Applicable"/>
Floor:	<input style="width: 95%;" type="text" value="Ground floor"/>
Room:	<input style="width: 95%;" type="text" value="Passageway"/>
Surveyor Name:	<input style="width: 95%;" type="text" value="J D Chilvers"/>
Drawing Ref:	<input style="width: 95%;" type="text" value="14"/>
Asbestos ?	<input style="width: 95%;" type="text" value="Yes"/>
Date:	<input style="width: 95%;" type="text" value="13 March 2007"/>

Priority Assessment Algorithm			
Assessment factor	Variable(s) selected	Score for each	Overall score
Normal Occupant Activity:			
Main type of activity in area:	Rare disturbance	0	average
Secondary activities for area:	Rare disturbance	0	0
Likelihood Of Disturbance:			
Location:	Rooms up to 100 m2	2	
Accessibility:	Usually inaccessible or unlikely to be disturbed	0	average
Extent/Amount:	Small items strings gaskets	0	1
Human Exposure Potential:			
Number of occupants:	1 to 3	1	
Frequency of use of area:	Daily	3	average
Average time area is in use:	<1 hour	0	1
Maintenance Activity:			
Type of maintenance activity:	Minor disturbance	0	average
Frequency of maintenance activity	<=1 per year	1	1

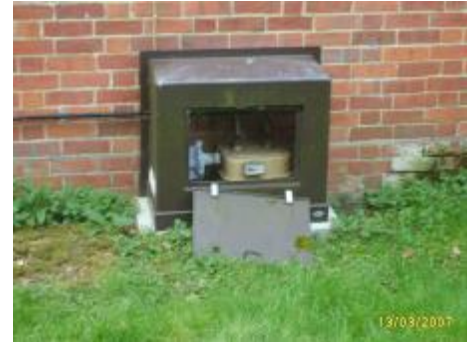
Location ID:	7492
Location Ref:	15
Product:	Gas meter
Area:	Not Applicable
Floor:	Ground floor
Room:	Gas cupboard
Surveyor Name:	J D Chilvers
Drawing Ref:	15
Asbestos ?	Yes
Date:	13 March 2007

Priority Assessment Algorithm	Variable(s) selected	Score for each	Overall score
Normal Occupant Activity:			
Main type of activity in area:	Rare disturbance	0	average
Secondary activities for area:	Rare disturbance	0	0
Likelihood Of Disturbance:			
Location:	Outdoors	0	average
Accessibility:	Usually inaccessible or unlikely to be disturbed	0	
Extent/Amount:	Small items strings gaskets	0	
Human Exposure Potential:			
Number of occupants:	1 to 3	1	average
Frequency of use of area:	Monthly	1	
Average time area is in use:	<1 hour	0	
Maintenance Activity:			
Type of maintenance activity:	Minor disturbance	0	average
Frequency of maintenance activity	<=1 per year	1	1

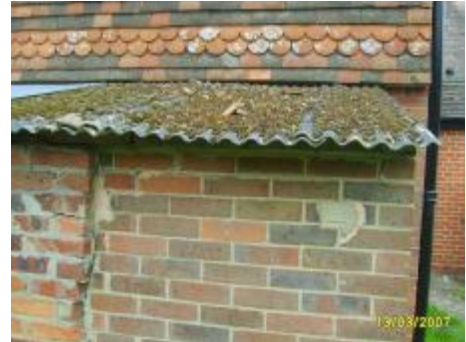
Location ID:	7493
Location Ref:	16
Product:	Roofing Sheets
Area:	Not Applicable
Floor:	Roof
Room:	Sheds / Outbuildings
Surveyor Name:	J D Chilvers
Drawing Ref:	16
Asbestos ?	Yes
Date:	13 March 2007

Priority Assessment Algorithm	Variable(s) selected	Score for each	Overall score
Normal Occupant Activity:			
Main type of activity in area:	Low disturbance	1	average 1
Secondary activities for area:	Rare disturbance	0	
Likelihood Of Disturbance:			
Location:	Outdoors	0	average 1
Accessibility:	Occasionally likely to be disturbed	1	
Extent/Amount:	<=10 m2 or <=10 m pipe run	1	
Human Exposure Potential:			
Number of occupants:	1 to 3	1	average 1
Frequency of use of area:	Daily	3	
Average time area is in use:	<1 hour	0	
Maintenance Activity:			
Type of maintenance activity:	Minor disturbance	0	average 1
Frequency of maintenance activity	<=1 per year	1
