Asbestos Survey for

Hall & Woodhouse Ltd

The Horse and Groom
Wood Green
Fordingbridge
Hampshire
SP6 2AS

Project Number: AS04180 - Horse & Groom

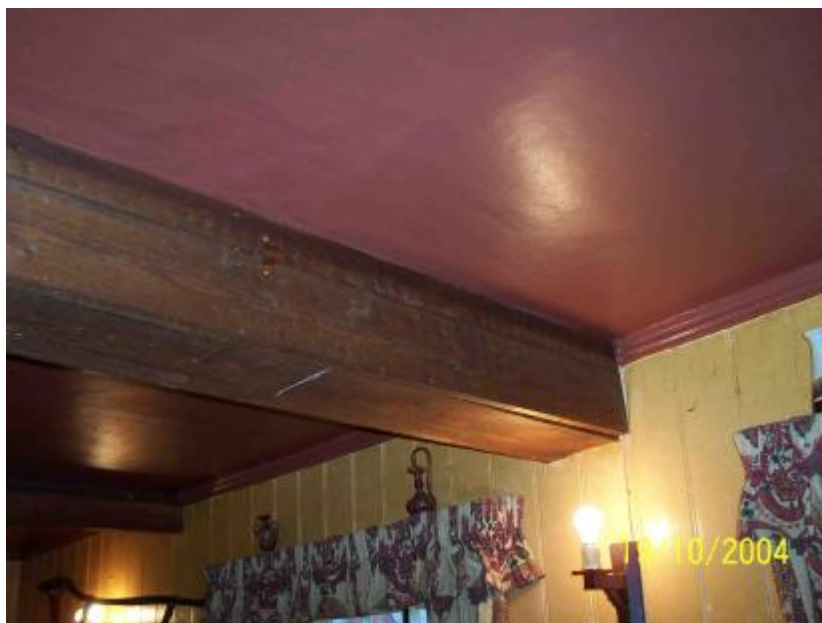
1

Damage:

No visible damage

Apply Warning Labels

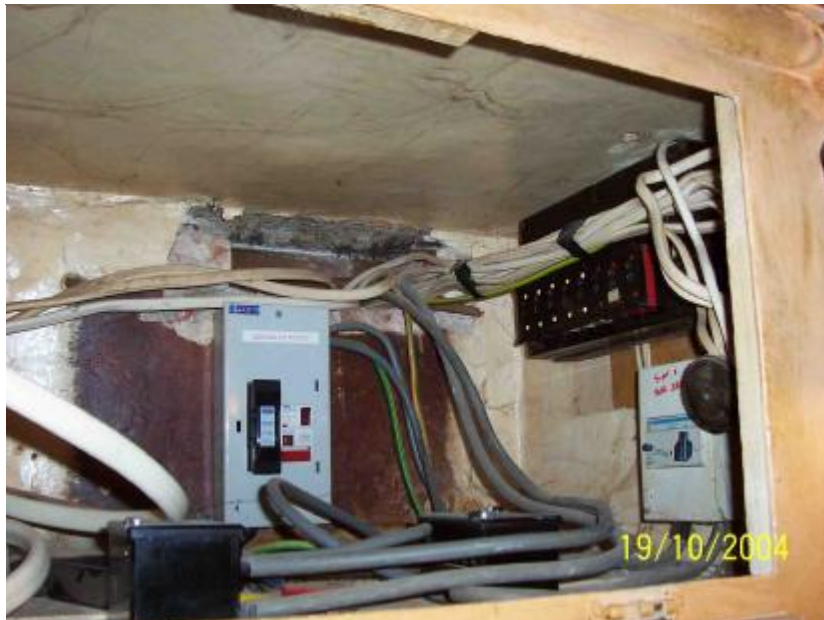
Location ID:	1672	Survey Type:	T 2
Location Ref:	3	Product Type:	Ropes and woven textiles
Product:	Fuse & Switchgear Flashguard	Damage:	No visible damage
Area:	Not Applicable	Treatment:	Composite asbestos materials
Floor:	Ground floor	Asbestos Type:	Chrysotile
Room:	Electrical cupboard	Identification:	Presumed
Surveyor Name:	J D Chilvers	Quantity:	
Drawing Ref:	3	Accessibility:	Medium Accessibility
Asbestos ?	Yes		
Date:	19 October 2004		
Next Inspection:	19 October 2005

Material Risk Score	3
Material Risk Band:	Very Low Risk
Priority Risk Score:	3

Action: Apply Warning Labels

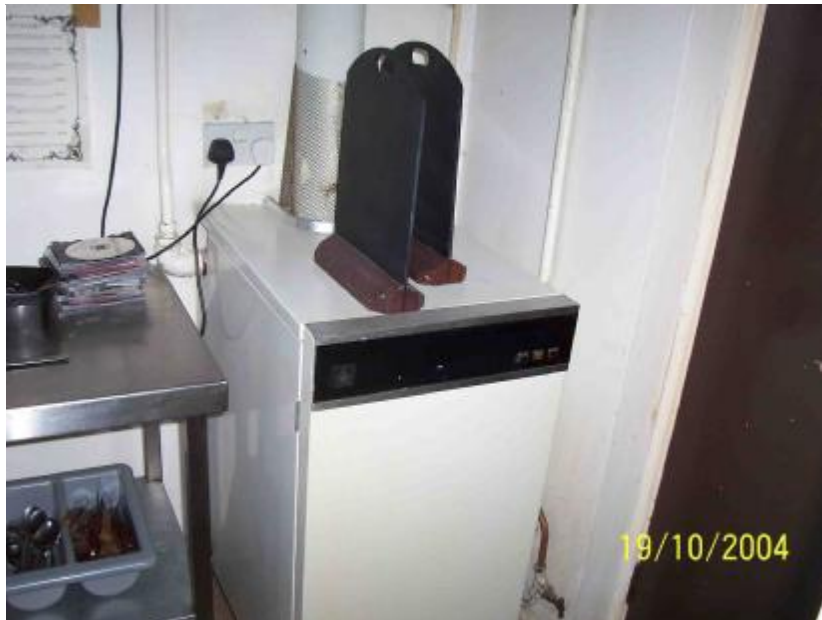
Location ID:	1673	Survey Type:	T 2
Location Ref:	4	Product Type:	Gaskets
Product:	Boiler	Damage:	No visible damage
Area:	Not Applicable	Treatment:	Composite asbestos materials
Floor:	Ground floor	Asbestos Type:	Chrysotile
Room:	Kitchen	Identification:	Presumed
Surveyor Name:	J D Chilvers	Quantity:	
Drawing Ref:	4	Accessibility:	Medium Accessibility
Asbestos ?	Yes		
Date:	19 October 2004		
Next Inspection:	19 October 2005

Priority Risk Score: 4

Action: Apply Warning Labels

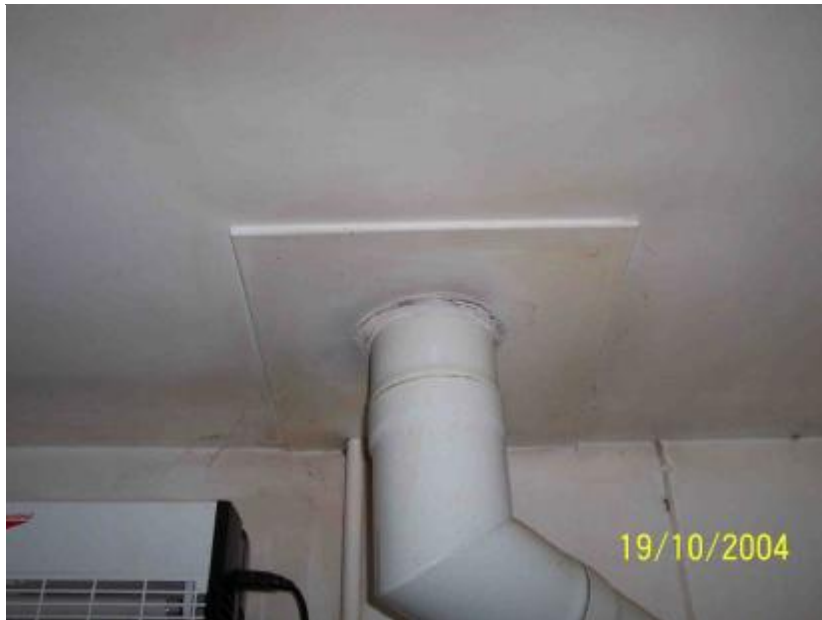
Location ID:	1674	Survey Type:	T 3
Location Ref:	5	Product Type:	NADIS
Product:	Heat Shield	Damage:	NADIS
Area:	Not Applicable	Treatment:	NADIS
Floor:	Ground floor	Asbestos Type:	NADIS
Room:	Kitchen	Identification:	Identified
Surveyor Name:	J D Chilvers	Quantity:	
Drawing Ref:	5	Accessibility:	
Asbestos ?	No		
Date:	04 October 2007		
Next Inspection:	Not Applicable

Priority Risk Score: 4

Action: No Action Required

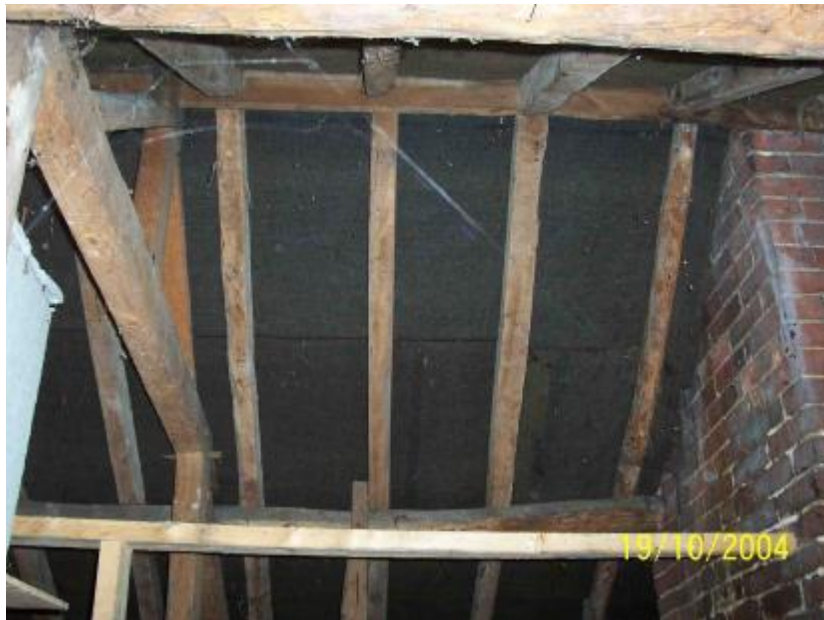
Location ID:	1675	Survey Type:	T 2
Location Ref:	6	Product Type:	Roofing felts
Product:	Roofing felt	Damage:	No visible damage
Area:	Not Applicable	Treatment:	Resins
Floor:	Roof level	Asbestos Type:	Chrysotile
Room:	Loft space	Identification:	Presumed
Surveyor Name:	J D Chilvers	Quantity:	
Drawing Ref:	6	Accessibility:	Difficult Accessibility
Asbestos ?	Yes		
Date:	19 October 2004		
Next Inspection:	19 October 2005

Priority Risk Score: 2

Action: No Action Required

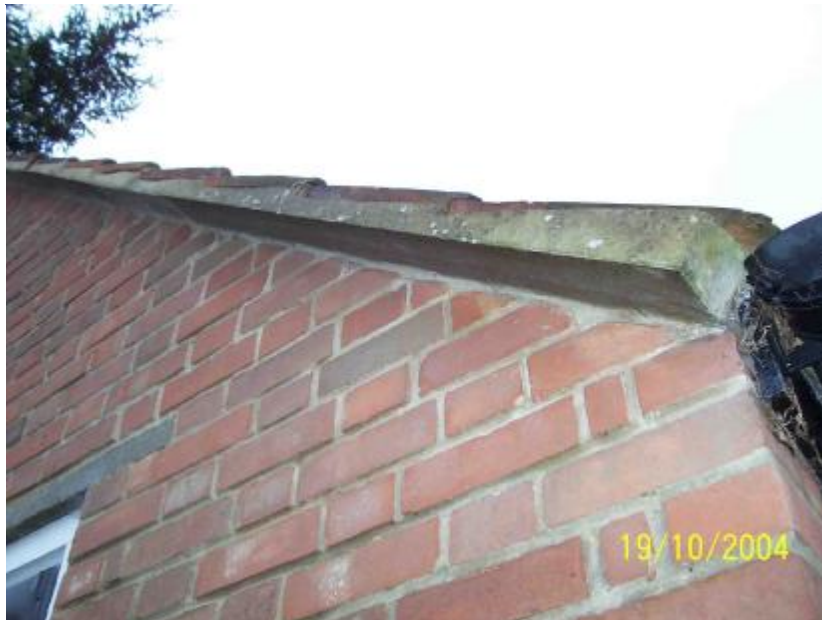
Location ID:	1678	Survey Type:	T 2
Location Ref:	9	Product Type:	Asbestos cement
Product:	Verge Undercloak	Damage:	No visible damage
Area:	Not Applicable	Treatment:	Asbestos cement sheets etc
Floor:	Roof level	Asbestos Type:	Chrysotile
Room:	Garage(s)	Identification:	Identified
Surveyor Name:	J D Chilvers	Quantity:	
Drawing Ref:	9	Accessibility:	Medium Accessibility
Asbestos ?	Yes		
Date:	19 October 2004		
Next Inspection:	19 October 2005

Priority Risk Score: 1

Action: No Action Required

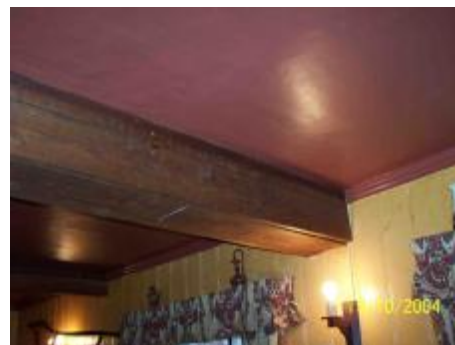
Location ID:	1670
Location Ref:	1
Product:	Beam cladding
Area:	Not Applicable
Floor:	Ground floor
Room:	Bar area
Surveyor Name:	J D Chilvers
Drawing Ref:	1
Asbestos ?	Yes
Date:	19 October 2004

Priority Assessment Algorithm			
Assessment factor	Variable(s) selected	Score for each	Overall score
Normal Occupant Activity:			
Main type of activity in area:	Low disturbance	1	average
Secondary activities for area:	Rare disturbance	0	1
Likelihood Of Disturbance:			
Location:	Large rooms or well-ventilated areas	1	
Accessibility:	Usually inaccessible or unlikely to be disturbed	0	average
Extent/Amount:	<=10 m2 or <=10 m pipe run	1	1
Human Exposure Potential:			
Number of occupants:	>10	3	
Frequency of use of area:	Daily	3	average
Average time area is in use:	>1 to <3 hours	1	2
Maintenance Activity:			
Type of maintenance activity:	Minor disturbance	0	average
Frequency of maintenance activity	<=1 per year	1	1

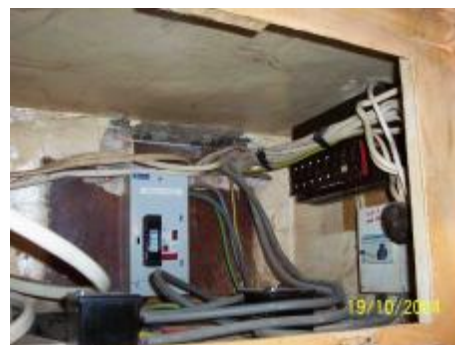
Location ID:	<div style="border: 1px solid black; padding: 2px;">1672</div>
Location Ref:	<div style="border: 1px solid black; padding: 2px;">3</div>
Product:	<div style="border: 1px solid black; padding: 2px;">Fuse & Switchgear Flashguard</div>
Area:	<div style="border: 1px solid black; padding: 2px;">Not Applicable</div>
Floor:	<div style="border: 1px solid black; padding: 2px;">Ground floor</div>
Room:	<div style="border: 1px solid black; padding: 2px;">Electrical cupboard</div>
Surveyor Name:	<div style="border: 1px solid black; padding: 2px;">J D Chilvers</div>
Drawing Ref:	<div style="border: 1px solid black; padding: 2px;">3</div>
Asbestos ?	<div style="border: 1px solid black; padding: 2px;">Yes</div>
Date:	<div style="border: 1px solid black; padding: 2px;">19 October 2004</div>

Priority Assessment Algorithm			
Assessment factor	Variable(s) selected	Score for each	Overall score
Normal Occupant Activity:			
Main type of activity in area:	Rare disturbance	0	average
Secondary activities for area:	Rare disturbance	0	0
Likelihood Of Disturbance:			
Location:	Rooms up to 100 m2	2	average 1
Accessibility:	Occasionally likely to be disturbed	1	
Extent/Amount:	Small items strings gaskets	0	
Human Exposure Potential:			
Number of occupants:	1 to 3	1	average 1
Frequency of use of area:	Monthly	1	
Average time area is in use:	<1 hour	0	
Maintenance Activity:			
Type of maintenance activity:	Minor disturbance	0	average
Frequency of maintenance activity	<=1 per year	1	1

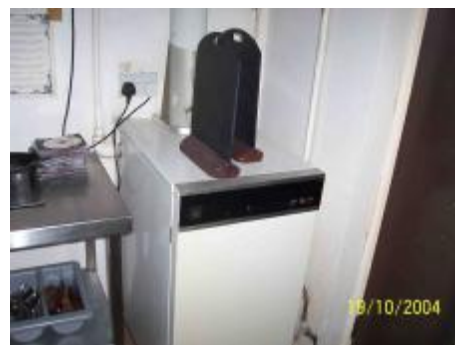
Location ID:	<div>1673</div>
Location Ref:	<div>4</div>
Product:	<div>Boiler</div>
Area:	<div>Not Applicable</div>
Floor:	<div>Ground floor</div>
Room:	<div>Kitchen</div>
Surveyor Name:	<div>J D Chilvers</div>
Drawing Ref:	<div>4</div>
Asbestos ?	<div>Yes</div>
Date:	<div>19 October 2004</div>

Priority Assessment Algorithm			
Assessment factor	Variable(s) selected	Score for each	Overall score
Normal Occupant Activity:			
Main type of activity in area:	Rare disturbance	0	average
Secondary activities for area:	Rare disturbance	0	0
Likelihood Of Disturbance:			
Location:	Large rooms or well-ventilated areas	1	average 1
Accessibility:	Occasionally likely to be disturbed	1	
Extent/Amount:	Small items strings gaskets	0	
Human Exposure Potential:			
Number of occupants:	1 to 3	1	average 2
Frequency of use of area:	Daily	3	
Average time area is in use:	>3 to <6 hours	2	
Maintenance Activity:			
Type of maintenance activity:	Minor disturbance	0	average
Frequency of maintenance activity	<=1 per year	1	1

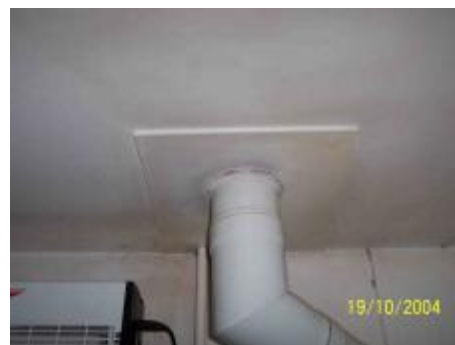
Location ID:	1674
Location Ref:	5
Product:	Heat Shield
Area:	Not Applicable
Floor:	Ground floor
Room:	Kitchen
Surveyor Name:	J D Chilvers
Drawing Ref:	5
Asbestos ?	No
Date:	19 October 2004

Priority Assessment Algorithm			
Assessment factor	Variable(s) selected	Score for each	Overall score
Normal Occupant Activity:			
Main type of activity in area:	Rare disturbance	0	average
Secondary activities for area:	Rare disturbance	0	0
Likelihood Of Disturbance:			
Location:	Large rooms or well-ventilated areas	1	average 1
Accessibility:	Occasionally likely to be disturbed	1	
Extent/Amount:	<=10 m2 or <=10 m pipe run	1	
Human Exposure Potential:			
Number of occupants:	1 to 3	1	average 2
Frequency of use of area:	Daily	3	
Average time area is in use:	>3 to <6 hours	2	
Maintenance Activity:			
Type of maintenance activity:	Minor disturbance	0	average
Frequency of maintenance activity	<=1 per year	1	1

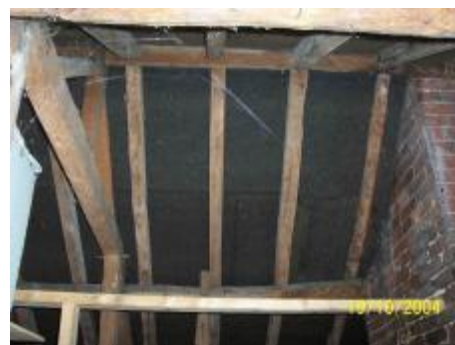
Location ID:	1675
Location Ref:	6
Product:	Roofing felt
Area:	Not Applicable
Floor:	Roof level
Room:	Loft space
Surveyor Name:	J D Chilvers
Drawing Ref:	6
Asbestos ?	Yes
Date:	19 October 2004

Priority Assessment Algorithm			
Assessment factor	Variable(s) selected	Score for each	Overall score
Normal Occupant Activity:			
Main type of activity in area:	Rare disturbance	0	average
Secondary activities for area:	Rare disturbance	0	0
Likelihood Of Disturbance:			
Location:	Large rooms or well-ventilated areas	1	average 1
Accessibility:	Usually inaccessible or unlikely to be disturbed	0	
Extent/Amount:	>50 m2 or >50 m pipe run	3	
Human Exposure Potential:			
Number of occupants:	1 to 3	1	average 0
Frequency of use of area:	Infrequent	0	
Average time area is in use:	<1 hour	0	
Maintenance Activity:			
Type of maintenance activity:	Minor disturbance	0	average 1
Frequency of maintenance activity	<=1 per year	1

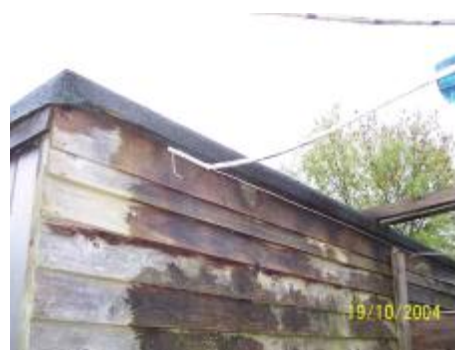
Location ID:	1676
Location Ref:	7
Product:	Roofing felt
Area:	Not Applicable
Floor:	External ground floor
Room:	Sheds / Outbuildings
Surveyor Name:	J D Chilvers
Drawing Ref:	7
Asbestos ?	Yes
Date:	19 October 2004

Priority Assessment Algorithm			
Assessment factor	Variable(s) selected	Score for each	Overall score
Normal Occupant Activity:			
Main type of activity in area:	Rare disturbance	0	average
Secondary activities for area:	Rare disturbance	0	0
Likelihood Of Disturbance:			
Location:	Outdoors	0	average 1
Accessibility:	Usually inaccessible or unlikely to be disturbed	0	
Extent/Amount:	>10 to <=50 (m2 or pipe run)	2	
Human Exposure Potential:			
Number of occupants:	1 to 3	1	average 0
Frequency of use of area:	Infrequent	0	
Average time area is in use:	<1 hour	0	
Maintenance Activity:			
Type of maintenance activity:	Minor disturbance	0	average
Frequency of maintenance activity	<=1 per year	1	1

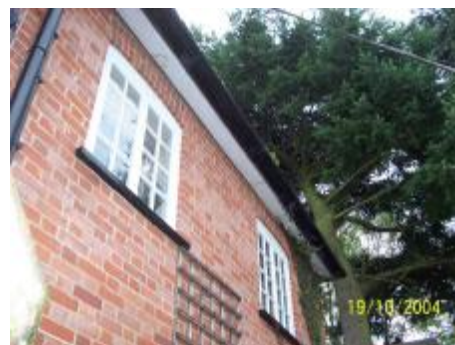
Location ID:	1677
Location Ref:	8
Product:	Soffit
Area:	Not Applicable
Floor:	Roof level
Room:	External
Surveyor Name:	J D Chilvers
Drawing Ref:	8
Asbestos ?	Yes
Date:	19 October 2004

Priority Assessment Algorithm			
Assessment factor	Variable(s) selected	Score for each	Overall score
Normal Occupant Activity:			
Main type of activity in area:	Rare disturbance	0	average
Secondary activities for area:	Rare disturbance	0	0
Likelihood Of Disturbance:			
Location:	Outdoors	0	average 0
Accessibility:	Usually inaccessible or unlikely to be disturbed	0	
Extent/Amount:	<=10 m2 or <=10 m pipe run	1	
Human Exposure Potential:			
Number of occupants:	1 to 3	1	average 0
Frequency of use of area:	Infrequent	0	
Average time area is in use:	<1 hour	0	
Maintenance Activity:			
Type of maintenance activity:	Minor disturbance	0	average
Frequency of maintenance activity	<=1 per year	1	1

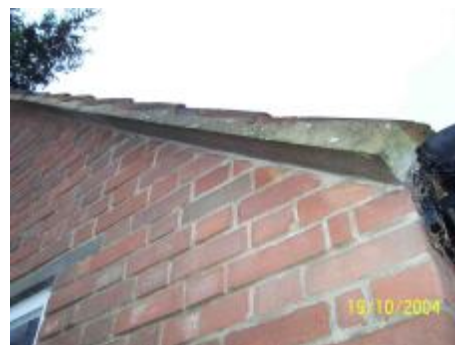
Location ID:	1678
Location Ref:	9
Product:	Verge Undercloak
Area:	Not Applicable
Floor:	Roof level
Room:	Garage(s)
Surveyor Name:	J D Chilvers
Drawing Ref:	9
Asbestos ?	Yes
Date:	19 October 2004

Priority Assessment Algorithm			
Assessment factor	Variable(s) selected	Score for each	Overall score
Normal Occupant Activity:			
Main type of activity in area:	Rare disturbance	0	average
Secondary activities for area:	Rare disturbance	0	0
Likelihood Of Disturbance:			
Location:	Outdoors	0	average 0
Accessibility:	Usually inaccessible or unlikely to be disturbed	0	
Extent/Amount:	<=10 m2 or <=10 m pipe run	1	
Human Exposure Potential:			
Number of occupants:	1 to 3	1	average 0
Frequency of use of area:	Infrequent	0	
Average time area is in use:	<1 hour	0	
Maintenance Activity:			
Type of maintenance activity:	Minor disturbance	0	average 1
Frequency of maintenance activity	<=1 per year	1
