JTEC Environmental Ltd.

Asbestos Survey for

Coach and Horses

Project Number: AS04179 - Coach & Horses Rotherwick

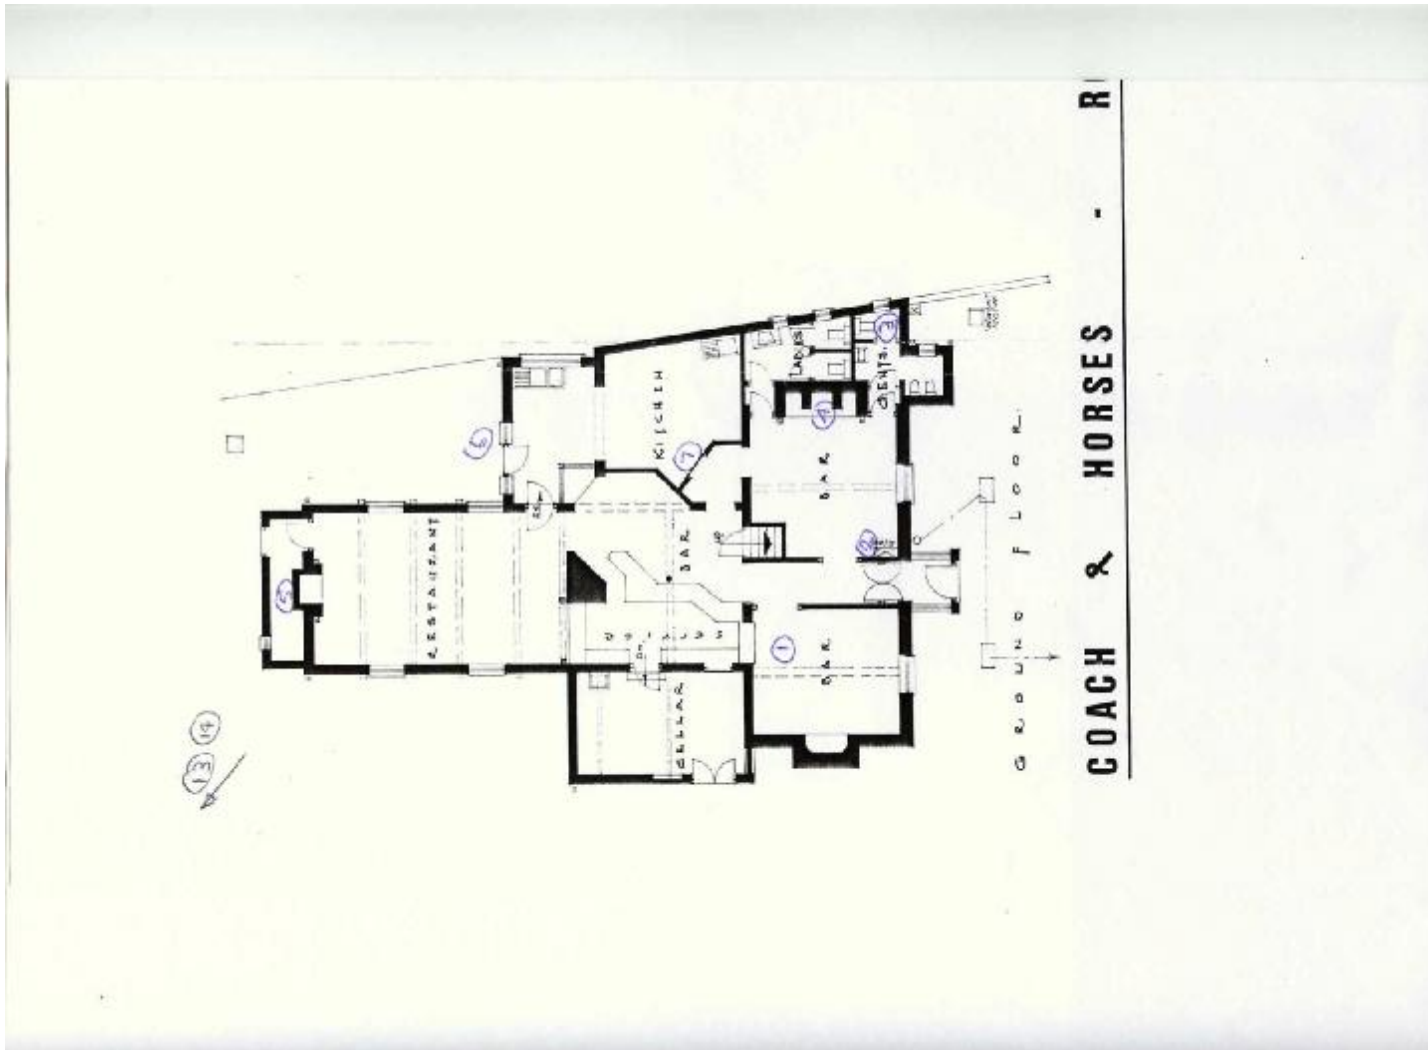
Description of Drawing:
Ground floor layout

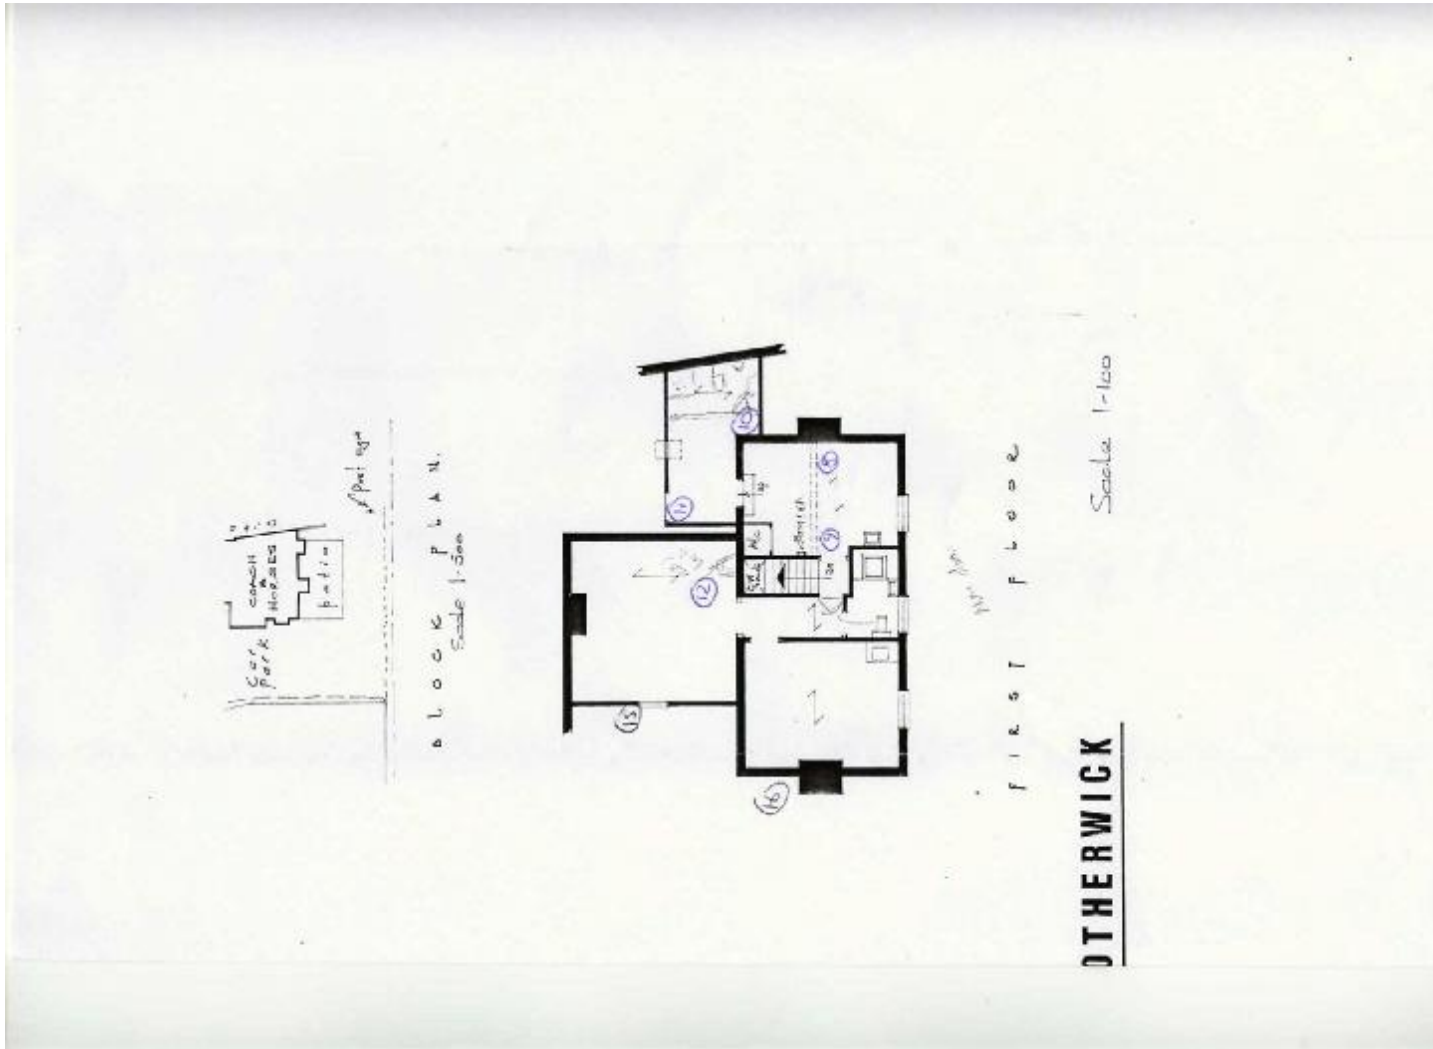
Description of Drawing:
First floor layout

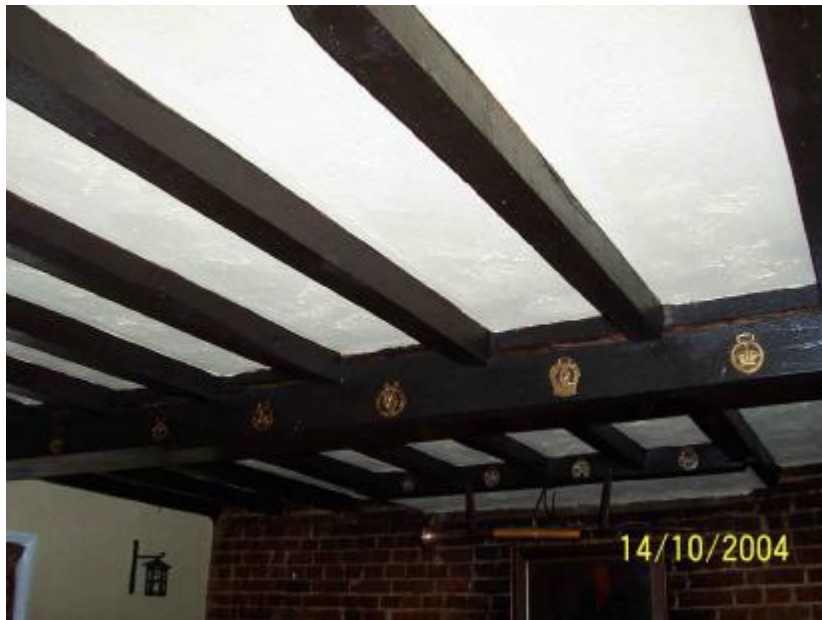
Location ID:	1654	Survey Type:	T 2
Location Ref:	1	Product Type:	NADIS
Product:	Textured coating	Damage:	NADIS
Area:	Not Applicable	Treatment:	NADIS
Floor:	Ground floor	Asbestos Type:	NADIS
Room:	Bar area	Identification:	Identified
Surveyor Name:	J D Chilvers	Quantity:	
Drawing Ref:	1	Accessibility:	
Asbestos ?	No		
Date:	14 October 2004		
Next Inspection:	Not Applicable

Priority Risk Score: N/A

Action: No Action Required

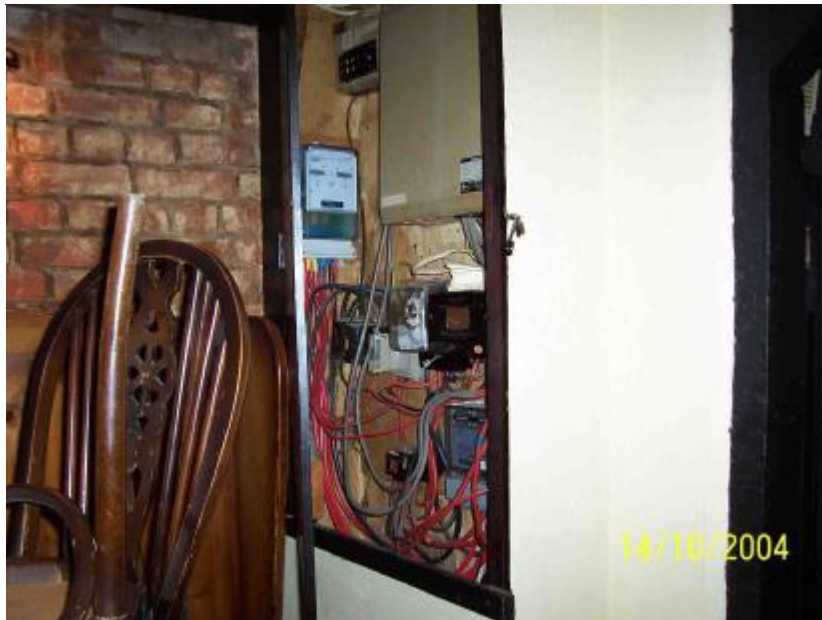
Location ID:	1655	Survey Type:	T 2
Location Ref:	2	Product Type:	Ropes and woven textiles
Product:	Fuse & Switchgear Flashguard	Damage:	No visible damage
Area:	Not Applicable	Treatment:	Composite asbestos materials
Floor:	Ground floor	Asbestos Type:	Chrysotile
Room:	Electrical cupboard	Identification:	Presumed
Surveyor Name:	J D Chilvers	Quantity:	
Drawing Ref:	2	Accessibility:	Medium Accessibility
Asbestos ?	Yes		
Date:	14 October 2004		
Next Inspection:	14 October 2005

Priority Risk Score: 2

Action: Apply Warning Labels

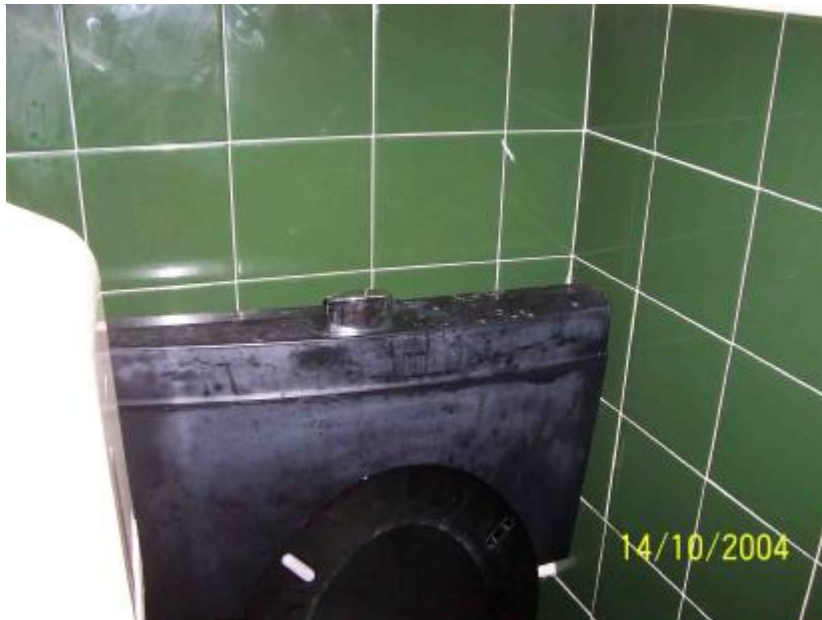
Location ID:	1656	Survey Type:	T 2
Location Ref:	3	Product Type:	Plastics
Product:	Cistern	Damage:	No visible damage
Area:	Not Applicable	Treatment:	Reinforced plastics
Floor:	Ground floor	Asbestos Type:	Chrysotile
Room:	WC - mens	Identification:	Strongly Presumed
Surveyor Name:	J D Chilvers	Quantity:	
Drawing Ref:	3	Accessibility:	Easy Accessibility
Asbestos ?	Yes		
Date:	14 October 2004		
Next Inspection:	14 October 2005

Material Risk Score	2
Material Risk Band:	Very Low Risk
Priority Risk Score:	4

Action: Apply Warning Labels

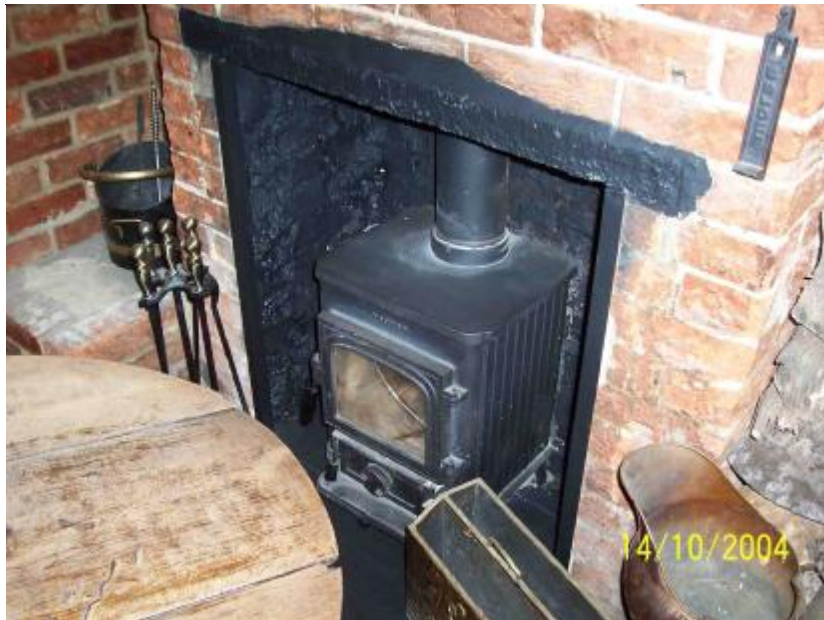
Location ID:	1657	Survey Type:	T 2
Location Ref:	4	Product Type:	Gaskets
Product:	Gasket	Damage:	No visible damage
Area:	Not Applicable	Treatment:	Composite asbestos materials
Floor:	Ground floor	Asbestos Type:	Chrysotile
Room:	Bar area	Identification:	Presumed
Surveyor Name:	J D Chilvers	Quantity:	
Drawing Ref:	4	Accessibility:	Medium Accessibility
Asbestos ?	Yes		
Date:	14 October 2004		
Next Inspection:	14 October 2005

Priority Risk Score: 4

Material Comments: This item may contain seals and gaskets which have ACM's present.

Action: Apply Warning Labels

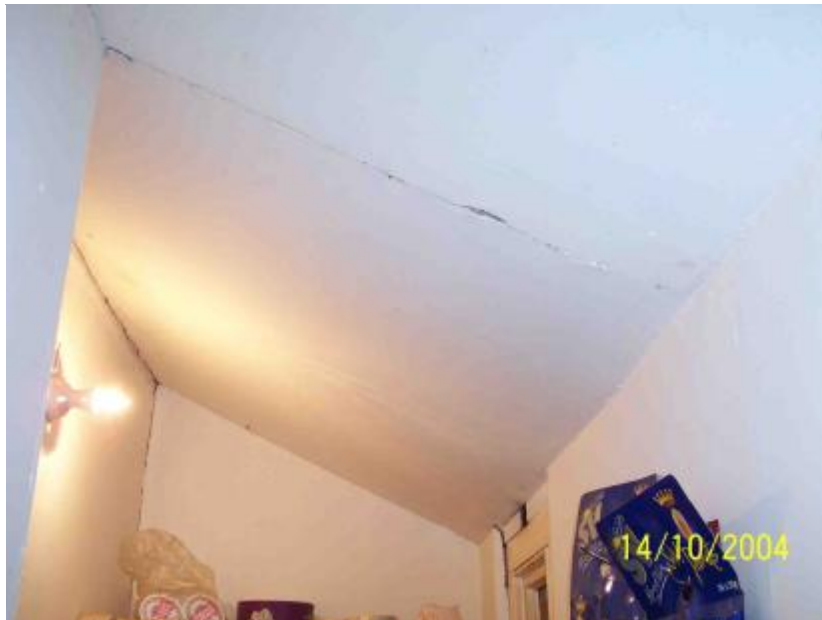
Location ID:	1658	Survey Type:	T 2
Location Ref:	5	Product Type:	Asbestos cement
Product:	Cladding	Damage:	No visible damage
Area:	Not Applicable	Treatment:	Asbestos cement sheets etc
Floor:	Ground floor	Asbestos Type:	Chrysotile
Room:	Store Room	Identification:	Presumed
Surveyor Name:	J D Chilvers	Quantity:	
Drawing Ref:	5	Accessibility:	Medium Accessibility
Asbestos ?	Yes		
Date:	14 October 2004		
Next Inspection:	14 October 2005

Material Risk Score	3
Material Risk Band:	Very Low Risk
Priority Risk Score:	4

Action: Apply Warning Labels

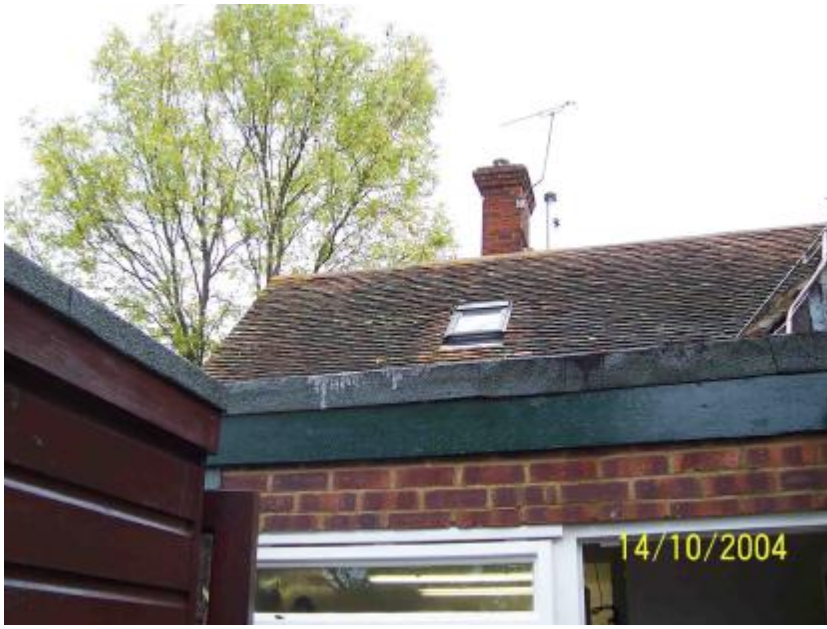
Location ID:	1659	Survey Type:	T 2
Location Ref:	6	Product Type:	Roofing felts
Product:	Roofing felt	Damage:	No visible damage
Area:	Not Applicable	Treatment:	Resins
Floor:	Roof level	Asbestos Type:	Chrysotile
Room:	Flat roof area	Identification:	Presumed
Surveyor Name:	J D Chilvers	Quantity:	
Drawing Ref:	6	Accessibility:	Medium Accessibility
Asbestos ?	Yes		
Date:	14 October 2004		
Next Inspection:	14 October 2005

Material Risk Score	2
Material Risk Band:	Very Low Risk
Priority Risk Score:	2

Action: No Action Required

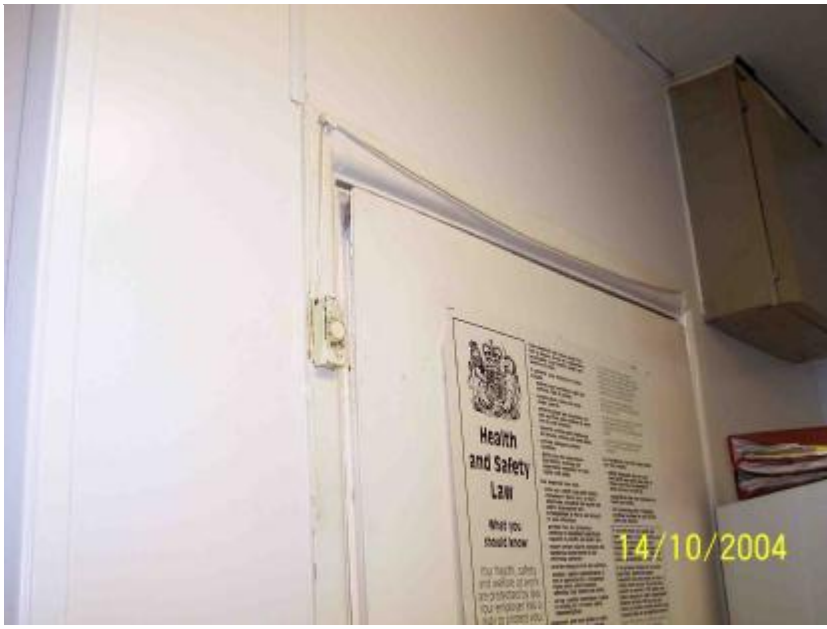
Location ID:	<input type="text" value="1660"/>	Survey Type:	<input type="text" value="T 2"/>						
Location Ref:	<input type="text" value="7"/>	Product Type:	<input type="text" value="Asbestos Insulating Board"/>						
Product:	<input type="text" value="Door panel"/>	Damage:	<input type="text" value="Low damage: Broken edge boards"/>						
Area:	<input type="text" value="Not Applicable"/>	Treatment:	<input type="text" value="AIB painted or encapsulated"/>						
Floor:	<input type="text" value="Ground floor"/>	Asbestos Type:	<input type="text" value="Amosite & Chrysotile"/>						
Room:	<input type="text" value="Kitchen"/>	Identification:	<input type="text" value="Identified"/>						
Surveyor Name:	<input type="text" value="J D Chilvers"/>	Quantity:	<input type="text"/>						
Drawing Ref:	<input type="text" value="7"/>	Accessibility:	<input type="text" value="Easy Accessibility"/>						
Asbestos ?	<input type="text" value="Yes"/>

Material Risk Score	<input type="text" value="6"/>	Material Risk Band:	<input type="text" value="Low Risk"/>	Priority Risk Score:	<input type="text" value="5"/>
Material Risk Score	<input type="text" value="6"/>								
Material Risk Band:	<input type="text" value="Low Risk"/>								
Priority Risk Score:	<input type="text" value="5"/>								
Date:	<input type="text" value="14 October 2004"/>								
Next Inspection:	<input type="text" value="15 April 2005"/>

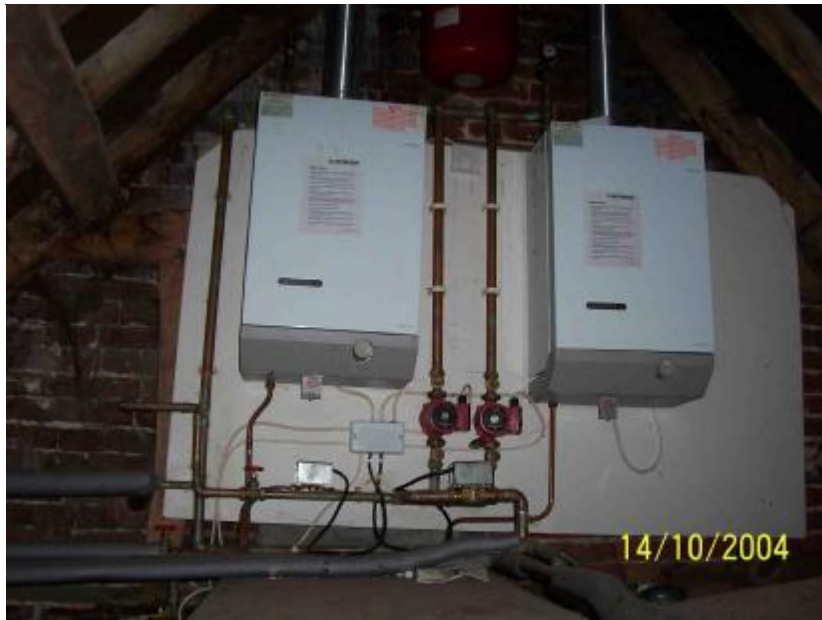
Location ID:	1661	Survey Type:	T 2
Location Ref:	8	Product Type:	Gaskets
Product:	Boiler	Damage:	No visible damage
Area:	Not Applicable	Treatment:	Composite asbestos materials
Floor:	Roof level	Asbestos Type:	Chrysotile
Room:	Loft space	Identification:	Presumed
Surveyor Name:	J D Chilvers	Quantity:	
Drawing Ref:	8	Accessibility:	Medium Accessibility
Asbestos ?	Yes		
Date:	14 October 2004		
Next Inspection:	14 October 2005

Material Risk Score	3
Material Risk Band:	Very Low Risk
Priority Risk Score:	2

Action: Apply Warning Labels

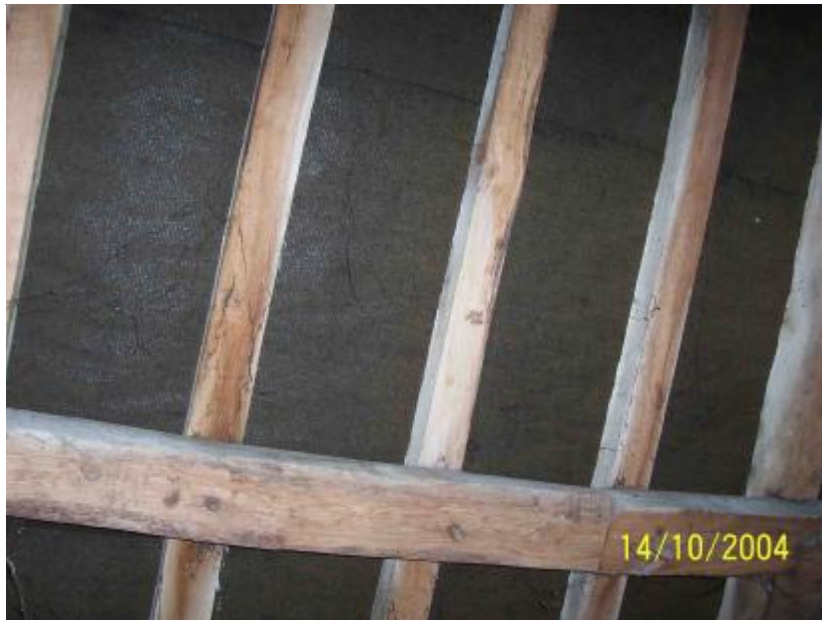
Location ID:	1662	Survey Type:	T 2
Location Ref:	9	Product Type:	Roofing felts
Product:	Roofing felt	Damage:	No visible damage
Area:	Not Applicable	Treatment:	Resins
Floor:	Roof level	Asbestos Type:	Chrysotile
Room:	Loft space	Identification:	Presumed
Surveyor Name:	J D Chilvers	Quantity:	
Drawing Ref:	9	Accessibility:	Medium Accessibility
Asbestos ?	Yes		
Date:	14 October 2004		
Next Inspection:	14 October 2005

Priority Risk Score: 3

Action: No Action Required

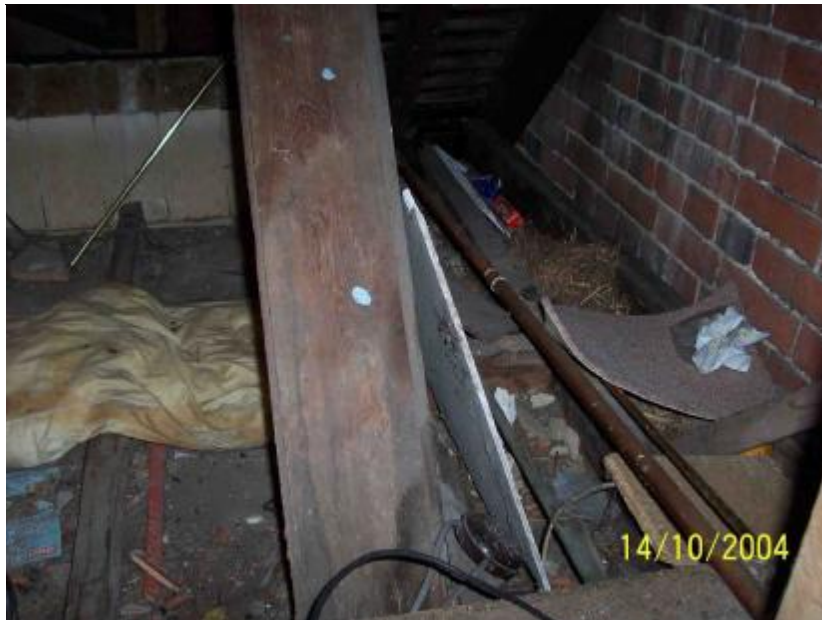
Location ID:	1663	Survey Type:	T 2
Location Ref:	10	Product Type:	Asbestos Insulating Board
Product:	Debris	Damage:	Medium damage: Breakage
Area:	Not Applicable	Treatment:	Unsealed AIB
Floor:	Roof level	Asbestos Type:	Amosite & Chrysotile
Room:	Loft space	Identification:	Identified
Surveyor Name:	J D Chilvers	Quantity:	
Drawing Ref:	10	Accessibility:	Medium Accessibility
Asbestos ?	Yes		
Date:	14 October 2004		
Next Inspection:	12 January 2005

Priority Risk Score: 2

Action: Removal

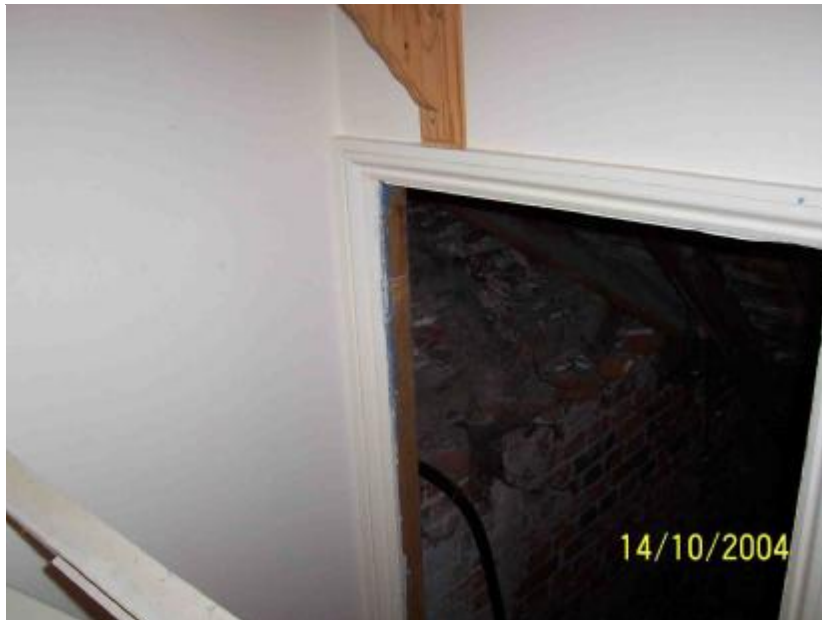
Location ID:	1664	Survey Type:	T 2
Location Ref:	11	Product Type:	NADIS
Product:	Wall board	Damage:	NADIS
Area:	Not Applicable	Treatment:	NADIS
Floor:	First floor	Asbestos Type:	NADIS
Room:	Bedroom	Identification:	Identified
Surveyor Name:	J D Chilvers	Quantity:	
Drawing Ref:	11	Accessibility:	
Asbestos ?	No		
Date:	14 October 2004		
Next Inspection:	Not Applicable

Material Risk Score	0
Material Risk Band:	NADIS
Priority Risk Score:	N/A

Action: No Action Required

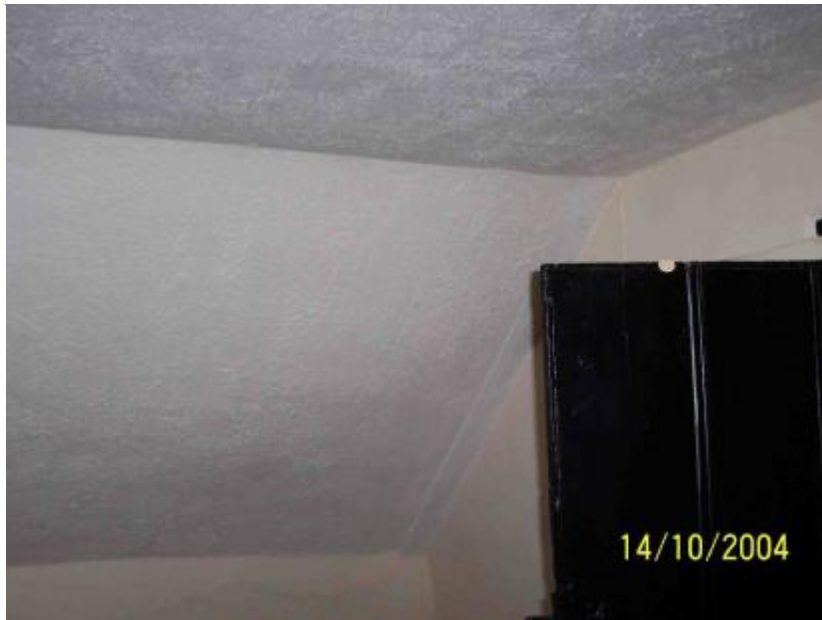
Location ID:	1665	Survey Type:	T 2
Location Ref:	12	Product Type:	NADIS
Product:	Textured coating	Damage:	NADIS
Area:	Not Applicable	Treatment:	NADIS
Floor:	First floor	Asbestos Type:	NADIS
Room:	Lounge	Identification:	Identified
Surveyor Name:	J D Chilvers	Quantity:	
Drawing Ref:	12	Accessibility:	
Asbestos ?	No		
Date:	14 October 2004		
Next Inspection:	Not Applicable

Material Risk Score	0
Material Risk Band:	NADIS
Priority Risk Score:	N/A

Action: No Action Required

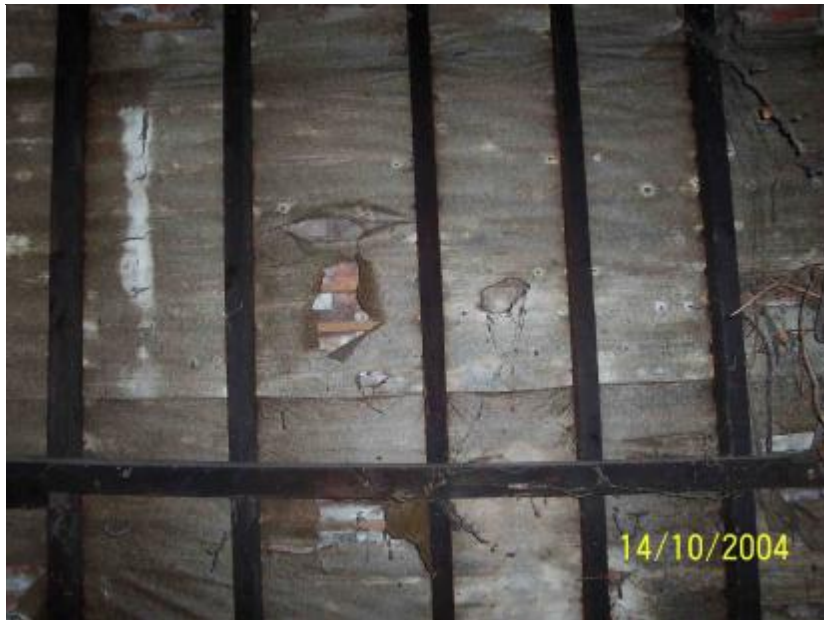
Location ID:	1666	Survey Type:	T 2
Location Ref:	13	Product Type:	Roofing felts
Product:	Roofing felt	Damage:	Low damage
Area:	Not Applicable	Treatment:	Resins
Floor:	Ground floor	Asbestos Type:	Chrysotile
Room:	Garage(s)	Identification:	Presumed
Surveyor Name:	J D Chilvers	Quantity:	
Drawing Ref:	13	Accessibility:	Medium Accessibility
Asbestos ?	Yes		
Date:	14 October 2004		
Next Inspection:	14 October 2005

Priority Risk Score: 3

Action: No Action Required

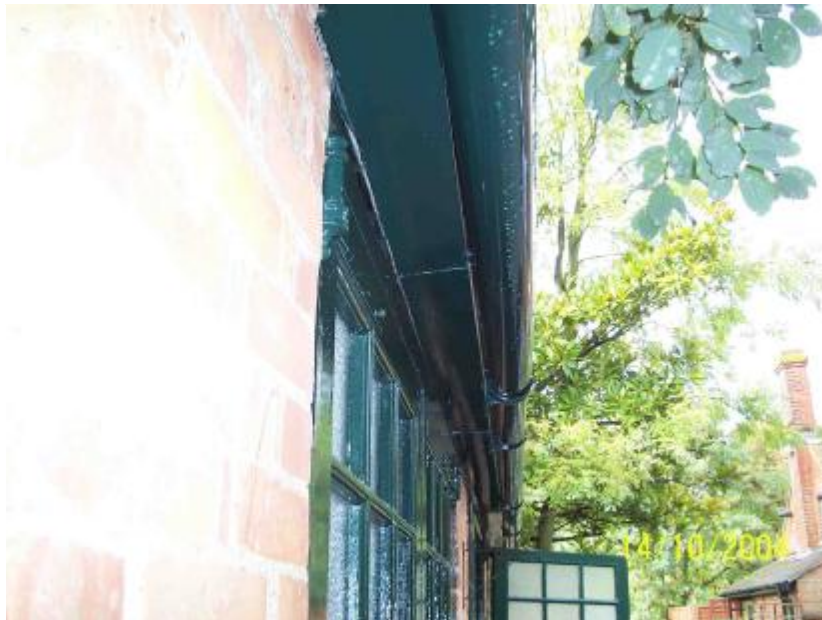
Location ID:	1667	Survey Type:	T 2
Location Ref:	14	Product Type:	Asbestos Insulating Board
Product:	Soffit	Damage:	No visible damage
Area:	Not Applicable	Treatment:	AIB painted or encapsulated
Floor:	Roof level	Asbestos Type:	Amosite & Chrysotile
Room:	External	Identification:	Identified
Surveyor Name:	J D Chilvers	Quantity:	
Drawing Ref:	14	Accessibility:	Medium Accessibility
Asbestos ?	Yes		
Date:	14 October 2004		
Next Inspection:	15 April 2005

Material Risk Score	5
Material Risk Band:	Low Risk
Priority Risk Score:	1

Action: Apply Warning Labels

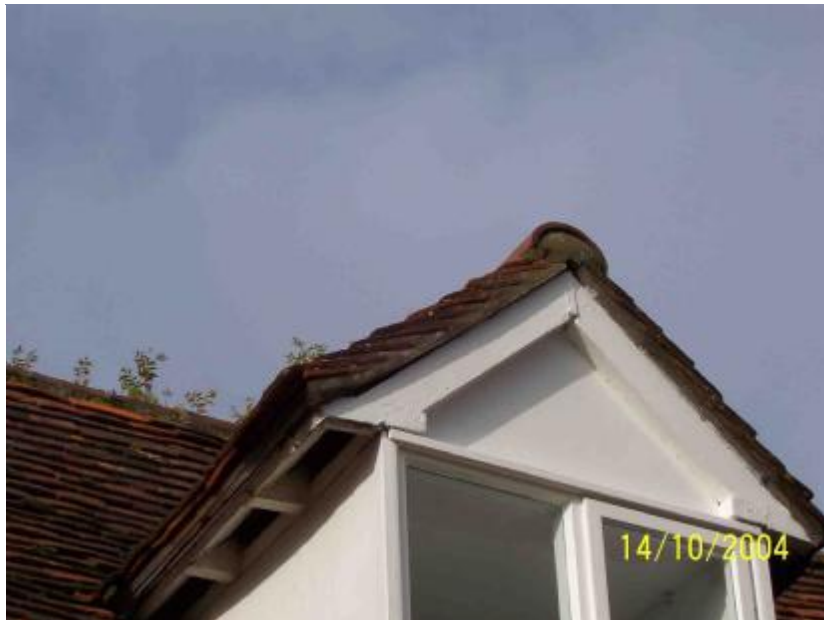
Location ID:	1668	Survey Type:	T 2
Location Ref:	15	Product Type:	Asbestos cement
Product:	Verge Undercloak	Damage:	No visible damage
Area:	Not Applicable	Treatment:	Asbestos cement sheets etc
Floor:	Roof level	Asbestos Type:	Chrysotile
Room:	External	Identification:	Strongly Presumed
Surveyor Name:	J D Chilvers	Quantity:	
Drawing Ref:	15	Accessibility:	Difficult Accessibility
Asbestos ?	Yes		
Date:	14 October 2004		
Next Inspection:	14 October 2005

Material Risk Score	3
Material Risk Band:	Very Low Risk
Priority Risk Score:	1

Action: Apply Warning Labels

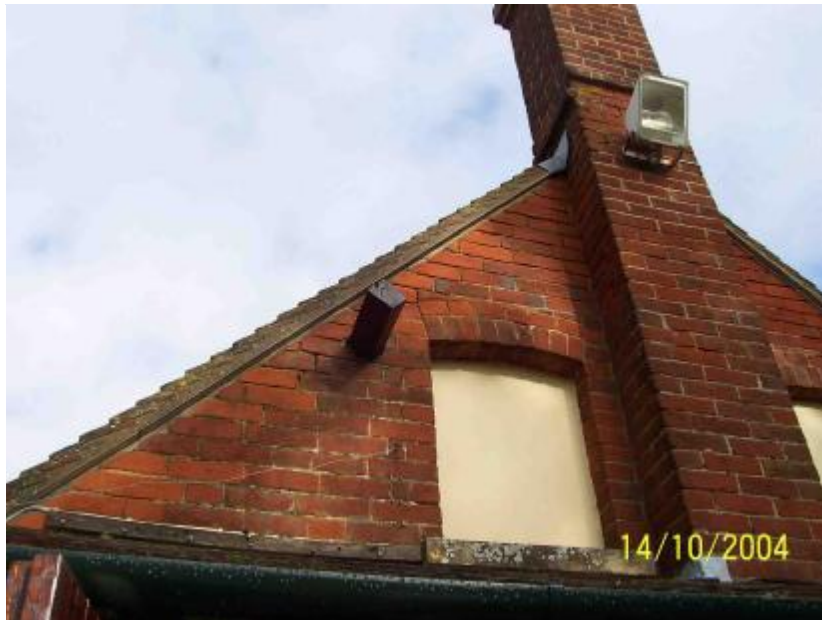
Location ID:	1669	Survey Type:	T 2
Location Ref:	16	Product Type:	Asbestos cement
Product:	Verge Undercloak	Damage:	No visible damage
Area:	Not Applicable	Treatment:	Asbestos cement sheets etc
Floor:	Roof level	Asbestos Type:	Chrysotile
Room:	External	Identification:	Strongly Presumed
Surveyor Name:	J D Chilvers	Quantity:	
Drawing Ref:	16	Accessibility:	Difficult Accessibility
Asbestos ?	Yes		
Date:	14 October 2004		
Next Inspection:	14 October 2005

Material Risk Score	3
Material Risk Band:	Very Low Risk
Priority Risk Score:	1

Action: Apply Warning Labels

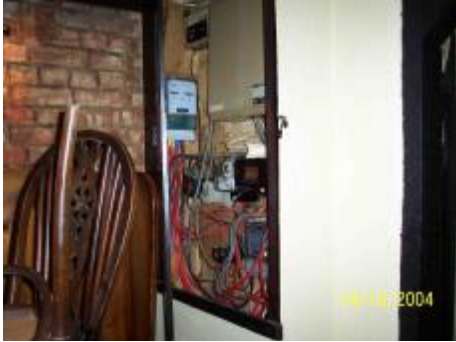
Location ID:	1655
Location Ref:	2
Product:	Fuse & Switchgear Flashguard
Area:	Not Applicable
Floor:	Ground floor
Room:	Electrical cupboard
Surveyor Name:	J D Chilvers
Drawing Ref:	2
Asbestos ?	Yes
Date:	14 October 2004

Priority Assessment Algorithm			
Assessment factor	Variable(s) selected	Score for each	Overall score
Normal Occupant Activity:			
Main type of activity in area:	Rare disturbance	0	average
Secondary activities for area:	Rare disturbance	0	0
Likelihood Of Disturbance:			
Location:	Rooms up to 100 m2	2	
Accessibility:	Occasionally likely to be disturbed	1	average
Extent/Amount:	Small items strings gaskets	0	1
Human Exposure Potential:			
Number of occupants:	None	0	
Frequency of use of area:	Monthly	1	average
Average time area is in use:	<1 hour	0	0
Maintenance Activity:			
Type of maintenance activity:	Low disturbance	1	average
Frequency of maintenance activity	<=1 per year	1	1

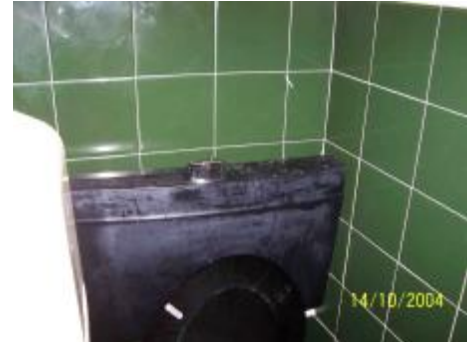
Location ID:	1656
Location Ref:	3
Product:	Cistern
Area:	Not Applicable
Floor:	Ground floor
Room:	WC - mens
Surveyor Name:	J D Chilvers
Drawing Ref:	3
Asbestos ?	Yes
Date:	14 October 2004

Priority Assessment Algorithm	Variable(s) selected	Score for each	Overall score
Normal Occupant Activity:			
Main type of activity in area:	Low disturbance	1	average
Secondary activities for area:	Low disturbance	1	1
Likelihood Of Disturbance:			
Location:	Rooms up to 100 m2	2	average
Accessibility:	Occasionally likely to be disturbed	1	
Extent/Amount:	Small items strings gaskets	0	
Human Exposure Potential:			
Number of occupants:	1 to 3	1	average
Frequency of use of area:	Daily	3	
Average time area is in use:	<1 hour	0	
Maintenance Activity:			
Type of maintenance activity:	Low disturbance	1	average
Frequency of maintenance activity	<=1 per year	1	1

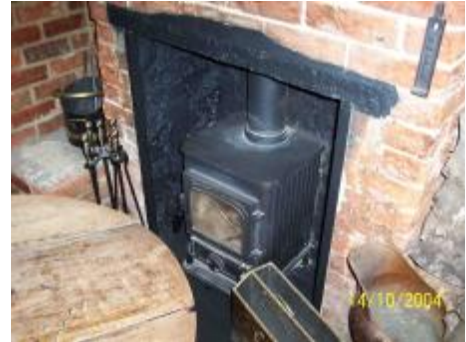
Location ID:	1657
Location Ref:	4
Product:	Gasket
Area:	Not Applicable
Floor:	Ground floor
Room:	Bar area
Surveyor Name:	J D Chilvers
Drawing Ref:	4
Asbestos ?	Yes
Date:	14 October 2004

Priority Assessment Algorithm	Variable(s) selected	Score for each	Overall score
Normal Occupant Activity:			
Main type of activity in area:	Low disturbance	1	average
Secondary activities for area:	Low disturbance	1	1
Likelihood Of Disturbance:			
Location:	Large rooms or well-ventilated areas	1	average
Accessibility:	Usually inaccessible or unlikely to be disturbed	0	
Extent/Amount:	Small items strings gaskets	0	
Human Exposure Potential:			
Number of occupants:	>10	3	average
Frequency of use of area:	Daily	3	
Average time area is in use:	>1 to <3 hours	1	
Maintenance Activity:			
Type of maintenance activity:	Low disturbance	1	average
Frequency of maintenance activity	<=1 per year	1	1

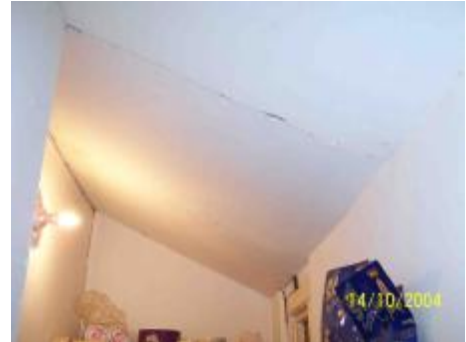
Location ID:	1658
Location Ref:	5
Product:	Cladding
Area:	Not Applicable
Floor:	Ground floor
Room:	Store Room
Surveyor Name:	J D Chilvers
Drawing Ref:	5
Asbestos ?	Yes
Date:	14 October 2004

Priority Assessment Algorithm	Variable(s) selected	Score for each	Overall score
Normal Occupant Activity:			
Main type of activity in area:	Low disturbance	1	average
Secondary activities for area:	Low disturbance	1	1
Likelihood Of Disturbance:			
Location:	Rooms up to 100 m2	2	average
Accessibility:	Occasionally likely to be disturbed	1	
Extent/Amount:	<=10 m2 or <=10 m pipe run	1	
Human Exposure Potential:			
Number of occupants:	1 to 3	1	average
Frequency of use of area:	Daily	3	
Average time area is in use:	<1 hour	0	
Maintenance Activity:			
Type of maintenance activity:	Minor disturbance	0	average
Frequency of maintenance activity	<=1 per year	1	1

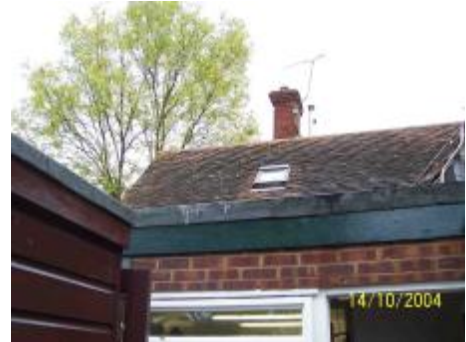
Location ID:	1659
Location Ref:	6
Product:	Roofing felt
Area:	Not Applicable
Floor:	Roof level
Room:	Flat roof area
Surveyor Name:	J D Chilvers
Drawing Ref:	6
Asbestos ?	Yes
Date:	14 October 2004

Priority Assessment Algorithm			
Assessment factor	Variable(s) selected	Score for each	Overall score
Normal Occupant Activity:			
Main type of activity in area:	Rare disturbance	0	average
Secondary activities for area:	Rare disturbance	0	0
Likelihood Of Disturbance:			
Location:	Outdoors	0	
Accessibility:	Usually inaccessible or unlikely to be disturbed	0	average
Extent/Amount:	>10 to <=50 (m2 or pipe run)	2	1
Human Exposure Potential:			
Number of occupants:	None	0	
Frequency of use of area:	Infrequent	0	average
Average time area is in use:	<1 hour	0	0
Maintenance Activity:			
Type of maintenance activity:	Minor disturbance	0	average
Frequency of maintenance activity	<=1 per year	1	1

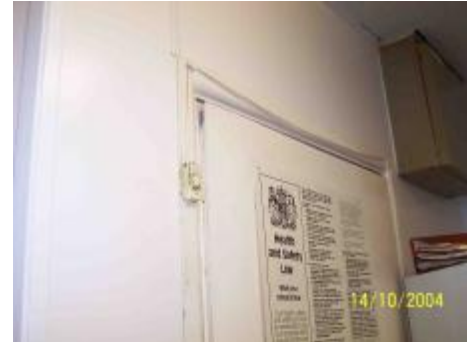
Location ID:	1660
Location Ref:	7
Product:	Door panel
Area:	Not Applicable
Floor:	Ground floor
Room:	Kitchen
Surveyor Name:	J D Chilvers
Drawing Ref:	7
Asbestos ?	Yes
Date:	14 October 2004

Priority Assessment Algorithm	Variable(s) selected	Score for each	Overall score
Normal Occupant Activity:			
Main type of activity in area:	Low disturbance	1	average
Secondary activities for area:	Low disturbance	1	1
Likelihood Of Disturbance:			
Location:	Rooms up to 100 m2	2	average
Accessibility:	Occasionally likely to be disturbed	1	
Extent/Amount:	<=10 m2 or <=10 m pipe run	1	
Human Exposure Potential:			
Number of occupants:	1 to 3	1	average
Frequency of use of area:	Daily	3	
Average time area is in use:	>3 to <6 hours	2	
Maintenance Activity:			
Type of maintenance activity:	Low disturbance	1	average
Frequency of maintenance activity	<=1 per year	1	1

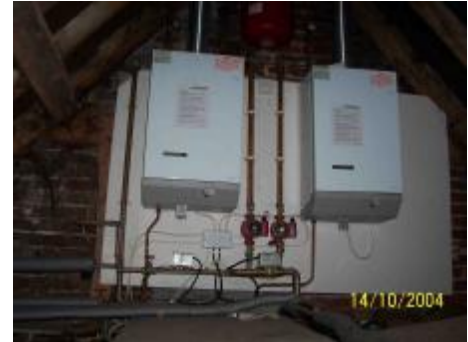
Location ID:	1661
Location Ref:	8
Product:	Boiler
Area:	Not Applicable
Floor:	Roof level
Room:	Loft space
Surveyor Name:	J D Chilvers
Drawing Ref:	8
Asbestos ?	Yes
Date:	14 October 2004

Priority Assessment Algorithm	Variable(s) selected	Score for each	Overall score
Normal Occupant Activity:			
Main type of activity in area:	Rare disturbance	0	average
Secondary activities for area:	Rare disturbance	0	0
Likelihood Of Disturbance:			
Location:	Rooms up to 100 m2	2	average
Accessibility:	Usually inaccessible or unlikely to be disturbed	0	
Extent/Amount:	Small items strings gaskets	0	
Human Exposure Potential:			
Number of occupants:	None	0	average
Frequency of use of area:	Monthly	1	
Average time area is in use:	<1 hour	0	
Maintenance Activity:			
Type of maintenance activity:	Minor disturbance	0	average
Frequency of maintenance activity	<=1 per year	1	1

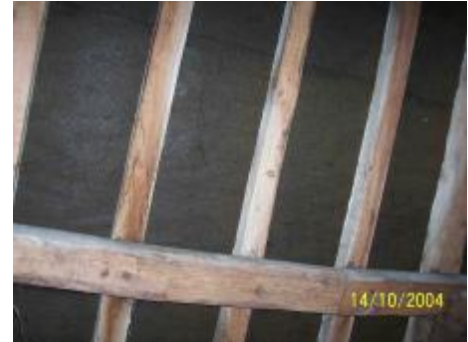
Location ID:	<input style="width: 95%;" type="text" value="1662"/>
Location Ref:	<input style="width: 95%;" type="text" value="9"/>
Product:	<input style="width: 95%;" type="text" value="Roofing felt"/>
Area:	<input style="width: 95%;" type="text" value="Not Applicable"/>
Floor:	<input style="width: 95%;" type="text" value="Roof level"/>
Room:	<input style="width: 95%;" type="text" value="Loft space"/>
Surveyor Name:	<input style="width: 95%;" type="text" value="J D Chilvers"/>
Drawing Ref:	<input style="width: 95%;" type="text" value="9"/>
Asbestos ?	<input style="width: 95%;" type="text" value="Yes"/>
Date:	<input style="width: 95%;" type="text" value="14 October 2004"/>

Priority Assessment Algorithm			
Assessment factor	Variable(s) selected	Score for each	Overall score
Normal Occupant Activity:			
Main type of activity in area:	Rare disturbance	0	average
Secondary activities for area:	Rare disturbance	0	0
Likelihood Of Disturbance:			
Location:	Rooms up to 100 m2	2	
Accessibility:	Usually inaccessible or unlikely to be disturbed	0	average
Extent/Amount:	>50 m2 or >50 m pipe run	3	2
Human Exposure Potential:			
Number of occupants:	None	0	
Frequency of use of area:	Monthly	1	average
Average time area is in use:	<1 hour	0	0
Maintenance Activity:			
Type of maintenance activity:	Minor disturbance	0	average
Frequency of maintenance activity	<=1 per year	1	1

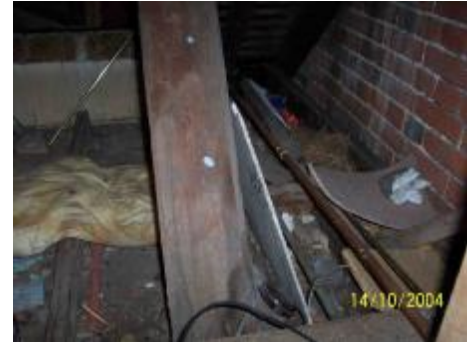
Location ID:	<input type="text" value="1663"/>
Location Ref:	<input type="text" value="10"/>
Product:	<input type="text" value="Debris"/>
Area:	<input type="text" value="Not Applicable"/>
Floor:	<input type="text" value="Roof level"/>
Room:	<input type="text" value="Loft space"/>
Surveyor Name:	<input type="text" value="J D Chilvers"/>
Drawing Ref:	<input type="text" value="10"/>
Asbestos ?	<input type="text" value="Yes"/>
Date:	<input type="text" value="14 October 2004"/>

Priority Assessment Algorithm			
Assessment factor	Variable(s) selected	Score for each	Overall score
Normal Occupant Activity:			
Main type of activity in area:	Rare disturbance	0	average
Secondary activities for area:	Rare disturbance	0	0
Likelihood Of Disturbance:			
Location:	Rooms up to 100 m2	2	
Accessibility:	Occasionally likely to be disturbed	1	average
Extent/Amount:	<=10 m2 or <=10 m pipe run	1	1
Human Exposure Potential:			
Number of occupants:	None	0	
Frequency of use of area:	Infrequent	0	average
Average time area is in use:	<1 hour	0	0
Maintenance Activity:			
Type of maintenance activity:	Minor disturbance	0	average
Frequency of maintenance activity	<=1 per year	1	1

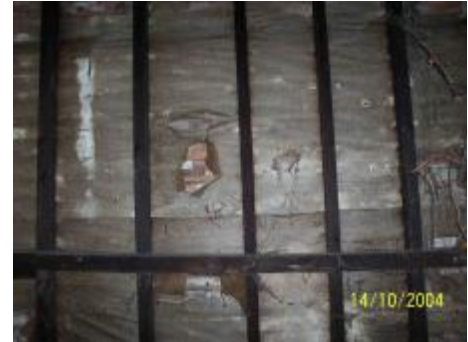
Location ID:	<input style="width: 90%;" type="text" value="1666"/>
Location Ref:	<input style="width: 90%;" type="text" value="13"/>
Product:	<input style="width: 90%;" type="text" value="Roofing felt"/>
Area:	<input style="width: 90%;" type="text" value="Not Applicable"/>
Floor:	<input style="width: 90%;" type="text" value="Ground floor"/>
Room:	<input style="width: 90%;" type="text" value="Garage(s)"/>
Surveyor Name:	<input style="width: 90%;" type="text" value="J D Chilvers"/>
Drawing Ref:	<input style="width: 90%;" type="text" value="13"/>
Asbestos ?	<input style="width: 90%;" type="text" value="Yes"/>
Date:	<input style="width: 90%;" type="text" value="14 October 2004"/>

Priority Assessment Algorithm			
Assessment factor	Variable(s) selected	Score for each	Overall score
Normal Occupant Activity:			
Main type of activity in area:	Rare disturbance	0	average
Secondary activities for area:	Rare disturbance	0	0
Likelihood Of Disturbance:			
Location:	Large rooms or well-ventilated areas	1	
Accessibility:	Usually inaccessible or unlikely to be disturbed	0	average
Extent/Amount:	>50 m2 or >50 m pipe run	3	1
Human Exposure Potential:			
Number of occupants:	None	0	
Frequency of use of area:	Weekly	2	average
Average time area is in use:	<1 hour	0	1
Maintenance Activity:			
Type of maintenance activity:	Minor disturbance	0	average
Frequency of maintenance activity	<=1 per year	1	1

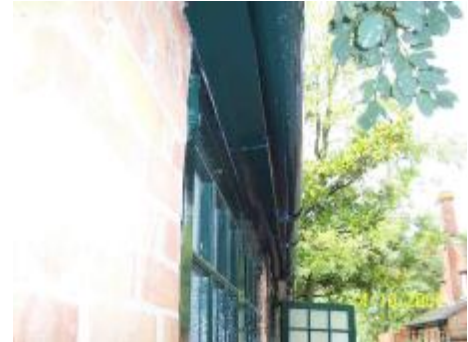
Location ID:	<input style="width: 95%;" type="text" value="1667"/>
Location Ref:	<input style="width: 95%;" type="text" value="14"/>
Product:	<input style="width: 95%;" type="text" value="Soffit"/>
Area:	<input style="width: 95%;" type="text" value="Not Applicable"/>
Floor:	<input style="width: 95%;" type="text" value="Roof level"/>
Room:	<input style="width: 95%;" type="text" value="External"/>
Surveyor Name:	<input style="width: 95%;" type="text" value="J D Chilvers"/>
Drawing Ref:	<input style="width: 95%;" type="text" value="14"/>
Asbestos ?	<input style="width: 95%;" type="text" value="Yes"/>
Date:	<input style="width: 95%;" type="text" value="14 October 2004"/>

Priority Assessment Algorithm			
Assessment factor	Variable(s) selected	Score for each	Overall score
Normal Occupant Activity:			
Main type of activity in area:	Rare disturbance	0	average
Secondary activities for area:	Rare disturbance	0	0
Likelihood Of Disturbance:			
Location:	Outdoors	0	
Accessibility:	Usually inaccessible or unlikely to be disturbed	0	average
Extent/Amount:	<=10 m2 or <=10 m pipe run	1	0
Human Exposure Potential:			
Number of occupants:	None	0	
Frequency of use of area:	Infrequent	0	average
Average time area is in use:	<1 hour	0	0
Maintenance Activity:			
Type of maintenance activity:	Low disturbance	1	average
Frequency of maintenance activity	<=1 per year	1	1

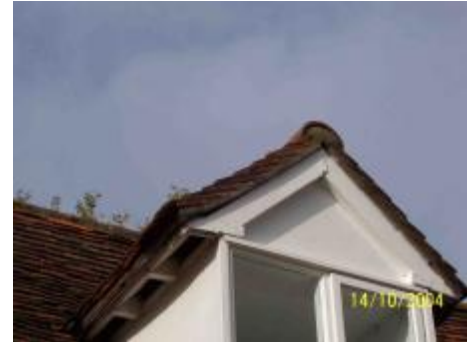
Location ID:	1668
Location Ref:	15
Product:	Verge Undercloak
Area:	Not Applicable
Floor:	Roof level
Room:	External
Surveyor Name:	J D Chilvers
Drawing Ref:	15
Asbestos ?	Yes
Date:	14 October 2004

Priority Assessment Algorithm	Variable(s) selected	Score for each	Overall score
Normal Occupant Activity:			
Main type of activity in area:	Rare disturbance	0	average
Secondary activities for area:	Rare disturbance	0	0
Likelihood Of Disturbance:			
Location:	Outdoors	0	
Accessibility:	Usually inaccessible or unlikely to be disturbed	0	average
Extent/Amount:	<=10 m2 or <=10 m pipe run	1	0
Human Exposure Potential:			
Number of occupants:	None	0	
Frequency of use of area:	Infrequent	0	average
Average time area is in use:	<1 hour	0	0
Maintenance Activity:			
Type of maintenance activity:	Minor disturbance	0	average
Frequency of maintenance activity	<=1 per year	1	1

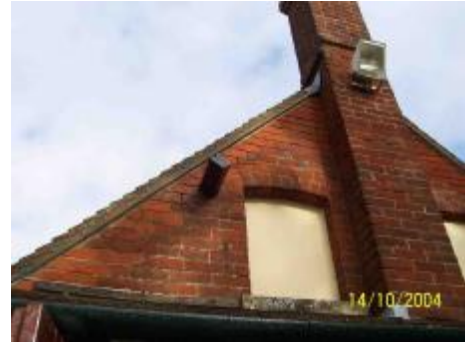
Location ID:	1669
Location Ref:	16
Product:	Verge Undercloak
Area:	Not Applicable
Floor:	Roof level
Room:	External
Surveyor Name:	J D Chilvers
Drawing Ref:	16
Asbestos ?	Yes
Date:	14 October 2004

Priority Assessment Algorithm	Variable(s) selected	Score for each	Overall score
Normal Occupant Activity:			
Main type of activity in area:	Rare disturbance	0	average
Secondary activities for area:	Rare disturbance	0	0
Likelihood Of Disturbance:			
Location:	Outdoors	0	
Accessibility:	Usually inaccessible or unlikely to be disturbed	0	average
Extent/Amount:	<=10 m2 or <=10 m pipe run	1	0
Human Exposure Potential:			
Number of occupants:	None	0	
Frequency of use of area:	Infrequent	0	average
Average time area is in use:	<1 hour	0	0
Maintenance Activity:			
Type of maintenance activity:	Low disturbance	1	average
Frequency of maintenance activity	<=1 per year	1	1
