# **Asbestos Survey for**

Hall & Woodhouse Ltd

Red Lion (Sturminster Marshall)

Project Number: AS04084 - Red Lion Sturminster Marshall

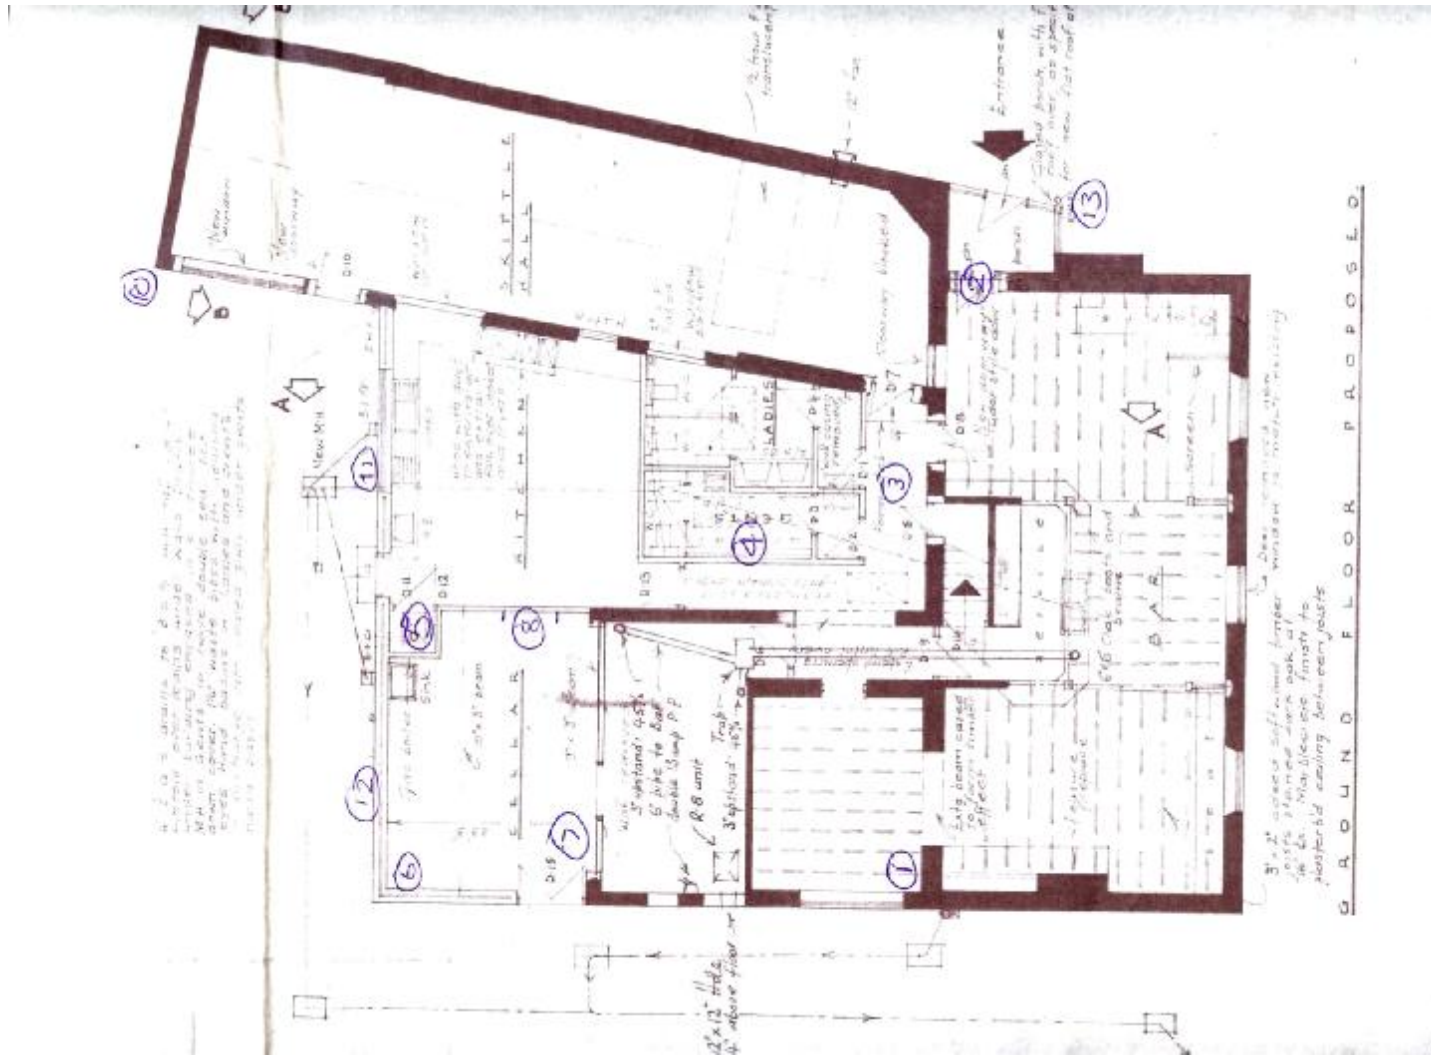
Description of Drawing:  
Ground floor layout.

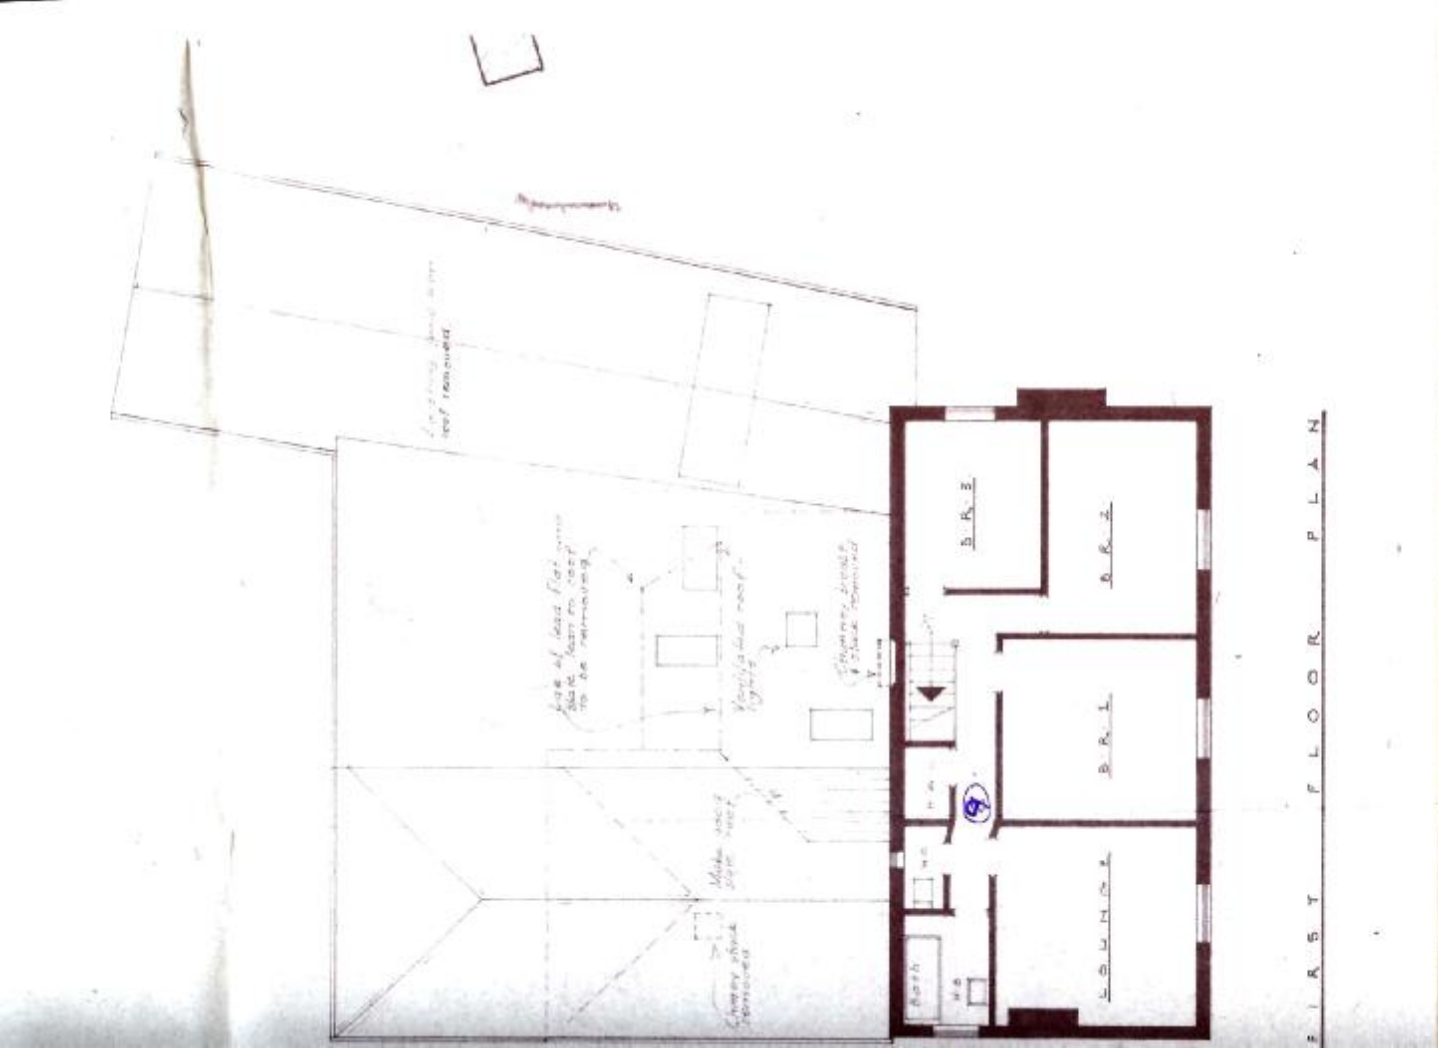
Description of Drawing:  
First floor layout.

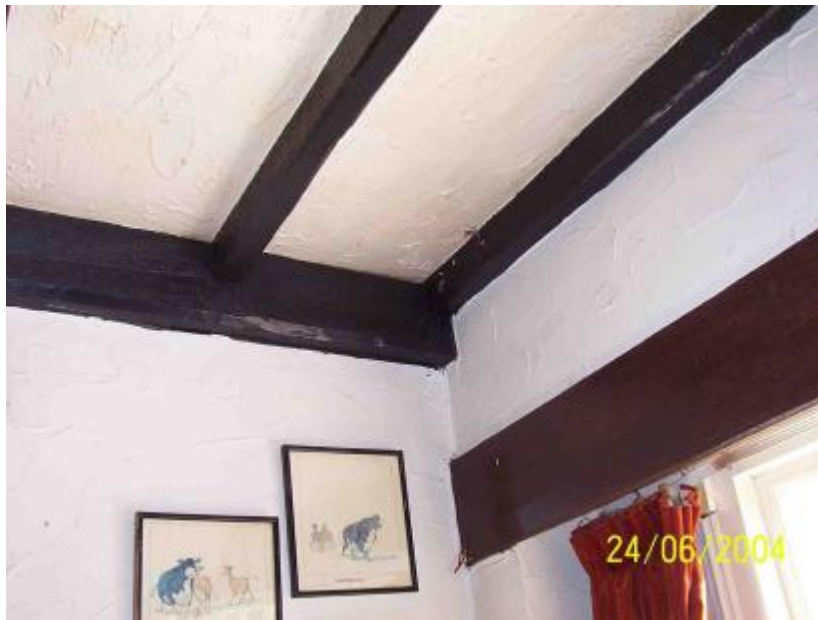
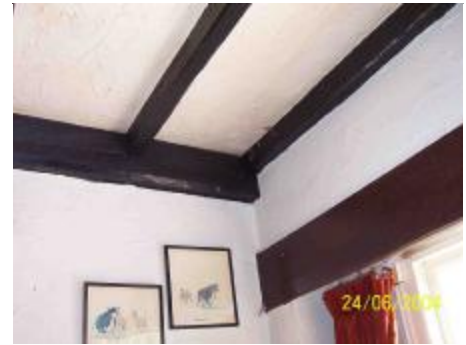
Location ID:	1896	Survey Type:	T 2
Location Ref:	1	Product Type:	Decorative finishes
Product:	Textured coating	Damage:	No visible damage
Area:	Not Applicable	Treatment:	Composite asbestos materials
Floor:	Ground floor	Asbestos Type:	Chrysotile
Room:	Bar area	Identification:	Identified
Surveyor Name:	J D Chilvers	Quantity:	
Drawing Ref:	1	Accessibility:	Medium Accessibility
Asbestos ?	Yes		
Date:	24 June 2004		
Next Inspection:	24 June 2005

Material Risk Score	2
Material Risk Band:	Very Low Risk
Priority Risk Score:	5

Location ID:	1896
Location Ref:	1
Product:	Textured coating
Area:	Not Applicable
Floor:	Ground floor
Room:	Bar area
Surveyor Name:	J D Chilvers
Drawing Ref:	1
Asbestos ?	Yes
Date:	24 June 2004

Action: Apply Warning Labels

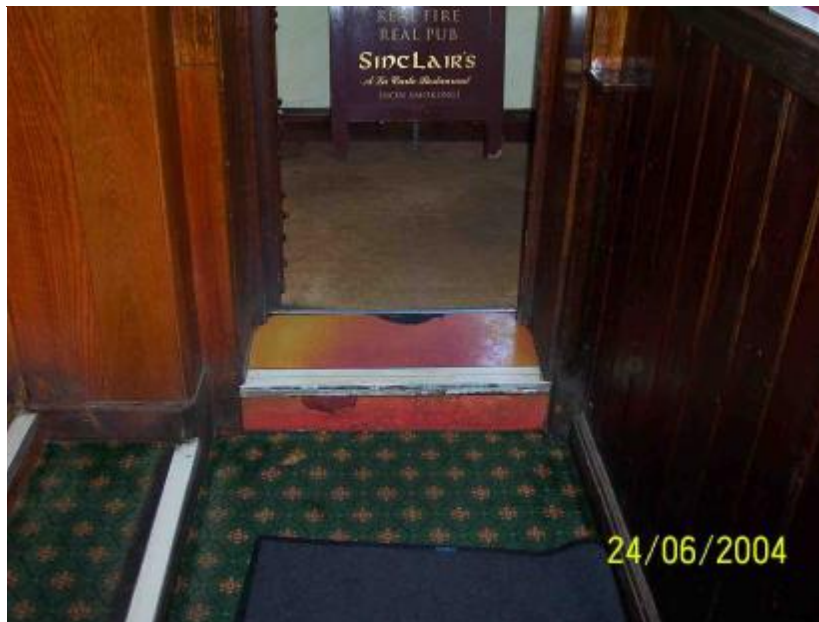
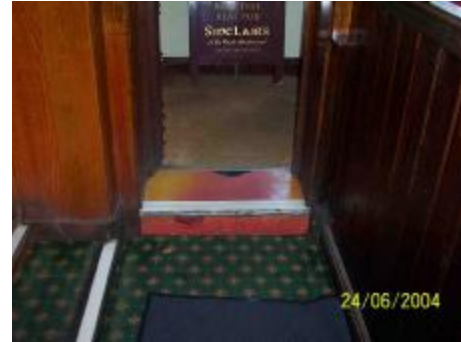
Location ID:	1897	Survey Type:	T 2
Location Ref:	2	Product Type:	Vinyl floor tiles
Product:	Floor tiles	Damage:	Low damage: Broken edge Tiles
Area:	Not Applicable	Treatment:	Vinyl tiles
Floor:	Ground floor	Asbestos Type:	Chrysotile
Room:	Lobby	Identification:	Identified
Surveyor Name:	J D Chilvers	Quantity:	
Drawing Ref:	2	Accessibility:	Easy Accessibility
Asbestos ?	Yes		
Date:	24 June 2004		
Next Inspection:	24 June 2005

Priority Risk Score: 5

Location ID:	1897
Location Ref:	2
Product:	Floor tiles
Area:	Not Applicable
Floor:	Ground floor
Room:	Lobby
Surveyor Name:	J D Chilvers
Drawing Ref:	2
Asbestos ?	Yes
Date:	24 June 2004

Action: Minor deterioration but No Action Required

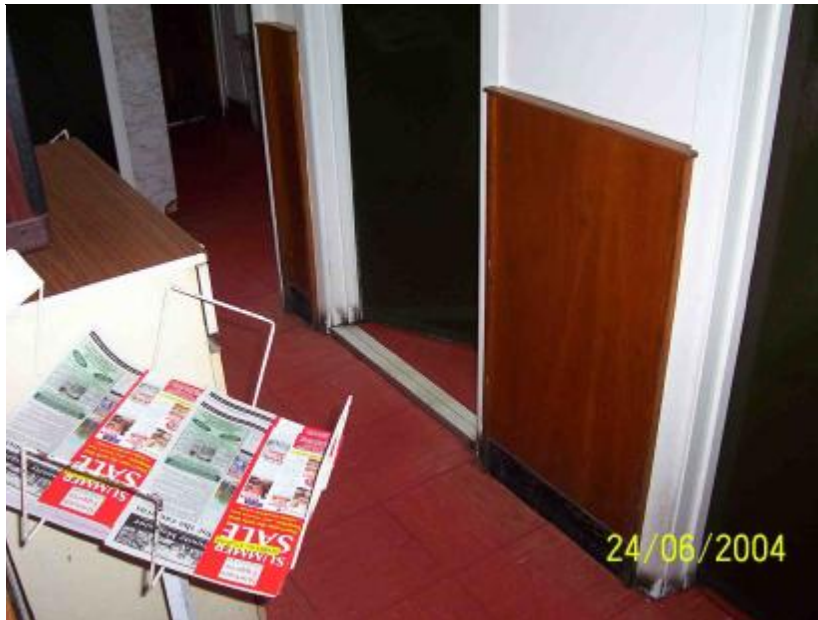
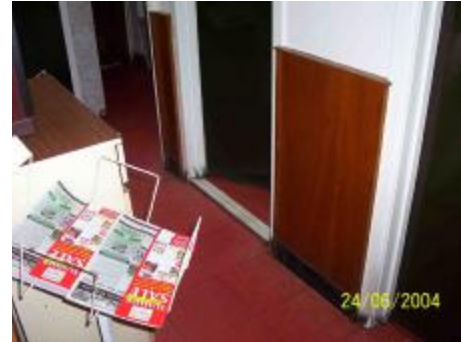
Location ID:	1898	Survey Type:	T 2
Location Ref:	3	Product Type:	Vinyl floor tiles
Product:	Floor tiles	Damage:	No visible damage
Area:	Not Applicable	Treatment:	Vinyl tiles
Floor:	Ground floor	Asbestos Type:	Chrysotile
Room:	Corridor	Identification:	Strongly Presumed as previous sample
Surveyor Name:	J D Chilvers	Quantity:	
Drawing Ref:	3	Accessibility:	Easy Accessibility
Asbestos ?	Yes		
Date:	24 June 2004		
Next Inspection:	24 June 2005

Material Risk Score	2
Material Risk Band:	Very Low Risk
Priority Risk Score:	4

Location ID:	1898
Location Ref:	3
Product:	Floor tiles
Area:	Not Applicable
Floor:	Ground floor
Room:	Corridor
Surveyor Name:	J D Chilvers
Drawing Ref:	3
Asbestos ?	Yes
Date:	24 June 2004

Action: No Action Required

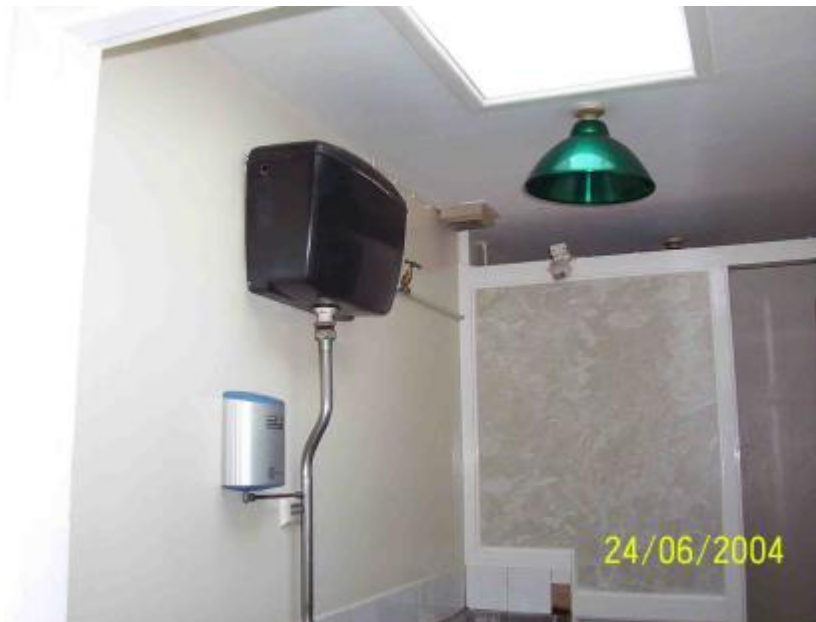
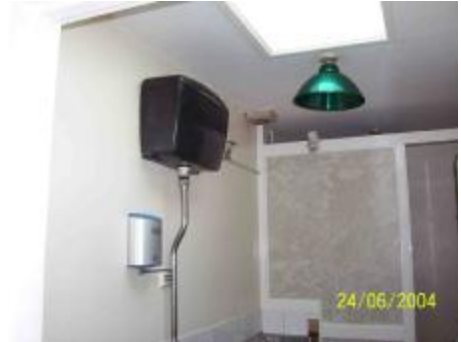
Location ID:	1899	Survey Type:	T 2
Location Ref:	4	Product Type:	Plastics
Product:	Cistern	Damage:	No visible damage
Area:	Not Applicable	Treatment:	Reinforced plastics
Floor:	Ground floor	Asbestos Type:	Chrysotile
Room:	WC - mens	Identification:	Presumed
Surveyor Name:	J D Chilvers	Quantity:	
Drawing Ref:	4	Accessibility:	Easy Accessibility
Asbestos ?	Yes		
Date:	24 June 2004		
Next Inspection:	24 June 2005

Material Risk Score	2
Material Risk Band:	Very Low Risk
Priority Risk Score:	4

Location ID:	1899
Location Ref:	4
Product:	Cistern
Area:	Not Applicable
Floor:	Ground floor
Room:	WC - mens
Surveyor Name:	J D Chilvers
Drawing Ref:	4
Asbestos ?	Yes
Date:	24 June 2004

Action: Apply Warning Labels

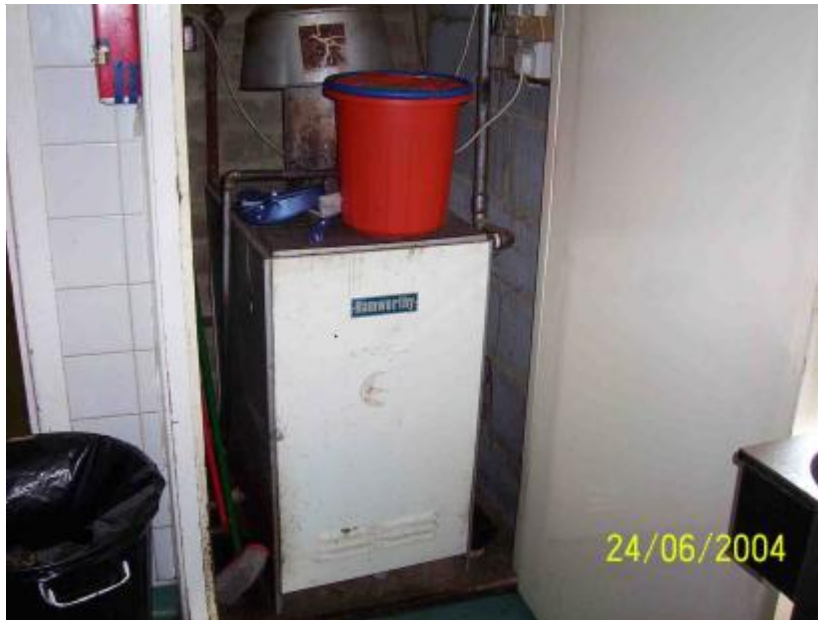
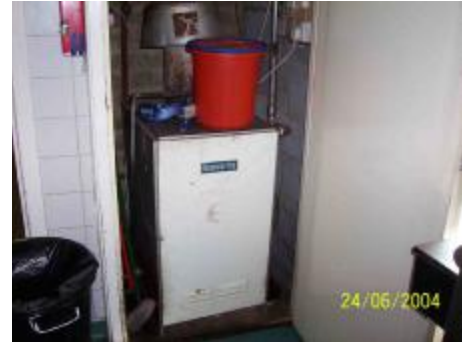
Location ID:	1900	Survey Type:	T 2
Location Ref:	5	Product Type:	Gaskets
Product:	Boiler	Damage:	No visible damage
Area:	Not Applicable	Treatment:	Composite asbestos materials
Floor:	Ground floor	Asbestos Type:	Chrysotile
Room:	Boiler cupboard	Identification:	Presumed
Surveyor Name:	J D Chilvers	Quantity:	
Drawing Ref:	5	Accessibility:	Medium Accessibility
Asbestos ?	Yes		
Date:	24 June 2004		
Next Inspection:	24 June 2005

Material Risk Score	3
Material Risk Band:	Very Low Risk
Priority Risk Score:	3

Location ID:	1900
Location Ref:	5
Product:	Boiler
Area:	Not Applicable
Floor:	Ground floor
Room:	Boiler cupboard
Surveyor Name:	J D Chilvers
Drawing Ref:	5
Asbestos ?	Yes
Date:	24 June 2004

Action: Apply Warning Labels

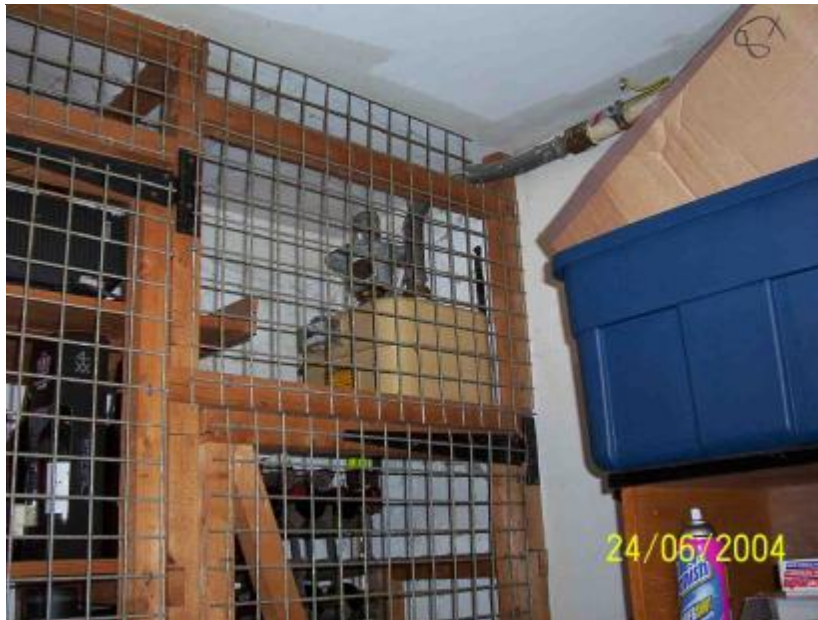
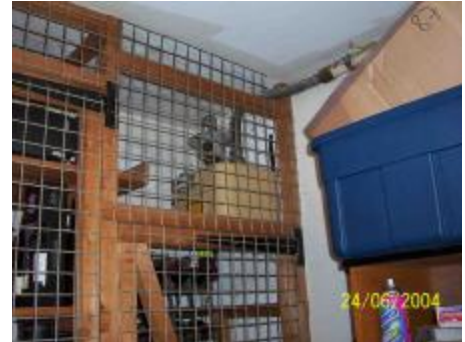
Location ID:	1901	Survey Type:	T 2
Location Ref:	6	Product Type:	Gaskets
Product:	Gas meter	Damage:	No visible damage
Area:	Not Applicable	Treatment:	Composite asbestos materials
Floor:	Ground floor	Asbestos Type:	Chrysotile
Room:	Cellar	Identification:	Presumed
Surveyor Name:	J D Chilvers	Quantity:	
Drawing Ref:	6	Accessibility:	Medium Accessibility
Asbestos ?	Yes		
Date:	24 June 2004		
Next Inspection:	24 June 2005

Material Risk Score	3
Material Risk Band:	Very Low Risk
Priority Risk Score:	3

Location ID:	1901
Location Ref:	6
Product:	Gas meter
Area:	Not Applicable
Floor:	Ground floor
Room:	Cellar
Surveyor Name:	J D Chilvers
Drawing Ref:	6
Asbestos ?	Yes
Date:	24 June 2004

Action: Apply Warning Labels

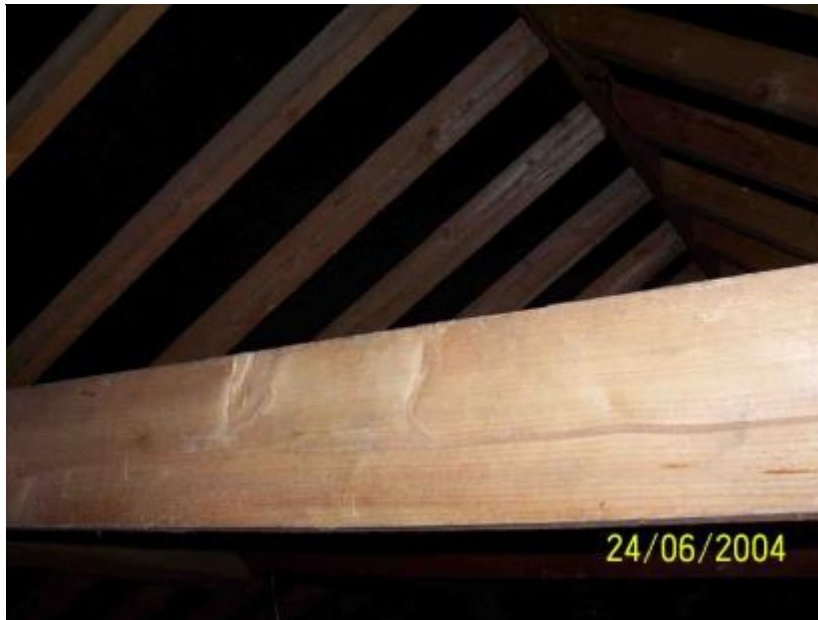
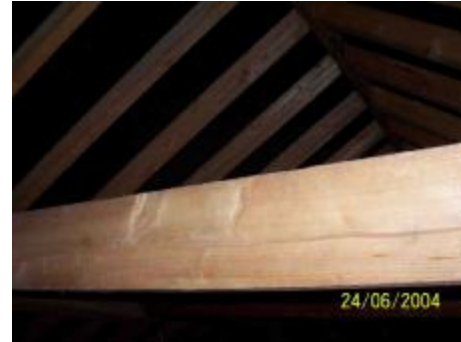
Location ID:	1902	Survey Type:	T 2
Location Ref:	7	Product Type:	Roofing felts
Product:	Roofing felt	Damage:	No visible damage
Area:	Not Applicable	Treatment:	Resins
Floor:	Roof level	Asbestos Type:	Chrysotile
Room:	Loft space	Identification:	Presumed
Surveyor Name:	J D Chilvers	Quantity:	
Drawing Ref:	7	Accessibility:	Medium Accessibility
Asbestos ?	Yes		
Date:	24 June 2004		
Next Inspection:	24 June 2005

Material Risk Score	2
Material Risk Band:	Very Low Risk
Priority Risk Score:	2

Location ID:	<span style="border: 1px solid black; padding: 2px;">1902</span>
Location Ref:	<span style="border: 1px solid black; padding: 2px;">7</span>
Product:	<span style="border: 1px solid black; padding: 2px;">Roofing felt</span>
Area:	<span style="border: 1px solid black; padding: 2px;">Not Applicable</span>
Floor:	<span style="border: 1px solid black; padding: 2px;">Roof level</span>
Room:	<span style="border: 1px solid black; padding: 2px;">Loft space</span>
Surveyor Name:	<span style="border: 1px solid black; padding: 2px;">J D Chilvers</span>
Drawing Ref:	<span style="border: 1px solid black; padding: 2px;">7</span>
Asbestos ?	<span style="border: 1px solid black; padding: 2px;">Yes</span>
Date:	<span style="border: 1px solid black; padding: 2px;">24 June 2004</span>

Action: No Action Required

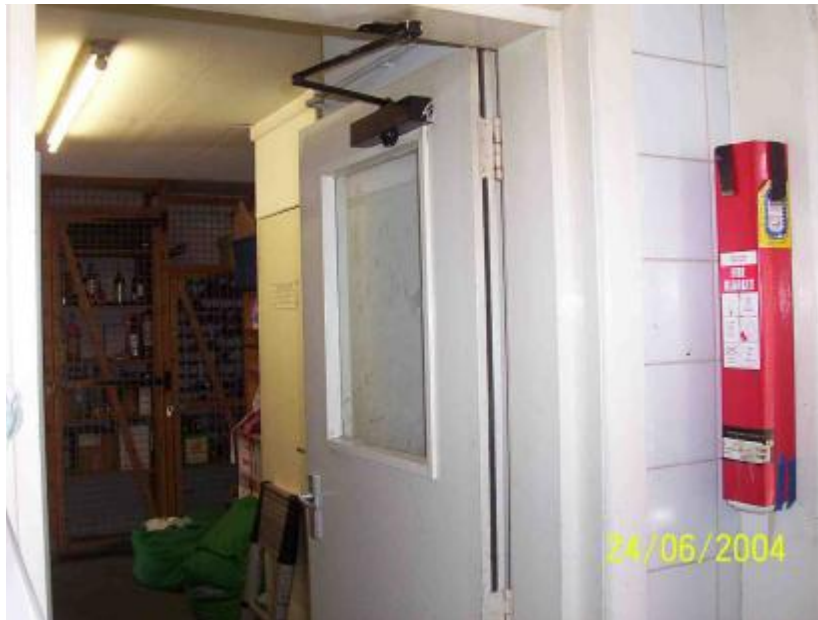
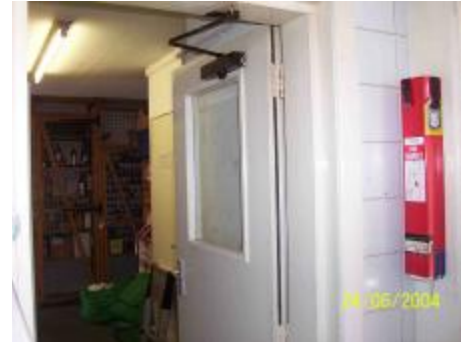
Location ID:	1903	Survey Type:	T 2
Location Ref:	8	Product Type:	Asbestos cement
Product:	Fire Door	Damage:	No visible damage
Area:	Not Applicable	Treatment:	Asbestos cement sheets etc
Floor:	Ground floor	Asbestos Type:	Chrysotile
Room:	All	Identification:	Presumed
Surveyor Name:	J D Chilvers	Quantity:	
Drawing Ref:	8	Accessibility:	Medium Accessibility
Asbestos ?	Yes		
Date:	24 June 2004		
Next Inspection:	24 June 2005

Priority Risk Score: 5

Material Comments: All fire doors are presumed to contain ACM's until proven otherwise.

Location ID:	1903
Location Ref:	8
Product:	Fire Door
Area:	Not Applicable
Floor:	Ground floor
Room:	All
Surveyor Name:	J D Chilvers
Drawing Ref:	8
Asbestos ?	Yes
Date:	24 June 2004

Action: Apply Warning Labels

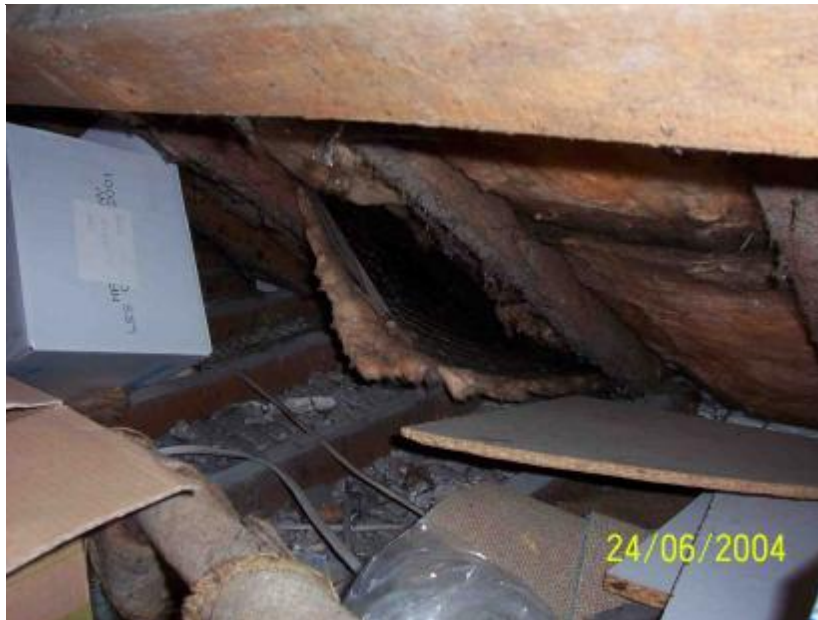
Location ID:	1904	Survey Type:	T 2
Location Ref:	9	Product Type:	NADIS
Product:	Insulation	Damage:	NADIS
Area:	Not Applicable	Treatment:	NADIS
Floor:	First floor	Asbestos Type:	NADIS
Room:	Loft space	Identification:	Identified
Surveyor Name:	J D Chilvers	Quantity:	
Drawing Ref:	9	Accessibility:	
Asbestos ?	No		
Date:	24 June 2004		
Next Inspection:	Not Applicable

Material Risk Score	0
Material Risk Band:	NADIS
Priority Risk Score:	N/A

Action: No Action Required

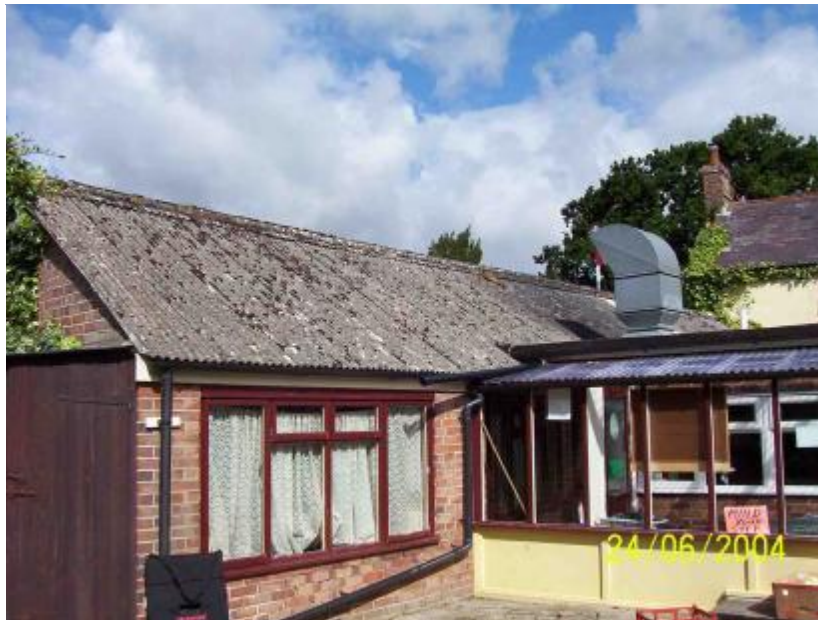
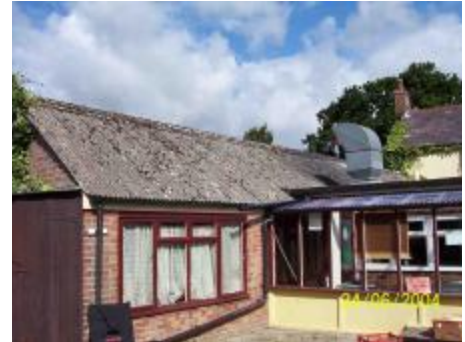
Location ID:	1905	Survey Type:	T 2
Location Ref:	10	Product Type:	Asbestos cement
Product:	Roofing Sheets	Damage:	No visible damage
Area:	Not Applicable	Treatment:	Asbestos cement sheets etc
Floor:	Roof	Asbestos Type:	Chrysotile
Room:	External	Identification:	Identified
Surveyor Name:	J D Chilvers	Quantity:	
Drawing Ref:	10	Accessibility:	Medium Accessibility
Asbestos ?	Yes		
Date:	24 June 2004		
Next Inspection:	24 June 2005

Material Risk Score	3
Material Risk Band:	Very Low Risk
Priority Risk Score:	2

Location ID:	1905
Location Ref:	10
Product:	Roofing Sheets
Area:	Not Applicable
Floor:	Roof
Room:	External
Surveyor Name:	J D Chilvers
Drawing Ref:	10
Asbestos ?	Yes
Date:	24 June 2004

Action: Apply Warning Labels

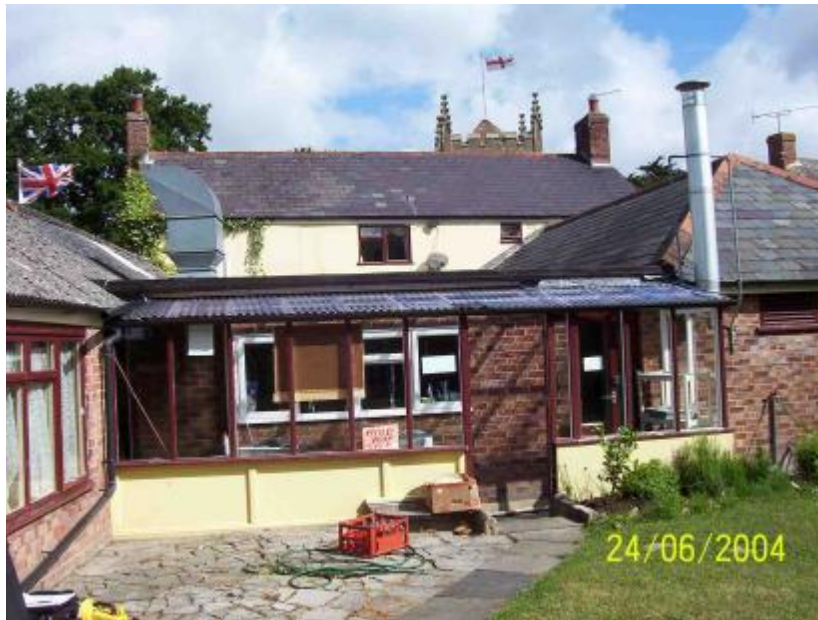
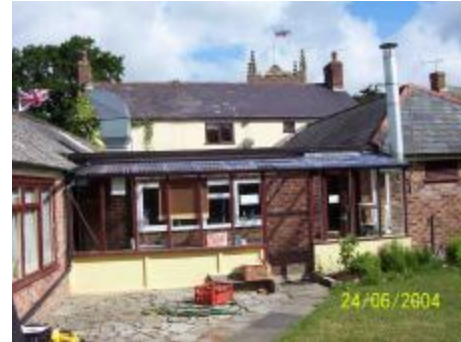
Location ID:	1906	Survey Type:	T 2
Location Ref:	11	Product Type:	Roofing felts
Product:	Roofing felt	Damage:	No visible damage
Area:	Not Applicable	Treatment:	Resins
Floor:	External	Asbestos Type:	Chrysotile
Room:	Flat roof area	Identification:	Presumed
Surveyor Name:	J D Chilvers	Quantity:	
Drawing Ref:	11	Accessibility:	Medium Accessibility
Asbestos ?	Yes		
Date:	24 June 2004		
Next Inspection:	24 June 2005

Material Risk Score	2
Material Risk Band:	Very Low Risk
Priority Risk Score:	2

Location ID:	1906
Location Ref:	11
Product:	Roofing felt
Area:	Not Applicable
Floor:	External
Room:	Flat roof area
Surveyor Name:	J D Chilvers
Drawing Ref:	11
Asbestos ?	Yes
Date:	24 June 2004

Action: No Action Required

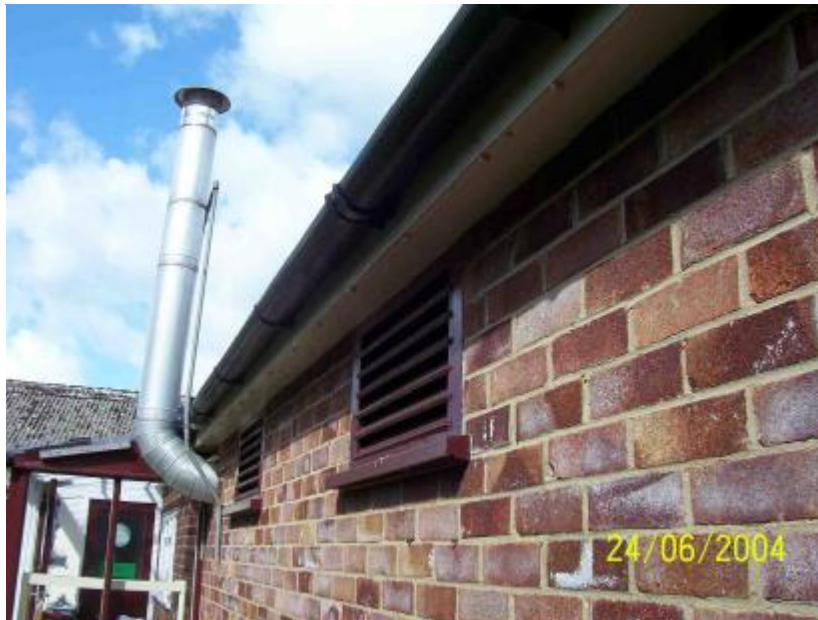
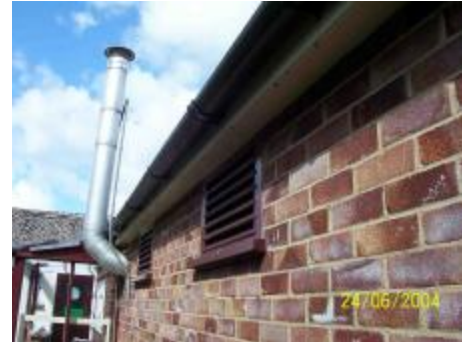
Location ID:	1907	Survey Type:	T 2
Location Ref:	12	Product Type:	Asbestos cement
Product:	Soffit	Damage:	No visible damage
Area:	Not Applicable	Treatment:	Asbestos cement sheets etc
Floor:	Roof level	Asbestos Type:	Chrysotile
Room:	External	Identification:	Strongly Presumed
Surveyor Name:	J D Chilvers	Quantity:	
Drawing Ref:	12	Accessibility:	Medium Accessibility
Asbestos ?	Yes		
Date:	24 June 2004		
Next Inspection:	24 June 2005

Material Risk Score	3
Material Risk Band:	Very Low Risk
Priority Risk Score:	2

Location ID:	1907
Location Ref:	12
Product:	Soffit
Area:	Not Applicable
Floor:	Roof level
Room:	External
Surveyor Name:	J D Chilvers
Drawing Ref:	12
Asbestos ?	Yes
Date:	24 June 2004

Action: Apply Warning Labels
