Asbestos Survey for

Hall & Woodhouse Ltd

Bull Tavern
Town Bridge
Sturminster Newton
Dorset
DT10 2BS

Project Number: AS04189 - Bull Tavern Sturminster Newton

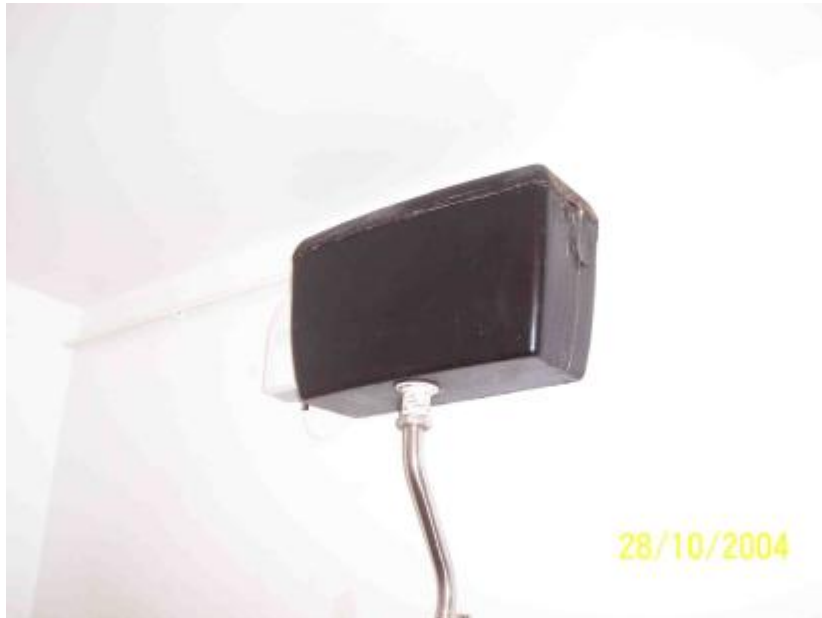
Location ID:	1783	Survey Type:	T 2
Location Ref:	1	Product Type:	Plastics
Product:	Cistern	Damage:	Low damage: Scratches or marks
Area:	Not Applicable	Treatment:	Reinforced plastics
Floor:	Ground floor	Asbestos Type:	Chrysotile
Room:	WC	Identification:	Presumed
Surveyor Name:	J D Chilvers	Quantity:	
Drawing Ref:	1	Accessibility:	Easy Accessibility
Asbestos ?	Yes		
Date:	28 October 2004		
Next Inspection:	28 October 2005

Material Risk Score	3
Material Risk Band:	Very Low Risk
Priority Risk Score:	4

Action: Apply Warning Labels

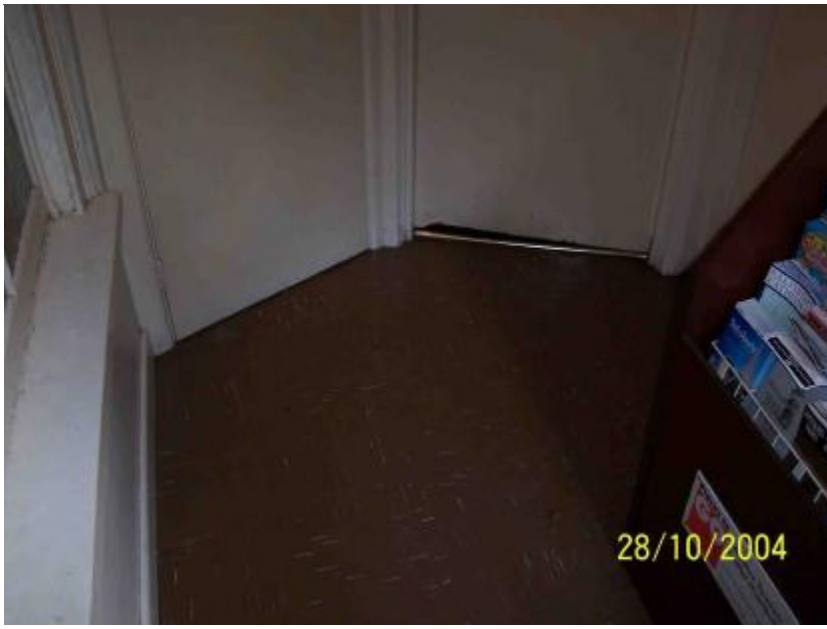
Location ID:	<input type="text" value="1784"/>	Survey Type:	<input type="text" value="T 2"/>						
Location Ref:	<input type="text" value="2"/>	Product Type:	<input type="text" value="Vinyl floor tiles"/>						
Product:	<input type="text" value="Floor tiles"/>	Damage:	<input type="text" value="No visible damage"/>						
Area:	<input type="text" value="Not Applicable"/>	Treatment:	<input type="text" value="Vinyl tiles"/>						
Floor:	<input type="text" value="Ground floor"/>	Asbestos Type:	<input type="text" value="Chrysotile"/>						
Room:	<input type="text" value="Passageway"/>	Identification:	<input type="text" value="Presumed"/>						
Surveyor Name:	<input type="text" value="J D Chilvers"/>	Quantity:	<input type="text"/>						
Drawing Ref:	<input type="text" value="2"/>	Accessibility:	<input type="text" value="Easy Accessibility"/>						
Asbestos ?	<input type="text" value="Yes"/>

Material Risk Score	<input type="text" value="2"/>	Material Risk Band:	<input type="text" value="Very Low Risk"/>	Priority Risk Score:	<input type="text" value="4"/>
Material Risk Score	<input type="text" value="2"/>								
Material Risk Band:	<input type="text" value="Very Low Risk"/>								
Priority Risk Score:	<input type="text" value="4"/>								
Date:	<input type="text" value="28 October 2004"/>								
Next Inspection:	<input type="text" value="28 October 2005"/>

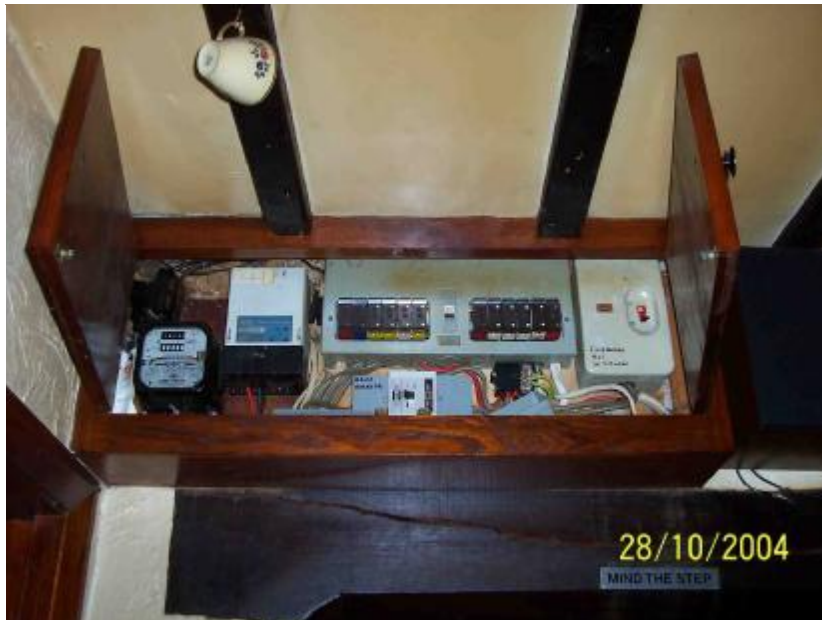
Location ID:	<input type="text" value="1785"/>	Survey Type:	<input type="text" value="T 2"/>						
Location Ref:	<input type="text" value="3"/>	Product Type:	<input type="text" value="Ropes and woven textiles"/>						
Product:	<input type="text" value="Fuse & Switchgear Flashguard"/>	Damage:	<input type="text" value="No visible damage"/>						
Area:	<input type="text" value="Not Applicable"/>	Treatment:	<input type="text" value="Composite asbestos materials"/>						
Floor:	<input type="text" value="Ground floor"/>	Asbestos Type:	<input type="text" value="Chrysotile"/>						
Room:	<input type="text" value="Electrical cupboard"/>	Identification:	<input type="text" value="Presumed"/>						
Surveyor Name:	<input type="text" value="J D Chilvers"/>	Quantity:	<input type="text"/>						
Drawing Ref:	<input type="text" value="3"/>	Accessibility:	<input type="text" value="Medium Accessibility"/>						
Asbestos ?	<input type="text" value="Yes"/>

Material Risk Score	<input type="text" value="3"/>	Material Risk Band:	<input type="text" value="Very Low Risk"/>	Priority Risk Score:	<input type="text" value="2"/>
Material Risk Score	<input type="text" value="3"/>								
Material Risk Band:	<input type="text" value="Very Low Risk"/>								
Priority Risk Score:	<input type="text" value="2"/>								
Date:	<input type="text" value="28 October 2004"/>								
Next Inspection:	<input type="text" value="28 October 2005"/>								
Action:	Apply Warning Labels

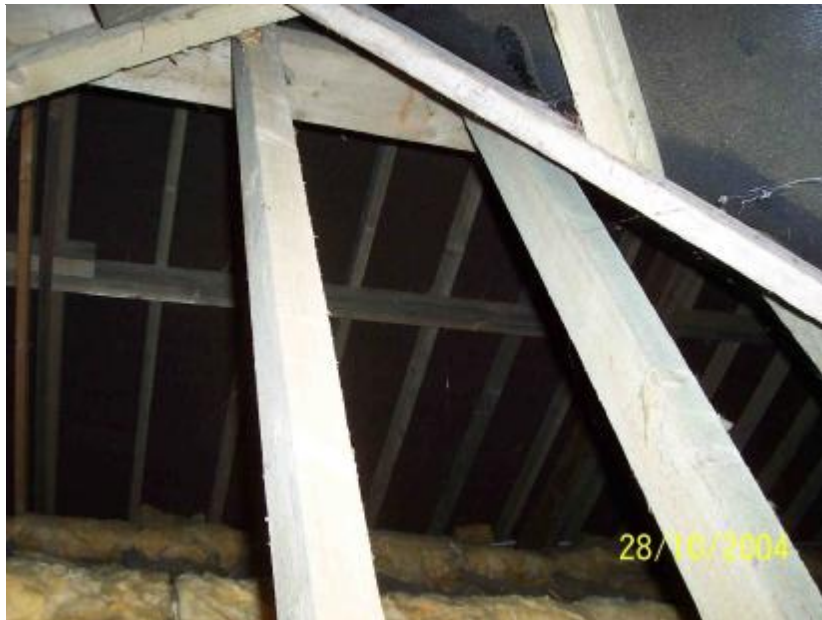
Location ID:	1786	Survey Type:	T 2
Location Ref:	4	Product Type:	Roofing felts
Product:	Roofing felt	Damage:	No visible damage
Area:	Not Applicable	Treatment:	Resins
Floor:	Roof level	Asbestos Type:	Chrysotile
Room:	Loft space	Identification:	Presumed
Surveyor Name:	J D Chilvers	Quantity:	
Drawing Ref:	4	Accessibility:	Difficult Accessibility
Asbestos ?	Yes		
Date:	28 October 2004		
Next Inspection:	28 October 2005

Priority Risk Score: 2

Action: No Action Required

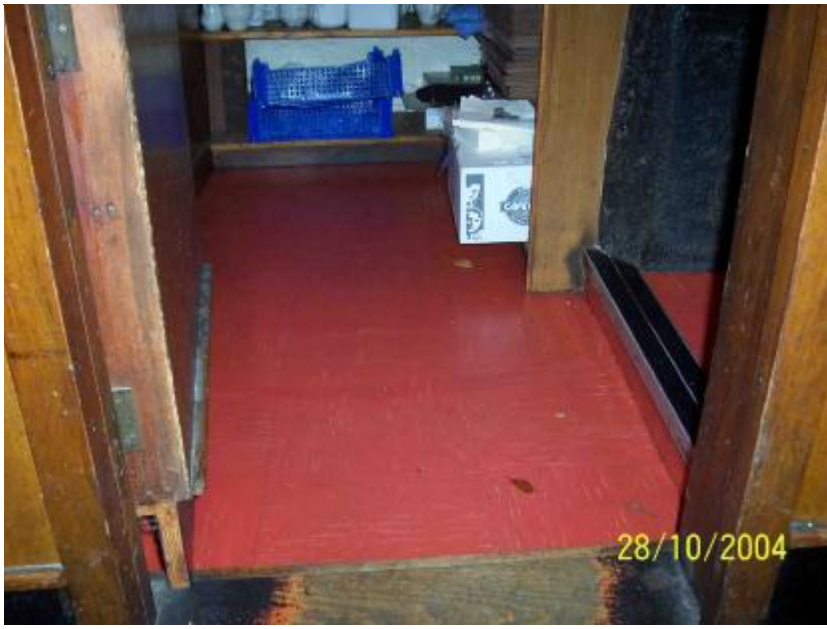
Location ID:	<input type="text" value="1787"/>	Survey Type:	<input type="text" value="T 2"/>
Location Ref:	<input type="text" value="5"/>	Product Type:	<input type="text" value="NADIS"/>
Product:	<input type="text" value="Floor tiles"/>	Damage:	<input type="text" value="NADIS"/>
Area:	<input type="text" value="Not Applicable"/>	Treatment:	<input type="text" value="NADIS"/>
Floor:	<input type="text" value="Ground floor"/>	Asbestos Type:	<input type="text" value="NADIS"/>
Room:	<input type="text" value="Bar area"/>	Identification:	<input type="text" value="Identified"/>
Surveyor Name:	<input type="text" value="J D Chilvers"/>	Quantity:	<input type="text"/>

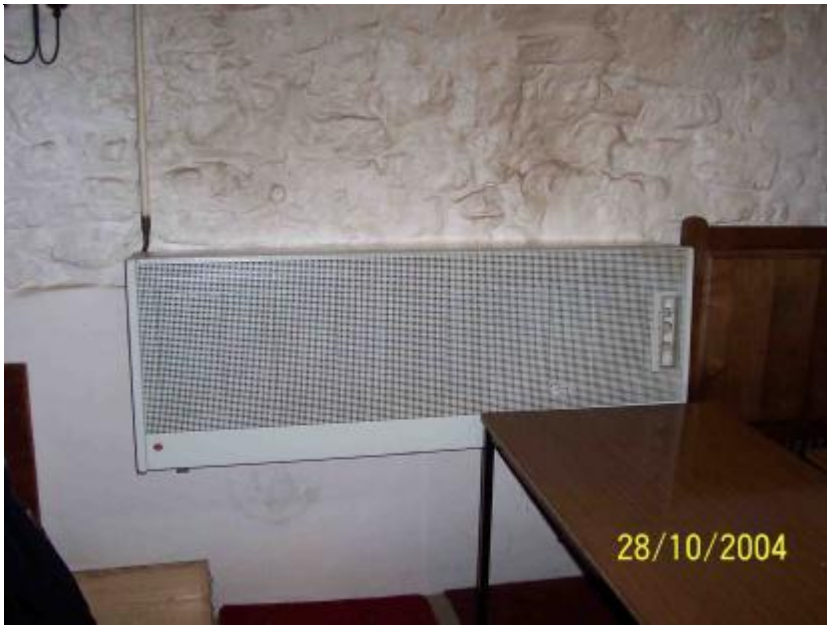
Location ID:	<input type="text" value="1788"/>	Survey Type:	<input type="text" value="T 2"/>						
Location Ref:	<input type="text" value="6"/>	Product Type:	<input type="text" value="Gaskets"/>						
Product:	<input type="text" value="Heater"/>	Damage:	<input type="text" value="No visible damage"/>						
Area:	<input type="text" value="Not Applicable"/>	Treatment:	<input type="text" value="Composite asbestos materials"/>						
Floor:	<input type="text" value="Ground floor"/>	Asbestos Type:	<input type="text" value="Chrysotile"/>						
Room:	<input type="text" value="Skittle Alley"/>	Identification:	<input type="text" value="Presumed"/>						
Surveyor Name:	<input type="text" value="J D Chilvers"/>	Quantity:	<input type="text"/>						
Drawing Ref:	<input type="text" value="6"/>	Accessibility:	<input type="text" value="Medium Accessibility"/>						
Asbestos ?	<input type="text" value="Yes"/>

Material Risk Score	<input type="text" value="3"/>	Material Risk Band:	<input type="text" value="Very Low Risk"/>	Priority Risk Score:	<input type="text" value="3"/>
Material Risk Score	<input type="text" value="3"/>								
Material Risk Band:	<input type="text" value="Very Low Risk"/>								
Priority Risk Score:	<input type="text" value="3"/>								
Date:	<input type="text" value="28 October 2004"/>								
Next Inspection:	<input type="text" value="28 October 2005"/>

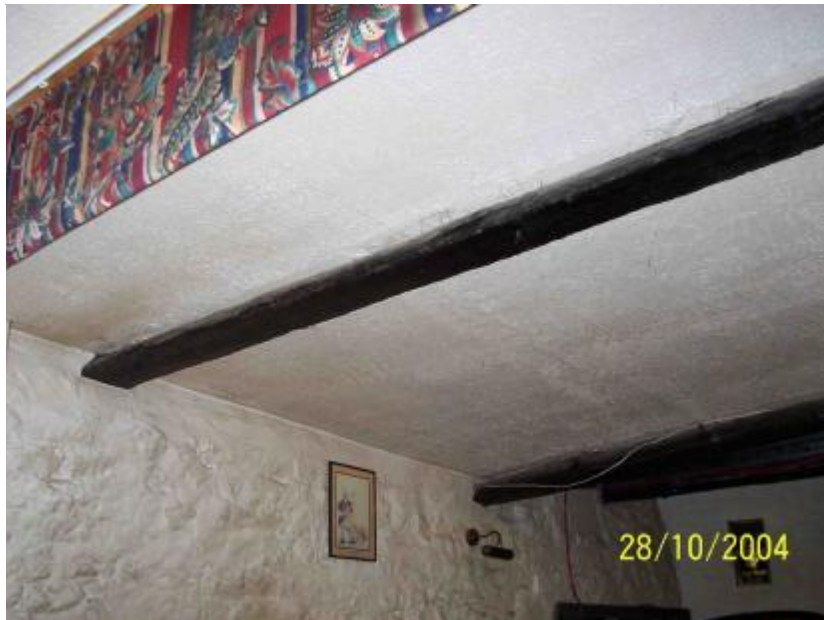
Location ID:	1789	Survey Type:	T 2
Location Ref:	7	Product Type:	NADIS
Product:	Textured coating	Damage:	NADIS
Area:	Not Applicable	Treatment:	NADIS
Floor:	Ground floor	Asbestos Type:	NADIS
Room:	Skittle Alley	Identification:	Identified
Surveyor Name:	J D Chilvers	Quantity:	
Drawing Ref:	7	Accessibility:	
Asbestos ?	No		
Date:	28 October 2004		
Next Inspection:	Not Applicable

Material Risk Score	0
Material Risk Band:	NADIS
Priority Risk Score:	N/A

Action: No Action Required

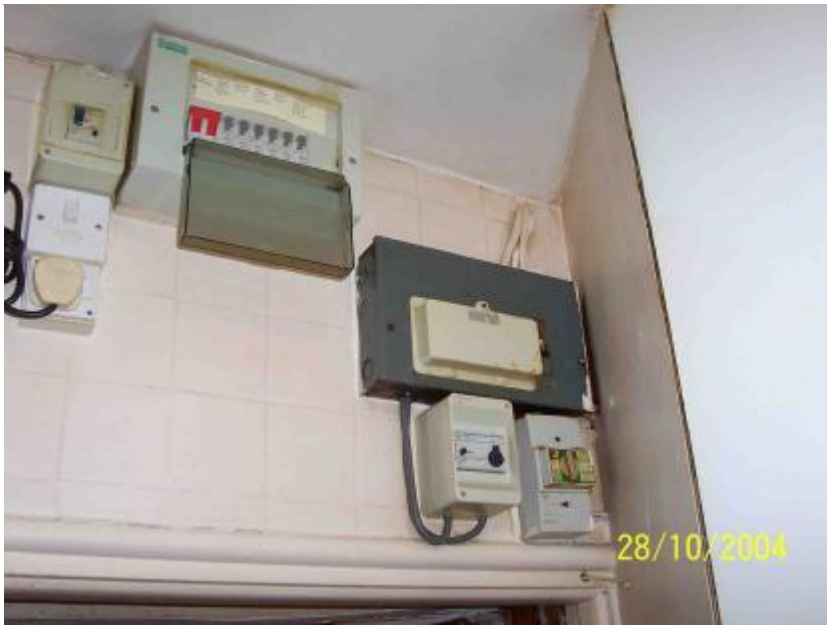
Location ID:	1790	Survey Type:	T 2
Location Ref:	8	Product Type:	Ropes and woven textiles
Product:	Fuse & Switchgear Flashguard	Damage:	No visible damage
Area:	Not Applicable	Treatment:	Composite asbestos materials
Floor:	Ground floor	Asbestos Type:	Chrysotile
Room:	Kitchen	Identification:	Presumed
Surveyor Name:	J D Chilvers	Quantity:	
Drawing Ref:	8	Accessibility:	Medium Accessibility
Asbestos ?	Yes		
Date:	28 October 2004		
Next Inspection:	28 October 2005

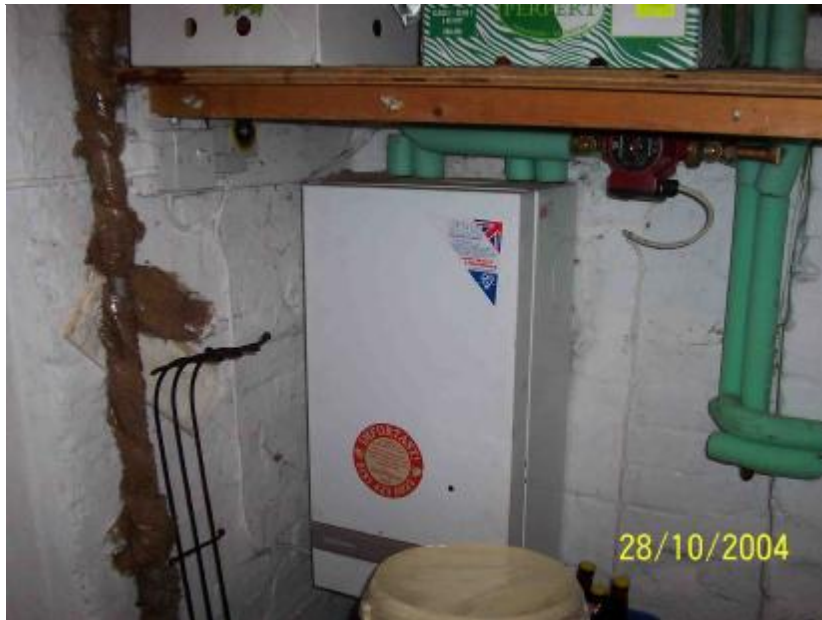
Location ID:	1791	Survey Type:	T 2
Location Ref:	9	Product Type:	Gaskets
Product:	Boiler	Damage:	No visible damage
Area:	Not Applicable	Treatment:	Composite asbestos materials
Floor:	Ground floor	Asbestos Type:	Chrysotile
Room:	Cellar	Identification:	Presumed
Surveyor Name:	J D Chilvers	Quantity:	
Drawing Ref:	9	Accessibility:	Medium Accessibility
Asbestos ?	Yes		
Date:	28 October 2004		
Next Inspection:	28 October 2005

Priority Risk Score: 3

Action: Apply Warning Labels

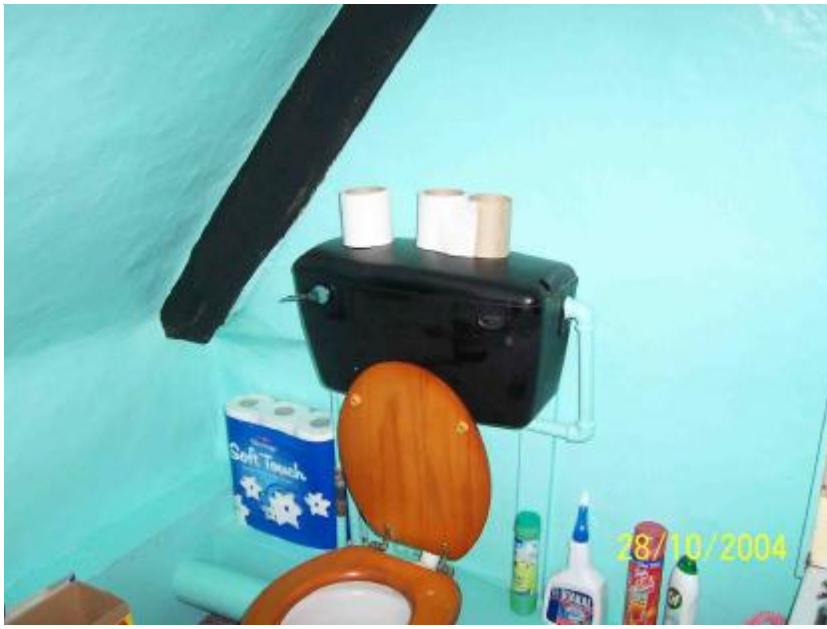
Location ID:	<input type="text" value="1792"/>	Survey Type:	<input type="text" value="T 2"/>						
Location Ref:	<input type="text" value="10"/>	Product Type:	<input type="text" value="Plastics"/>						
Product:	<input type="text" value="Cistern"/>	Damage:	<input type="text" value="No visible damage"/>						
Area:	<input type="text" value="Not Applicable"/>	Treatment:	<input type="text" value="Reinforced plastics"/>						
Floor:	<input type="text" value="First floor"/>	Asbestos Type:	<input type="text" value="Chrysotile"/>						
Room:	<input type="text" value="WC"/>	Identification:	<input type="text" value="Presumed"/>						
Surveyor Name:	<input type="text" value="J D Chilvers"/>	Quantity:	<input type="text"/>						
Drawing Ref:	<input type="text" value="10"/>	Accessibility:	<input type="text" value="Easy Accessibility"/>						
Asbestos ?	<input type="text" value="Yes"/>

Material Risk Score	<input type="text" value="2"/>	Material Risk Band:	<input type="text" value="Very Low Risk"/>	Priority Risk Score:	<input type="text" value="3"/>
Material Risk Score	<input type="text" value="2"/>								
Material Risk Band:	<input type="text" value="Very Low Risk"/>								
Priority Risk Score:	<input type="text" value="3"/>								
Date:	<input type="text" value="28 October 2004"/>								
Next Inspection:	<input type="text" value="28 October 2005"/>

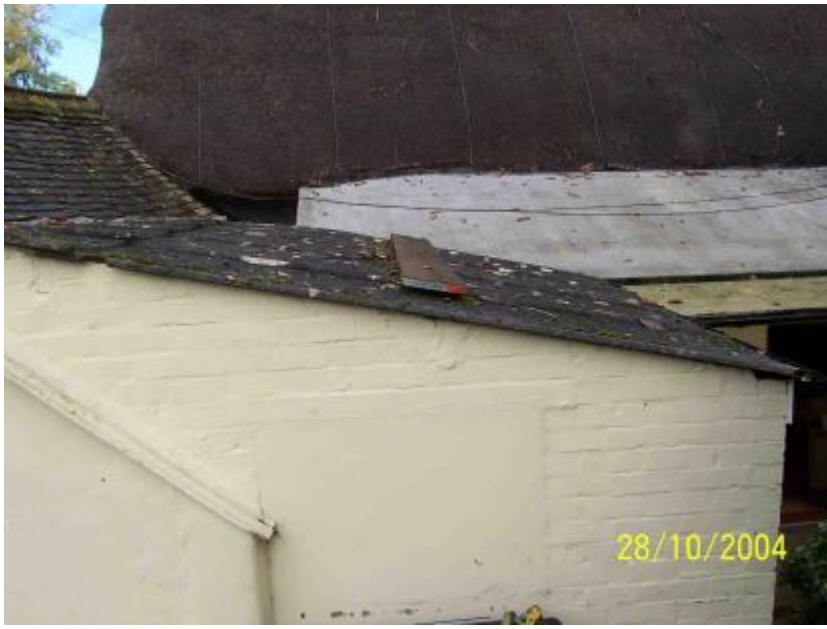
Location ID:	<input type="text" value="1793"/>	Survey Type:	<input type="text" value="T 2"/>						
Location Ref:	<input type="text" value="11"/>	Product Type:	<input type="text" value="Asbestos cement"/>						
Product:	<input type="text" value="Roof sheet"/>	Damage:	<input type="text" value="Low damage: Scratches or marks"/>						
Area:	<input type="text" value="Not Applicable"/>	Treatment:	<input type="text" value="Asbestos cement sheets etc"/>						
Floor:	<input type="text" value="Roof level"/>	Asbestos Type:	<input type="text" value="Chrysotile"/>						
Room:	<input type="text" value="Store Room"/>	Identification:	<input type="text" value="Identified"/>						
Surveyor Name:	<input type="text" value="J D Chilvers"/>	Quantity:	<input type="text"/>						
Drawing Ref:	<input type="text" value="11"/>	Accessibility:	<input type="text" value="Medium Accessibility"/>						
Asbestos ?	<input type="text" value="Yes"/>

Material Risk Score	<input type="text" value="4"/>	Material Risk Band:	<input type="text" value="Very Low Risk"/>	Priority Risk Score:	<input type="text" value="2"/>
Material Risk Score	<input type="text" value="4"/>								
Material Risk Band:	<input type="text" value="Very Low Risk"/>								
Priority Risk Score:	<input type="text" value="2"/>								
Date:	<input type="text" value="28 October 2004"/>								
Next Inspection:	<input type="text" value="28 October 2005"/>

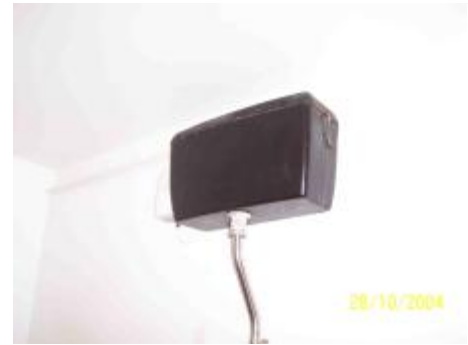
Location ID:	1783
Location Ref:	1
Product:	Cistern
Area:	Not Applicable
Floor:	Ground floor
Room:	WC
Surveyor Name:	J D Chilvers
Drawing Ref:	1
Asbestos ?	Yes
Date:	28 October 2004

Priority Assessment Algorithm			
Assessment factor	Variable(s) selected	Score for each	Overall score
Normal Occupant Activity:			
Main type of activity in area:	Low disturbance	1	average 1
Secondary activities for area:	Rare disturbance	0	
Likelihood Of Disturbance:			
Location:	Rooms up to 100 m2	2	average 1
Accessibility:	Occasionally likely to be disturbed	1	
Extent/Amount:	Small items strings gaskets	0	
Human Exposure Potential:			
Number of occupants:	1 to 3	1	average 1
Frequency of use of area:	Daily	3	
Average time area is in use:	<1 hour	0	
Maintenance Activity:			
Type of maintenance activity:	Minor disturbance	0	average 1
Frequency of maintenance activity	<=1 per year	1

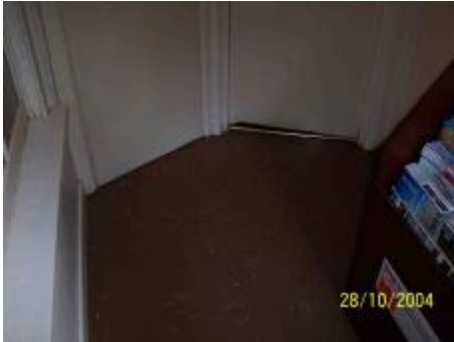
Location ID:	1784
Location Ref:	2
Product:	Floor tiles
Area:	Not Applicable
Floor:	Ground floor
Room:	Passageway
Surveyor Name:	J D Chilvers
Drawing Ref:	2
Asbestos ?	Yes
Date:	28 October 2004

Priority Assessment Algorithm	Variable(s) selected	Score for each	Overall score
Normal Occupant Activity:			
Main type of activity in area:	Low disturbance	1	average 1
Secondary activities for area:	Rare disturbance	0	
Likelihood Of Disturbance:			
Location:	Rooms up to 100 m2	2	average 1
Accessibility:	Occasionally likely to be disturbed	1	
Extent/Amount:	<=10 m2 or <=10 m pipe run	1	
Human Exposure Potential:			
Number of occupants:	1 to 3	1	average 1
Frequency of use of area:	Daily	3	
Average time area is in use:	<1 hour	0	
Maintenance Activity:			
Type of maintenance activity:	Minor disturbance	0	average 1
Frequency of maintenance activity	<=1 per year	1

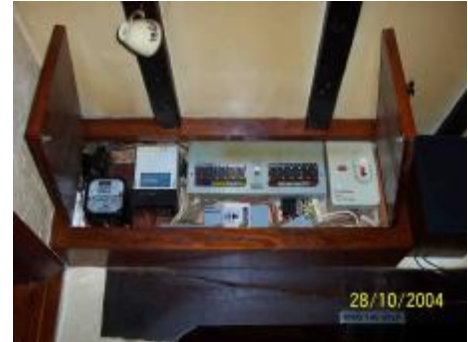
Location ID:	1785
Location Ref:	3
Product:	Fuse & Switchgear Flashguard
Area:	Not Applicable
Floor:	Ground floor
Room:	Electrical cupboard
Surveyor Name:	J D Chilvers
Drawing Ref:	3
Asbestos ?	Yes
Date:	28 October 2004

Priority Assessment Algorithm	Variable(s) selected	Score for each	Overall score
Normal Occupant Activity:			
Main type of activity in area:	Rare disturbance	0	average
Secondary activities for area:	Rare disturbance	0	0
Likelihood Of Disturbance:			
Location:	Rooms up to 100 m2	2	average
Accessibility:	Occasionally likely to be disturbed	1	
Extent/Amount:	Small items strings gaskets	0	
Human Exposure Potential:			
Number of occupants:	1 to 3	1	average
Frequency of use of area:	Infrequent	0	
Average time area is in use:	<1 hour	0	
Maintenance Activity:			
Type of maintenance activity:	Minor disturbance	0	average
Frequency of maintenance activity	<=1 per year	1	1

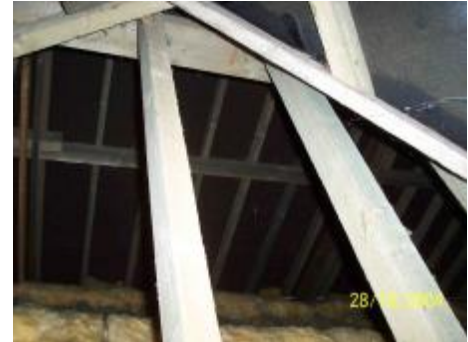
Location ID:	1786
Location Ref:	4
Product:	Roofing felt
Area:	Not Applicable
Floor:	Roof level
Room:	Loft space
Surveyor Name:	J D Chilvers
Drawing Ref:	4
Asbestos ?	Yes
Date:	28 October 2004

Priority Assessment Algorithm	Variable(s) selected	Score for each	Overall score
Normal Occupant Activity:			
Main type of activity in area:	Rare disturbance	0	average
Secondary activities for area:	Rare disturbance	0	0
Likelihood Of Disturbance:			
Location:	Large rooms or well-ventilated areas	1	average 1
Accessibility:	Usually inaccessible or unlikely to be disturbed	0	
Extent/Amount:	>50 m2 or >50 m pipe run	3	
Human Exposure Potential:			
Number of occupants:	1 to 3	1	average 0
Frequency of use of area:	Infrequent	0	
Average time area is in use:	<1 hour	0	
Maintenance Activity:			
Type of maintenance activity:	Minor disturbance	0	average 1
Frequency of maintenance activity	<=1 per year	1

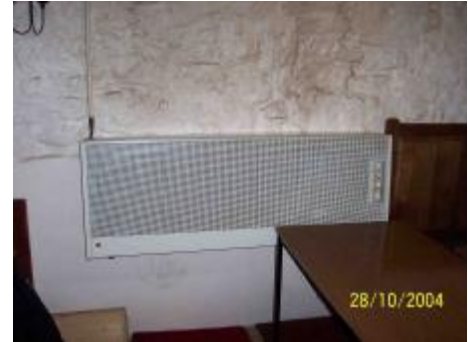
Location ID:	1788
Location Ref:	6
Product:	Heater
Area:	Not Applicable
Floor:	Ground floor
Room:	Skittle Alley
Surveyor Name:	J D Chilvers
Drawing Ref:	6
Asbestos ?	Yes
Date:	28 October 2004

Priority Assessment Algorithm	Variable(s) selected	Score for each	Overall score
Normal Occupant Activity:			
Main type of activity in area:	Rare disturbance	0	average
Secondary activities for area:	Rare disturbance	0	0
Likelihood Of Disturbance:			
Location:	Large rooms or well-ventilated areas	1	average 1
Accessibility:	Occasionally likely to be disturbed	1	
Extent/Amount:	Small items strings gaskets	0	
Human Exposure Potential:			
Number of occupants:	1 to 3	1	average 1
Frequency of use of area:	Weekly	2	
Average time area is in use:	>1 to <3 hours	1	
Maintenance Activity:			
Type of maintenance activity:	Minor disturbance	0	average
Frequency of maintenance activity	<=1 per year	1	1

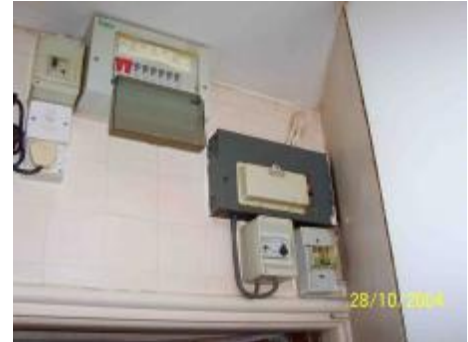
Location ID:	1790
Location Ref:	8
Product:	Fuse & Switchgear Flashguard
Area:	Not Applicable
Floor:	Ground floor
Room:	Kitchen
Surveyor Name:	J D Chilvers
Drawing Ref:	8
Asbestos ?	Yes
Date:	28 October 2004

Priority Assessment Algorithm	Variable(s) selected	Score for each	Overall score
Normal Occupant Activity:			
Main type of activity in area:	Low disturbance	1	average 1
Secondary activities for area:	Rare disturbance	0	
Likelihood Of Disturbance:			
Location:	Rooms up to 100 m2	2	average 1
Accessibility:	Occasionally likely to be disturbed	1	
Extent/Amount:	Small items strings gaskets	0	
Human Exposure Potential:			
Number of occupants:	1 to 3	1	average 2
Frequency of use of area:	Daily	3	
Average time area is in use:	>3 to <6 hours	2	
Maintenance Activity:			
Type of maintenance activity:	Minor disturbance	0	average 1
Frequency of maintenance activity	<=1 per year	1

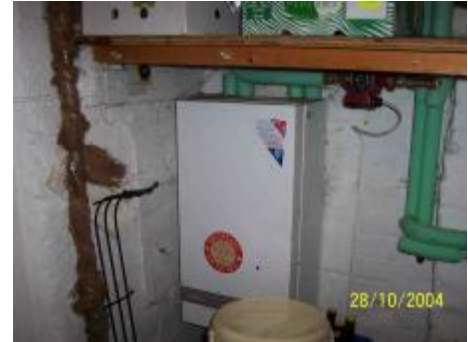
Location ID:	1791
Location Ref:	9
Product:	Boiler
Area:	Not Applicable
Floor:	Ground floor
Room:	Cellar
Surveyor Name:	J D Chilvers
Drawing Ref:	9
Asbestos ?	Yes
Date:	28 October 2004

Priority Assessment Algorithm			
Assessment factor	Variable(s) selected	Score for each	Overall score
Normal Occupant Activity:			
Main type of activity in area:	Rare disturbance	0	average
Secondary activities for area:	Rare disturbance	0	0
Likelihood Of Disturbance:			
Location:	Rooms up to 100 m2	2	
Accessibility:	Usually inaccessible or unlikely to be disturbed	0	average
Extent/Amount:	Small items strings gaskets	0	1
Human Exposure Potential:			
Number of occupants:	1 to 3	1	
Frequency of use of area:	Daily	3	average
Average time area is in use:	<1 hour	0	1
Maintenance Activity:			
Type of maintenance activity:	Minor disturbance	0	average
Frequency of maintenance activity	<=1 per year	1	1

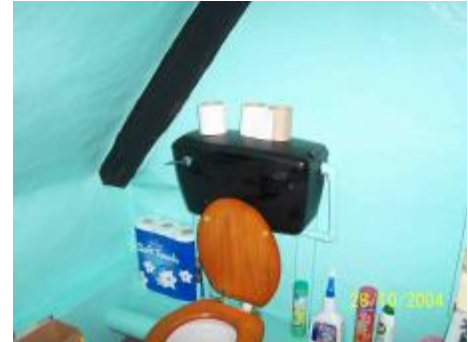
Location ID:	1792
Location Ref:	10
Product:	Cistern
Area:	Not Applicable
Floor:	First floor
Room:	WC
Surveyor Name:	J D Chilvers
Drawing Ref:	10
Asbestos ?	Yes
Date:	28 October 2004

Priority Assessment Algorithm			
Assessment factor	Variable(s) selected	Score for each	Overall score
Normal Occupant Activity:			
Main type of activity in area:	Rare disturbance	0	average
Secondary activities for area:	Rare disturbance	0	0
Likelihood Of Disturbance:			
Location:	Rooms up to 100 m2	2	
Accessibility:	Occasionally likely to be disturbed	1	average
Extent/Amount:	Small items strings gaskets	0	1
Human Exposure Potential:			
Number of occupants:	1 to 3	1	
Frequency of use of area:	Daily	3	average
Average time area is in use:	<1 hour	0	1
Maintenance Activity:			
Type of maintenance activity:	Minor disturbance	0	average
Frequency of maintenance activity	<=1 per year	1	1

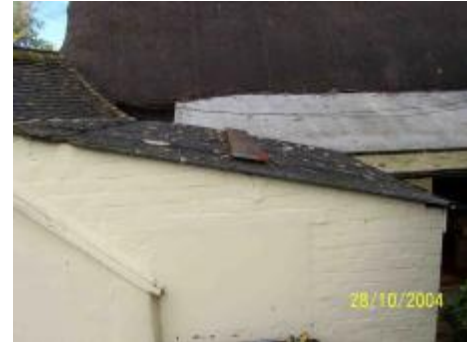
Location ID:	1793
Location Ref:	11
Product:	Roof sheet
Area:	Not Applicable
Floor:	Roof level
Room:	Store Room
Surveyor Name:	J D Chilvers
Drawing Ref:	11
Asbestos ?	Yes
Date:	28 October 2004

Priority Assessment Algorithm	Variable(s) selected	Score for each	Overall score
Normal Occupant Activity:			
Main type of activity in area:	Rare disturbance	0	average
Secondary activities for area:	Rare disturbance	0	0
Likelihood Of Disturbance:			
Location:	Outdoors	0	average 1
Accessibility:	Usually inaccessible or unlikely to be disturbed	0	
Extent/Amount:	>10 to <=50 (m2 or pipe run)	2	
Human Exposure Potential:			
Number of occupants:	1 to 3	1	average 0
Frequency of use of area:	Infrequent	0	
Average time area is in use:	<1 hour	0	
Maintenance Activity:			
Type of maintenance activity:	Minor disturbance	0	average 1
Frequency of maintenance activity	<=1 per year	1
