JTEC Environmental Ltd.

Asbestos Survey for

Hall & Woodhouse Ltd

Barford Inn,
Grovely Road
Barford St Martin
Salisbury
Wiltshire
SP3 4AB

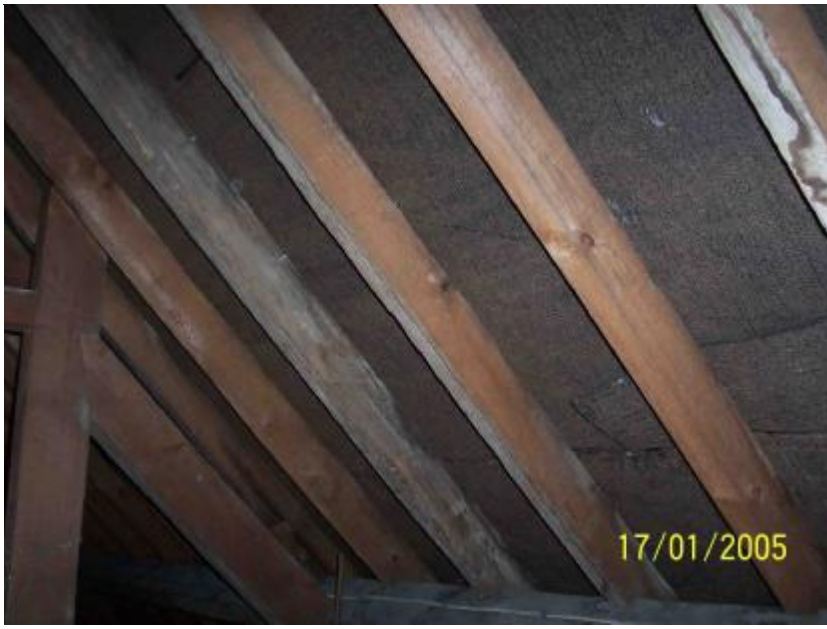
Material Risk Score	2
Material Risk Band:	Very Low Risk
Priority Risk Score:	1

Action: No Action Required

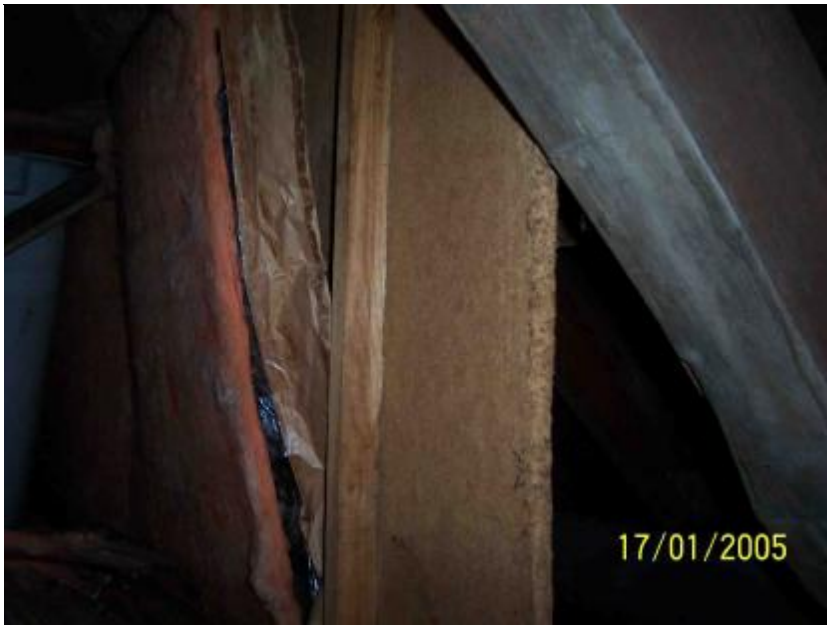
Material Risk Score	0
Material Risk Band:	NADIS
Priority Risk Score:	N/A

Action:	No Action Required
---------	--------------------

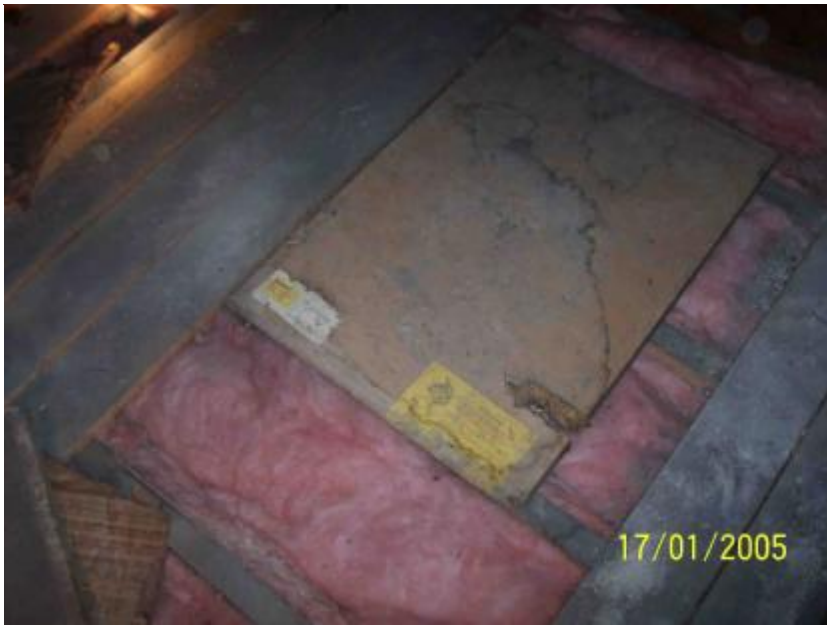
Material Risk Score	0
Material Risk Band:	NADIS
Priority Risk Score:	N/A

Action:	No Action Required
---------	--------------------

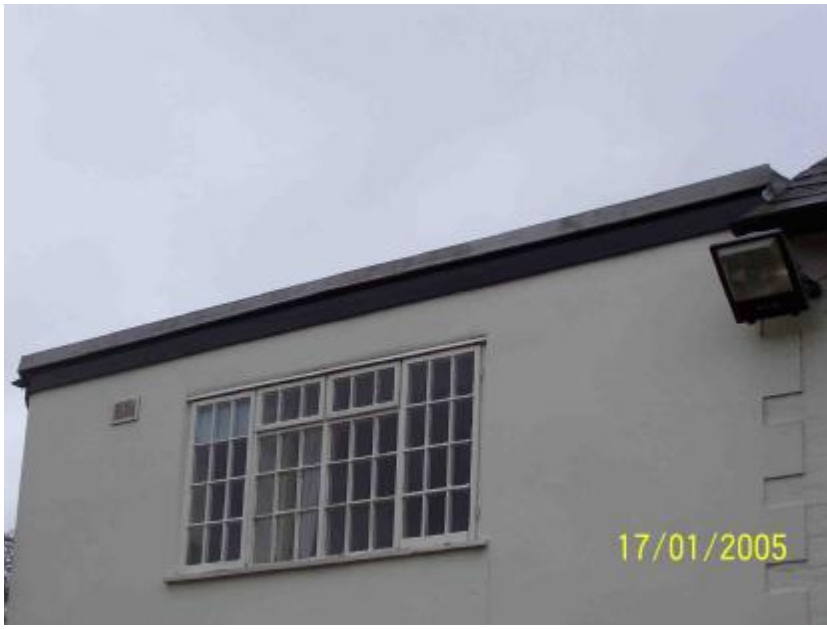
Material Risk Score	2
Material Risk Band:	Very Low Risk
Priority Risk Score:	1

Action: No Action Required

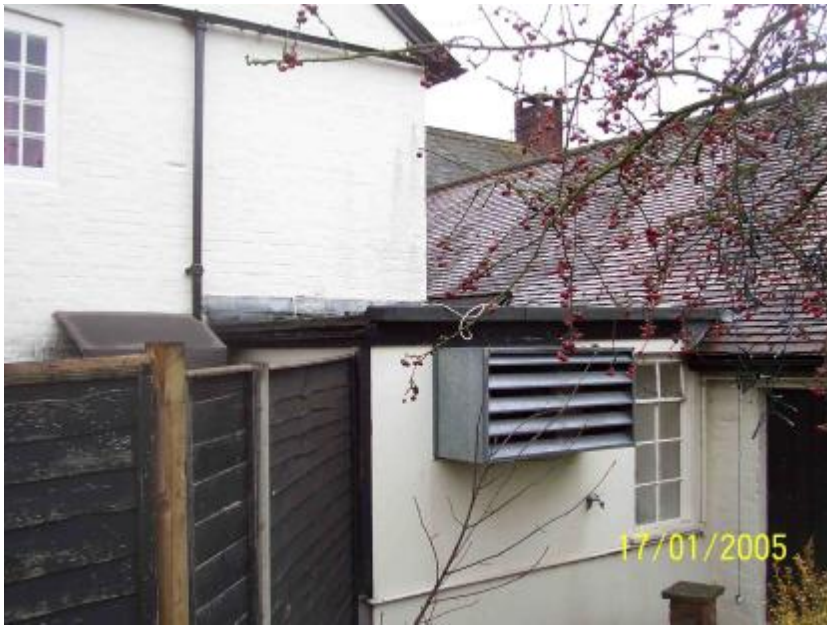
Material Risk Score	2
Material Risk Band:	Very Low Risk
Priority Risk Score:	1

Action: No Action Required

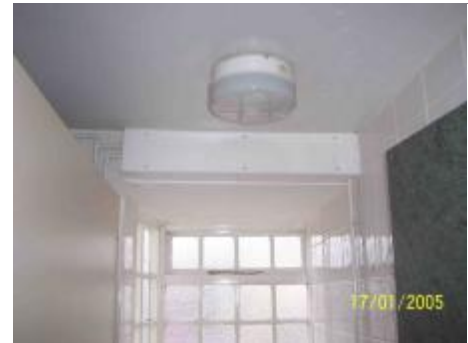
Location ID:	2382	Survey Type:	T 2
Location Ref:	1	Product Type:	Asbestos Insulating Board
Product:	Box panelling	Damage:	No visible damage
Area:	Not Applicable	Treatment:	AIB painted or encapsulated
Floor:	Ground floor	Asbestos Type:	Amosite
Room:	WC	Identification:	Presumed
Surveyor Name:	J D Chilvers	Quantity:	
Drawing Ref:	1	Accessibility:	Medium Accessibility
Asbestos ?	Yes		
Date:	17 January 2005		
Next Inspection:	19 July 2005

Location ID:	<input style="width: 85%;" type="text" value="2382"/>
Location Ref:	<input style="width: 85%;" type="text" value="1"/>
Product:	<input style="width: 85%;" type="text" value="Box panelling"/>
Area:	<input style="width: 85%;" type="text" value="Not Applicable"/>
Floor:	<input style="width: 85%;" type="text" value="Ground floor"/>
Room:	<input style="width: 85%;" type="text" value="WC"/>
Surveyor Name:	<input style="width: 85%;" type="text" value="J D Chilvers"/>
Drawing Ref:	<input style="width: 85%;" type="text" value="1"/>
Asbestos ?	<input style="width: 85%;" type="text" value="Yes"/>
Date:	<input style="width: 85%;" type="text" value="17 January 2005"/>

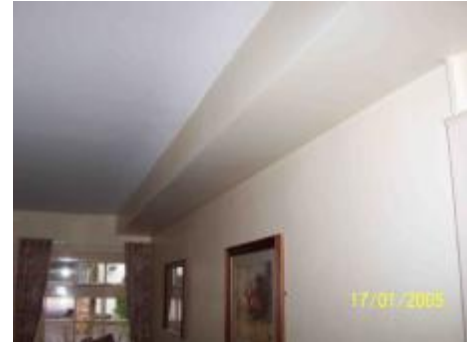
Location ID:	2383	Survey Type:	T 2
Location Ref:	2	Product Type:	Asbestos Insulating Board
Product:	Box panelling	Damage:	No visible damage
Area:	Not Applicable	Treatment:	AIB painted or encapsulated
Floor:	Ground floor	Asbestos Type:	Amosite
Room:	Corridor	Identification:	Presumed
Surveyor Name:	J D Chilvers	Quantity:	
Drawing Ref:	2	Accessibility:	Medium Accessibility
Asbestos ?	Yes		
Date:	17 January 2005		
Next Inspection:	19 July 2005

Location ID:	2383
Location Ref:	2
Product:	Box panelling
Area:	Not Applicable
Floor:	Ground floor
Room:	Corridor
Surveyor Name:	J D Chilvers
Drawing Ref:	2
Asbestos ?	Yes
Date:	17 January 2005

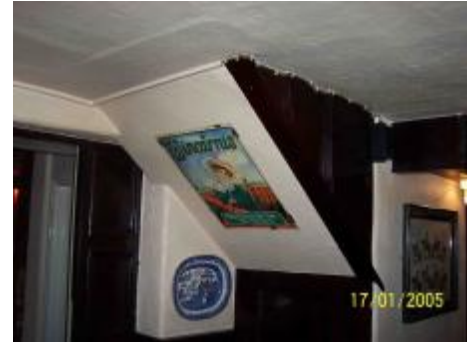
Location ID:	2384	Survey Type:	T 2
Location Ref:	3	Product Type:	Asbestos Insulating Board
Product:	Stair Backing / Cladding	Damage:	No visible damage
Area:	Not Applicable	Treatment:	AIB painted or encapsulated
Floor:	Ground floor	Asbestos Type:	Amosite
Room:	Bar area	Identification:	Presumed
Surveyor Name:	J D Chilvers	Quantity:	
Drawing Ref:	3	Accessibility:	Easy Accessibility
Asbestos ?	Yes		
Date:	17 January 2005		
Next Inspection:	19 July 2005

Location ID:	2384
Location Ref:	3
Product:	Stair Backing / Cladding
Area:	Not Applicable
Floor:	Ground floor
Room:	Bar area
Surveyor Name:	J D Chilvers
Drawing Ref:	3
Asbestos ?	Yes
Date:	17 January 2005

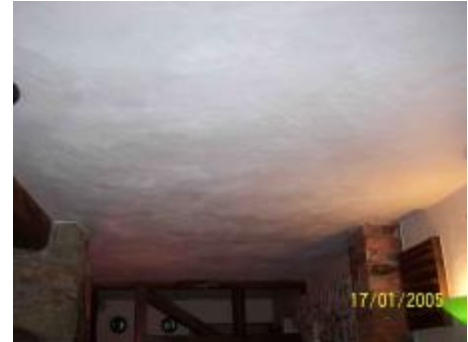
Location ID:	2385	Survey Type:	T 2
Location Ref:	4	Product Type:	Decorative finishes
Product:	Textured coating	Damage:	Low damage: Scratches or marks
Area:	Not Applicable	Treatment:	Composite asbestos materials
Floor:	Ground floor	Asbestos Type:	Chrysotile
Room:	Restaurant	Identification:	Presumed
Surveyor Name:	J D Chilvers	Quantity:	
Drawing Ref:	4	Accessibility:	Medium Accessibility
Asbestos ?	Yes		
Date:	17 January 2005		
Next Inspection:	17 January 2006

Location ID:	<input style="width: 85%;" type="text" value="2385"/>
Location Ref:	<input style="width: 85%;" type="text" value="4"/>
Product:	<input style="width: 85%;" type="text" value="Textured coating"/>
Area:	<input style="width: 85%;" type="text" value="Not Applicable"/>
Floor:	<input style="width: 85%;" type="text" value="Ground floor"/>
Room:	<input style="width: 85%;" type="text" value="Restaurant"/>
Surveyor Name:	<input style="width: 85%;" type="text" value="J D Chilvers"/>
Drawing Ref:	<input style="width: 85%;" type="text" value="4"/>
Asbestos ?	<input style="width: 85%;" type="text" value="Yes"/>
Date:	<input style="width: 85%;" type="text" value="17 January 2005"/>

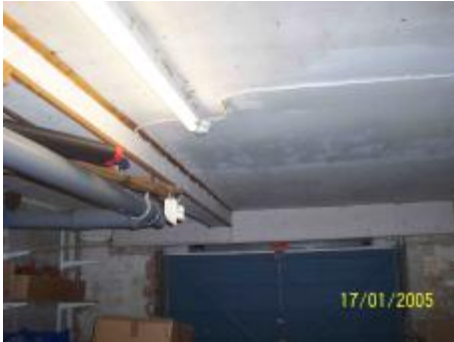
Location ID:	<input type="text" value="2386"/>	Survey Type:	<input type="text" value="T 2"/>						
Location Ref:	<input type="text" value="5"/>	Product Type:	<input type="text" value="Asbestos Insulating Board"/>						
Product:	<input type="text" value="Ceiling"/>	Damage:	<input type="text" value="Low damage: Scratches or marks"/>						
Area:	<input type="text" value="Not Applicable"/>	Treatment:	<input type="text" value="Unsealed AIB"/>						
Floor:	<input type="text" value="Ground floor"/>	Asbestos Type:	<input type="text" value="Amosite"/>						
Room:	<input type="text" value="Garage(s)"/>	Identification:	<input type="text" value="Identified"/>						
Surveyor Name:	<input type="text" value="J D Chilvers"/>	Quantity:	<input type="text"/>						
Drawing Ref:	<input type="text" value="5"/>	Accessibility:	<input type="text" value="Easy Accessibility"/>						
Asbestos ?	<input type="text" value="Yes"/>

Location ID:	<input style="width: 95%;" type="text" value="2386"/>
Location Ref:	<input style="width: 95%;" type="text" value="5"/>
Product:	<input style="width: 95%;" type="text" value="Ceiling"/>
Area:	<input style="width: 95%;" type="text" value="Not Applicable"/>
Floor:	<input style="width: 95%;" type="text" value="Ground floor"/>
Room:	<input style="width: 95%;" type="text" value="Garage(s)"/>
Surveyor Name:	<input style="width: 95%;" type="text" value="J D Chilvers"/>
Drawing Ref:	<input style="width: 95%;" type="text" value="5"/>
Asbestos ?	<input style="width: 95%;" type="text" value="Yes"/>
Date:	<input style="width: 95%;" type="text" value="17 January 2005"/>

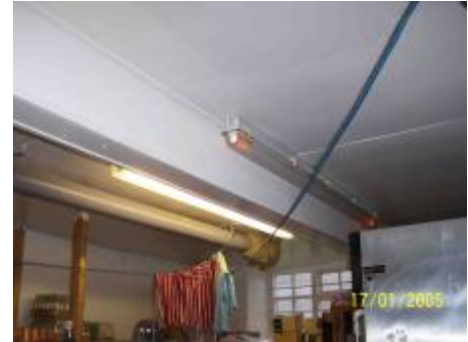
Location ID:	2387	Survey Type:	T 2
Location Ref:	6	Product Type:	Asbestos Insulating Board
Product:	Ceiling & Beam Cladding	Damage:	Low damage: Scratches or marks
Area:	Not Applicable	Treatment:	AIB painted or encapsulated
Floor:	Ground floor	Asbestos Type:	Amosite
Room:	Store Room	Identification:	Identified
Surveyor Name:	J D Chilvers	Quantity:	
Drawing Ref:	6	Accessibility:	Medium Accessibility
Asbestos ?	Yes		
Date:	17 January 2005		
Next Inspection:	19 July 2005

Location ID:	2387
Location Ref:	6
Product:	Ceiling & Beam Cladding
Area:	Not Applicable
Floor:	Ground floor
Room:	Store Room
Surveyor Name:	J D Chilvers
Drawing Ref:	6
Asbestos ?	Yes
Date:	17 January 2005

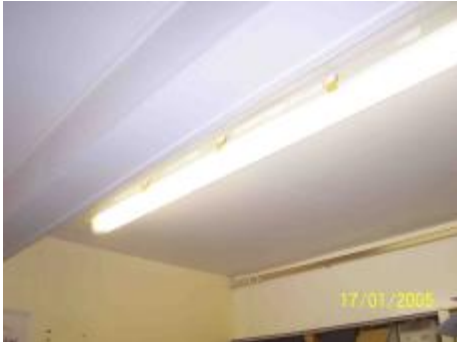
Location ID:	2388	Survey Type:	T 2
Location Ref:	7	Product Type:	Asbestos Insulating Board
Product:	Ceiling & Beam Cladding	Damage:	Low damage: Scratches or marks
Area:	Not Applicable	Treatment:	AIB painted or encapsulated
Floor:	Ground floor	Asbestos Type:	Amosite
Room:	Office	Identification:	Strongly Presumed as previous sample
Surveyor Name:	J D Chilvers	Quantity:	
Drawing Ref:	7	Accessibility:	Medium Accessibility
Asbestos ?	Yes		
Date:	17 January 2005		
Next Inspection:	19 July 2005

Location ID:	<input style="width: 95%;" type="text" value="2388"/>
Location Ref:	<input style="width: 95%;" type="text" value="7"/>
Product:	<input style="width: 95%;" type="text" value="Ceiling & Beam Cladding"/>
Area:	<input style="width: 95%;" type="text" value="Not Applicable"/>
Floor:	<input style="width: 95%;" type="text" value="Ground floor"/>
Room:	<input style="width: 95%;" type="text" value="Office"/>
Surveyor Name:	<input style="width: 95%;" type="text" value="J D Chilvers"/>
Drawing Ref:	<input style="width: 95%;" type="text" value="7"/>
Asbestos ?	<input style="width: 95%;" type="text" value="Yes"/>
Date:	<input style="width: 95%;" type="text" value="17 January 2005"/>

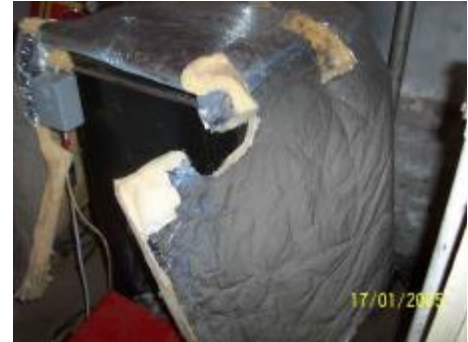
Location ID:	2389	Survey Type:	T 2
Location Ref:	8	Product Type:	Gaskets
Product:	Boiler	Damage:	No visible damage
Area:	Not Applicable	Treatment:	Composite asbestos materials
Floor:	Ground floor	Asbestos Type:	Chrysotile
Room:	Boiler room	Identification:	Presumed
Surveyor Name:	J D Chilvers	Quantity:	
Drawing Ref:	8	Accessibility:	Medium Accessibility
Asbestos ?	Yes		
Date:	17 January 2005		
Next Inspection:	17 January 2006

Location ID:	<input style="width: 95%;" type="text" value="2389"/>
Location Ref:	<input style="width: 95%;" type="text" value="8"/>
Product:	<input style="width: 95%;" type="text" value="Boiler"/>
Area:	<input style="width: 95%;" type="text" value="Not Applicable"/>
Floor:	<input style="width: 95%;" type="text" value="Ground floor"/>
Room:	<input style="width: 95%;" type="text" value="Boiler room"/>
Surveyor Name:	<input style="width: 95%;" type="text" value="J D Chilvers"/>
Drawing Ref:	<input style="width: 95%;" type="text" value="8"/>
Asbestos ?	<input style="width: 95%;" type="text" value="Yes"/>
Date:	<input style="width: 95%;" type="text" value="17 January 2005"/>

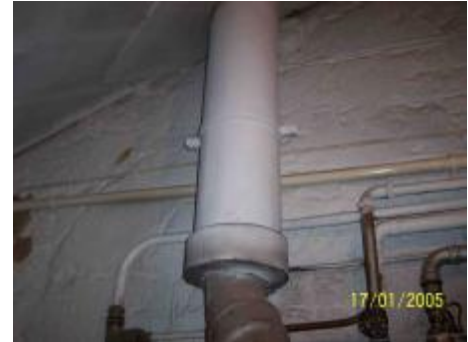
Location ID:	2390	Survey Type:	T 2
Location Ref:	9	Product Type:	Asbestos cement
Product:	Flue	Damage:	Low damage: Scratches or marks
Area:	Not Applicable	Treatment:	Asbestos cement sheets etc
Floor:	Ground floor	Asbestos Type:	Chrysotile
Room:	Boiler room	Identification:	Identified
Surveyor Name:	J D Chilvers	Quantity:	
Drawing Ref:	9	Accessibility:	Easy Accessibility
Asbestos ?	Yes		
Date:	17 January 2005		
Next Inspection:	17 January 2006

Location ID:	2390
Location Ref:	9
Product:	Flue
Area:	Not Applicable
Floor:	Ground floor
Room:	Boiler room
Surveyor Name:	J D Chilvers
Drawing Ref:	9
Asbestos ?	Yes
Date:	17 January 2005

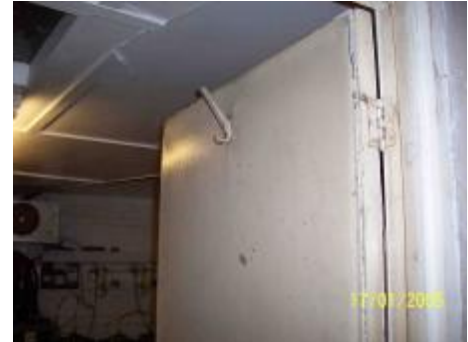
Location ID:	2392	Survey Type:	T 2
Location Ref:	11	Product Type:	Asbestos Insulating Board
Product:	Door panel	Damage:	Low damage: Broken edge boards
Area:	Not Applicable	Treatment:	AIB painted or encapsulated
Floor:	Ground floor	Asbestos Type:	Amosite
Room:	Boiler room	Identification:	Identified
Surveyor Name:	J D Chilvers	Quantity:	
Drawing Ref:	11	Accessibility:	Easy Accessibility
Asbestos ?	Yes		
Date:	17 January 2005		
Next Inspection:	19 July 2005

Location ID:	2392
Location Ref:	11
Product:	Door panel
Area:	Not Applicable
Floor:	Ground floor
Room:	Boiler room
Surveyor Name:	J D Chilvers
Drawing Ref:	11
Asbestos ?	Yes
Date:	17 January 2005

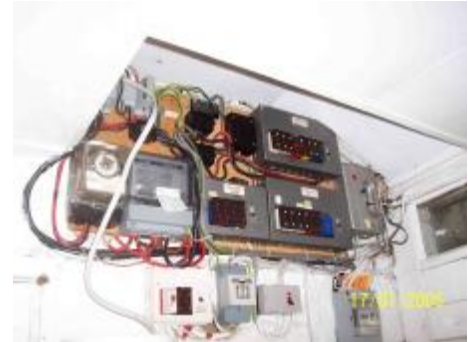
Location ID:	2393	Survey Type:	T 2
Location Ref:	12	Product Type:	Ropes and woven textiles
Product:	Fuse & Switchgear Flashguard	Damage:	No visible damage
Area:	Not Applicable	Treatment:	Composite asbestos materials
Floor:	Ground floor	Asbestos Type:	Chrysotile
Room:	Cellar	Identification:	Presumed
Surveyor Name:	J D Chilvers	Quantity:	
Drawing Ref:	12	Accessibility:	Medium Accessibility
Asbestos ?	Yes		
Date:	17 January 2005		
Next Inspection:	17 January 2006

Location ID:	<input style="width: 95%;" type="text" value="2393"/>
Location Ref:	<input style="width: 95%;" type="text" value="12"/>
Product:	<input style="width: 95%;" type="text" value="Fuse & Switchgear Flashguard"/>
Area:	<input style="width: 95%;" type="text" value="Not Applicable"/>
Floor:	<input style="width: 95%;" type="text" value="Ground floor"/>
Room:	<input style="width: 95%;" type="text" value="Cellar"/>
Surveyor Name:	<input style="width: 95%;" type="text" value="J D Chilvers"/>
Drawing Ref:	<input style="width: 95%;" type="text" value="12"/>
Asbestos ?	<input style="width: 95%;" type="text" value="Yes"/>
Date:	<input style="width: 95%;" type="text" value="17 January 2005"/>

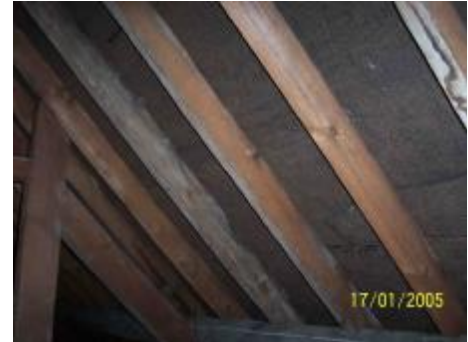
Location ID:	2394	Survey Type:	T 2
Location Ref:	13	Product Type:	Roofing felts
Product:	Roofing felt	Damage:	No visible damage
Area:	Not Applicable	Treatment:	Resins
Floor:	Roof level	Asbestos Type:	Chrysotile
Room:	Loft space	Identification:	Presumed
Surveyor Name:	J D Chilvers	Quantity:	
Drawing Ref:	13	Accessibility:	Medium Accessibility
Asbestos ?	Yes		
Date:	17 January 2005		
Next Inspection:	17 January 2006

Location ID:	<input style="width: 95%;" type="text" value="2394"/>
Location Ref:	<input style="width: 95%;" type="text" value="13"/>
Product:	<input style="width: 95%;" type="text" value="Roofing felt"/>
Area:	<input style="width: 95%;" type="text" value="Not Applicable"/>
Floor:	<input style="width: 95%;" type="text" value="Roof level"/>
Room:	<input style="width: 95%;" type="text" value="Loft space"/>
Surveyor Name:	<input style="width: 95%;" type="text" value="J D Chilvers"/>
Drawing Ref:	<input style="width: 95%;" type="text" value="13"/>
Asbestos ?	<input style="width: 95%;" type="text" value="Yes"/>
Date:	<input style="width: 95%;" type="text" value="17 January 2005"/>

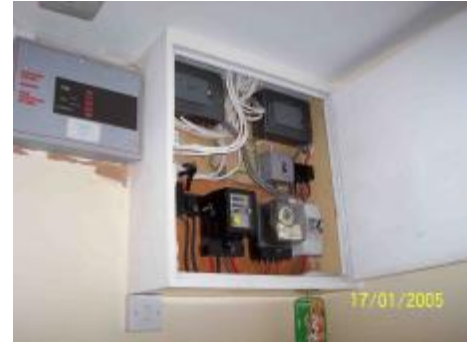
Location ID:	<input type="text" value="2397"/>	Survey Type:	<input type="text" value="T 2"/>						
Location Ref:	<input type="text" value="16"/>	Product Type:	<input type="text" value="Ropes and woven textiles"/>						
Product:	<input type="text" value="Fuse & Switchgear Flashguard"/>	Damage:	<input type="text" value="No visible damage"/>						
Area:	<input type="text" value="Not Applicable"/>	Treatment:	<input type="text" value="Composite asbestos materials"/>						
Floor:	<input type="text" value="Ground floor"/>	Asbestos Type:	<input type="text" value="Chrysotile"/>						
Room:	<input type="text" value="Corridor"/>	Identification:	<input type="text" value="Presumed"/>						
Surveyor Name:	<input type="text" value="J D Chilvers"/>	Quantity:	<input type="text"/>						
Drawing Ref:	<input type="text" value="16"/>	Accessibility:	<input type="text" value="Medium Accessibility"/>						
Asbestos ?	<input type="text" value="Yes"/>

Location ID:	2397
Location Ref:	16
Product:	Fuse & Switchgear Flashguard
Area:	Not Applicable
Floor:	Ground floor
Room:	Corridor
Surveyor Name:	J D Chilvers
Drawing Ref:	16
Asbestos ?	Yes
Date:	17 January 2005

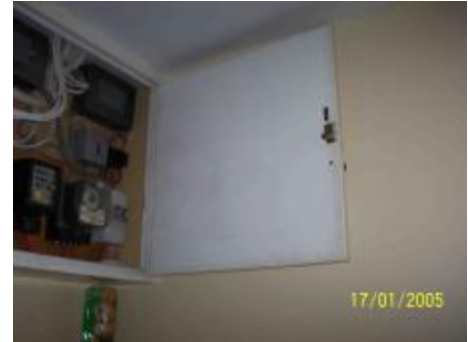
Location ID:	2398	Survey Type:	T 2
Location Ref:	17	Product Type:	Asbestos Insulating Board
Product:	Door panel	Damage:	Low damage: Scratches or marks
Area:	Not Applicable	Treatment:	AIB painted or encapsulated
Floor:	Ground floor	Asbestos Type:	Amosite
Room:	Corridor	Identification:	Identified
Surveyor Name:	J D Chilvers	Quantity:	
Drawing Ref:	17	Accessibility:	Medium Accessibility
Asbestos ?	Yes		
Date:	17 January 2005		
Next Inspection:	19 July 2005

Location ID:	2398
Location Ref:	17
Product:	Door panel
Area:	Not Applicable
Floor:	Ground floor
Room:	Corridor
Surveyor Name:	J D Chilvers
Drawing Ref:	17
Asbestos ?	Yes
Date:	17 January 2005

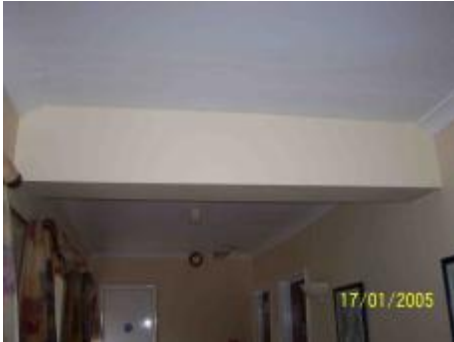
Location ID:	2399	Survey Type:	T 2
Location Ref:	18	Product Type:	Asbestos Insulating Board
Product:	Beam cladding	Damage:	No visible damage
Area:	Not Applicable	Treatment:	AIB painted or encapsulated
Floor:	First floor	Asbestos Type:	Amosite
Room:	Corridor	Identification:	Presumed
Surveyor Name:	J D Chilvers	Quantity:	
Drawing Ref:	18	Accessibility:	Medium Accessibility
Asbestos ?	Yes		
Date:	17 January 2005		
Next Inspection:	19 July 2005

Location ID:	2399
Location Ref:	18
Product:	Beam cladding
Area:	Not Applicable
Floor:	First floor
Room:	Corridor
Surveyor Name:	J D Chilvers
Drawing Ref:	18
Asbestos ?	Yes
Date:	17 January 2005

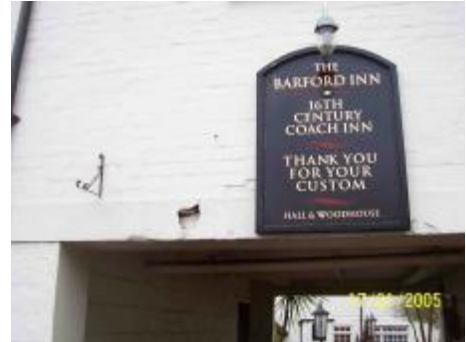
Location ID:	<input type="text" value="2400"/>	Survey Type:	<input type="text" value="T 2"/>						
Location Ref:	<input type="text" value="19"/>	Product Type:	<input type="text" value="Asbestos Insulating Board"/>						
Product:	<input type="text" value="Cladding"/>	Damage:	<input type="text" value="Medium damage: Breakage"/>						
Area:	<input type="text" value="Not Applicable"/>	Treatment:	<input type="text" value="AIB painted or encapsulated"/>						
Floor:	<input type="text" value="External ground floor"/>	Asbestos Type:	<input type="text" value="Amosite"/>						
Room:	<input type="text" value="External"/>	Identification:	<input type="text" value="Identified"/>						
Surveyor Name:	<input type="text" value="J D Chilvers"/>	Quantity:	<input type="text"/>						
Drawing Ref:	<input type="text" value="19"/>	Accessibility:	<input type="text" value="Easy Accessibility"/>						
Asbestos ?	<input type="text" value="Yes"/>

Location ID:	2400
Location Ref:	19
Product:	Cladding
Area:	Not Applicable
Floor:	External ground floor
Room:	External
Surveyor Name:	J D Chilvers
Drawing Ref:	19
Asbestos ?	Yes
Date:	17 January 2005

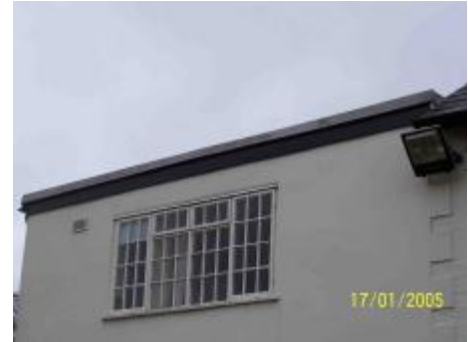
Location ID:	2401	Survey Type:	T 2
Location Ref:	20	Product Type:	Roofing felts
Product:	Roofing felt	Damage:	No visible damage
Area:	Not Applicable	Treatment:	Resins
Floor:	Roof level	Asbestos Type:	Chrysotile
Room:	Flat roof area	Identification:	Presumed
Surveyor Name:	J D Chilvers	Quantity:	
Drawing Ref:	20	Accessibility:	Difficult Accessibility
Asbestos ?	Yes		
Date:	17 January 2005		
Next Inspection:	17 January 2006

Location ID:	2401
Location Ref:	20
Product:	Roofing felt
Area:	Not Applicable
Floor:	Roof level
Room:	Flat roof area
Surveyor Name:	J D Chilvers
Drawing Ref:	20
Asbestos ?	Yes
Date:	17 January 2005

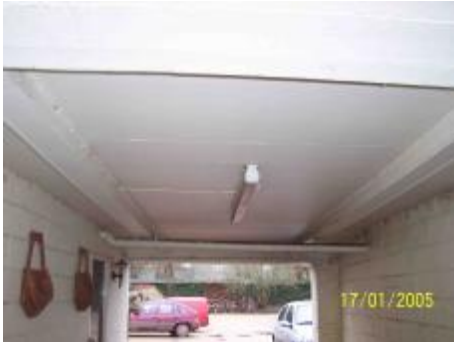
Location ID:	<input type="text" value="2402"/>	Survey Type:	<input type="text" value="T 2"/>						
Location Ref:	<input type="text" value="21"/>	Product Type:	<input type="text" value="Asbestos Insulating Board"/>						
Product:	<input type="text" value="Ceiling panels"/>	Damage:	<input type="text" value="Low damage: Scratches or marks"/>						
Area:	<input type="text" value="Not Applicable"/>	Treatment:	<input type="text" value="AIB painted or encapsulated"/>						
Floor:	<input type="text" value="External ground floor"/>	Asbestos Type:	<input type="text" value="Amosite"/>						
Room:	<input type="text" value="Corridor"/>	Identification:	<input type="text" value="Strongly Presumed"/>						
Surveyor Name:	<input type="text" value="J D Chilvers"/>	Quantity:	<input type="text"/>						
Drawing Ref:	<input type="text" value="21"/>	Accessibility:	<input type="text" value="Medium Accessibility"/>						
Asbestos ?	<input type="text" value="Yes"/>

Location ID:	2402
Location Ref:	21
Product:	Ceiling panels
Area:	Not Applicable
Floor:	External ground floor
Room:	Corridor
Surveyor Name:	J D Chilvers
Drawing Ref:	21
Asbestos ?	Yes
Date:	17 January 2005

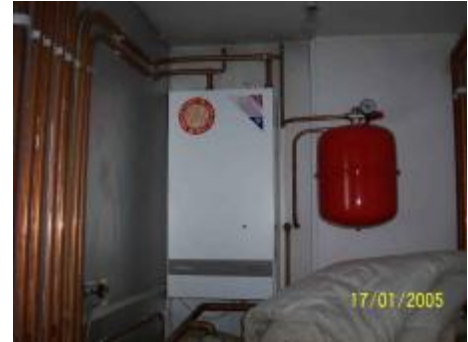
Location ID:	2403	Survey Type:	T 2
Location Ref:	22	Product Type:	Gaskets
Product:	Boiler	Damage:	No visible damage
Area:	Not Applicable	Treatment:	Composite asbestos materials
Floor:	First floor	Asbestos Type:	Chrysotile
Room:	Boiler cupboard	Identification:	Presumed
Surveyor Name:	J D Chilvers	Quantity:	
Drawing Ref:	22	Accessibility:	Medium Accessibility
Asbestos ?	Yes		
Date:	17 January 2005		
Next Inspection:	17 January 2006

Location ID:	2403
Location Ref:	22
Product:	Boiler
Area:	Not Applicable
Floor:	First floor
Room:	Boiler cupboard
Surveyor Name:	J D Chilvers
Drawing Ref:	22
Asbestos ?	Yes
Date:	17 January 2005

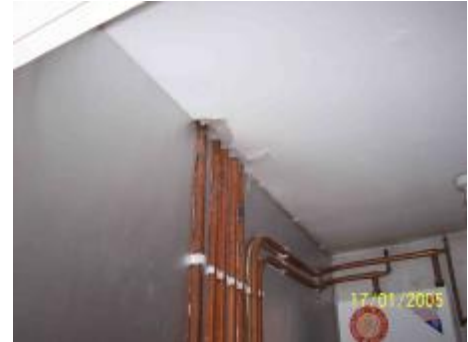
Location ID:	2404	Survey Type:	T 2
Location Ref:	23	Product Type:	Asbestos Insulating Board
Product:	Ceiling panel	Damage:	Low damage
Area:	Not Applicable	Treatment:	AIB painted or encapsulated
Floor:	First floor	Asbestos Type:	Amosite
Room:	Boiler cupboard	Identification:	Presumed
Surveyor Name:	J D Chilvers	Quantity:	
Drawing Ref:	23	Accessibility:	Medium Accessibility
Asbestos ?	Yes		
Date:	17 January 2005		
Next Inspection:	19 July 2005

Location ID:	2404
Location Ref:	23
Product:	Ceiling panel
Area:	Not Applicable
Floor:	First floor
Room:	Boiler cupboard
Surveyor Name:	J D Chilvers
Drawing Ref:	23
Asbestos ?	Yes
Date:	17 January 2005

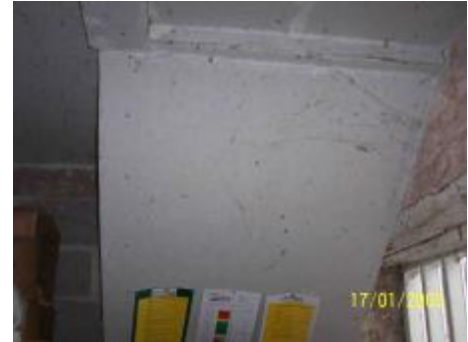
Location ID:	2405	Survey Type:	T 2
Location Ref:	24	Product Type:	Asbestos Insulating Board
Product:	Stair Backing / Cladding	Damage:	Medium damage: Loose fibres
Area:	Not Applicable	Treatment:	Unsealed AIB
Floor:	Ground floor	Asbestos Type:	Amosite
Room:	Boiler cupboard	Identification:	Identified
Surveyor Name:	J D Chilvers	Quantity:	
Drawing Ref:	24	Accessibility:	Easy Accessibility
Asbestos ?	Yes		
Date:	17 January 2005		
Next Inspection:	17 April 2005

Location ID:	2405
Location Ref:	24
Product:	Stair Backing / Cladding
Area:	Not Applicable
Floor:	Ground floor
Room:	Boiler cupboard
Surveyor Name:	J D Chilvers
Drawing Ref:	24
Asbestos ?	Yes
Date:	17 January 2005

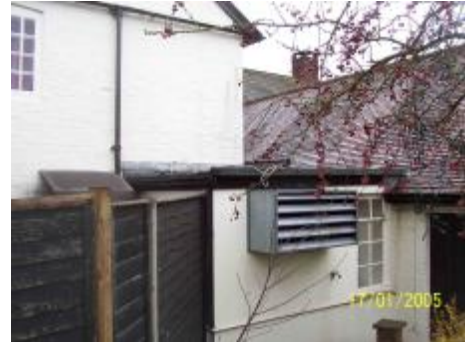
Location ID:	2406	Survey Type:	T 2
Location Ref:	25	Product Type:	Roofing felts
Product:	Roofing felt	Damage:	No visible damage
Area:	Not Applicable	Treatment:	Resins
Floor:	Roof level	Asbestos Type:	Chrysotile
Room:	Flat roof area	Identification:	Presumed
Surveyor Name:	J D Chilvers	Quantity:	
Drawing Ref:	25	Accessibility:	Medium Accessibility
Asbestos ?	Yes		
Date:	17 January 2005		
Next Inspection:	17 January 2006

Location ID:	2406
Location Ref:	25
Product:	Roofing felt
Area:	Not Applicable
Floor:	Roof level
Room:	Flat roof area
Surveyor Name:	J D Chilvers
Drawing Ref:	25
Asbestos ?	Yes
Date:	17 January 2005

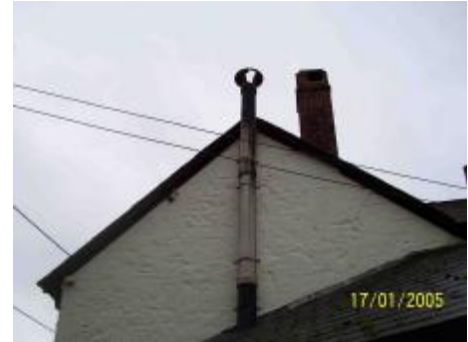
Location ID:	2407	Survey Type:	T 2
Location Ref:	26	Product Type:	Asbestos cement
Product:	Flue	Damage:	No visible damage
Area:	Not Applicable	Treatment:	Asbestos cement sheets etc
Floor:	Roof level	Asbestos Type:	Chrysotile
Room:	External	Identification:	Strongly Presumed
Surveyor Name:	J D Chilvers	Quantity:	
Drawing Ref:	26	Accessibility:	Difficult Accessibility
Asbestos ?	Yes		
Date:	17 January 2005		
Next Inspection:	17 January 2006

Location ID:	2407
Location Ref:	26
Product:	Flue
Area:	Not Applicable
Floor:	Roof level
Room:	External
Surveyor Name:	J D Chilvers
Drawing Ref:	26
Asbestos ?	Yes
Date:	17 January 2005
