# **Asbestos Survey for**

Hall & Woodhouse Ltd

Wheatsheaf (Midhurst)

Project Number: AS05070 - Wheatsheaf Midhurst

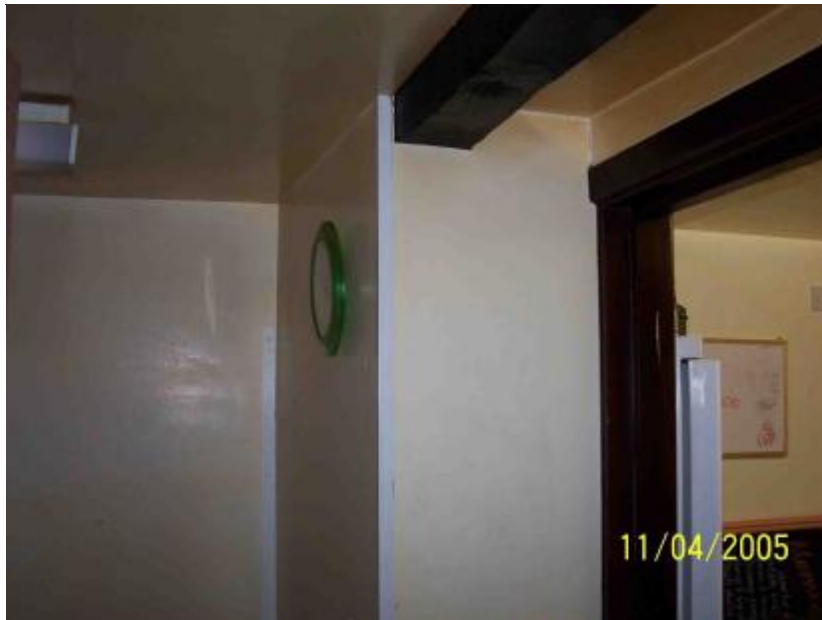
Location ID:	<input type="text" value="3145"/>	Survey Type:	<input type="text" value="T 2"/>
Location Ref:	<input type="text" value="3"/>	Product Type:	<input type="text" value="NADIS"/>
Product:	<input type="text" value="Wall sheeting"/>	Damage:	<input type="text" value="NADIS"/>
Area:	<input type="text" value="Not Applicable"/>	Treatment:	<input type="text" value="NADIS"/>
Floor:	<input type="text" value="Ground floor"/>	Asbestos Type:	<input type="text" value="NADIS"/>
Room:	<input type="text" value="Corridor"/>	Identification:	<input type="text" value="Identified"/>
Surveyor Name:	<input type="text" value="J D Chilvers"/>	Quantity:	<input type="text"/>

Material Risk Score	<input type="text" value="0"/>
Material Risk Band:	<input type="text" value="NADIS"/>
Priority Risk Score:	<input type="text" value="N/A"/>

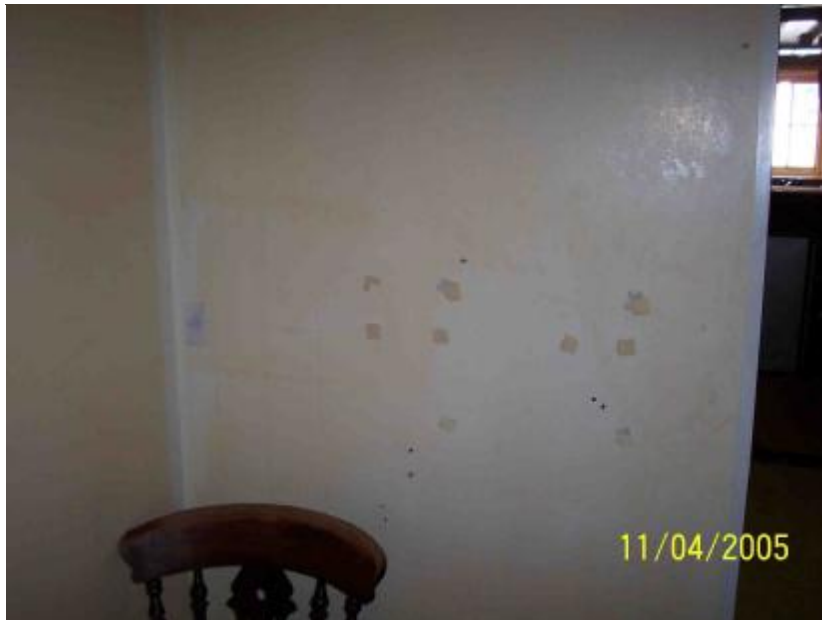
Location ID:	<input type="text" value="3146"/>	Survey Type:	<input type="text" value="T 2"/>
Location Ref:	<input type="text" value="4"/>	Product Type:	<input type="text" value="NADIS"/>
Product:	<input type="text" value="Wall sheeting"/>	Damage:	<input type="text" value="NADIS"/>
Area:	<input type="text" value="Not Applicable"/>	Treatment:	<input type="text" value="NADIS"/>
Floor:	<input type="text" value="Ground floor"/>	Asbestos Type:	<input type="text" value="NADIS"/>
Room:	<input type="text" value="Corridor"/>	Identification:	<input type="text" value="Identified"/>
Surveyor Name:	<input type="text" value="J D Chilvers"/>	Quantity:	<input type="text"/>

Material Risk Score	<input type="text" value="0"/>
Material Risk Band:	<input type="text" value="NADIS"/>
Priority Risk Score:	<input type="text" value="N/A"/>

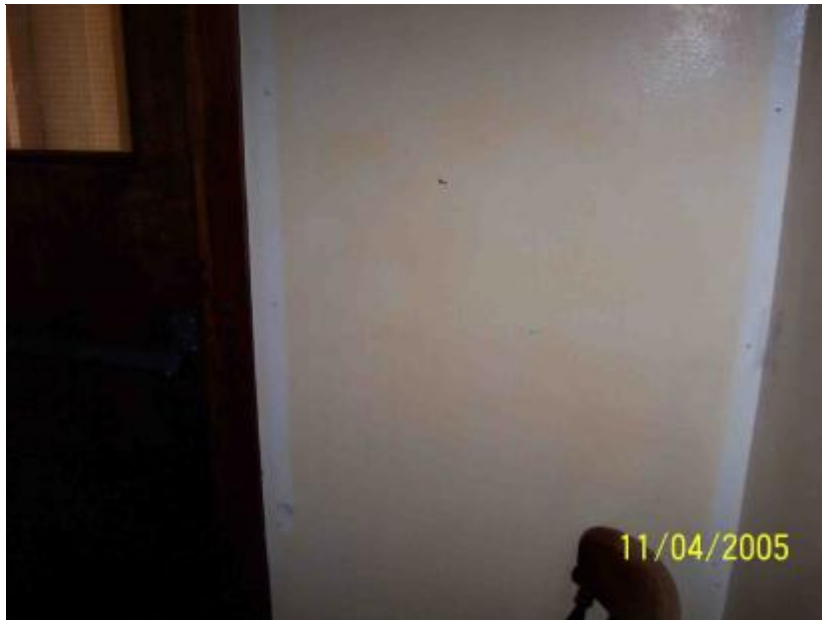
Location ID:	<input type="text" value="3147"/>	Survey Type:	<input type="text" value="T 2"/>
Location Ref:	<input type="text" value="5"/>	Product Type:	<input type="text" value="NADIS"/>
Product:	<input type="text" value="Wall sheeting"/>	Damage:	<input type="text" value="NADIS"/>
Area:	<input type="text" value="Not Applicable"/>	Treatment:	<input type="text" value="NADIS"/>
Floor:	<input type="text" value="Ground floor"/>	Asbestos Type:	<input type="text" value="NADIS"/>
Room:	<input type="text" value="Corridor"/>	Identification:	<input type="text" value="Identified"/>
Surveyor Name:	<input type="text" value="J D Chilvers"/>	Quantity:	<input type="text"/>

Material Risk Score	<input type="text" value="0"/>
Material Risk Band:	<input type="text" value="NADIS"/>
Priority Risk Score:	<input type="text" value="N/A"/>

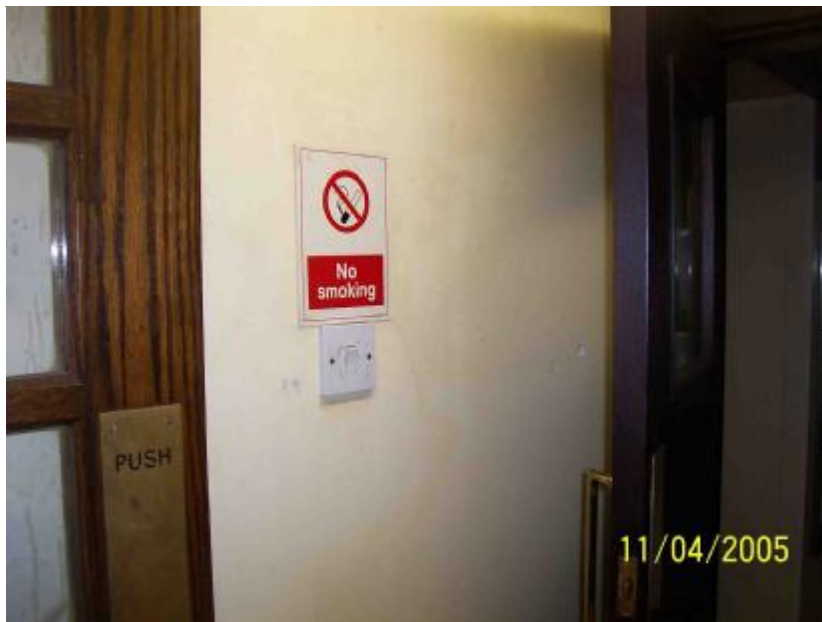
Location ID:	<input type="text" value="3148"/>	Survey Type:	<input type="text" value="T 2"/>
Location Ref:	<input type="text" value="6"/>	Product Type:	<input type="text" value="NADIS"/>
Product:	<input type="text" value="Wall sheeting"/>	Damage:	<input type="text" value="NADIS"/>
Area:	<input type="text" value="Not Applicable"/>	Treatment:	<input type="text" value="NADIS"/>
Floor:	<input type="text" value="Ground floor"/>	Asbestos Type:	<input type="text" value="NADIS"/>
Room:	<input type="text" value="Store Room"/>	Identification:	<input type="text" value="Identified"/>
Surveyor Name:	<input type="text" value="J D Chilvers"/>	Quantity:	<input type="text"/>

Material Risk Score	<input type="text" value="0"/>
Material Risk Band:	<input type="text" value="NADIS"/>
Priority Risk Score:	<input type="text" value="N/A"/>

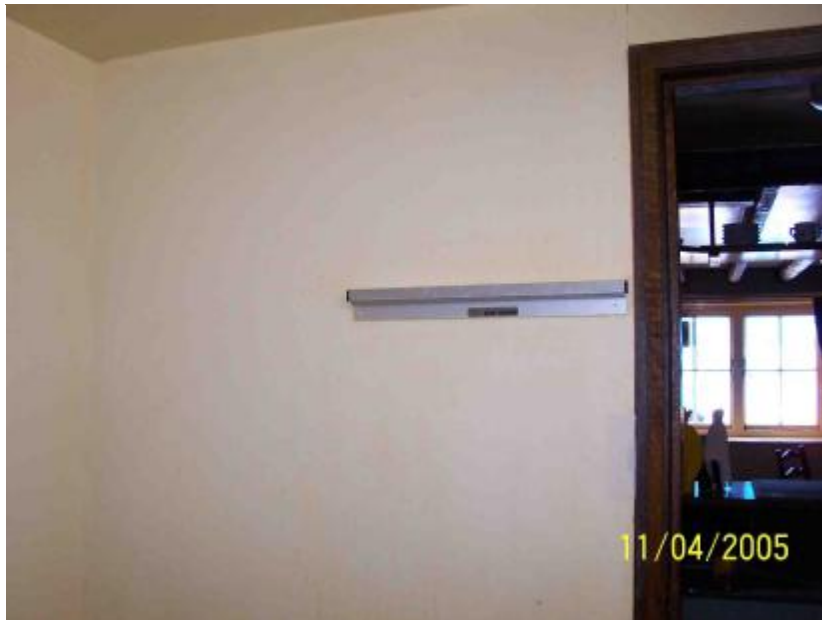
Location ID:	<input type="text" value="3150"/>	Survey Type:	<input type="text" value="T 2"/>
Location Ref:	<input type="text" value="8"/>	Product Type:	<input type="text" value="NADIS"/>
Product:	<input type="text" value="Wall sheeting"/>	Damage:	<input type="text" value="NADIS"/>
Area:	<input type="text" value="Not Applicable"/>	Treatment:	<input type="text" value="NADIS"/>
Floor:	<input type="text" value="Ground floor"/>	Asbestos Type:	<input type="text" value="NADIS"/>
Room:	<input type="text" value="Store Room"/>	Identification:	<input type="text" value="Identified"/>
Surveyor Name:	<input type="text" value="J D Chilvers"/>	Quantity:	<input type="text"/>

Material Risk Score	<input type="text" value="0"/>
Material Risk Band:	<input type="text" value="NADIS"/>
Priority Risk Score:	<input type="text" value="N/A"/>

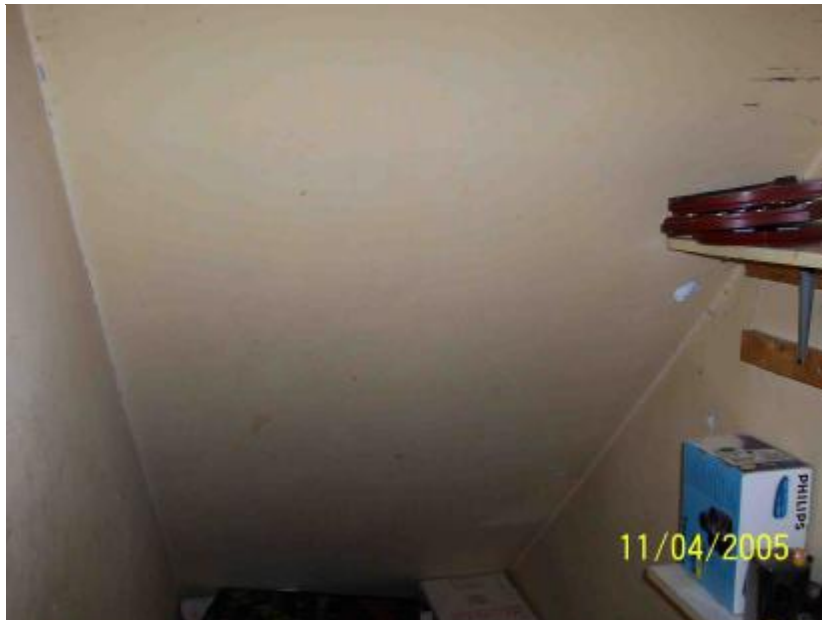
Location ID:	<input type="text" value="3151"/>	Survey Type:	<input type="text" value="T 2"/>
Location Ref:	<input type="text" value="9"/>	Product Type:	<input type="text" value="NADIS"/>
Product:	<input type="text" value="Wall sheeting"/>	Damage:	<input type="text" value="NADIS"/>
Area:	<input type="text" value="Not Applicable"/>	Treatment:	<input type="text" value="NADIS"/>
Floor:	<input type="text" value="Ground floor"/>	Asbestos Type:	<input type="text" value="NADIS"/>
Room:	<input type="text" value="Understair Cupboard"/>	Identification:	<input type="text" value="Identified"/>
Surveyor Name:	<input type="text" value="J D Chilvers"/>	Quantity:	<input type="text"/>

Material Risk Score	<input type="text" value="0"/>
Material Risk Band:	<input type="text" value="NADIS"/>
Priority Risk Score:	<input type="text" value="N/A"/>

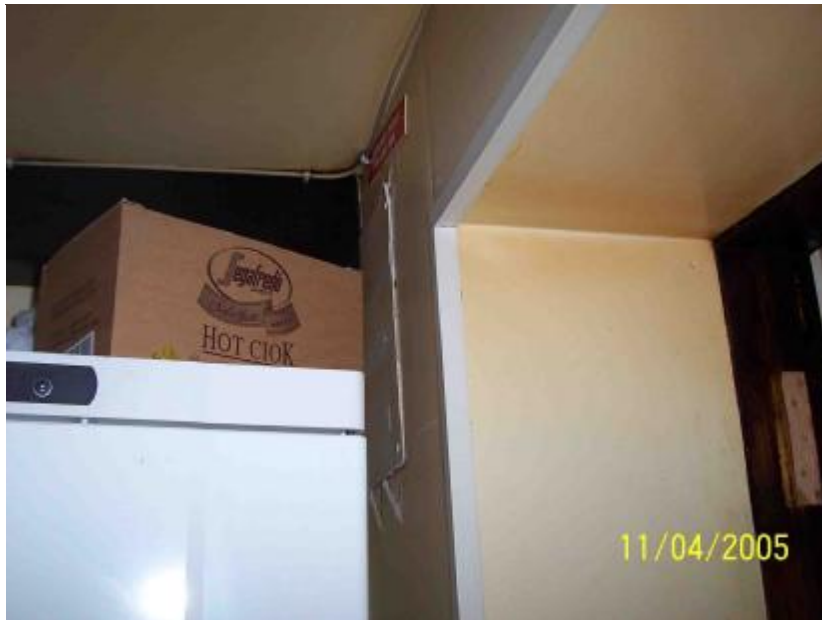
Location ID:	<input type="text" value="3152"/>	Survey Type:	<input type="text" value="T 2"/>
Location Ref:	<input type="text" value="10"/>	Product Type:	<input type="text" value="NADIS"/>
Product:	<input type="text" value="Wall sheeting"/>	Damage:	<input type="text" value="NADIS"/>
Area:	<input type="text" value="Not Applicable"/>	Treatment:	<input type="text" value="NADIS"/>
Floor:	<input type="text" value="Ground floor"/>	Asbestos Type:	<input type="text" value="NADIS"/>
Room:	<input type="text" value="Corridor"/>	Identification:	<input type="text" value="Identified"/>
Surveyor Name:	<input type="text" value="J D Chivers"/>	Quantity:	<input type="text"/>

Material Risk Score	<input type="text" value="0"/>
Material Risk Band:	<input type="text" value="NADIS"/>
Priority Risk Score:	<input type="text" value="N/A"/>

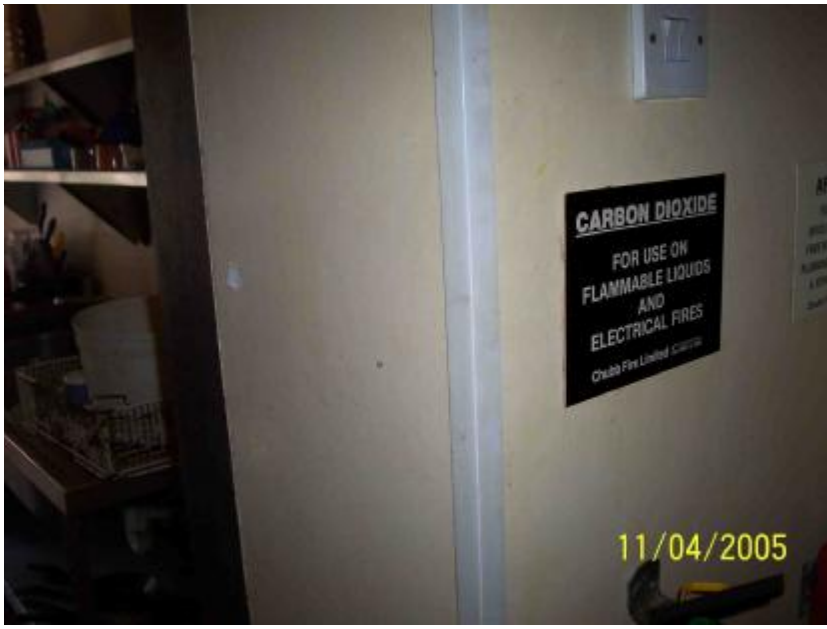
Location ID:	3153	Survey Type:	T 2
Location Ref:	11	Product Type:	NADIS
Product:	Wall sheeting	Damage:	NADIS
Area:	Not Applicable	Treatment:	NADIS
Floor:	Ground floor	Asbestos Type:	NADIS
Room:	Corridor	Identification:	Identified
Surveyor Name:	J D Chilvers	Quantity:	
Drawing Ref:	11	Accessibility:	
Asbestos ?	No		
Date:	11 April 2005		
Next Inspection:	Not Applicable

Material Risk Score	0
Material Risk Band:	NADIS
Priority Risk Score:	N/A

Action:	No Action Required
---------	--------------------

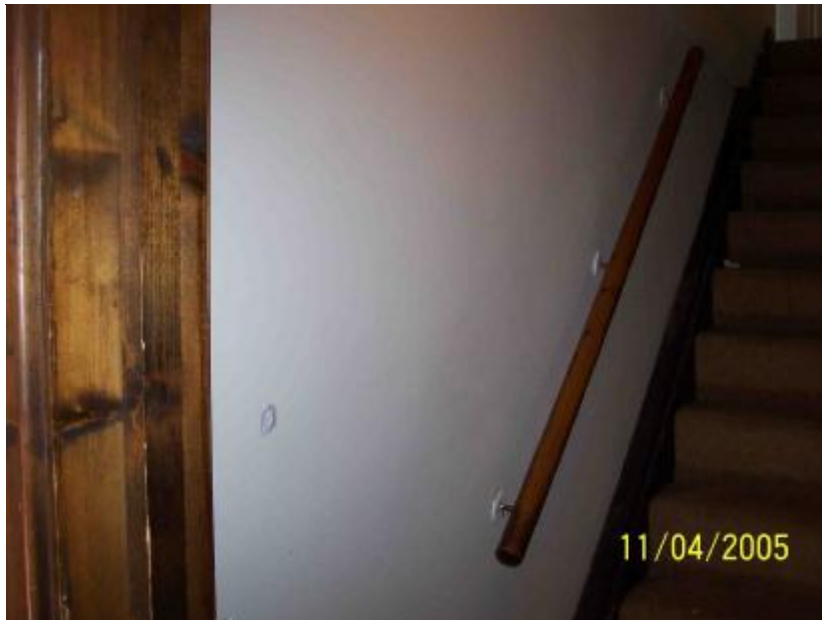
Location ID:	<input type="text" value="3154"/>	Survey Type:	<input type="text" value="T 2"/>
Location Ref:	<input type="text" value="12"/>	Product Type:	<input type="text" value="NADIS"/>
Product:	<input type="text" value="Wall sheeting"/>	Damage:	<input type="text" value="NADIS"/>
Area:	<input type="text" value="Not Applicable"/>	Treatment:	<input type="text" value="NADIS"/>
Floor:	<input type="text" value="Ground floor"/>	Asbestos Type:	<input type="text" value="NADIS"/>
Room:	<input type="text" value="Staircase"/>	Identification:	<input type="text" value="Identified"/>
Surveyor Name:	<input type="text" value="J D Chilvers"/>	Quantity:	<input type="text"/>

Material Risk Score	<input type="text" value="0"/>
Material Risk Band:	<input type="text" value="NADIS"/>
Priority Risk Score:	<input type="text" value="N/A"/>

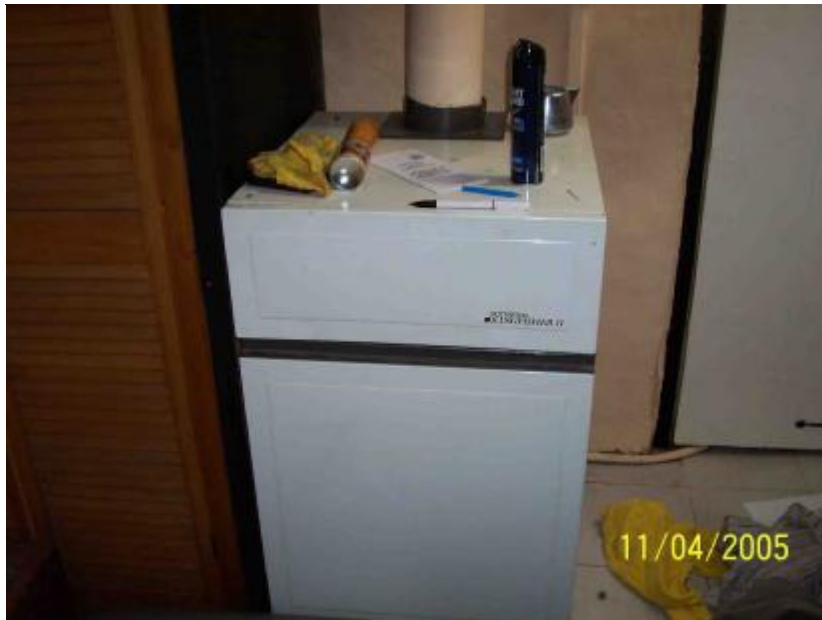
Location ID:	<input type="text" value="3155"/>	Survey Type:	<input type="text" value="T 2"/>
Location Ref:	<input type="text" value="13"/>	Product Type:	<input type="text" value="Gaskets"/>
Product:	<input type="text" value="Boiler"/>	Damage:	<input type="text" value="No visible damage"/>
Area:	<input type="text" value="Not Applicable"/>	Treatment:	<input type="text" value="Composite asbestos materials"/>
Floor:	<input type="text" value="First floor"/>	Asbestos Type:	<input type="text" value="Chrysotile"/>
Room:	<input type="text" value="Boiler room"/>	Identification:	<input type="text" value="Presumed"/>
Surveyor Name:	<input type="text" value="J D Chilvers"/>	Quantity:	<input type="text"/>

Material Risk Score	<input type="text" value="3"/>
Material Risk Band:	<input type="text" value="Very Low Risk"/>
Priority Risk Score:	<input type="text" value="3"/>

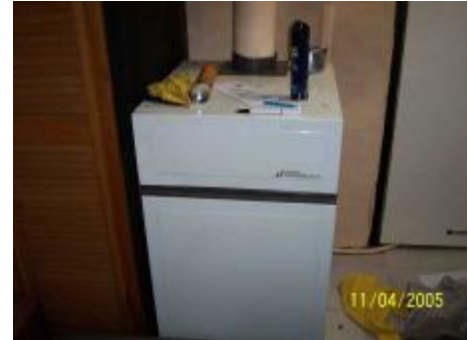
Location ID:	<input style="width: 95%;" type="text" value="3155"/>
Location Ref:	<input style="width: 95%;" type="text" value="13"/>
Product:	<input style="width: 95%;" type="text" value="Boiler"/>
Area:	<input style="width: 95%;" type="text" value="Not Applicable"/>
Floor:	<input style="width: 95%;" type="text" value="First floor"/>
Room:	<input style="width: 95%;" type="text" value="Boiler room"/>
Surveyor Name:	<input style="width: 95%;" type="text" value="J D Chilvers"/>
Drawing Ref:	<input style="width: 95%;" type="text" value="12a"/>
Asbestos ?	<input style="width: 95%;" type="text" value="Yes"/>
Date:	<input style="width: 95%;" type="text" value="11 April 2005"/>

Priority Assessment Algorithm	Variable(s) selected	Score for each	Overall score
<b>Normal Occupant Activity:</b>			
Main type of activity in area:	Rare disturbance	0	average
Secondary activities for area:	Rare disturbance	0	0
<b>Likelihood Of Disturbance:</b>			
Location:	Rooms up to 100 m2	2	average
Accessibility:	Occasionally likely to be disturbed	1	
Extent/Amount:	Small items strings gaskets	0	
<b>Human Exposure Potential:</b>			
Number of occupants:	1 to 3	1	average
Frequency of use of area:	Monthly	1	
Average time area is in use:	<1 hour	0	
<b>Maintenance Activity:</b>			
Type of maintenance activity:	Low disturbance	1	average
Frequency of maintenance activity	Unlikely to be disturbed	0	1

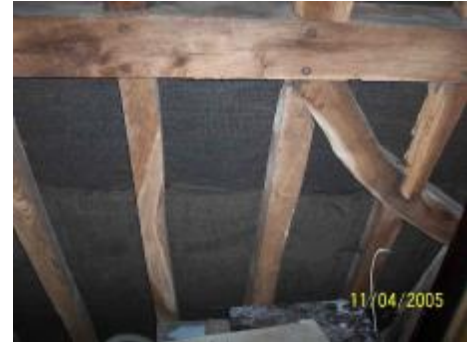
Location ID:	<input style="width: 95%;" type="text" value="3157"/>
Location Ref:	<input style="width: 95%;" type="text" value="15"/>
Product:	<input style="width: 95%;" type="text" value="Roofing felt"/>
Area:	<input style="width: 95%;" type="text" value="Not Applicable"/>
Floor:	<input style="width: 95%;" type="text" value="Roof level"/>
Room:	<input style="width: 95%;" type="text" value="Loft space"/>
Surveyor Name:	<input style="width: 95%;" type="text" value="J D Chilvers"/>
Drawing Ref:	<input style="width: 95%;" type="text" value="14"/>
Asbestos ?	<input style="width: 95%;" type="text" value="Yes"/>
Date:	<input style="width: 95%;" type="text" value="11 April 2005"/>

Priority Assessment Algorithm			
Assessment factor	Variable(s) selected	Score for each	Overall score
<b>Normal Occupant Activity:</b>			
Main type of activity in area:	Rare disturbance	0	average
Secondary activities for area:	Rare disturbance	0	0
<b>Likelihood Of Disturbance:</b>			
Location:	Large rooms or well-ventilated areas	1	
Accessibility:	Usually inaccessible or unlikely to be disturbed	0	average
Extent/Amount:	>50 m2 or >50 m pipe run	3	1
<b>Human Exposure Potential:</b>			
Number of occupants:	1 to 3	1	
Frequency of use of area:	Infrequent	0	average
Average time area is in use:	<1 hour	0	0
<b>Maintenance Activity:</b>			
Type of maintenance activity:	Minor disturbance	0	average
Frequency of maintenance activity	Unlikely to be disturbed	0	0

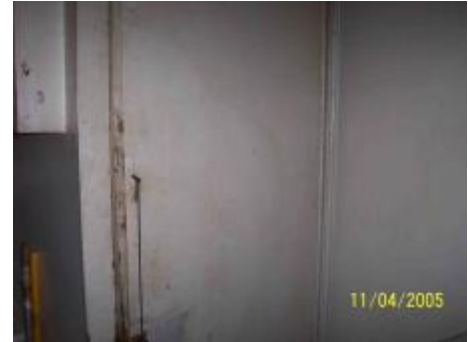
Location ID:	<input style="width: 95%;" type="text" value="3161"/>
Location Ref:	<input style="width: 95%;" type="text" value="19"/>
Product:	<input style="width: 95%;" type="text" value="Door panel"/>
Area:	<input style="width: 95%;" type="text" value="Not Applicable"/>
Floor:	<input style="width: 95%;" type="text" value="Ground floor"/>
Room:	<input style="width: 95%;" type="text" value="Kitchen"/>
Surveyor Name:	<input style="width: 95%;" type="text" value="J D Chilvers"/>
Drawing Ref:	<input style="width: 95%;" type="text" value="18"/>
Asbestos ?	<input style="width: 95%;" type="text" value="Yes"/>
Date:	<input style="width: 95%;" type="text" value="11 April 2005"/>

Priority Assessment Algorithm	Variable(s) selected	Score for each	Overall score
<b>Normal Occupant Activity:</b>			
Main type of activity in area:	Low disturbance	1	average
Secondary activities for area:	Low disturbance	1	1
<b>Likelihood Of Disturbance:</b>			
Location:	Rooms up to 100 m2	2	average
Accessibility:	Easily disturbed	2	
Extent/Amount:	<=10 m2 or <=10 m pipe run	1	
<b>Human Exposure Potential:</b>			
Number of occupants:	1 to 3	1	average
Frequency of use of area:	Daily	3	
Average time area is in use:	>3 to <6 hours	2	
<b>Maintenance Activity:</b>			
Type of maintenance activity:	Low disturbance	1	average
Frequency of maintenance activity	<=1 per year	1	1

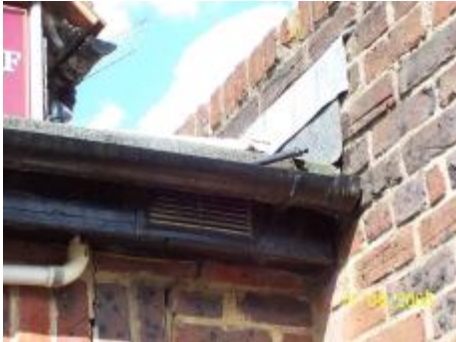
Location ID:	<input style="width: 95%;" type="text" value="3167"/>
Location Ref:	<input style="width: 95%;" type="text" value="25"/>
Product:	<input style="width: 95%;" type="text" value="Roofing felt"/>
Area:	<input style="width: 95%;" type="text" value="Not Applicable"/>
Floor:	<input style="width: 95%;" type="text" value="Roof level"/>
Room:	<input style="width: 95%;" type="text" value="Flat roof area"/>
Surveyor Name:	<input style="width: 95%;" type="text" value="J D Chilvers"/>
Drawing Ref:	<input style="width: 95%;" type="text" value="24"/>
Asbestos ?	<input style="width: 95%;" type="text" value="Yes"/>
Date:	<input style="width: 95%;" type="text" value="11 April 2005"/>

Priority Assessment Algorithm			
Assessment factor	Variable(s) selected	Score for each	Overall score
<b>Normal Occupant Activity:</b>			
Main type of activity in area:	Rare disturbance	0	average
Secondary activities for area:	Rare disturbance	0	0
<b>Likelihood Of Disturbance:</b>			
Location:	Outdoors	0	
Accessibility:	Usually inaccessible or unlikely to be disturbed	0	average
Extent/Amount:	>10 to <=50 (m2 or pipe run)	2	1
<b>Human Exposure Potential:</b>			
Number of occupants:	1 to 3	1	
Frequency of use of area:	Infrequent	0	average
Average time area is in use:	<1 hour	0	0
<b>Maintenance Activity:</b>			
Type of maintenance activity:	Minor disturbance	0	average
Frequency of maintenance activity	Unlikely to be disturbed	0	0

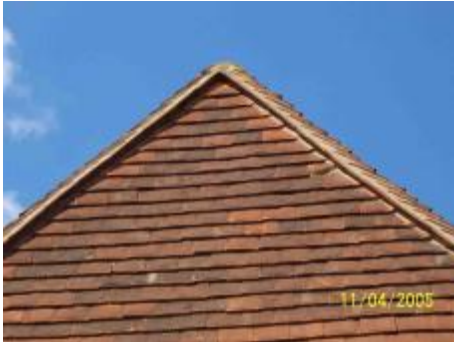
Location ID:	<input style="width: 95%;" type="text" value="3168"/>
Location Ref:	<input style="width: 95%;" type="text" value="26"/>
Product:	<input style="width: 95%;" type="text" value="Verge Undercloak"/>
Area:	<input style="width: 95%;" type="text" value="Not Applicable"/>
Floor:	<input style="width: 95%;" type="text" value="Roof level"/>
Room:	<input style="width: 95%;" type="text" value="External"/>
Surveyor Name:	<input style="width: 95%;" type="text" value="J D Chilvers"/>
Drawing Ref:	<input style="width: 95%;" type="text" value="25"/>
Asbestos ?	<input style="width: 95%;" type="text" value="Yes"/>
Date:	<input style="width: 95%;" type="text" value="11 April 2005"/>

Priority Assessment Algorithm	Variable(s) selected	Score for each	Overall score
<b>Normal Occupant Activity:</b>			
Main type of activity in area:	Rare disturbance	0	average
Secondary activities for area:	Rare disturbance	0	0
<b>Likelihood Of Disturbance:</b>			
Location:	Outdoors	0	average
Accessibility:	Usually inaccessible or unlikely to be disturbed	0	
Extent/Amount:	<=10 m2 or <=10 m pipe run	1	
<b>Human Exposure Potential:</b>			
Number of occupants:	None	0	average
Frequency of use of area:	Infrequent	0	
Average time area is in use:	<1 hour	0	
<b>Maintenance Activity:</b>			
Type of maintenance activity:	Minor disturbance	0	average
Frequency of maintenance activity	Unlikely to be disturbed	0	0
